Expertise

Protocol number: 46923268  
Order No. / Reference: 26747088  
Inspection date: 6 Aug 2026

Manufacturer: Mercedes-Benz

Model: C 220 d 4Matic T 9G-TRONIC AMG Line

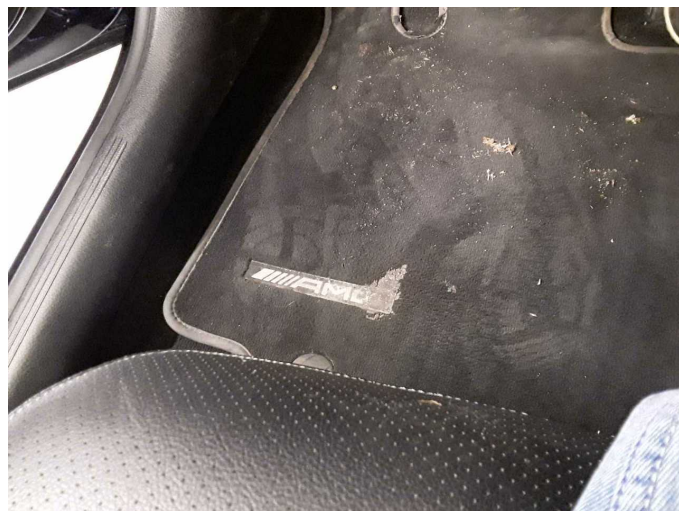
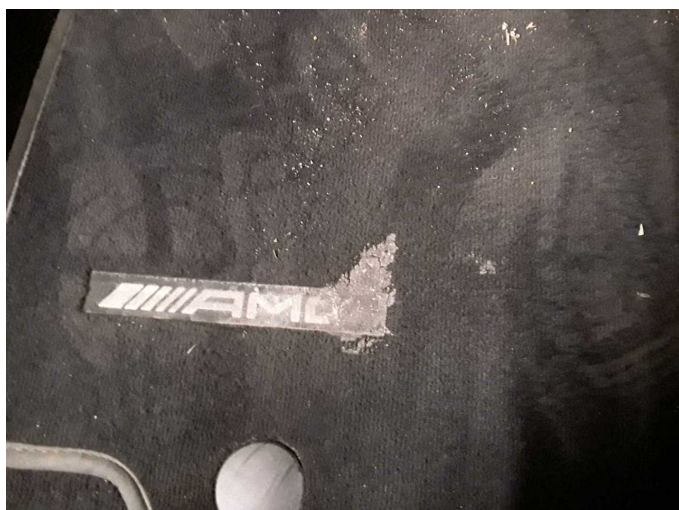
| No. | Component group | Description |
|---|---|---|
| 1 | Trim / covers | Carpet - front left side - Damaged - Replace |

**Damage 1:** Trim / covers: Carpet - front left side - Damaged - Replace

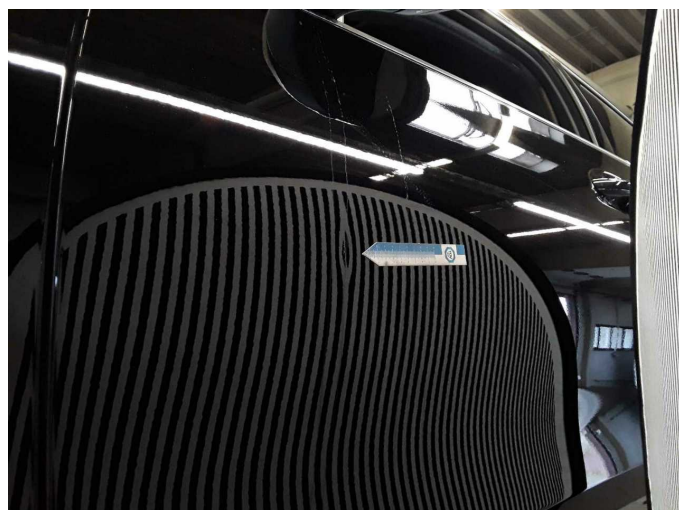
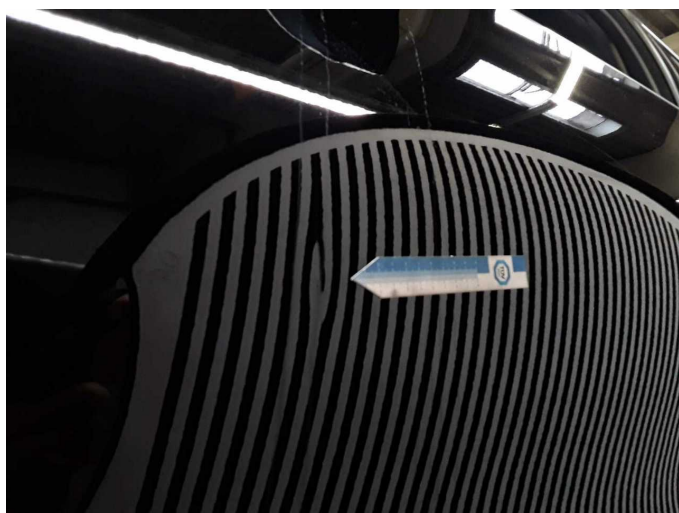
| No. | Component group | Description |
|---|---|---|
| 2 | Door - front left side | Door - Dent / paintcoat damage - Smooth repair work |

**Damage 2:** Door - front left side: Door - Dent / paintcoat damage - Smooth repair work

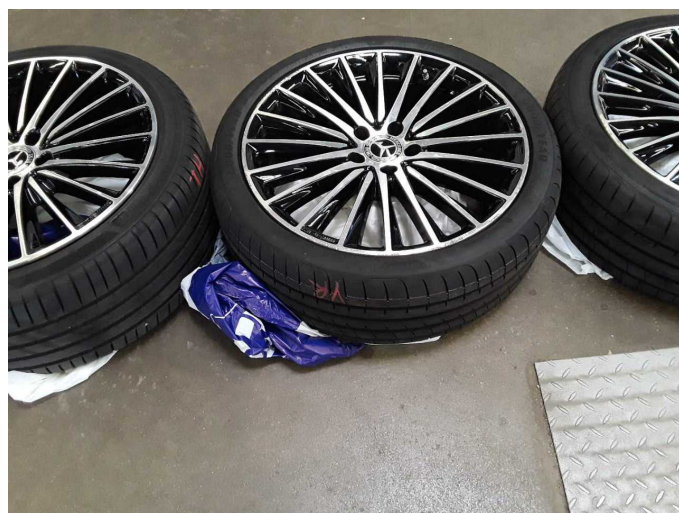
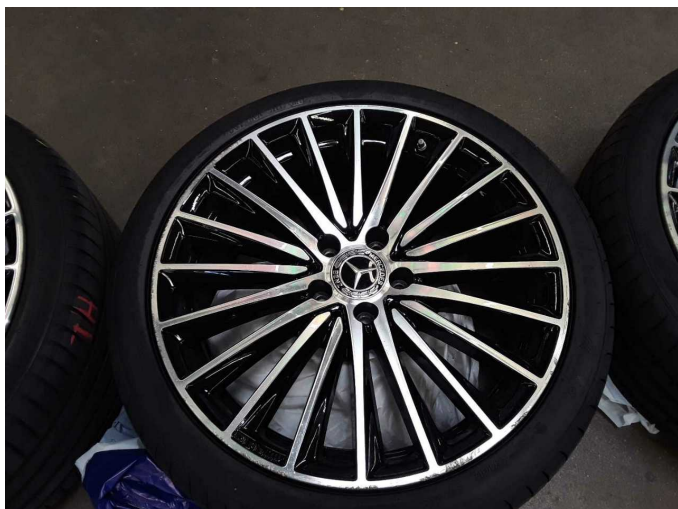
| No. | Component group | Description |
|---|---|---|
| 3 | 2nd wheel set | 1 tyre (VR platt) - Replace |

**Damage 3:** 2nd wheel set: 1 tyre (VR platt) - Replace

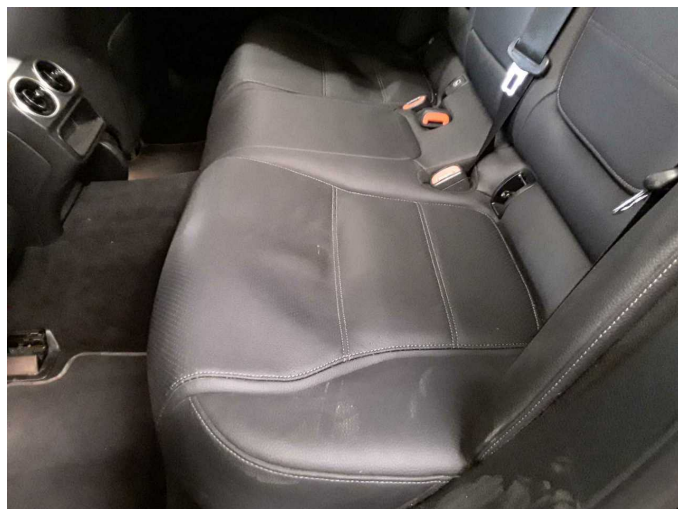
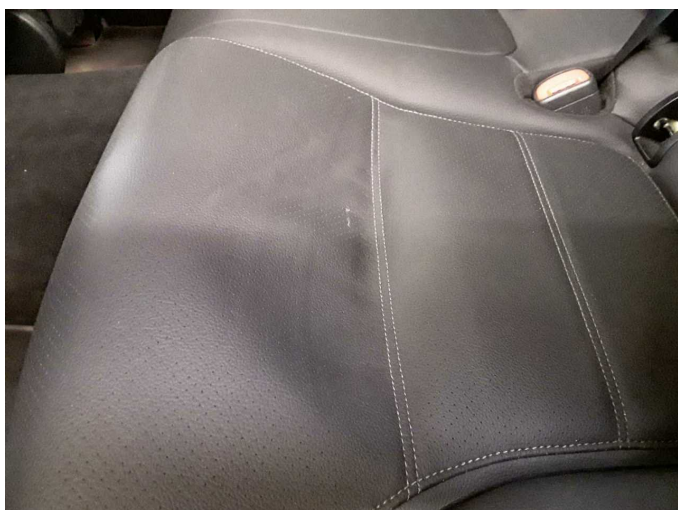
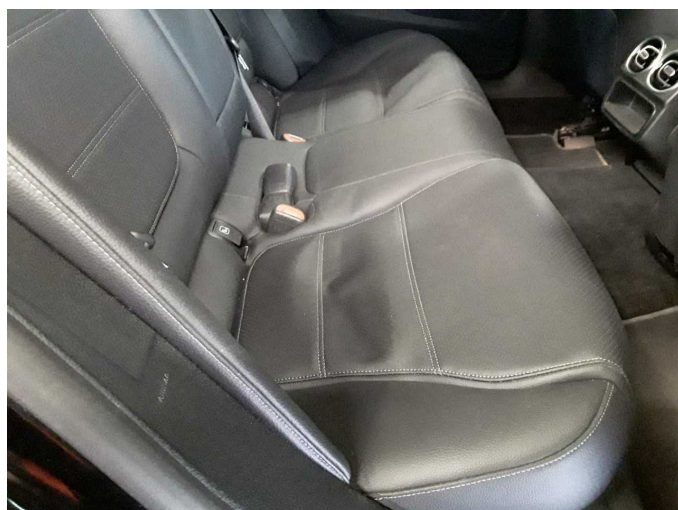
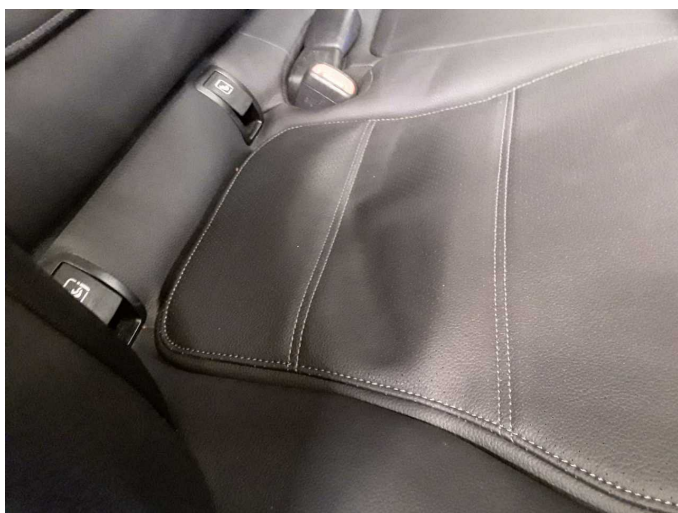
| No. | Component group | Description |
|---|---|---|
| 4 | Seat - rear | Seat upholstery - 2nd row (Druckstellen) - Damaged - Loss in value |

**Damage 4:** Seat - rear: Seat upholstery - 2nd row (Druckstellen) - Damaged - Loss in value

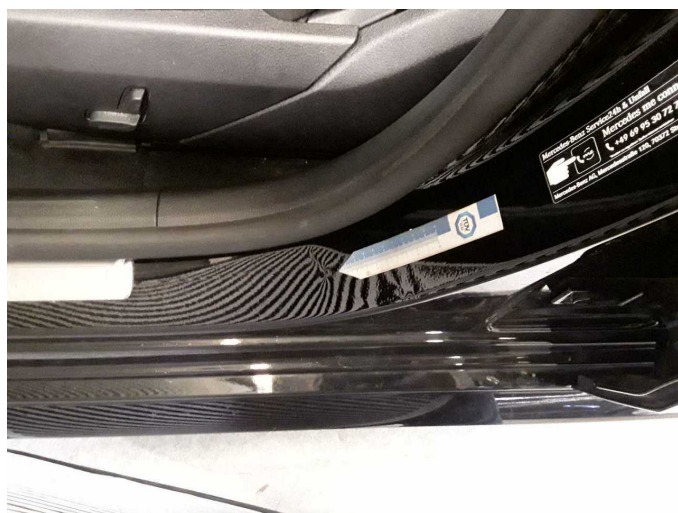
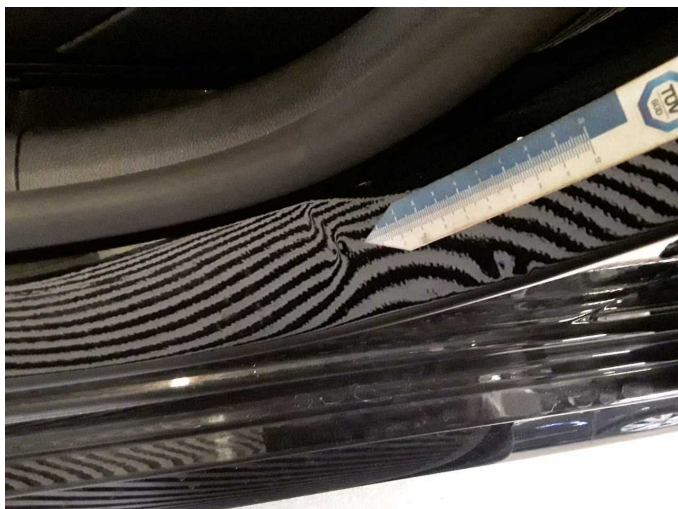
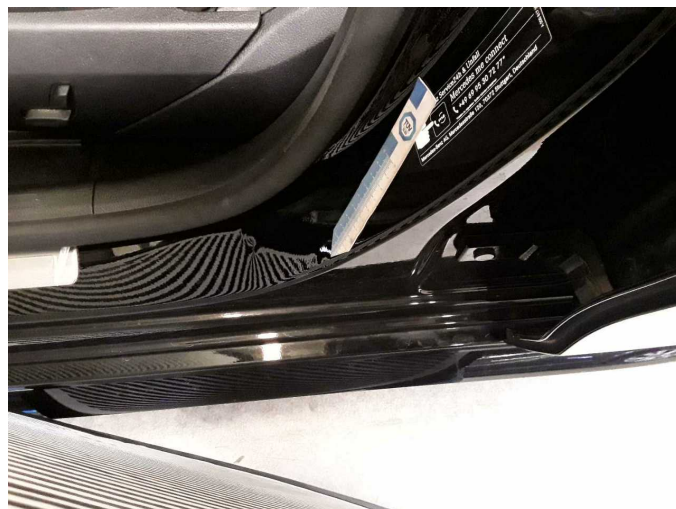
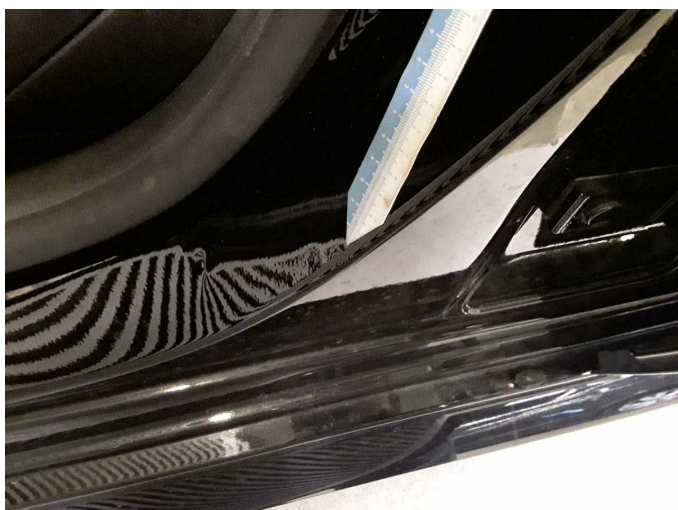
| No. | Component group | Description |
|---|---|---|
| 5 | Sill - left side | Sill - dent(s) - Repair and paint |

**Damage 5:** Sill - left side: Sill - dent(s) - Repair and paint

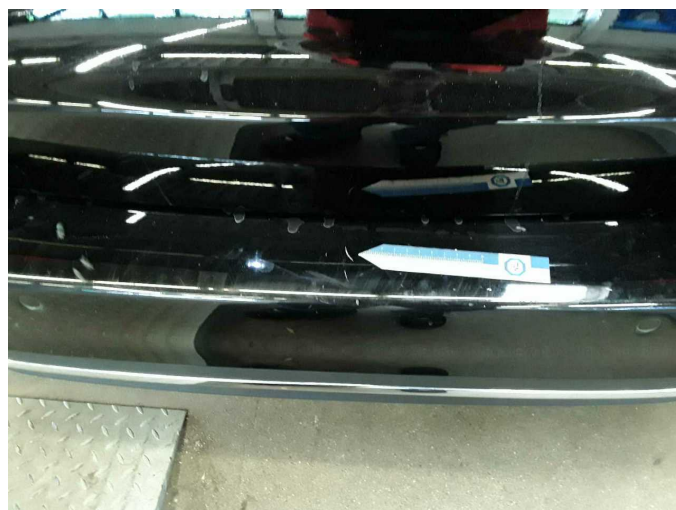
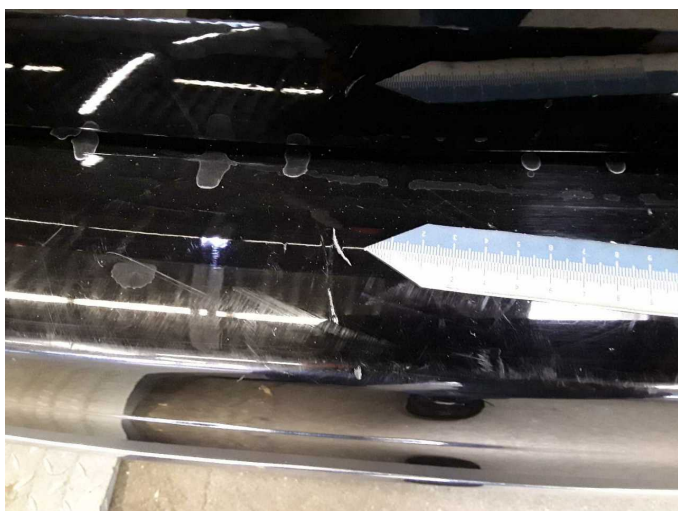
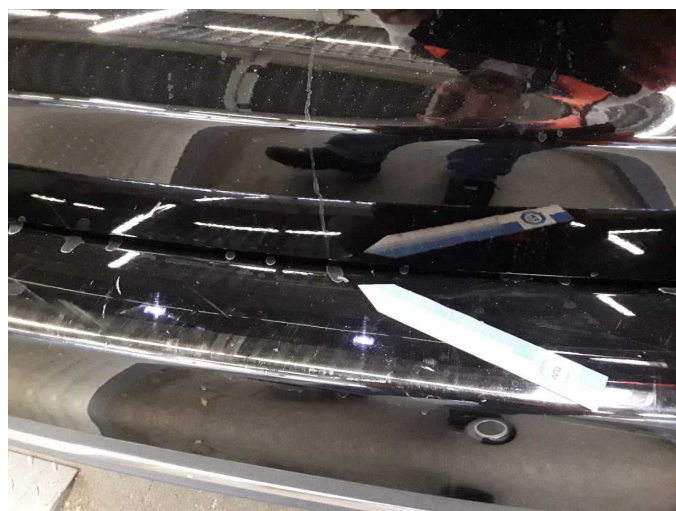
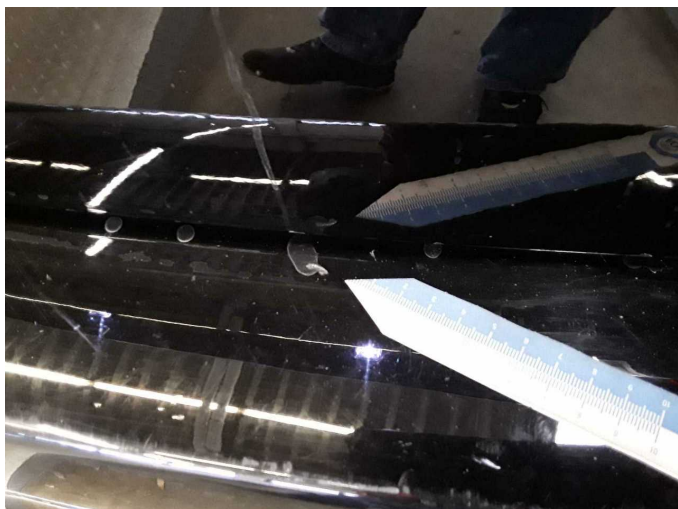
| No. | Component group | Description |
|---|---|---|
| 6 | Rear bumper | Rear bumper - Scratched - Paint |

**Damage 6:** Rear bumper: Rear bumper - Scratched - Paint

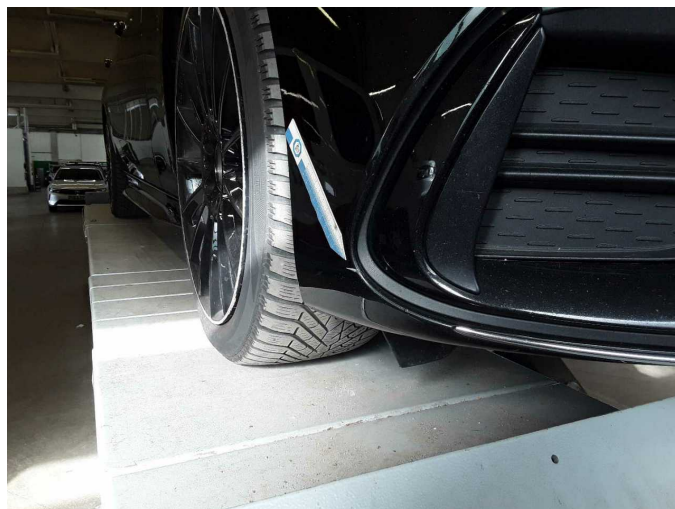
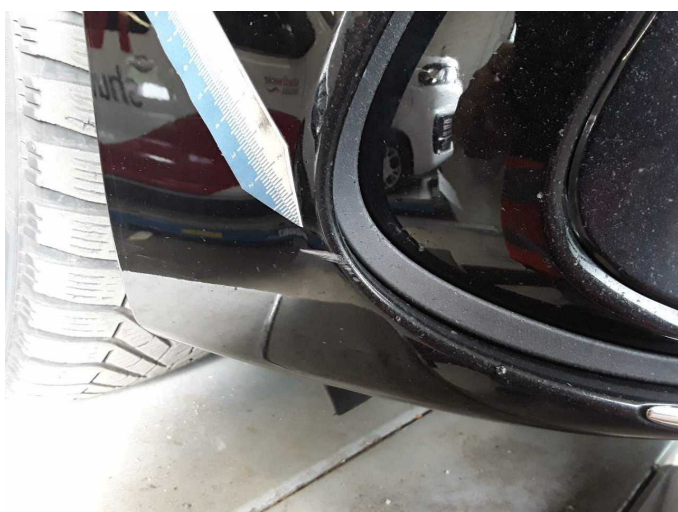
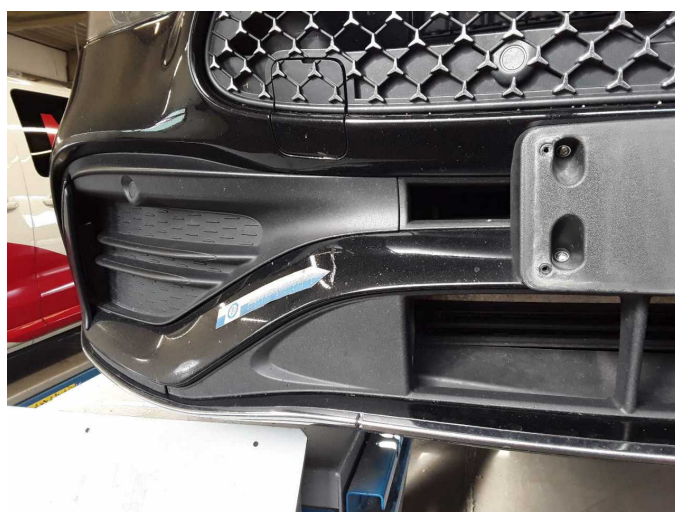
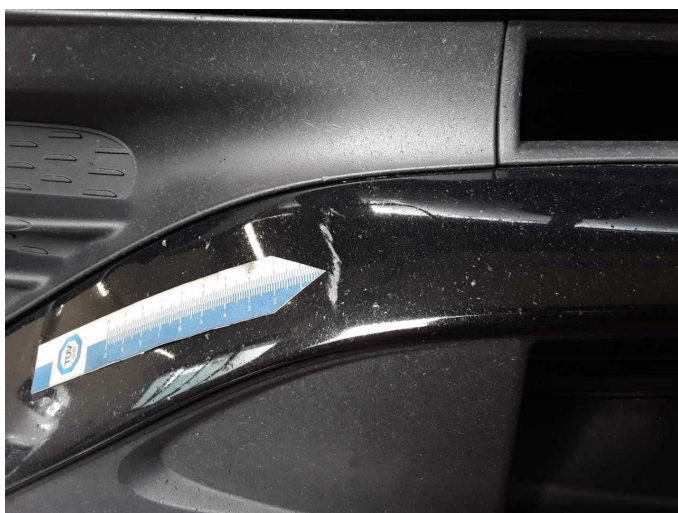
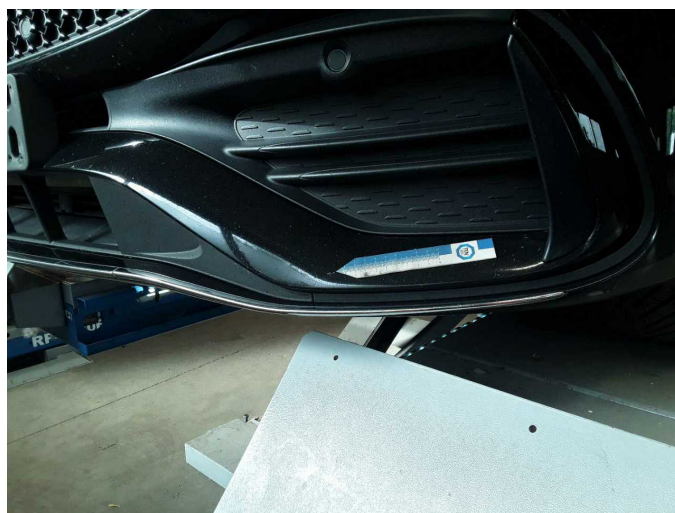
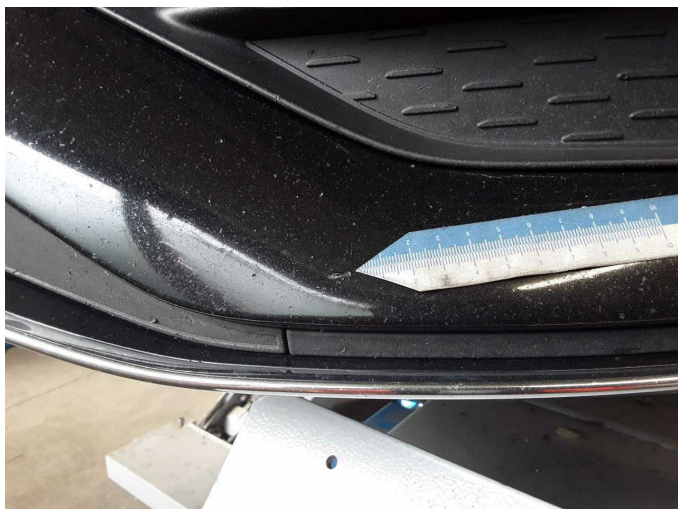
| No. | Component group | Description |
|---|---|---|
| 7 | Front bumper | Front bumper - Scratched - Paint |

**Damage 7:** Front bumper: Front bumper - Scratched - Paint

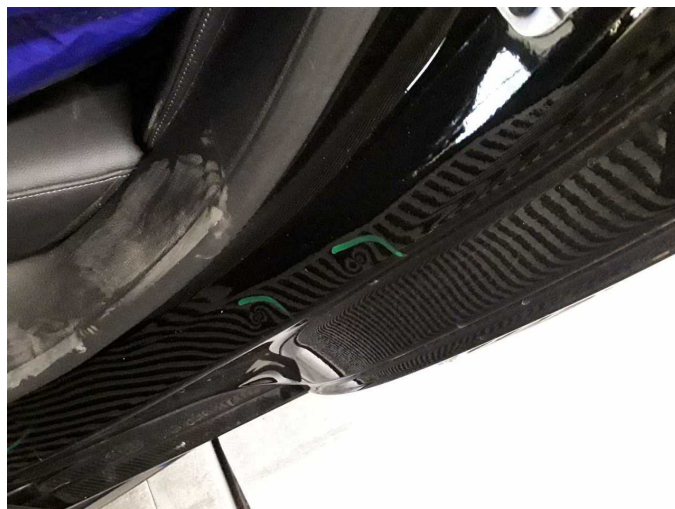
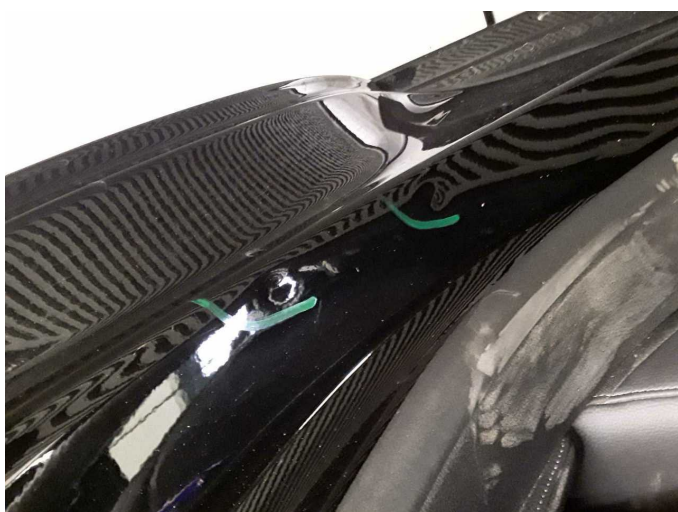
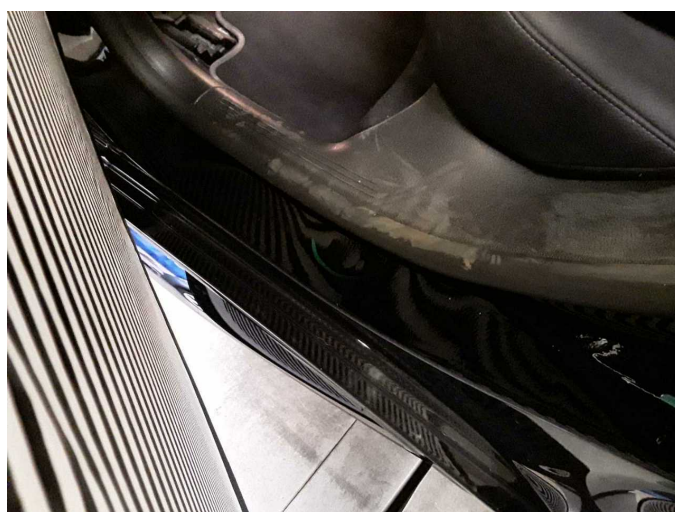
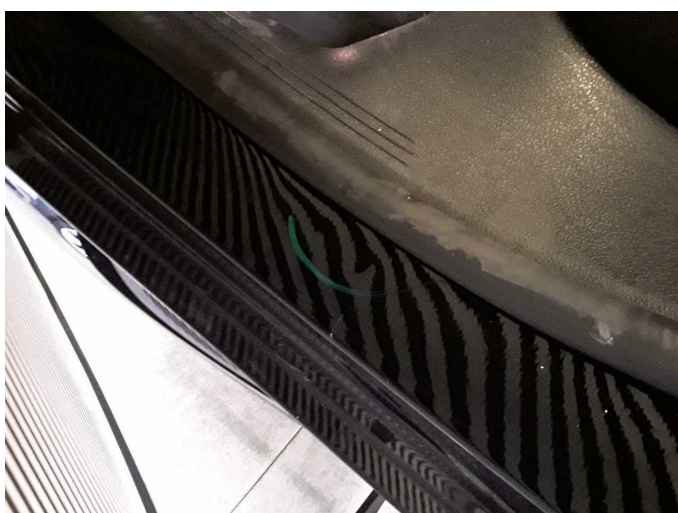
| No. | Component group | Description |
|---|---|---|
| 8 | Side panel - rear left side | Sill - dent(s) - Repair and paint |

**Damage 8:** Side panel - rear left side: Sill - dent(s) - Repair and paint

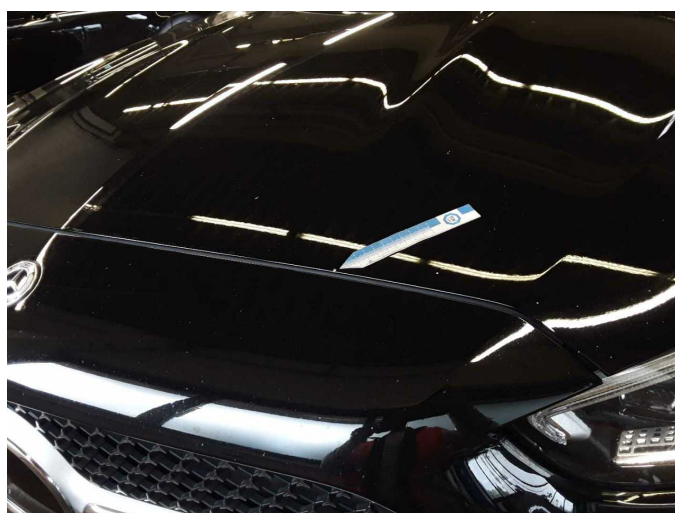
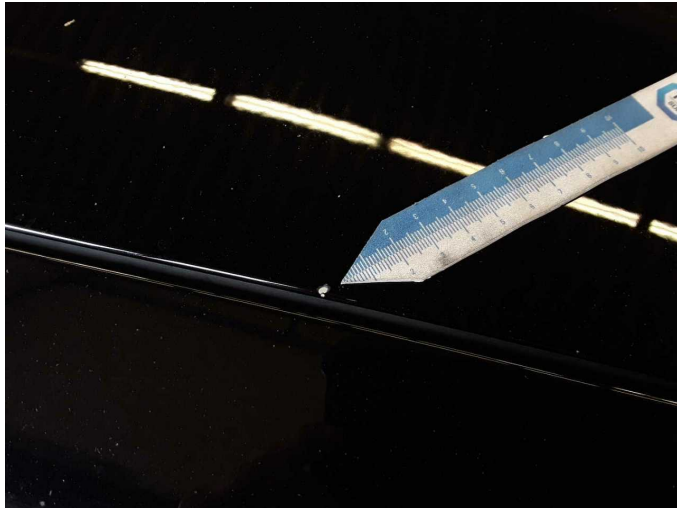
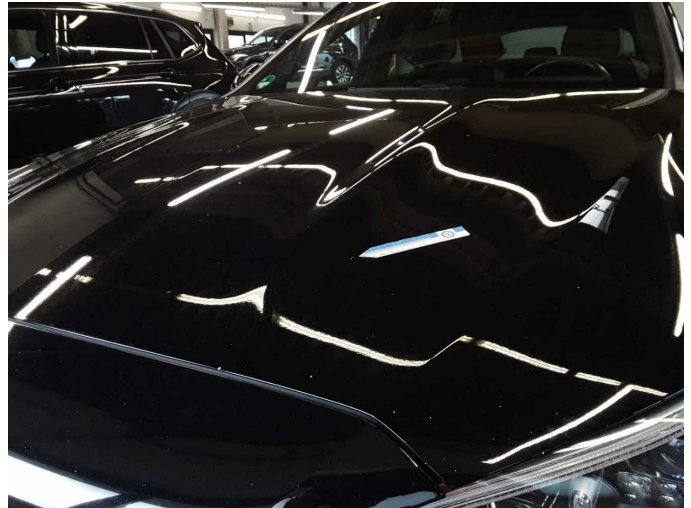
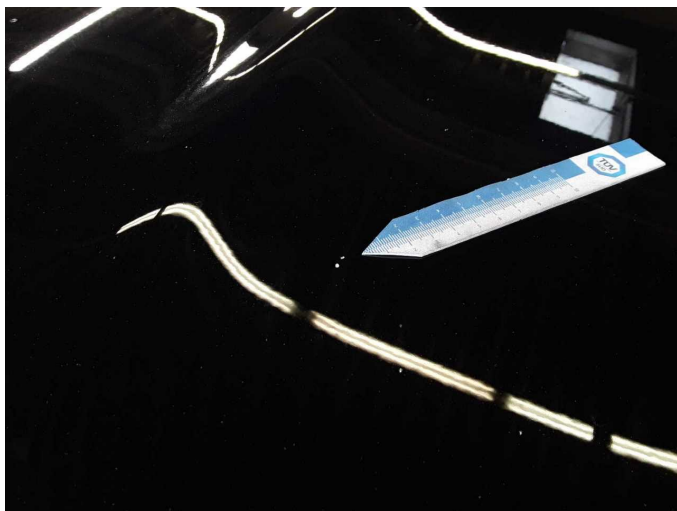
| No. | Component group | Description |
|---|---|---|
| 9 | Bonnet | Bonnet - Stone chips - Paint |

**Damage 9:** Bonnet: Bonnet - Stone chips - Paint

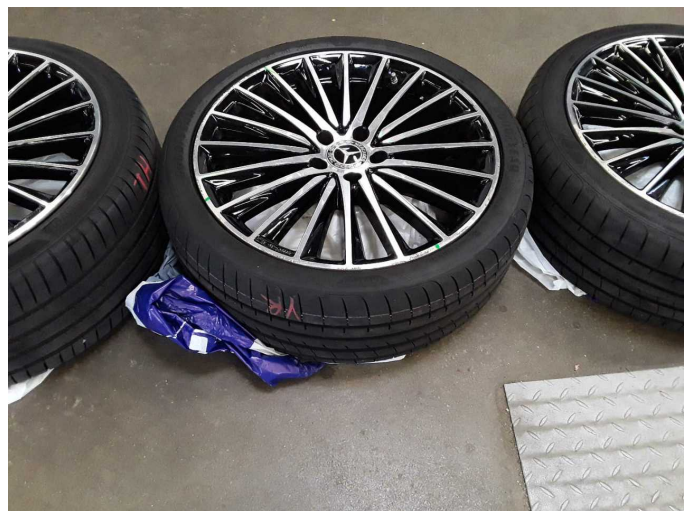
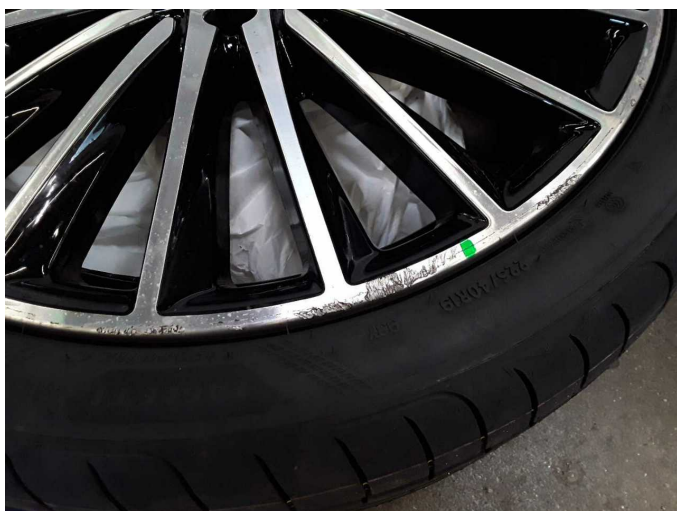
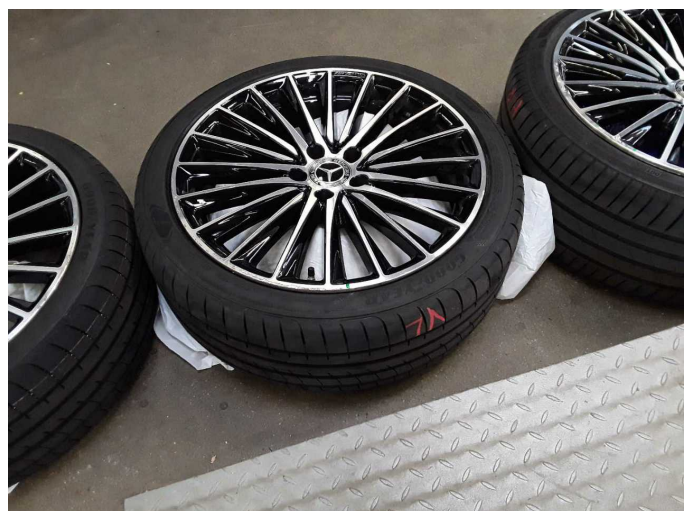
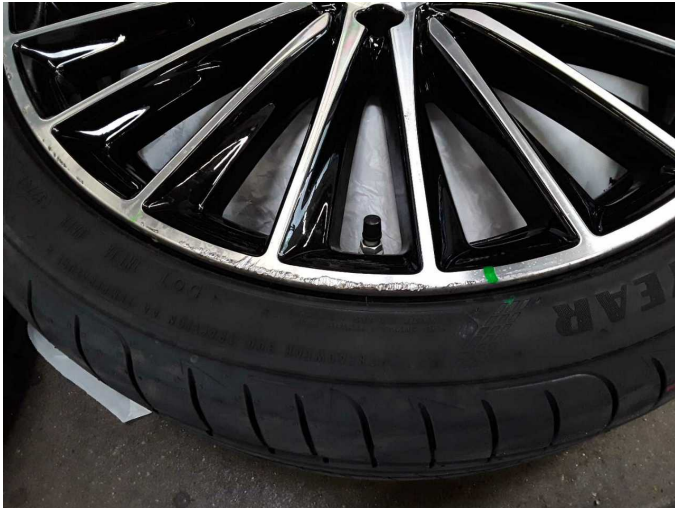
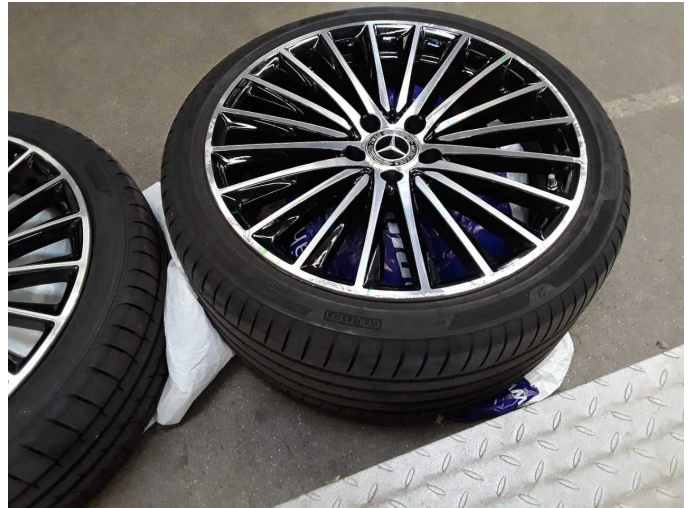
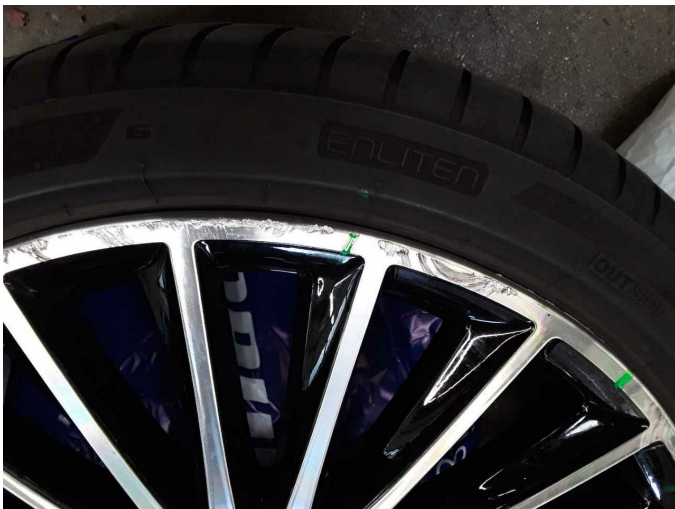
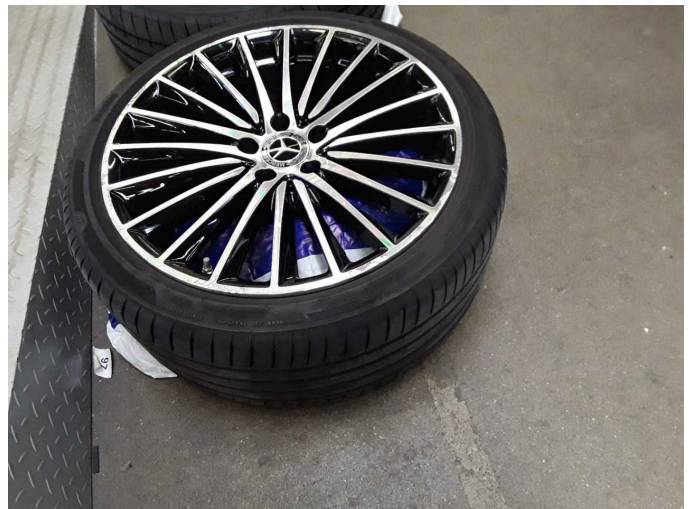
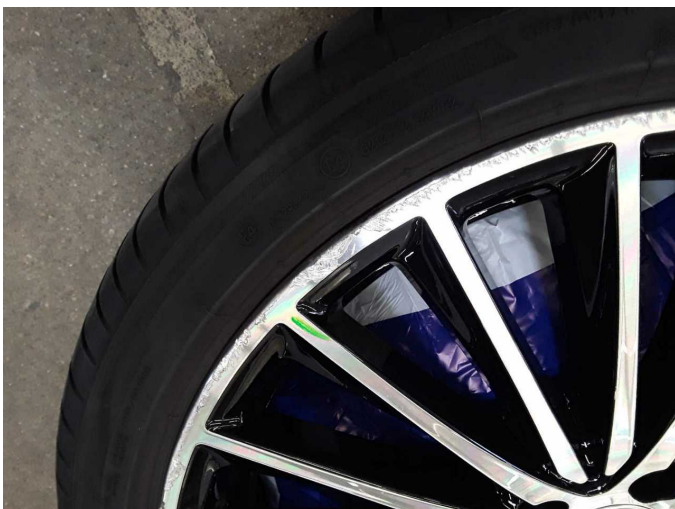
| No. | Component group | Description |
|---|---|---|
| 10 | 2nd wheel set | 3 alloy rims (VL VR HR) - Scratched - Replace |

**Damage 10:** 2nd wheel set: 3 alloy rims (VL VR HR) - Scratched - Replace

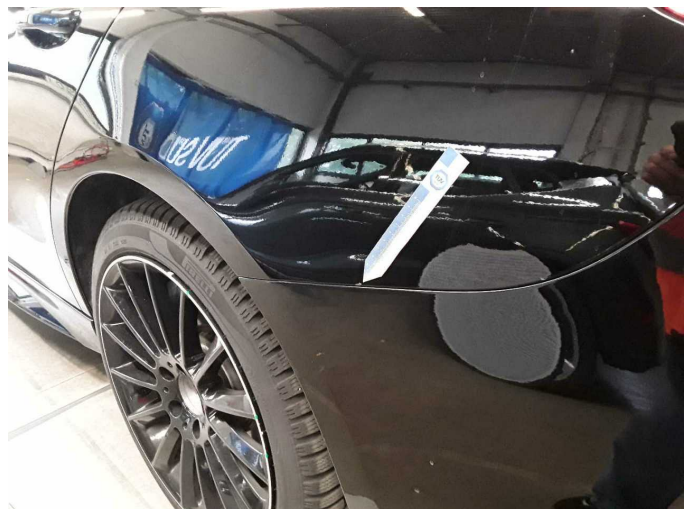
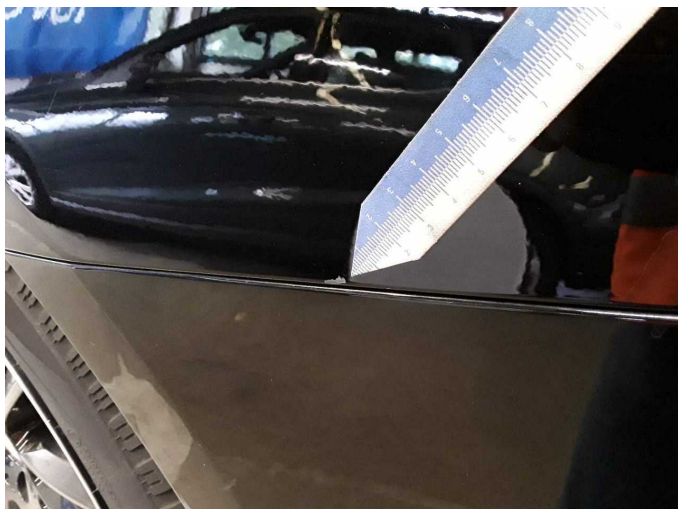
| No. | Component group | Description |
|---|---|---|
| 1 | Side panel - rear left side | Side panel - Scratched - No deduction |

**Wear and tear 1:** Side panel - rear left side: Side panel - Scratched - No deduction

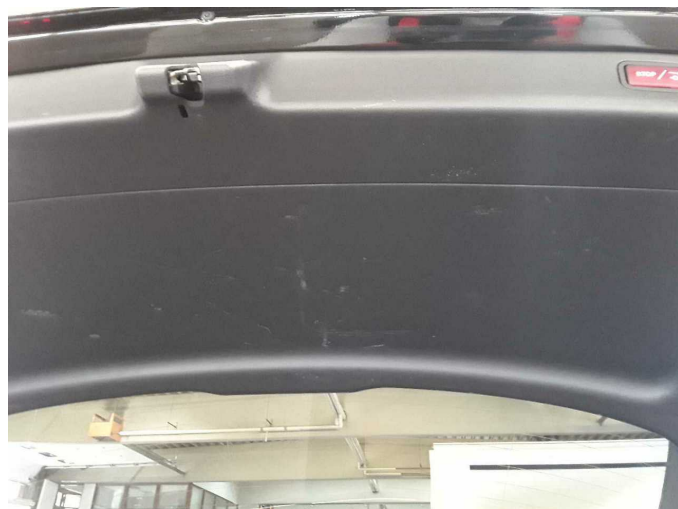
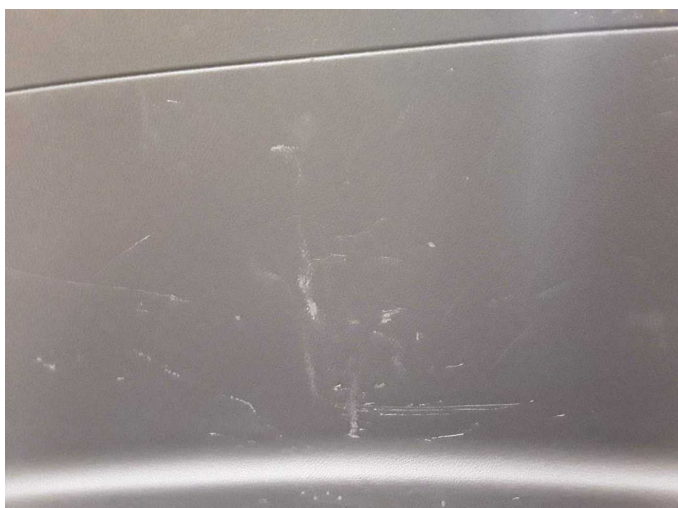
| No. | Component group | Description |
|---|---|---|
| 2 | Boot lid / rear door | Trim - standard - lower - Scratched - No deduction |

**Wear and tear 2:** Boot lid / rear door: Trim - standard - lower - Scratched - No deduction

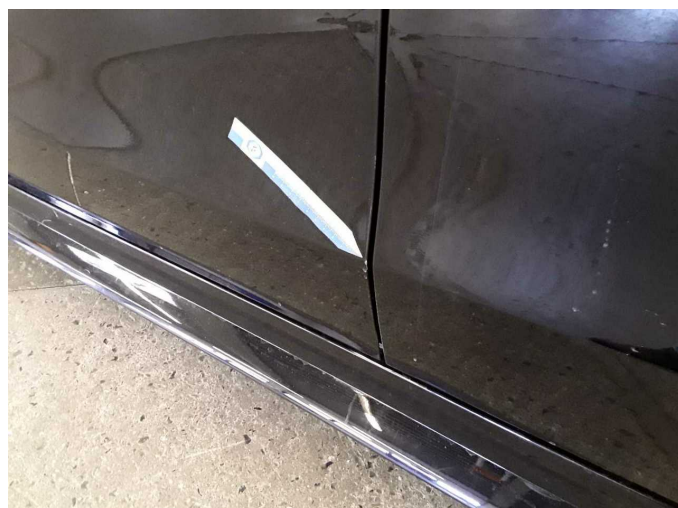
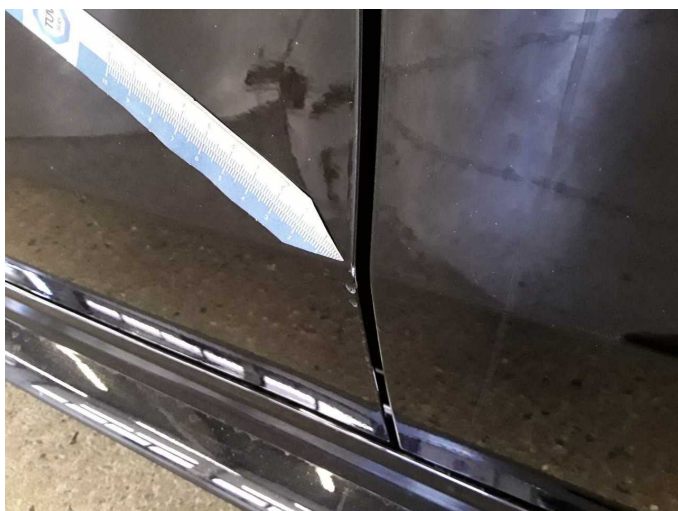
| No. | Component group | Description |
|---|---|---|
| 3 | Door - front left side | Door edge - Scratched - No deduction |

**Wear and tear 3:** Door - front left side: Door edge - Scratched - No deduction

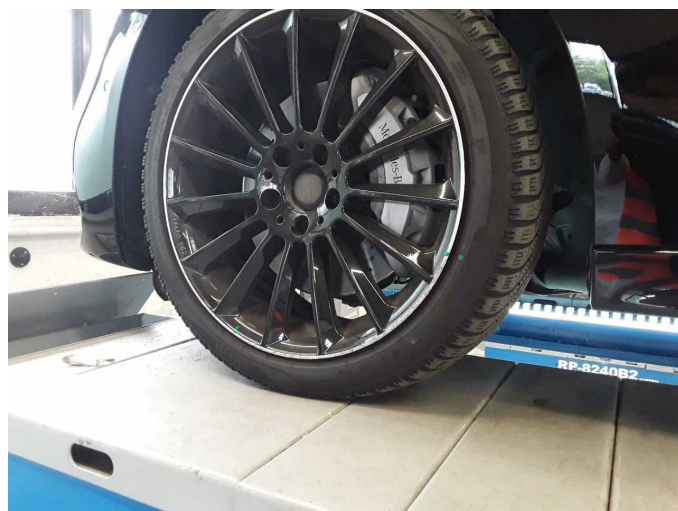
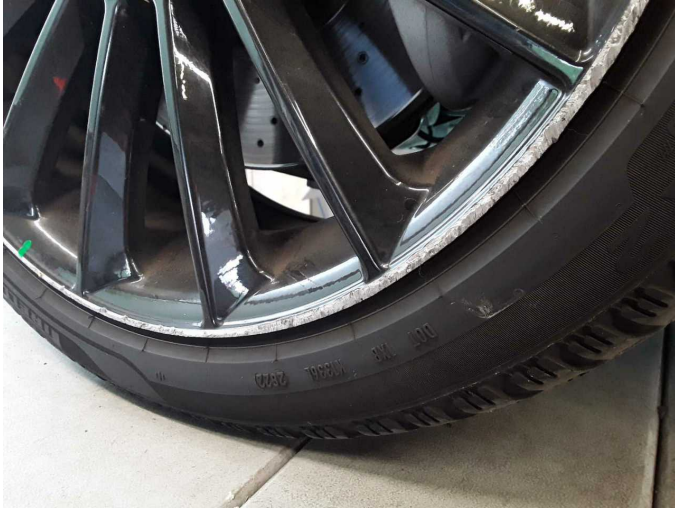
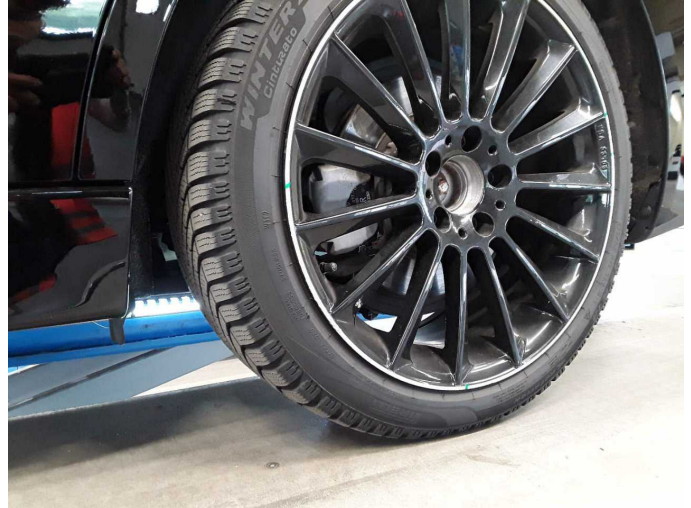
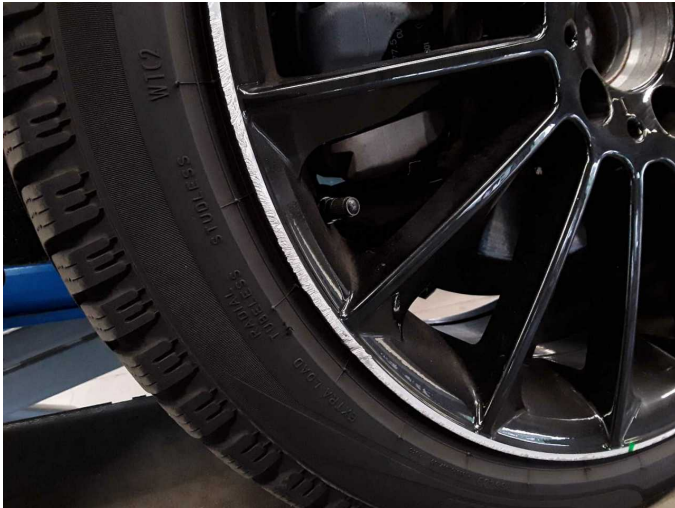
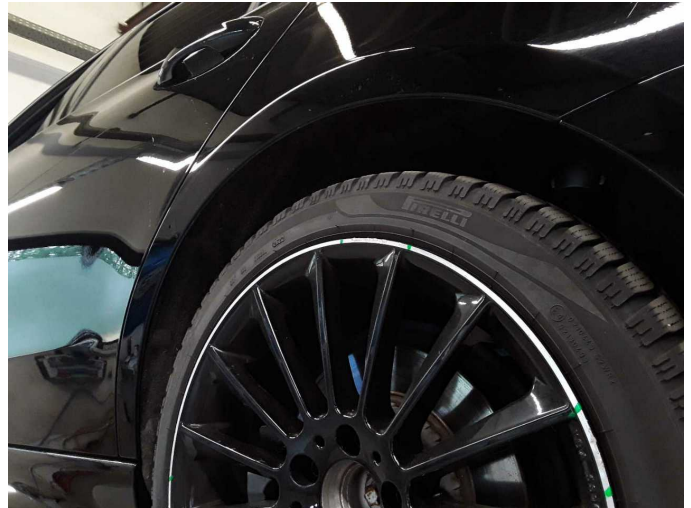
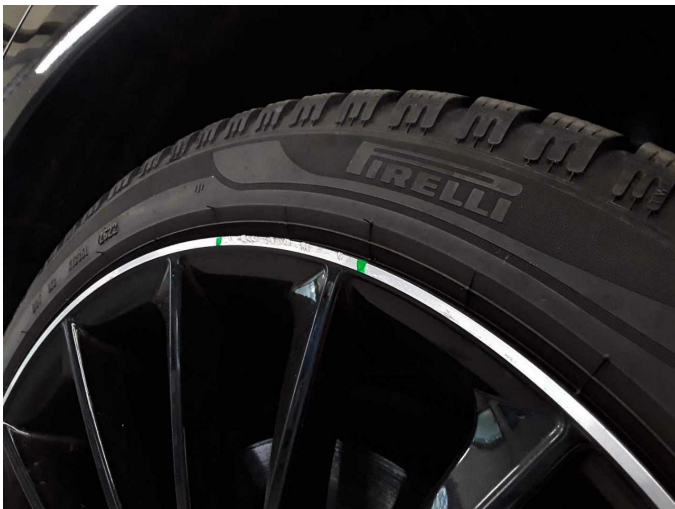
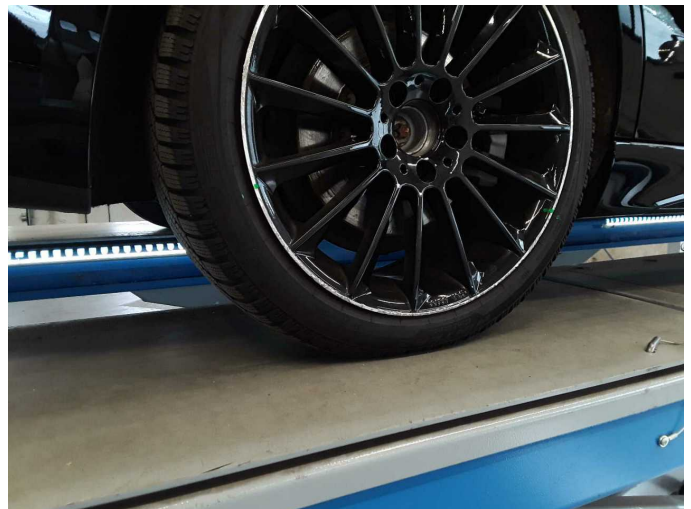
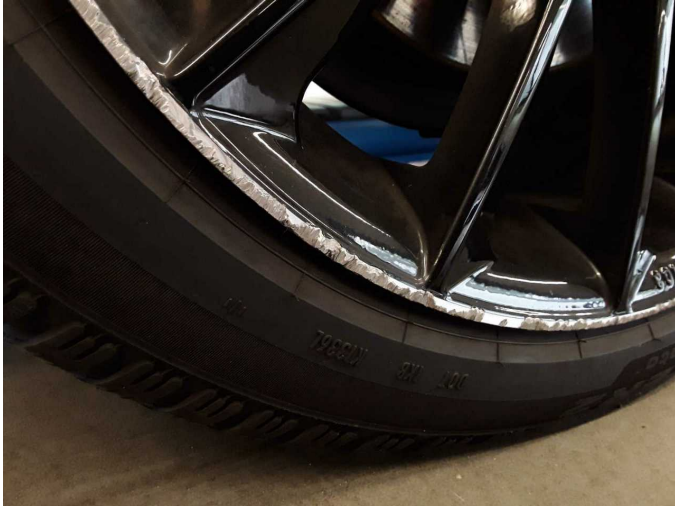
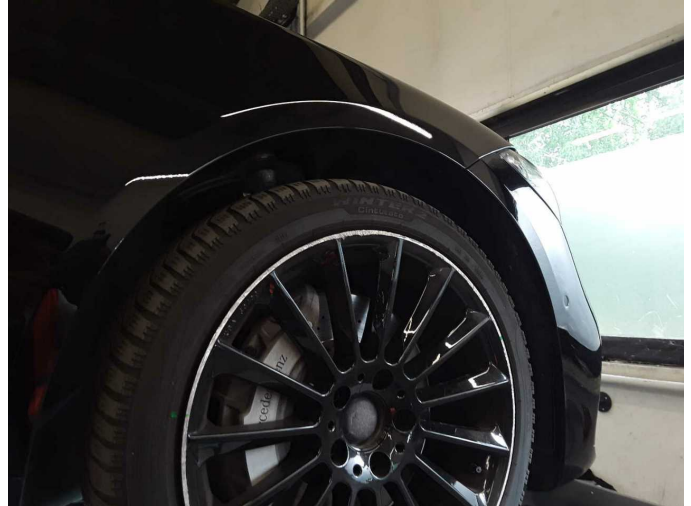
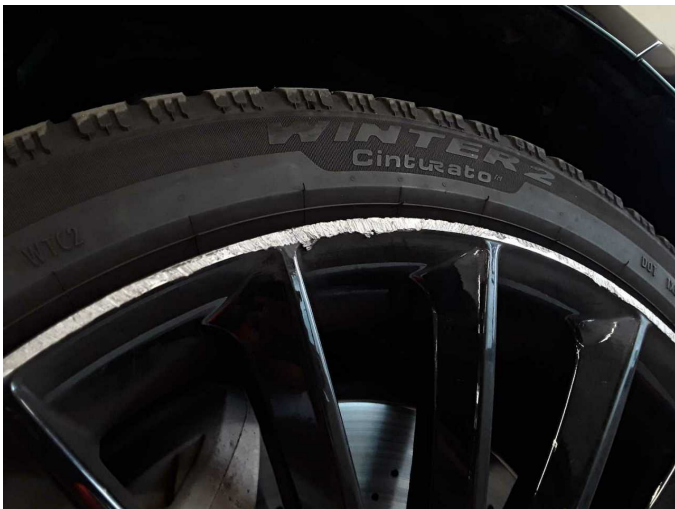
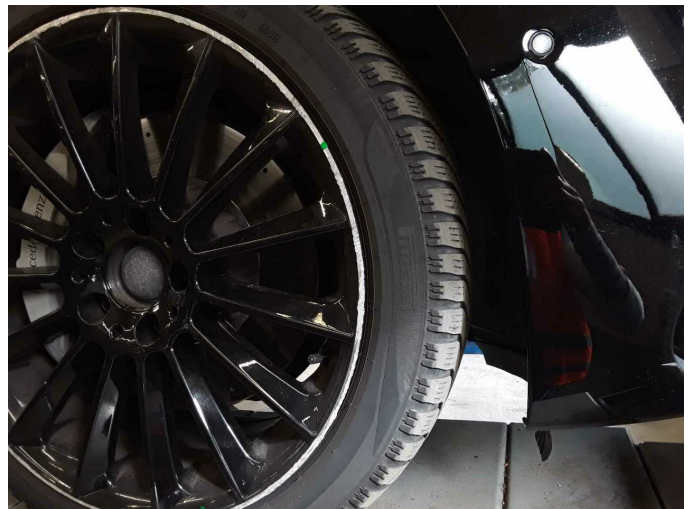
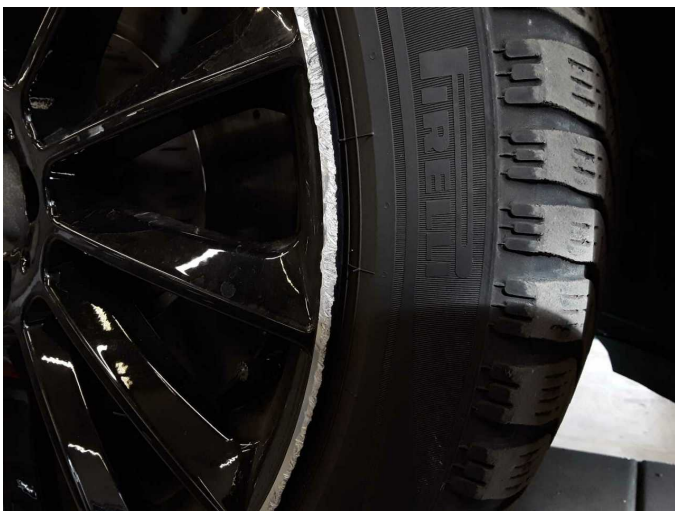
| No. | Component group | Description |
|---|---|---|
| 4 | Wheel / tyres | Wheel rims - complete set - Scratched - No deduction |

**Wear and tear 4:** Wheel / tyres: Wheel rims - complete set - Scratched - No deduction

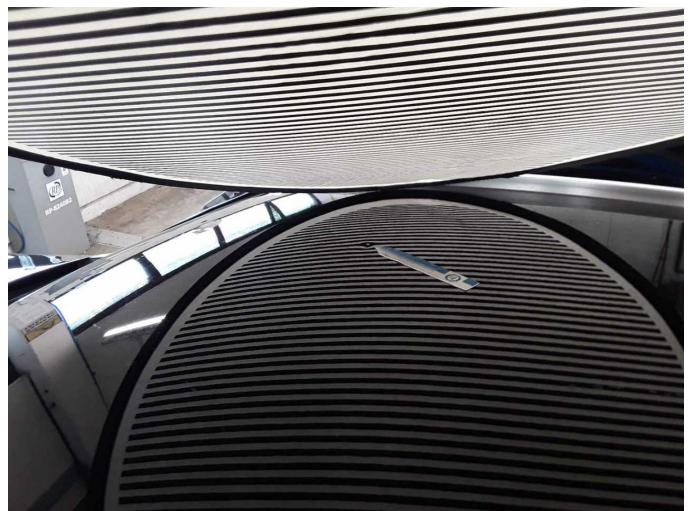
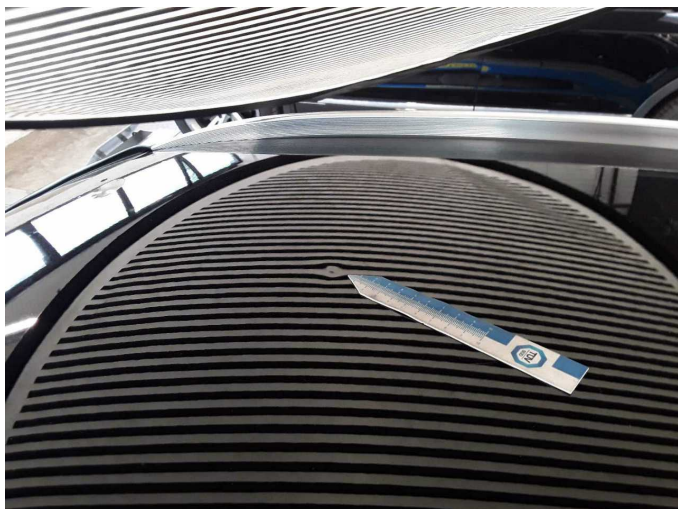
| No. | Component group | Description |
|---|---|---|
| 5 | Roof | Roof - dent(s) - No deduction |

**Wear and tear 5:** Roof: Roof - dent(s) - No deduction

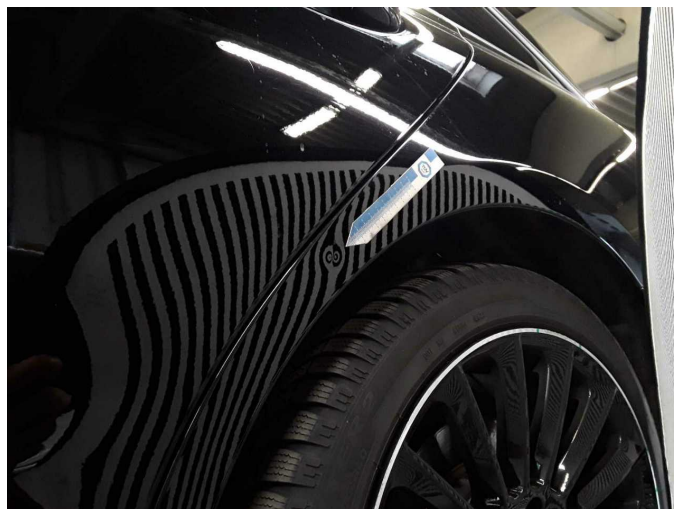
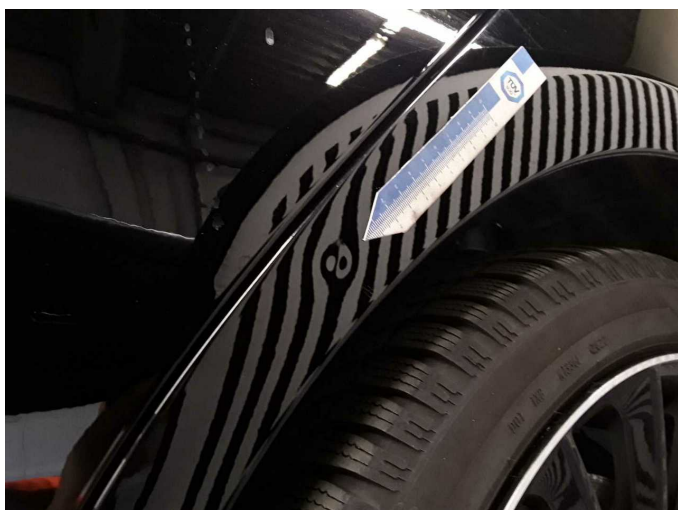
| No. | Component group | Description |
|---|---|---|
| 6 | Side panel - rear left side | Elbow - dent(s) - No deduction |

**Wear and tear 6:** Side panel - rear left side: Elbow - dent(s) - No deduction

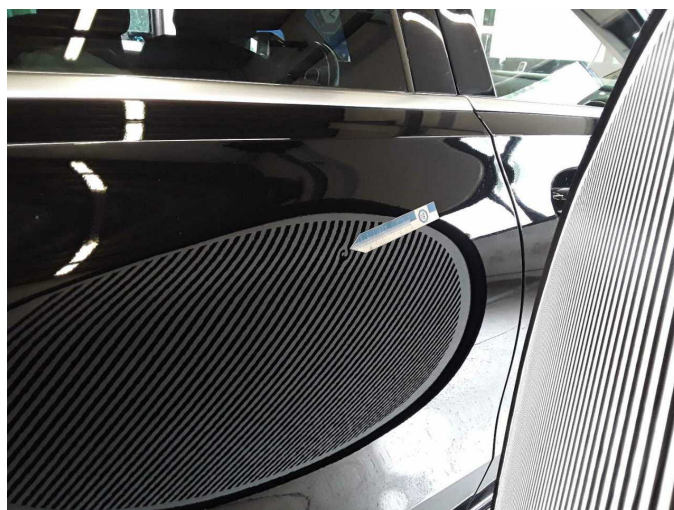
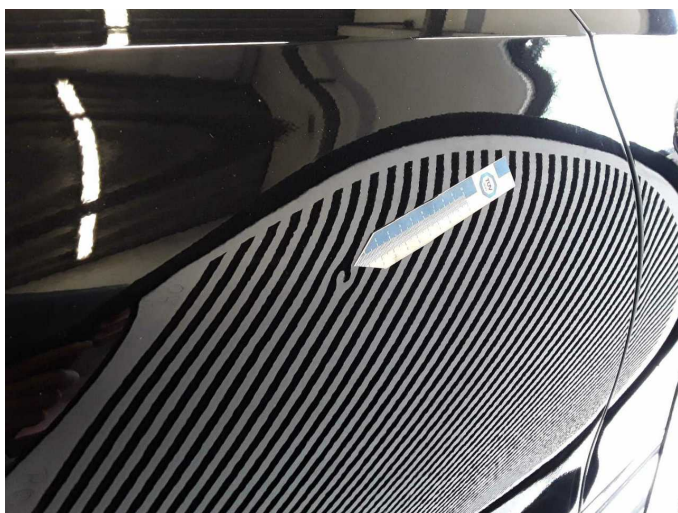
| No. | Component group | Description |
|---|---|---|
| 7 | Door - rear right side | Door - dent(s) - No deduction |

**Wear and tear 7:** Door - rear right side: Door - dent(s) - No deduction
