Expertise

Protocol number: 46607636  
Order No. / Reference: 26681174  
Inspection date: 14 Jul 2026

Manufacturer: Volkswagen

Model: Passat Variant 2.0 TDI SCR DSG Business

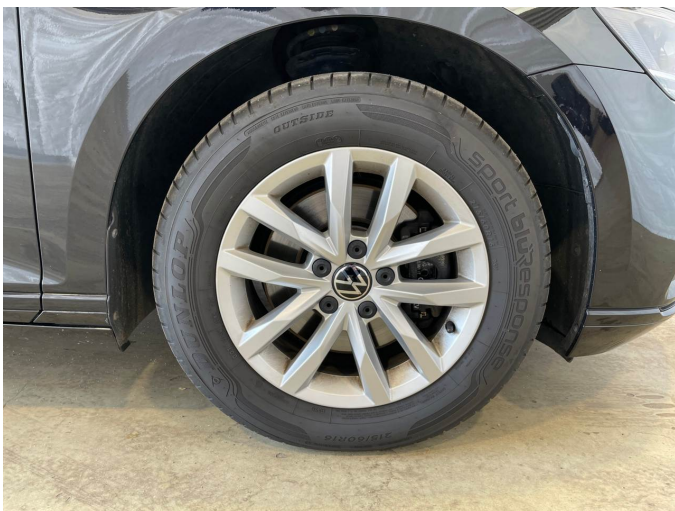
Figure 11: Mounted tyres

| # | Tyre size | Type of tyre | Manufacturer | Tread depth |
|---|---|---|---|---|
| 1) | 215/60 R16 95V | Summer tyres on Light alloy | Dunlop | 3mm / 3mm |
| 2) | 215/60 R16 95V | Summer tyres on Light alloy | Dunlop | 5mm / 5mm |

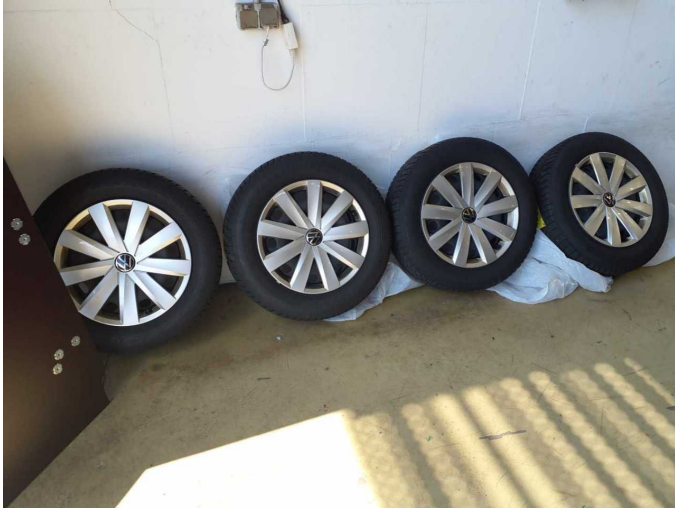
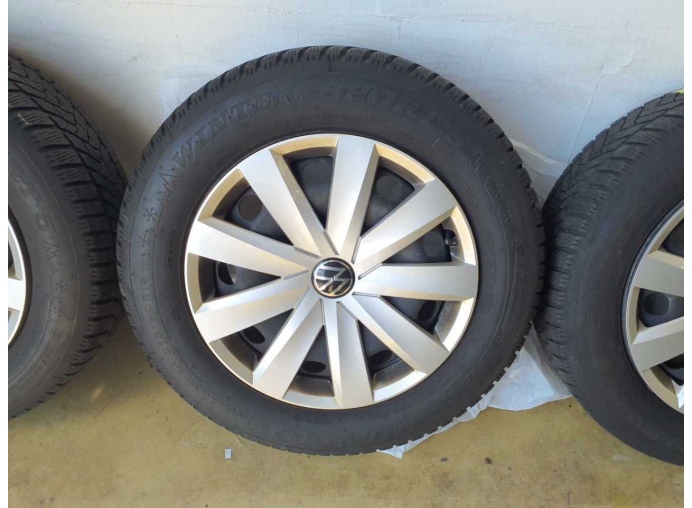
Figure 13: Additional tyres

| # | Tyre size | Type of tyre | Manufacturer | Tread depth |
|---|---|---|---|---|
| 1) | 215/60 R16 95H | Winter tyres on Steel rim with wheel cover | Dunlop | 5mm / 5mm |
| 2) | 215/60 R16 95H | Winter tyres on Steel rim with wheel cover | Dunlop | 8mm / 8mm |

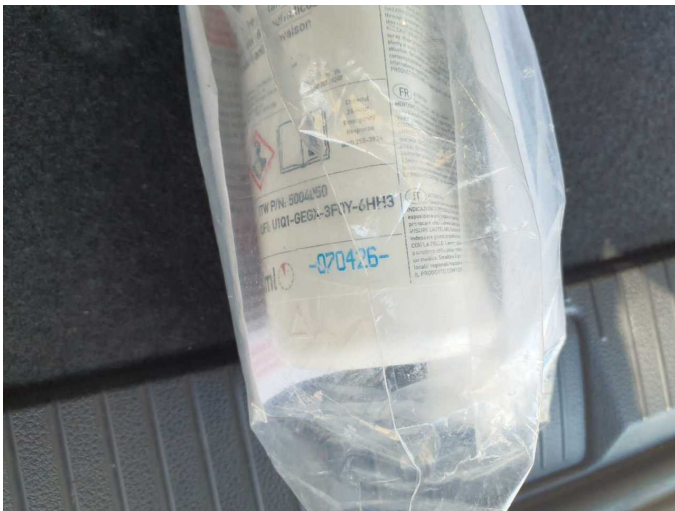
**Damage 2:** Equipment: Tirefit filler - Expired - Replace

| No. | Component group | Description |
|---|---|---|
| 2 | Equipment | Tirefit filler - Expired - Replace |

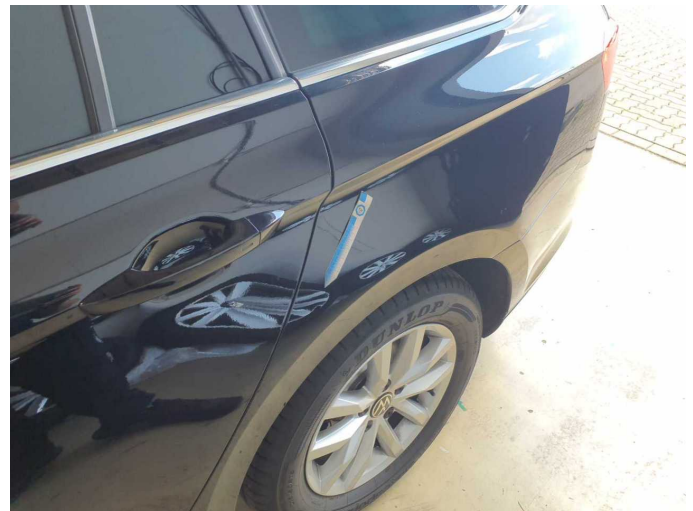
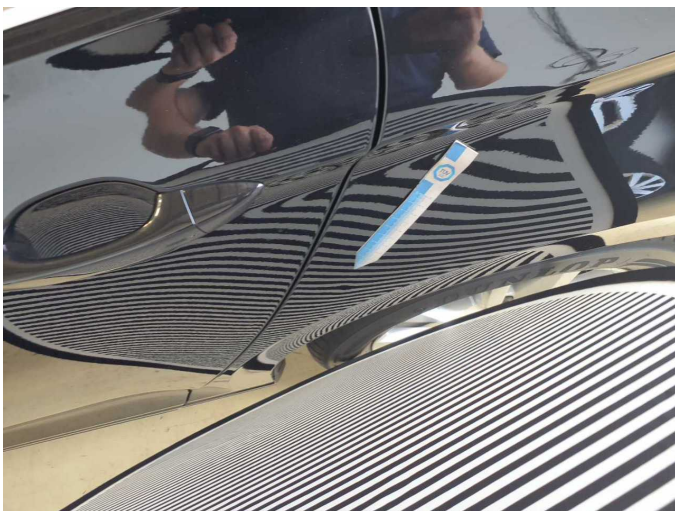
**Damage 3:** Side panel - rear left side: Side panel - dent(s) - Smooth repair work

| No. | Component group | Description |
|---|---|---|
| 3 | Side panel - rear left side | Side panel - dent(s) - Smooth repair work |

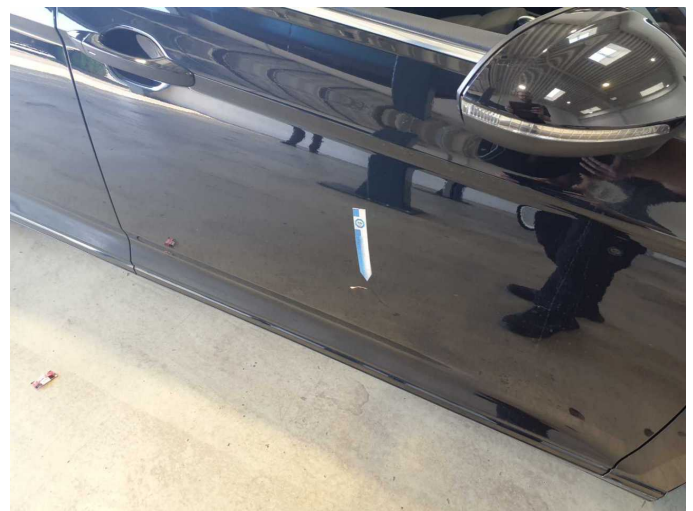
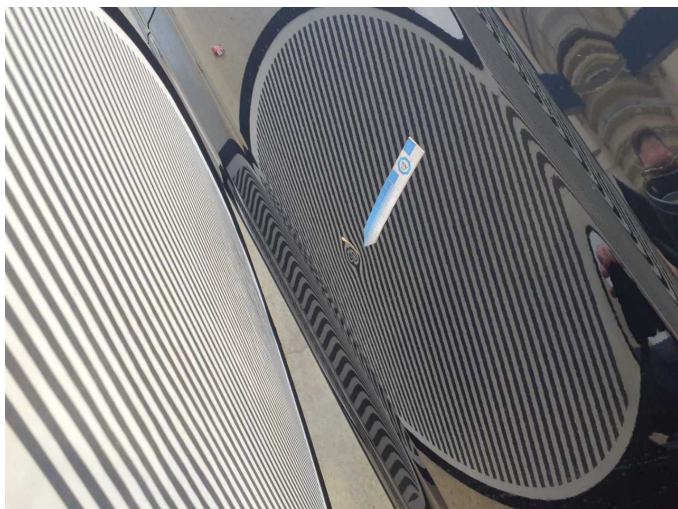
**Damage 4:** Door - front right side: Door - dent(s) - Smooth repair work

| No. | Component group | Description |
|---|---|---|
| 4 | Door - front right side | Door - dent(s) - Smooth repair work |

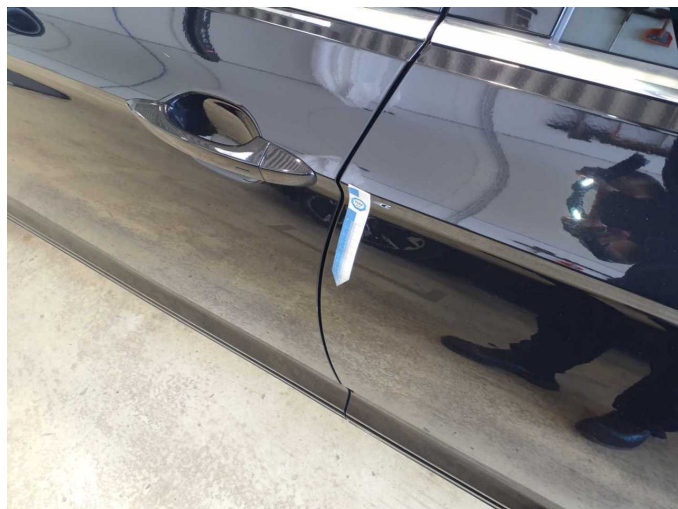
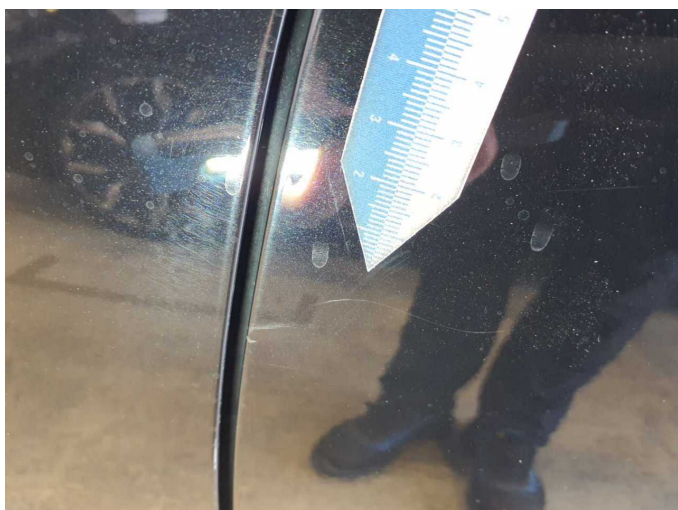
**Damage 5:** Door - rear left side: Door - Scratch(es) - Smart repair

| No. | Component group | Description |
|---|---|---|
| 5 | Door - rear left side | Door - Scratch(es) - Smart repair |

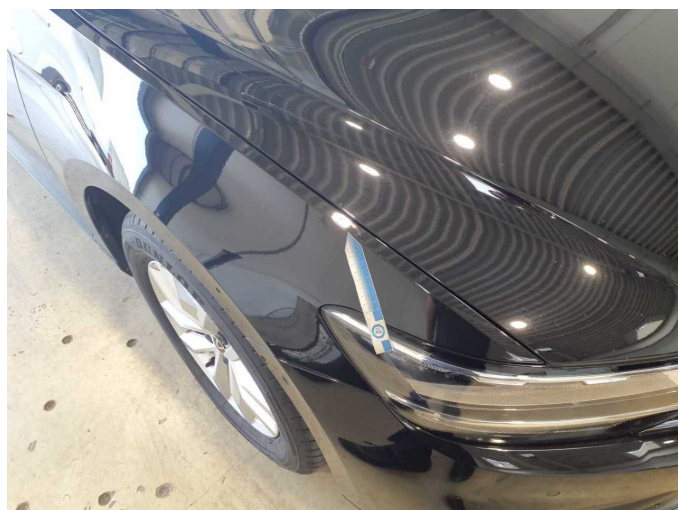
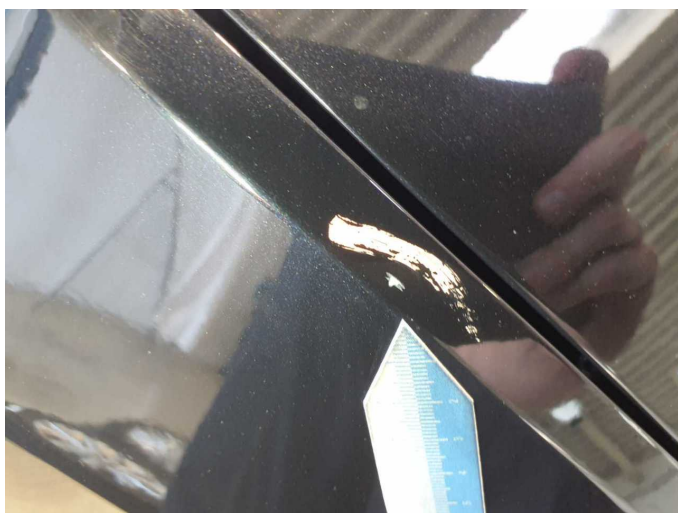
**Damage 6:** Mudguard - right side: Mudguard - right side - Scratch(es) - Smart repair

| No. | Component group | Description |
|---|---|---|
| 6 | Mudguard - right side | Mudguard - right side - Scratch(es) - Smart repair |

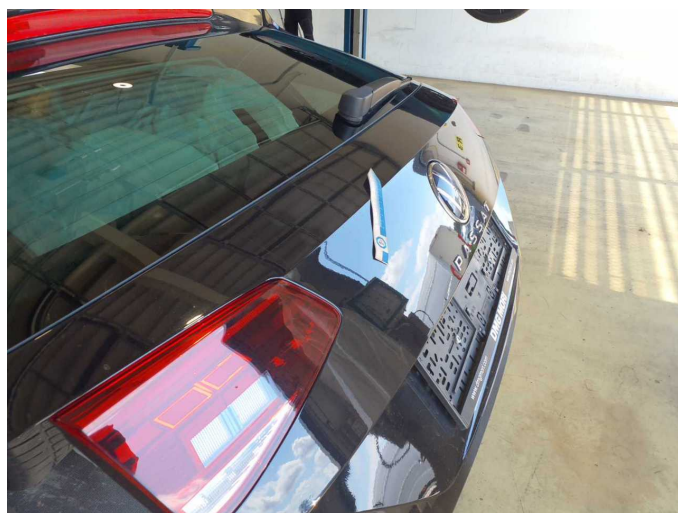
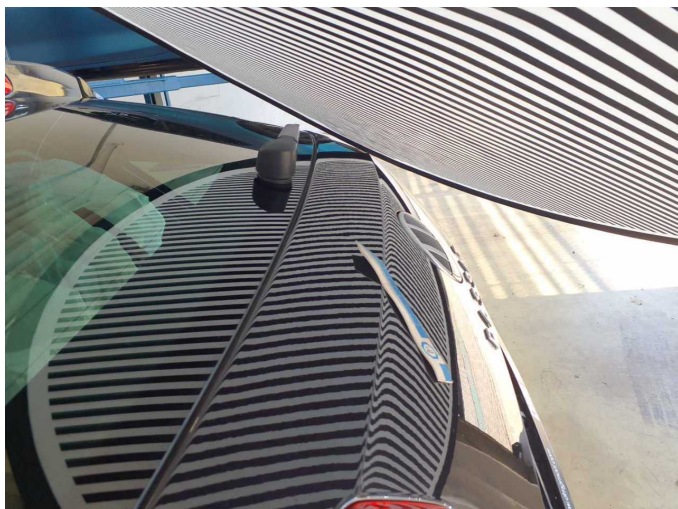
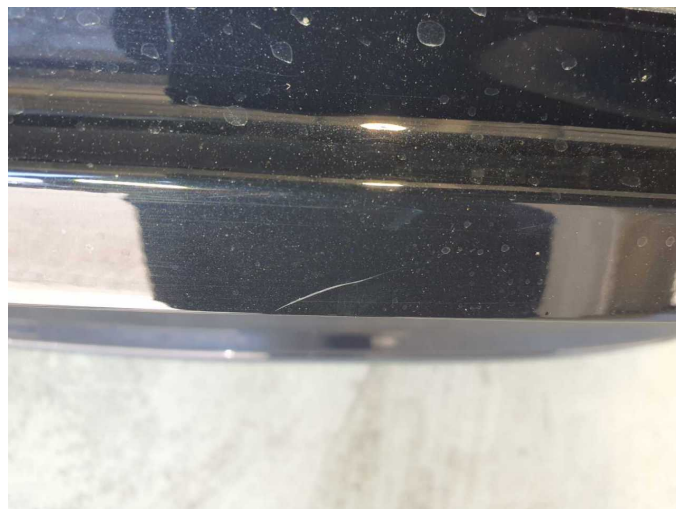
**Damage 7:** Boot lid / rear door: Boot lid - Dent / paintcoat damage - Smart repair

| No. | Component group | Description |
|---|---|---|
| 7 | Boot lid / rear door | Boot lid - Dent / paintcoat damage - Smart repair |

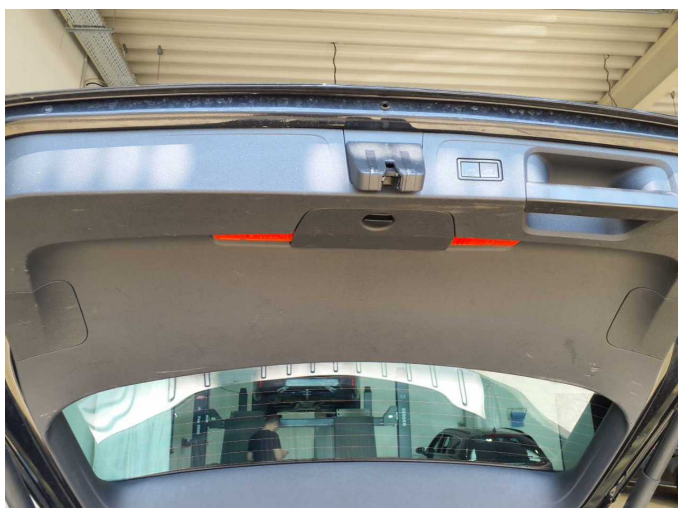
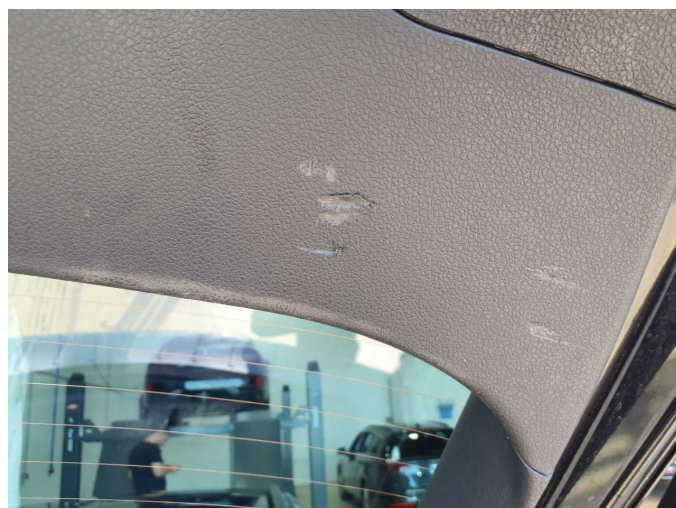
**Damage 8:** Trim / covers: Boot lid - interior trim - Scratch(es) - Replace

| No. | Component group | Description |
|---|---|---|
| 8 | Trim / covers | Boot lid - interior trim - Scratch(es) - Replace |

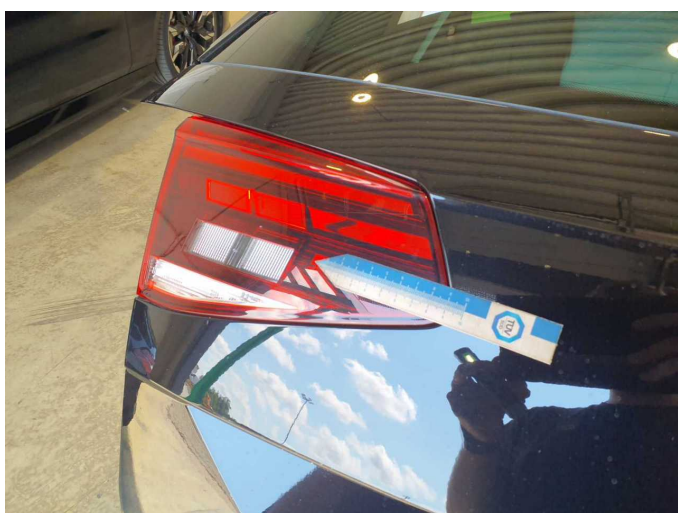
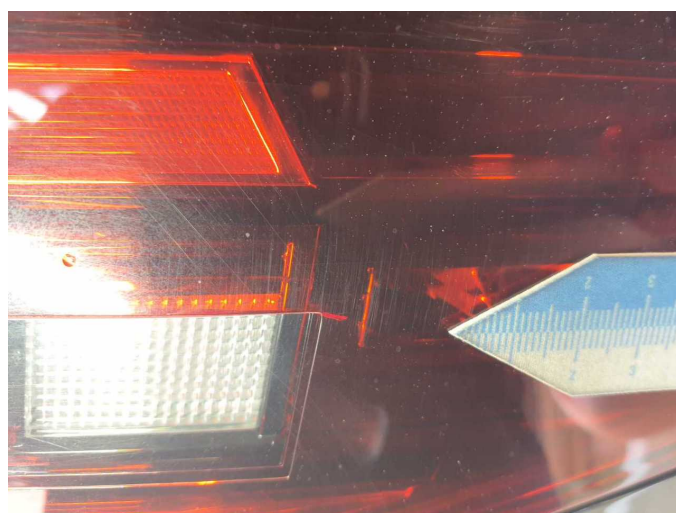
**Damage 9:** Tail light: Tail lamp - left side - Broken / torn - Replace

| No. | Component group | Description |
|---|---|---|
| 9 | Tail light | Tail lamp - left side - Broken / torn - Replace |

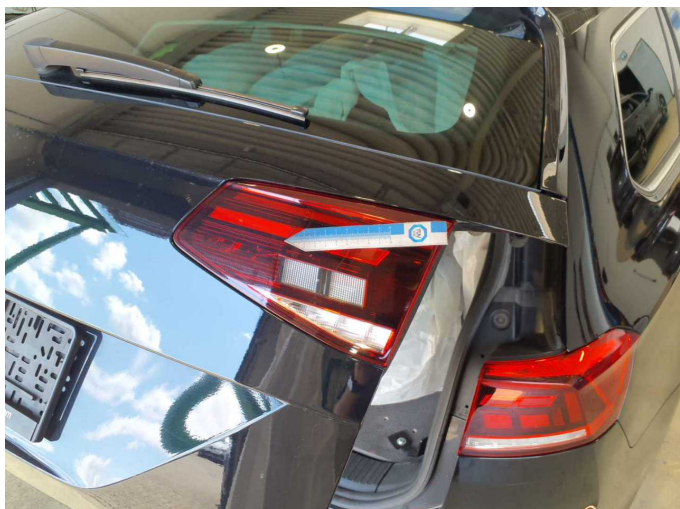
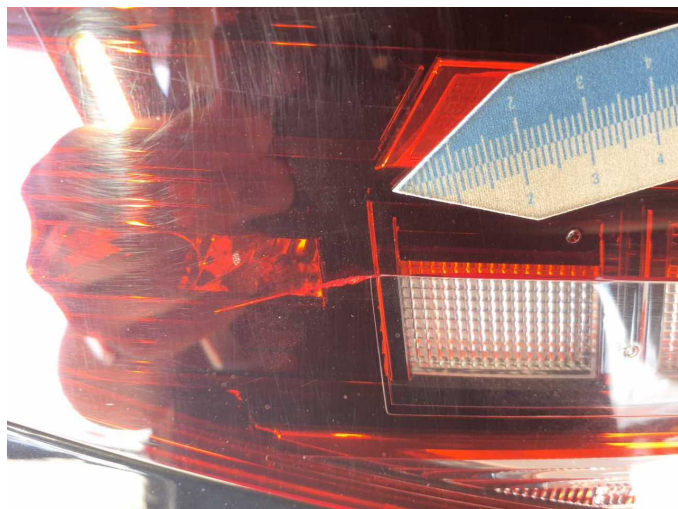
**Damage 10:** Tail light: Tail lamp - right side - Broken / torn - Replace

| No. | Component group | Description |
|---|---|---|
| 10 | Tail light | Tail lamp - right side - Broken / torn - Replace |

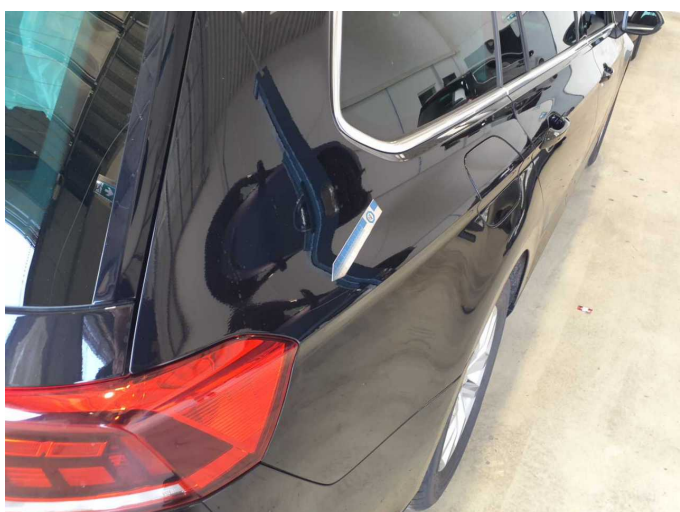
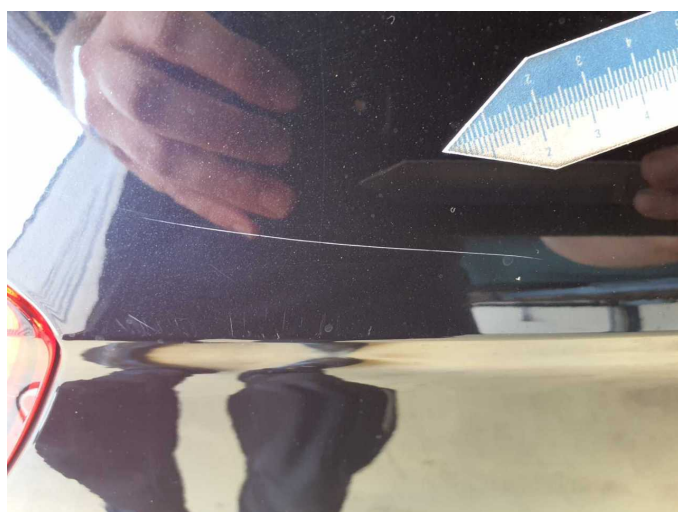
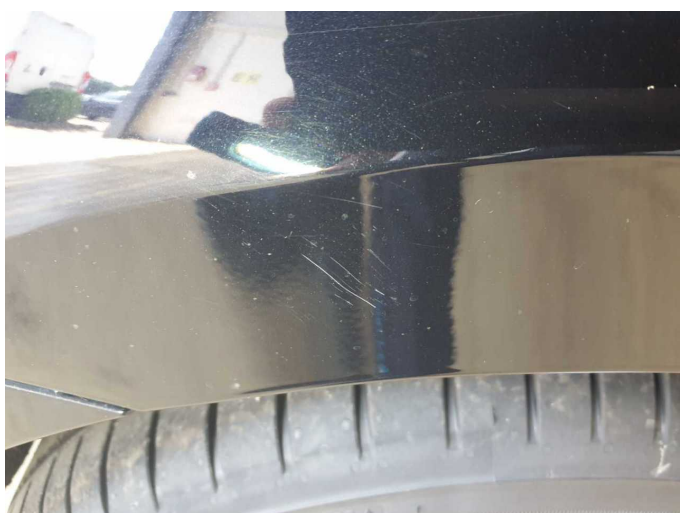
**Damage 11:** Side panel - rear right side: Side panel - Scratch(es) - Paint

| No. | Component group | Description |
|---|---|---|
| 11 | Side panel - rear right side | Side panel - Scratch(es) - Paint |

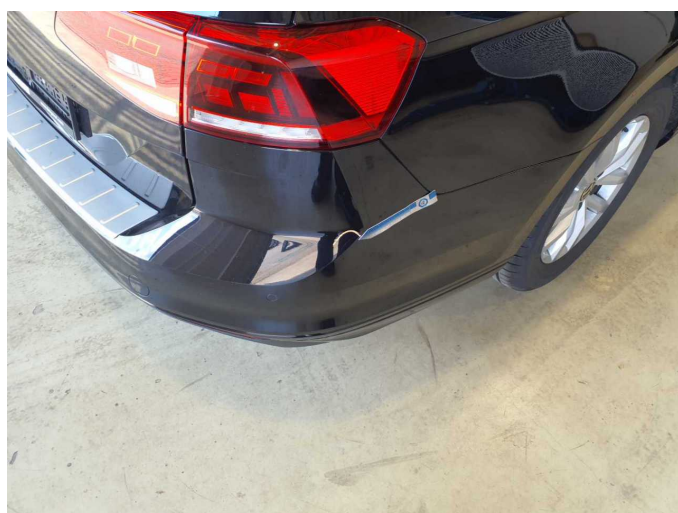
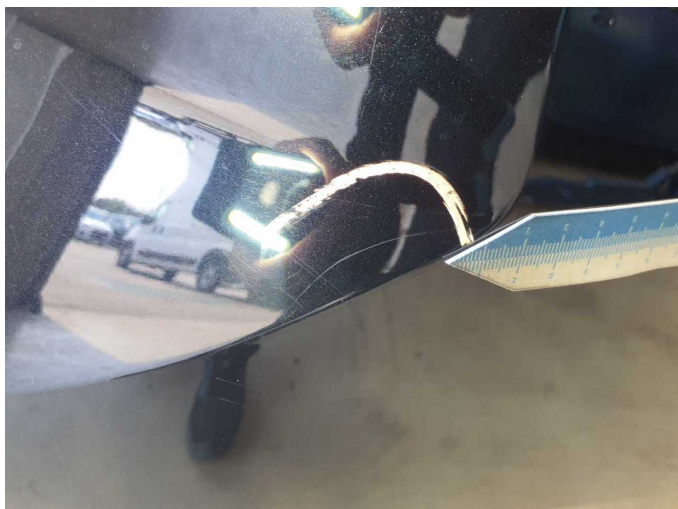
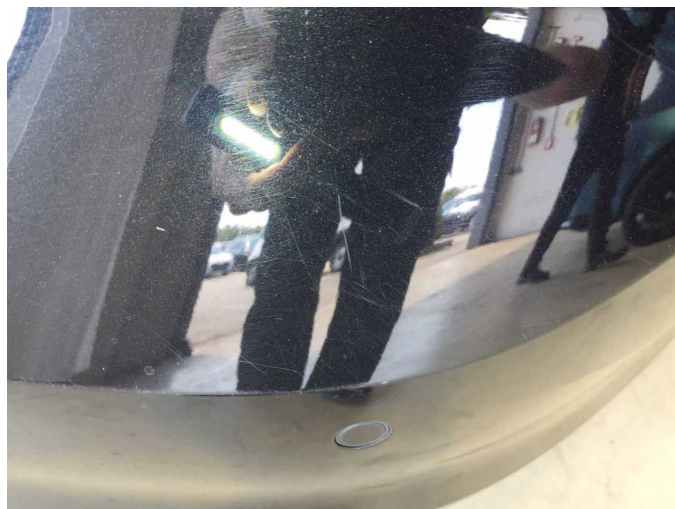
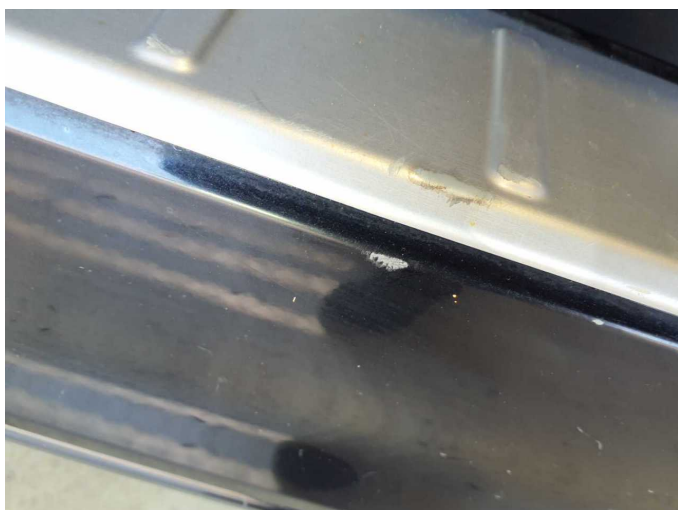
**Damage 12:** Rear bumper: Rear bumper - Scratch(es) - Paint

| No. | Component group | Description |
|---|---|---|
| 12 | Rear bumper | Rear bumper - Scratch(es) - Paint |

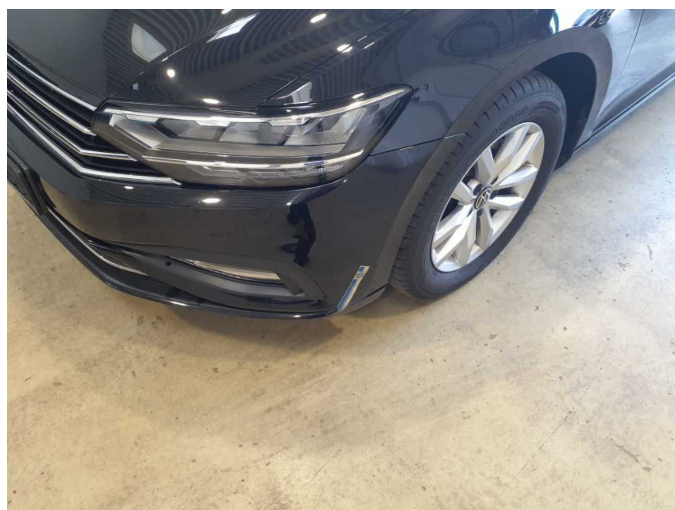
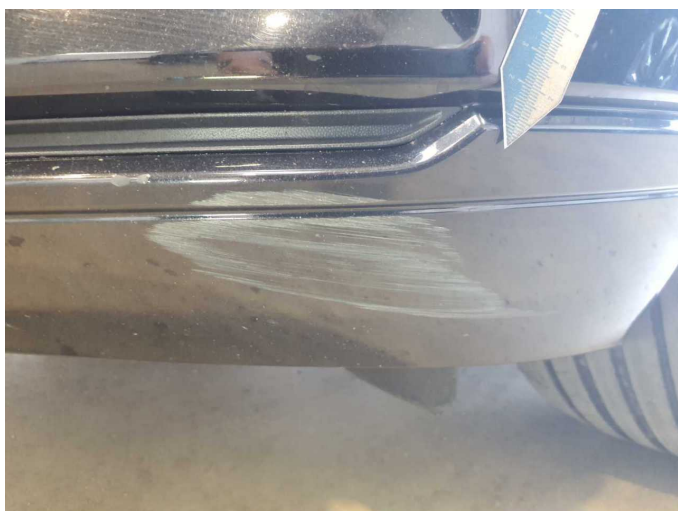
**Damage 13:** Front bumper: Front bumper - Scratch(es) - Paint

| No. | Component group | Description |
|---|---|---|
| 13 | Front bumper | Front bumper - Scratch(es) - Paint |

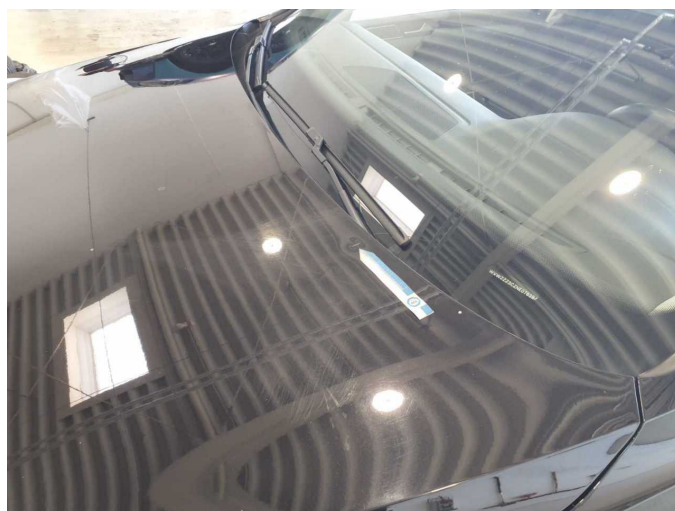
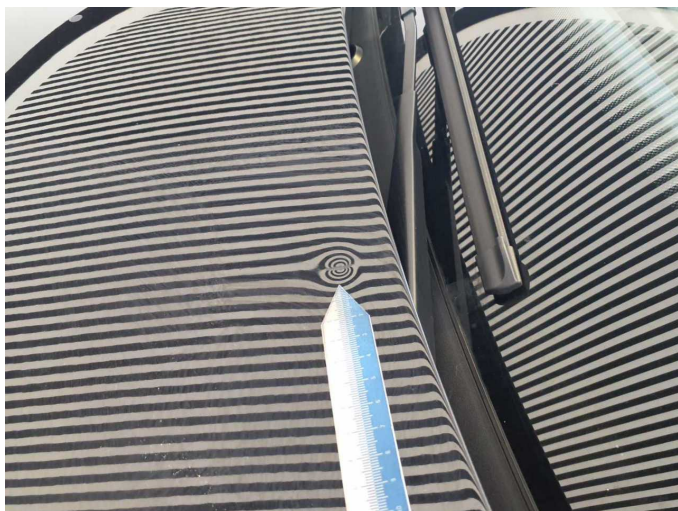
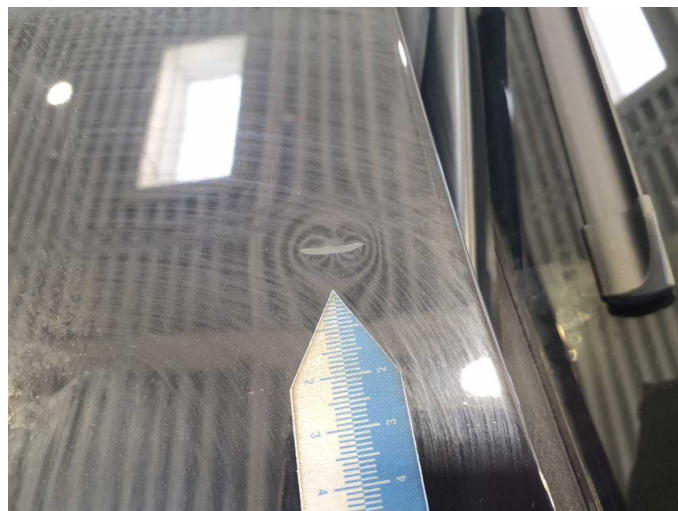
**Damage 14:** Bonnet: Bonnet - Dent / paintcoat damage - Repair and paint

| No. | Component group | Description |
|---|---|---|
| 14 | Bonnet | Bonnet - Dent / paintcoat damage - Repair and paint |

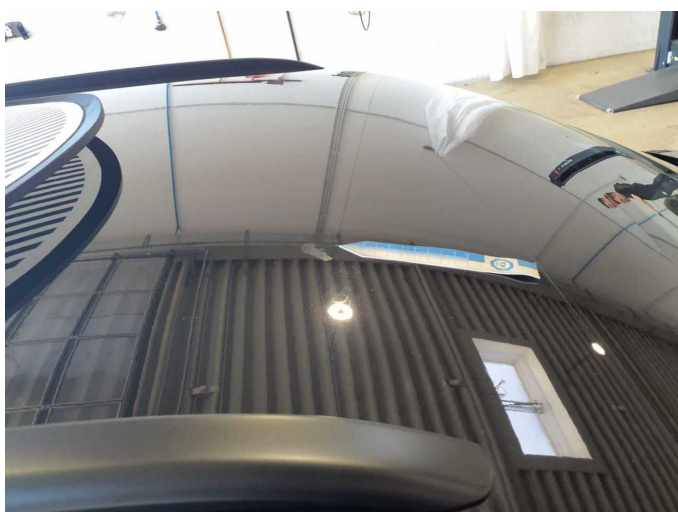
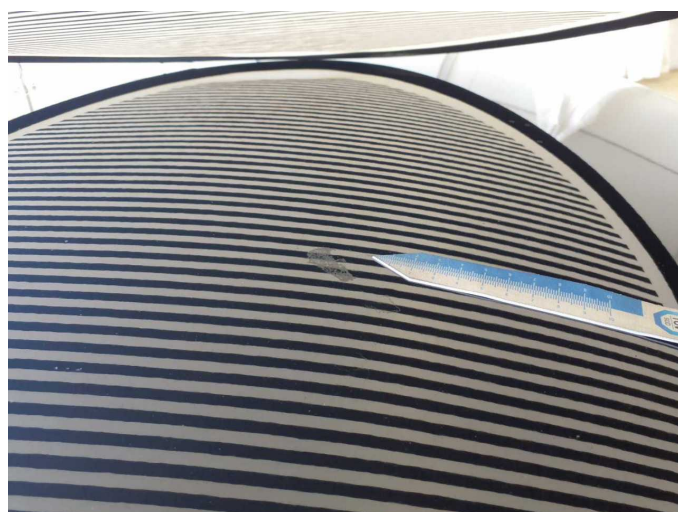
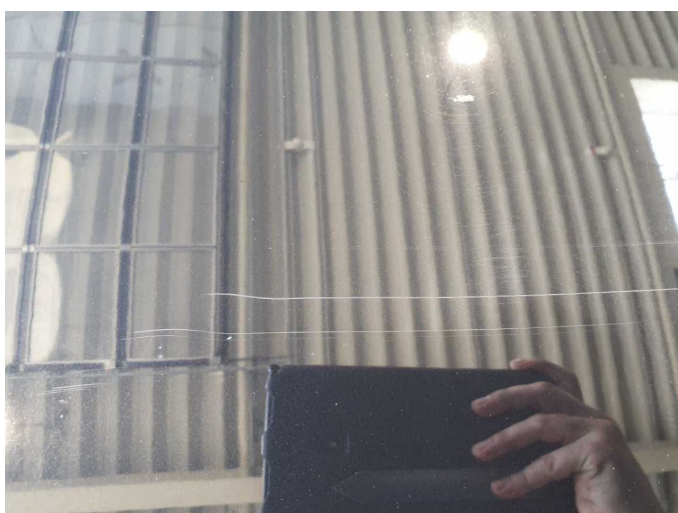
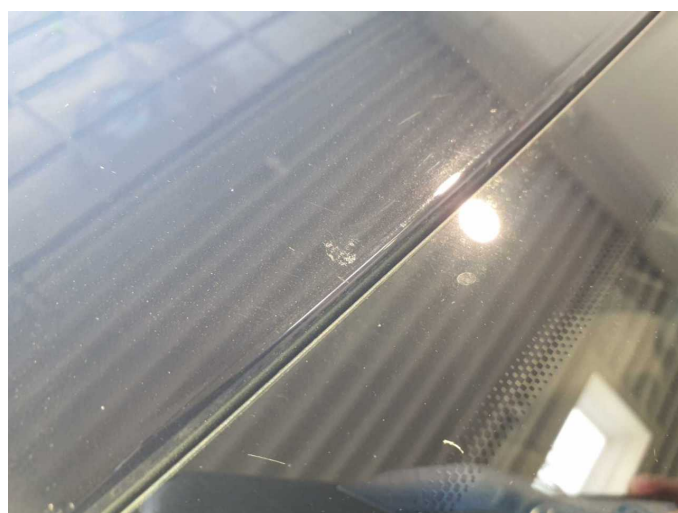
**Damage 15:** Roof: Roof (Anätzung) - Paint defect - Paint

| No. | Component group | Description |
|---|---|---|
| 15 | Roof | Roof (Anätzung) - Paint defect - Paint |
