## Condition Report / Loss of Value Assessment II

| Type / sales designation | A6 Avant 45 TDI quattro advanced | Kilometres read | 28,878 km |

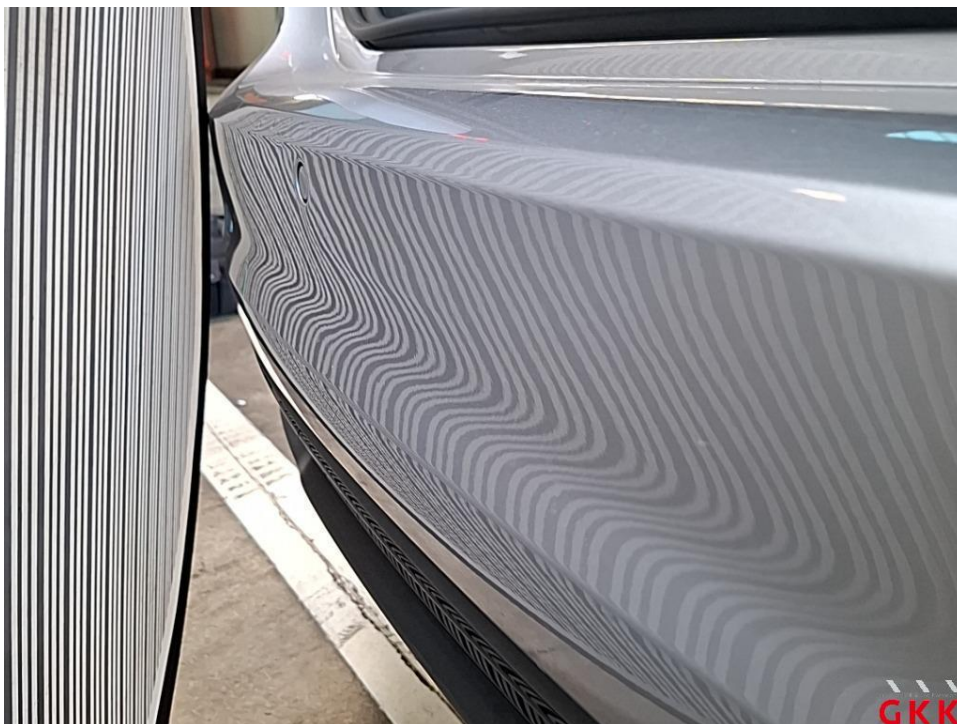
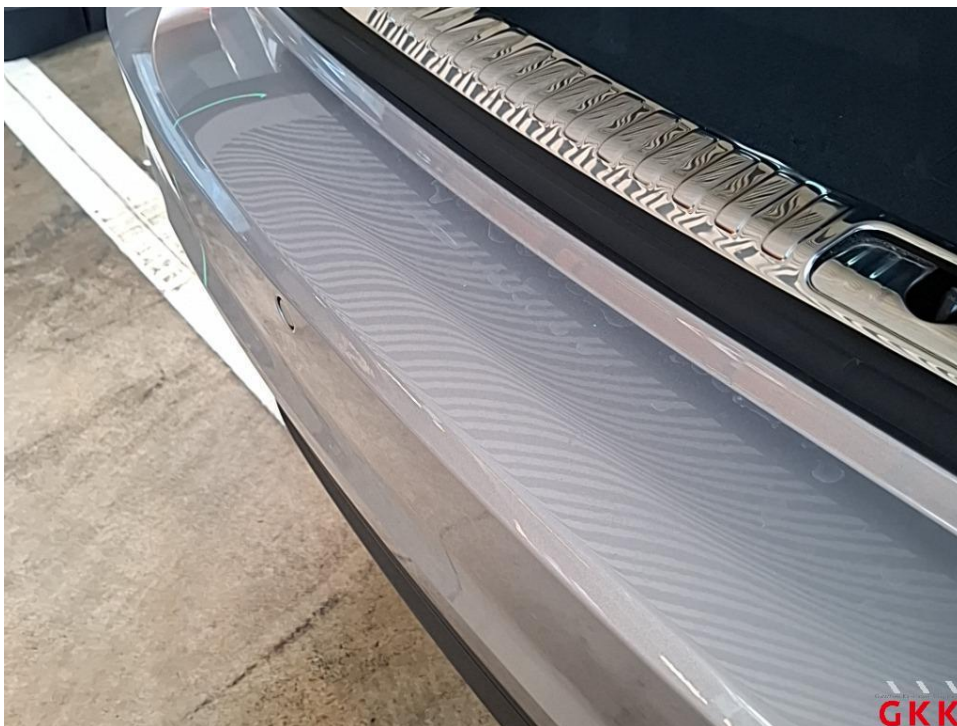
bumper rear panel -painted-, deformed, replace (Image 17, Image 18)

Picture 17 bumper rear, panel -painted-, deformed, replace

Picture 18 bumper rear, panel -painted-, deformed, replace

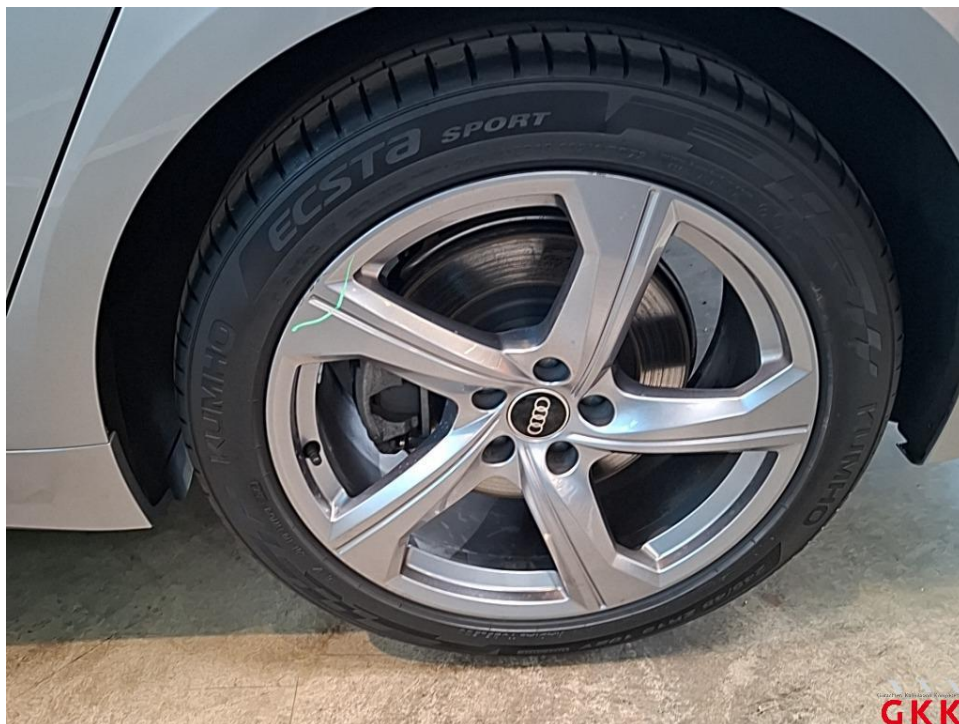
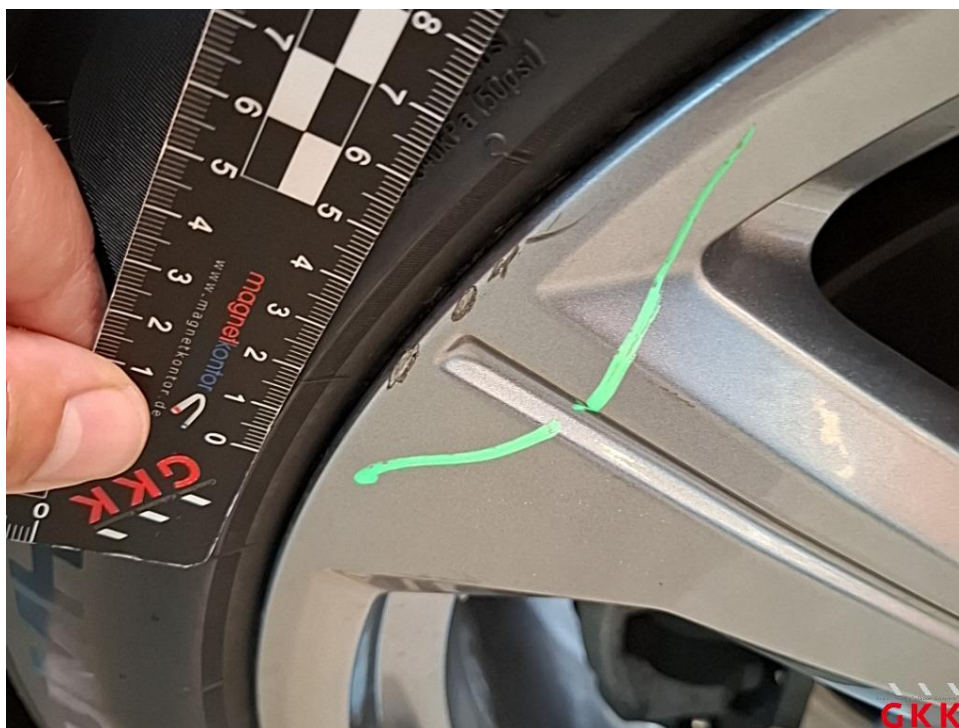
LM wheel rear left, scratched, depreciation (Image 19, Image 20)

Picture 19 LM wheel, rear left, scratched, depreciation

Picture 20 LM wheel, rear left, scratched, depreciation

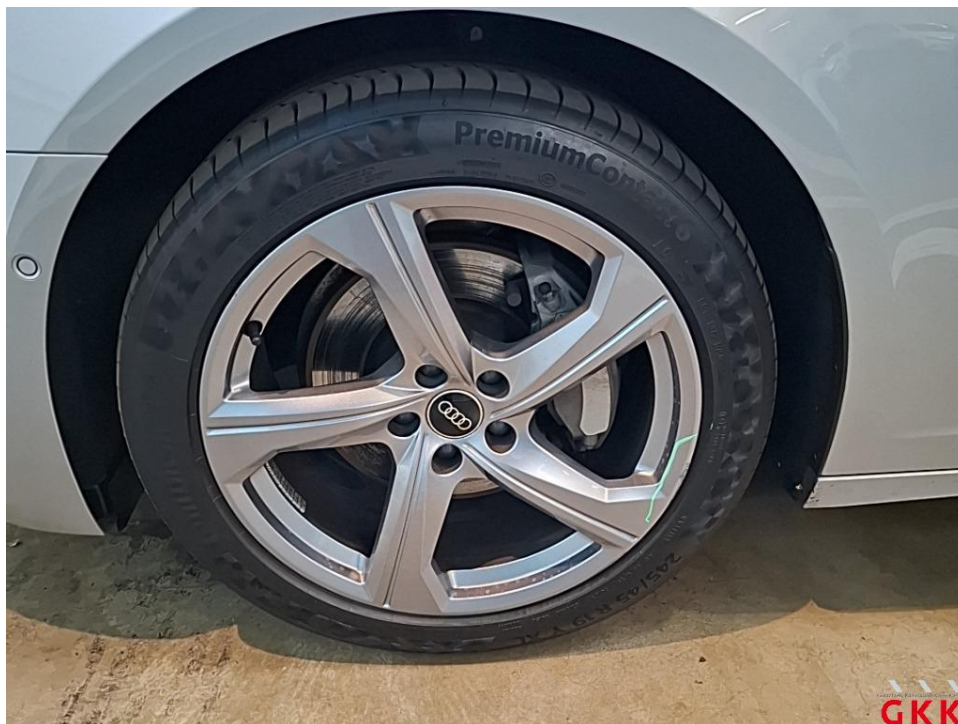
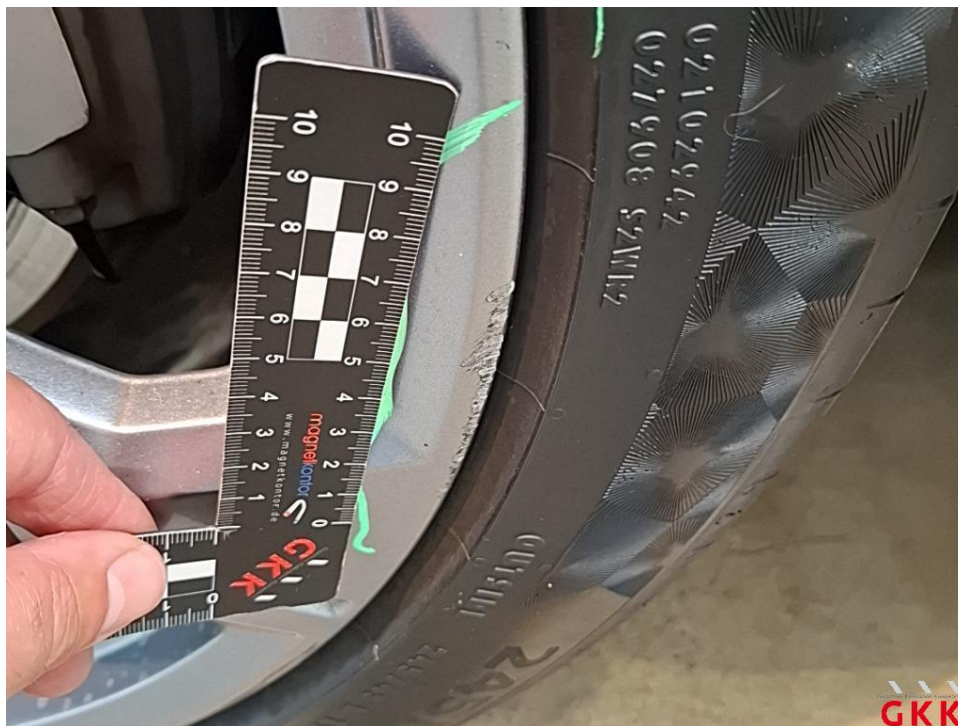
LM wheel front left, scratched, depreciation (Image 21, Image 22)

Picture 21 LM wheel, front left, scratched, depreciation

Picture 22 LM wheel, front left, scratched, depreciation
