Expertise

Protocol number: 46376510  
Order No. / Reference: 26652553  
Inspection date: 6 Jul 2026

Manufacturer: Ford

Model: Puma 1.0 EcoBoost Hybrid ST-LINE DESIGN

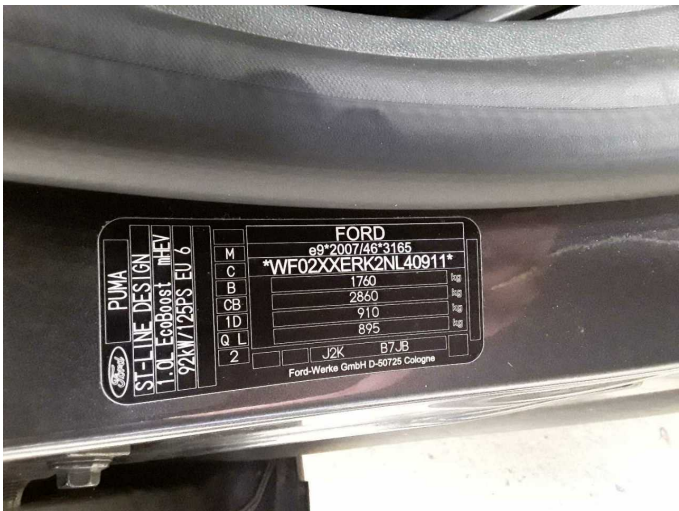
| VIN comparison | The vehicle identification number (VIN) was read from the vehicle and its conformity with the submitted documents was confirmed by the undersigned during the inspection. |

Figure 10: VIN

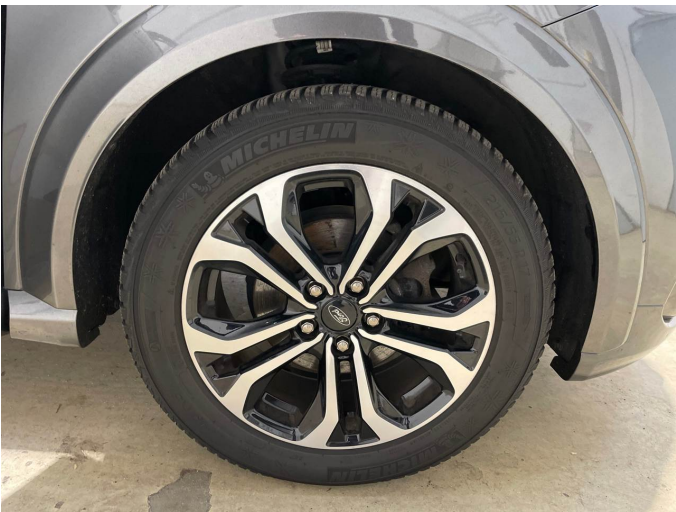
| # | Tyre size | Type of tyre | Manufacturer | Tread depth |
|---|---|---|---|---|
| 1) | 215/55 R17 94V | Winter tyres on Light alloy | Michelin | 2mm / 2mm |
| 2) | 215/55 R17 94V | Winter tyres on Light alloy | Michelin | 6mm / 6mm |

Figure 11: Mounted tyres

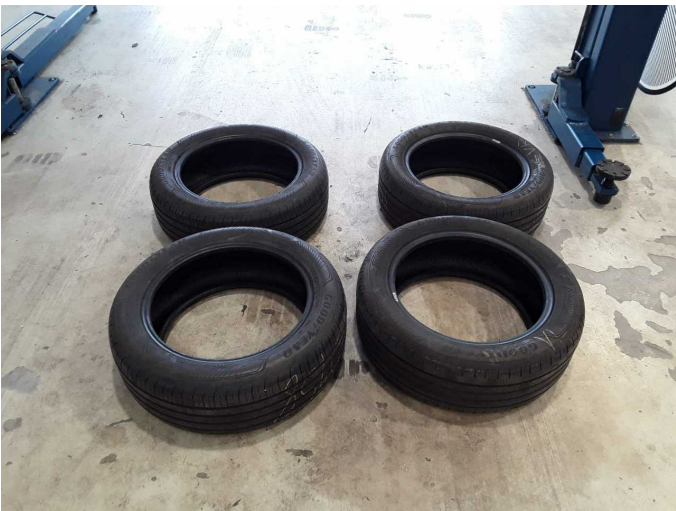
| # | Tyre size | Type of tyre | Manufacturer | Tread depth |
|---|---|---|---|---|
| 1) | 215/55 R17 98W | Summer tyres (Without wheel rim) | Goodyear | 2mm / 2mm |
| 2) | 215/55 R17 98W | Summer tyres (Without wheel rim) | Goodyear | 5mm / 5mm |

Figure 15: Additional tyres

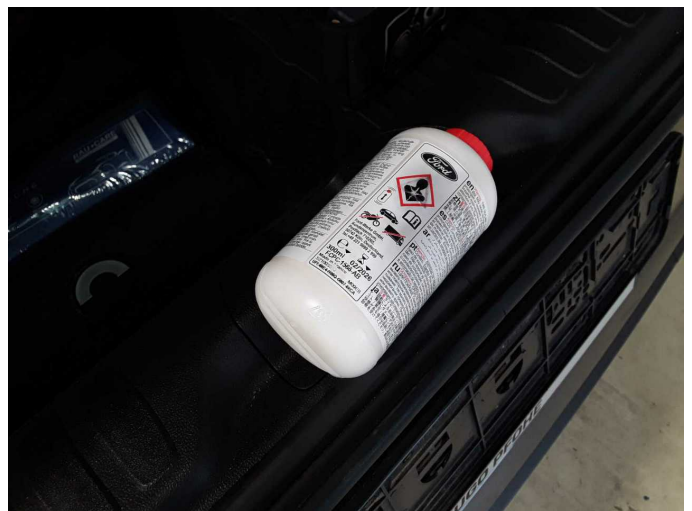
| No. | Component group | Description |
|---|---|---|
| 3 | Equipment | Tirefit filler - Expired - Replace |

Damage 3: Equipment: Tirefit filler - Expired - Replace

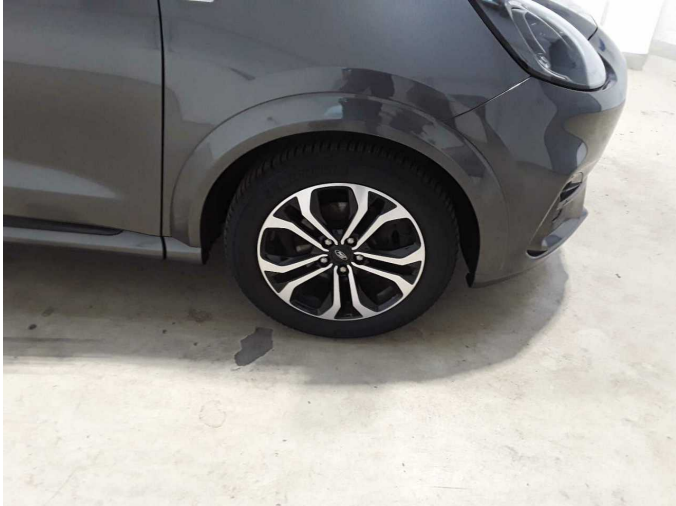
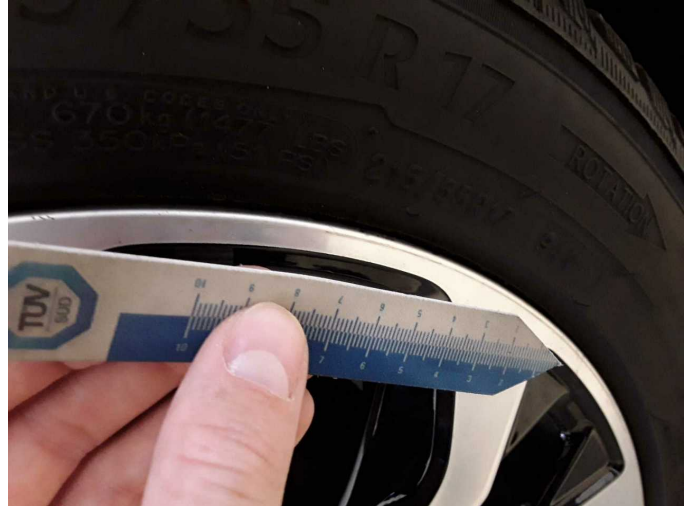
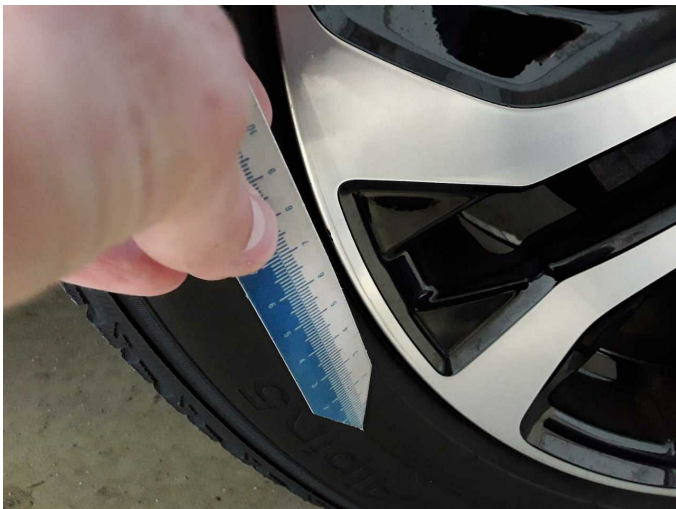
| No. | Component group | Description |
|---|---|---|
| 4 | Wheel / tyres | Alloy rim - front right side - Scratch(es) - Loss in value |

**Damage 4:** Wheel / tyres: Alloy rim - front right side - Scratch(es) - Loss in value

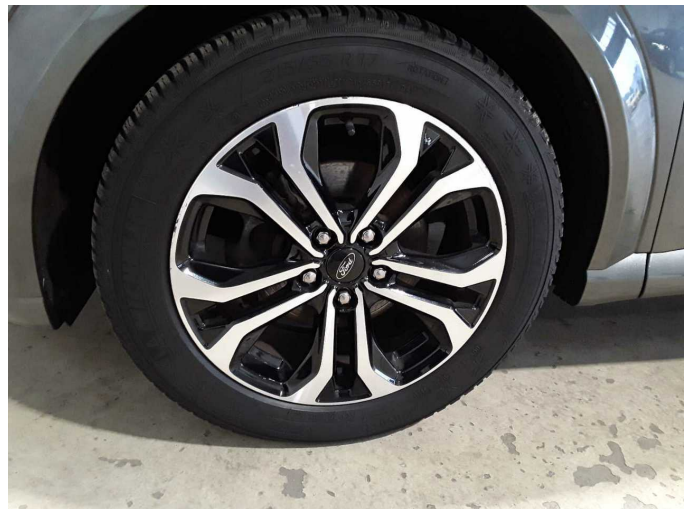
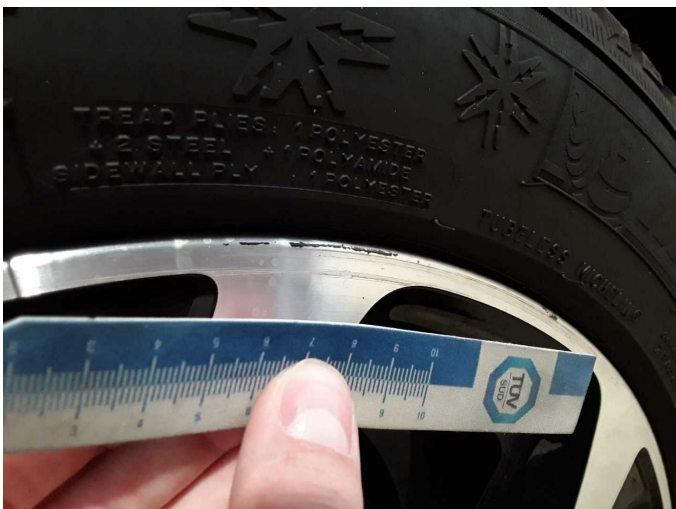
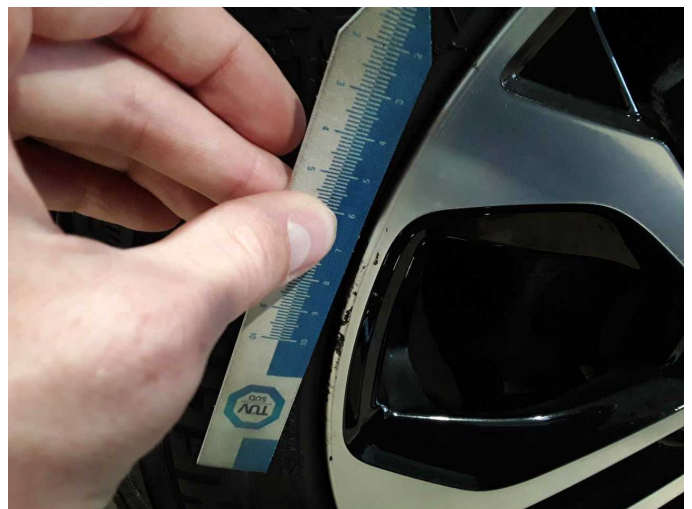
| No. | Component group | Description |
|---|---|---|
| 5 | Wheel / tyres | Alloy rim - front left side - Scratch(es) - Loss in value |

**Damage 5:** Wheel / tyres: Alloy rim - front left side - Scratch(es) - Loss in value

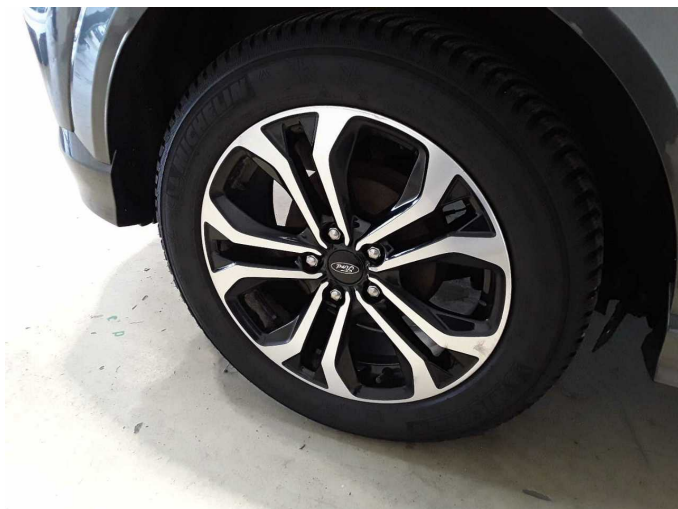
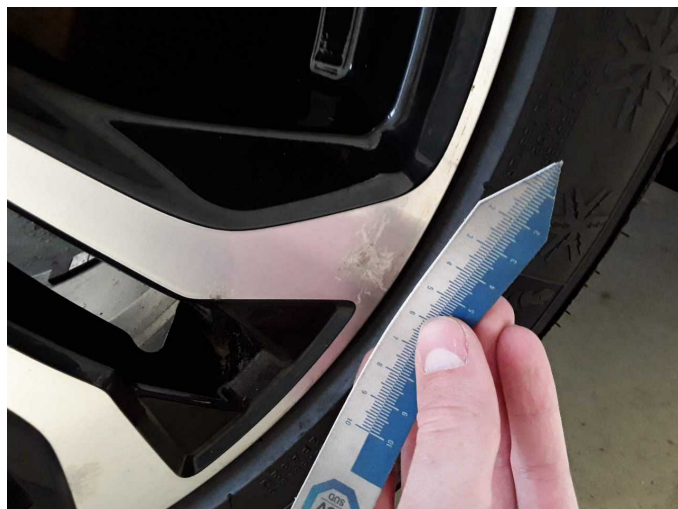
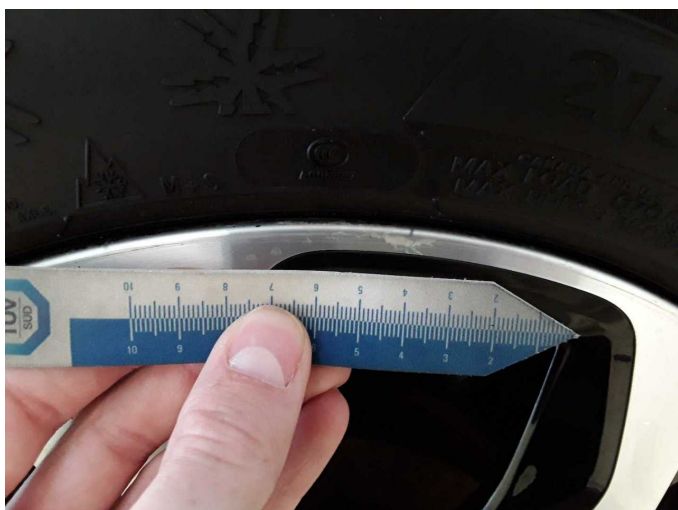
| No. | Component group | Description |
|---|---|---|
| 6 | Wheel / tyres | Alloy rim - rear right side - Corrosion - Loss in value |

**Damage 6:** Wheel / tyres: Alloy rim - rear right side - Corrosion - Loss in value
