Expertise

Protocol number: 46231187  
Order No. / Reference: 26571482  
Inspection date: 25 Jun 2026

Manufacturer: Skoda  
VIN: TMBLR9NP0P7050797

Model: Superb Combi 2.0 TDI 4x4 DSG L&K

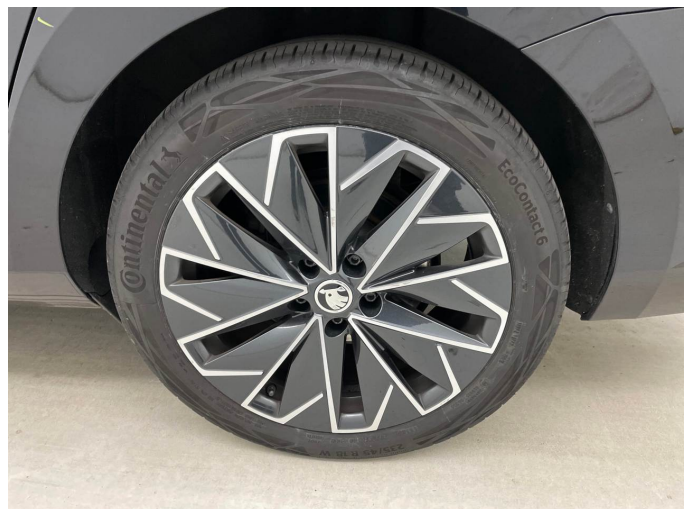
Figure 12: Mounted tyres

| # | Tyre size | Type of tyre | Manufacturer | Tread depth |
|---|---|---|---|---|
| 1) | 235/45 R18 98Y | Summer tyres on Light alloy | Kleber | 6mm / 6mm |
| 2) | 235/45 R18 94W | Summer tyres on Light alloy | Continental | 4mm / 4mm |

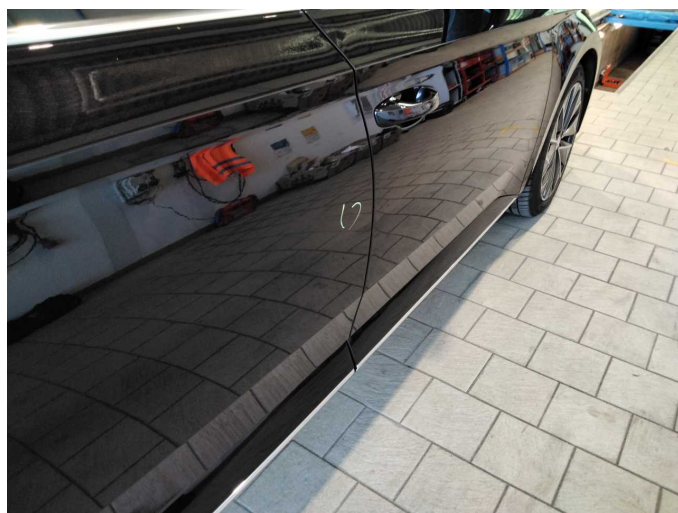
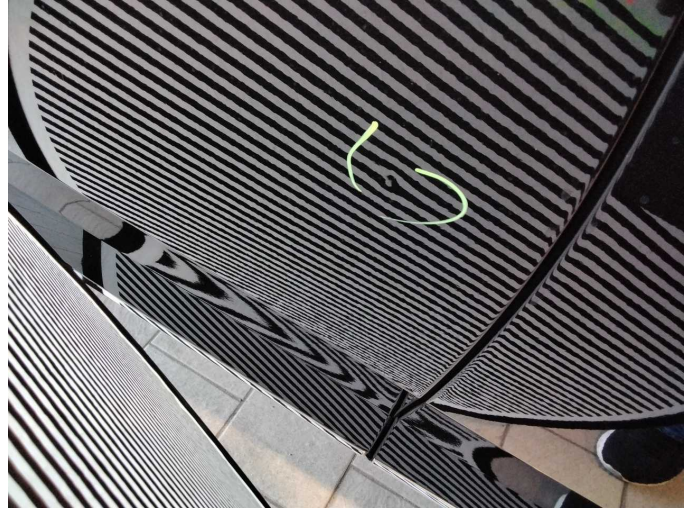
| No. | Component group | Description |
|---|---|---|
| 2 | Door - rear right side | Door - Dent / paintcoat damage - Smart repair |

Damage 2: Door - rear right side: Door - Dent / paintcoat damage - Smart repair

**Damage 2:** Door - rear right side: Door - Dent / paintcoat damage - Smart repair

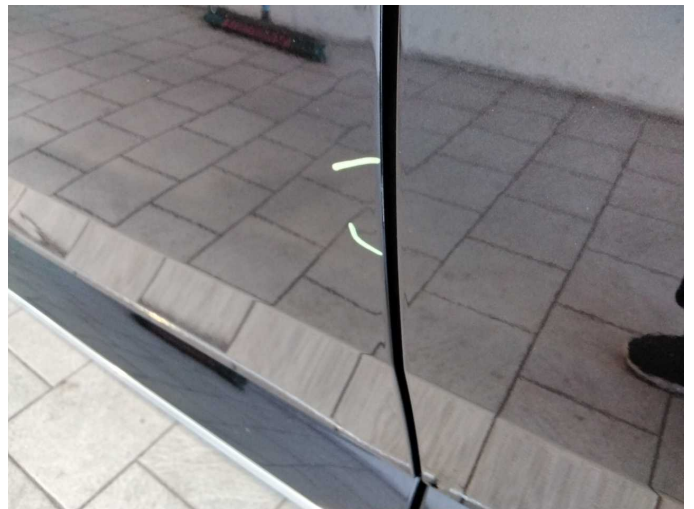
| No. | Component group | Description |
|---|---|---|
| 3 | Door - front left side | Door edge - Scratch(es) - Smart repair |

**Damage 3:** Door - front left side: Door edge - Scratch(es) - Smart repair

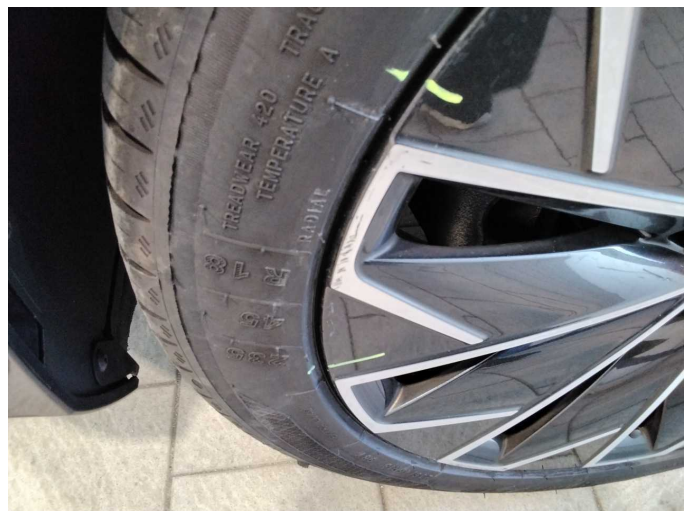
| No. | Component group | Description |
|---|---|---|
| 4 | Wheel / tyres | Alloy rim - front left side - Scratch(es) - Loss in value |

**Damage 4:** Wheel / tyres: Alloy rim - front left side - Scratch(es) - Loss in value

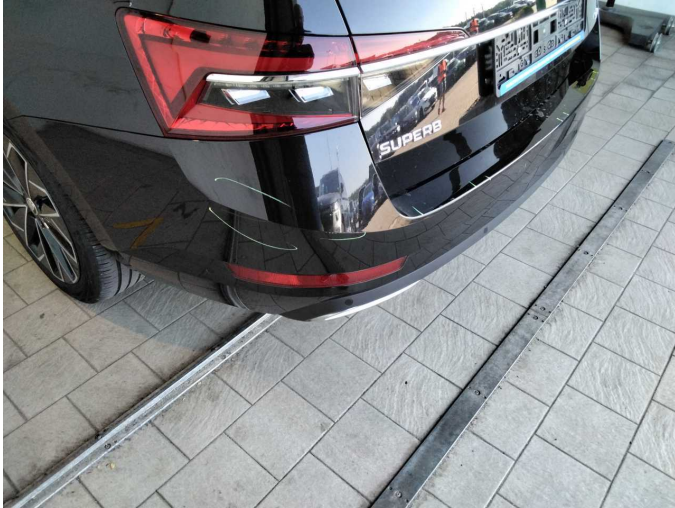
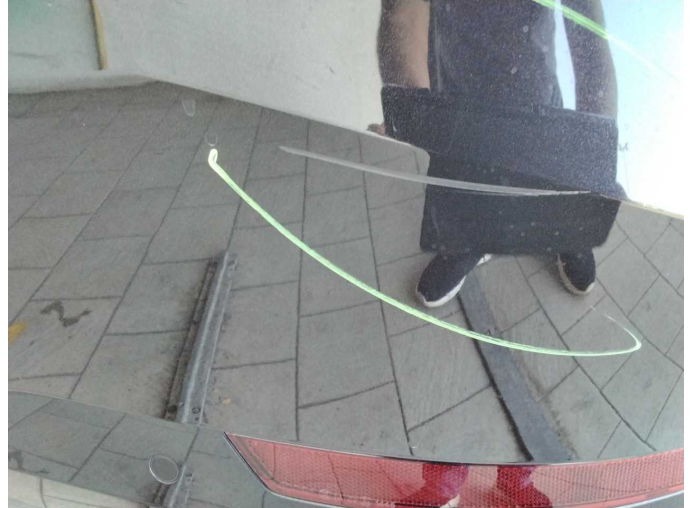
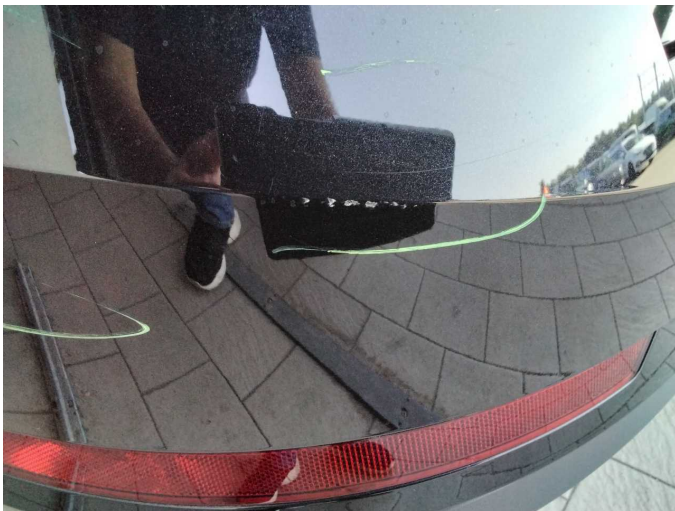
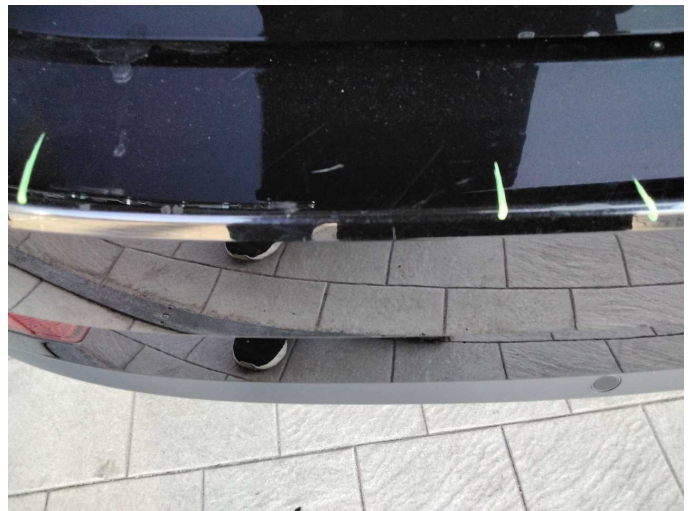
| No. | Component group | Description |
|---|---|---|
| 5 | Rear bumper | Rear bumper - Scratch(es) - Paint |

**Damage 5:** Rear bumper: Rear bumper - Scratch(es) - Paint

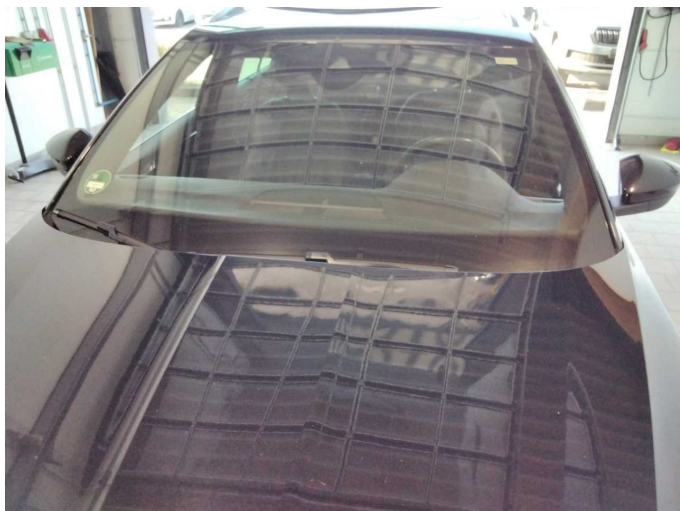
| No. | Component group | Description |
|---|---|---|
| 1 | Vehicle glazing | Windscreen - Stone chips - No deduction |

**Wear and tear 1:** Vehicle glazing: Windscreen - Stone chips - No deduction

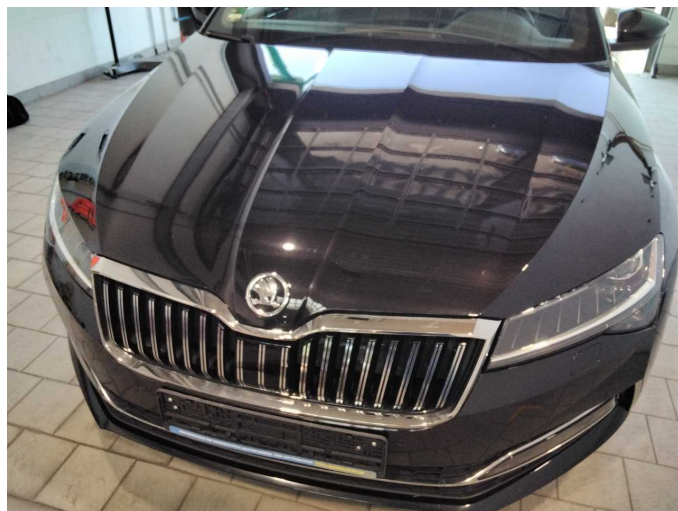
| No. | Component group | Description |
|---|---|---|
| 2 | Bonnet | Bonnet - Stone chips - No deduction |

**Wear and tear 2:** Bonnet: Bonnet - Stone chips - No deduction

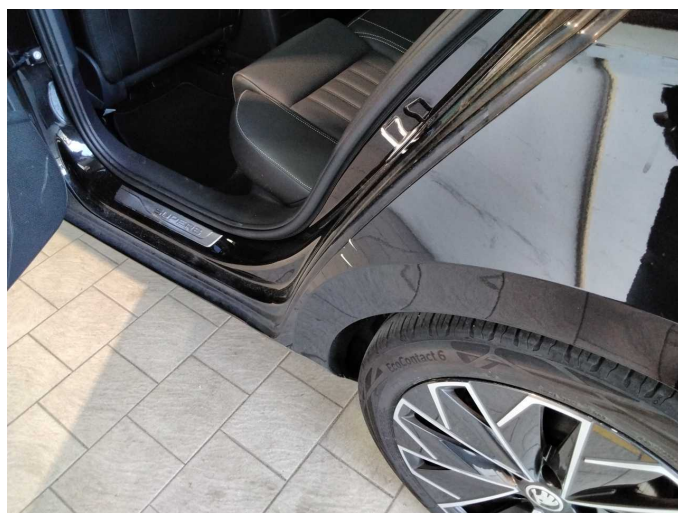
| No. | Component group | Description |
|---|---|---|
| 4 | Side panel - rear left side | Side panel - Scratch(es) - Cover / polish |

**Wear and tear 4:** Side panel - rear left side: Side panel - Scratch(es) - Cover / polish
