Expertise

Protocol number: 46105718  
Order No. / Reference: 26470207  
Inspection date: 23 Jun 2026

Manufacturer: Mercedes-Benz  
VIN: W1NKM0FB5PF001635

Model: GLC 220 d 4Matic 9G-TRONIC AMG Line Advanced

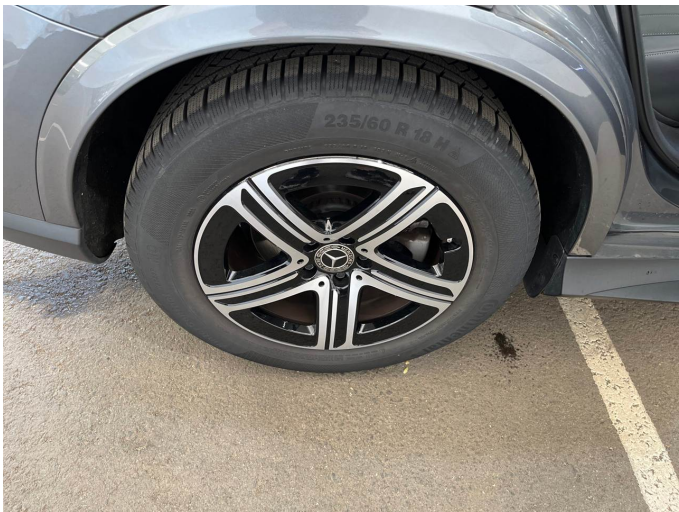
Figure 12: Mounted tyres

| # | Tyre size | Type of tyre | Manufacturer | Tread depth |
|---|---|---|---|---|
| 1) | 235/60 R18 103H | Winter tyres on Light alloy | Continental | 6mm / 6mm |
| 2) | 235/60 R18 103H | Winter tyres on Light alloy | Continental | 6mm / 6mm |

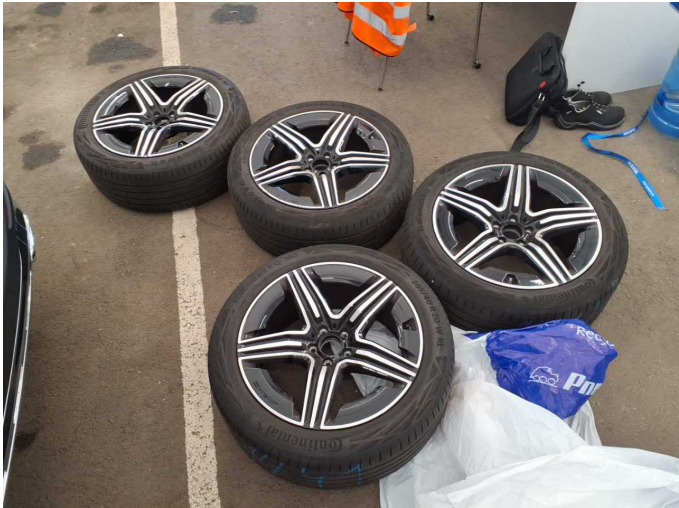
Figure 16: Additional tyres

| No. | Component group | Description |
|---|---|---|
| 1 | 2nd wheel set | 1 tyre - Broken / torn - Replace |

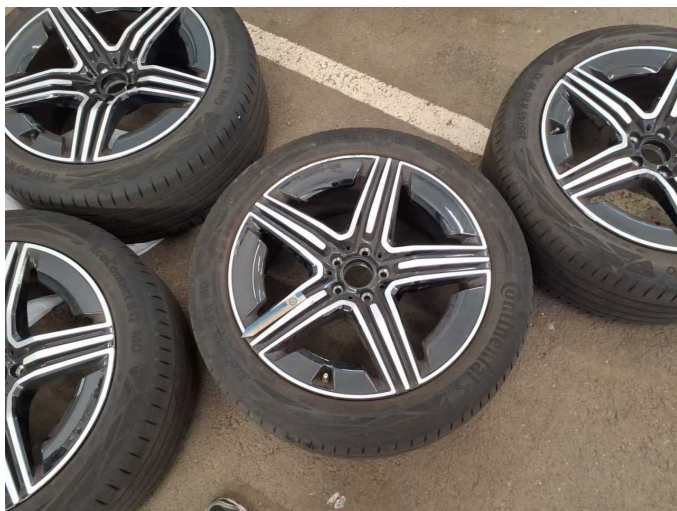
| No. | Component group | Description |
|---|---|---|
| 2 | Misc. | Inspection / maintenance - Expired - Perform |

Damage 2: Misc.: Inspection / maintenance - Expired - Perform

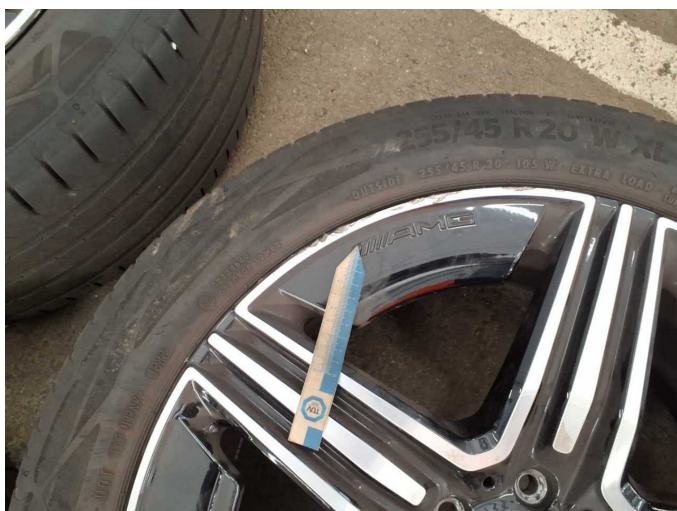
| No. | Component group | Description |
|---|---|---|
| 3 | 2nd wheel set | 1 alloy rim - Scratched - Loss in value |

Damage 3: 2nd wheel set: 1 alloy rim - Scratched - Loss in value

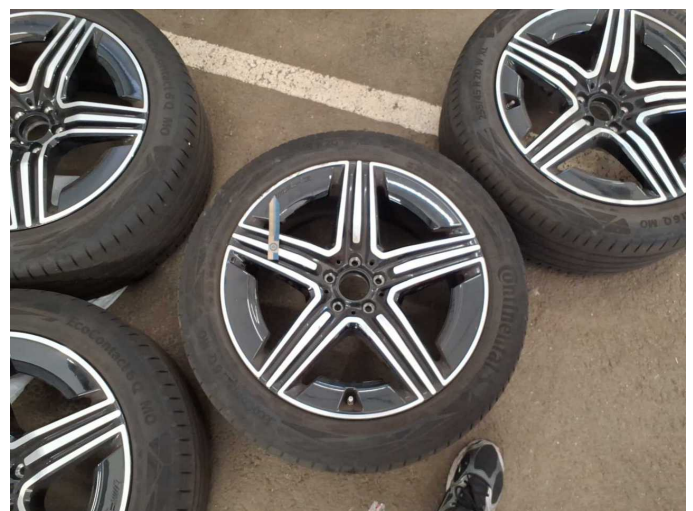
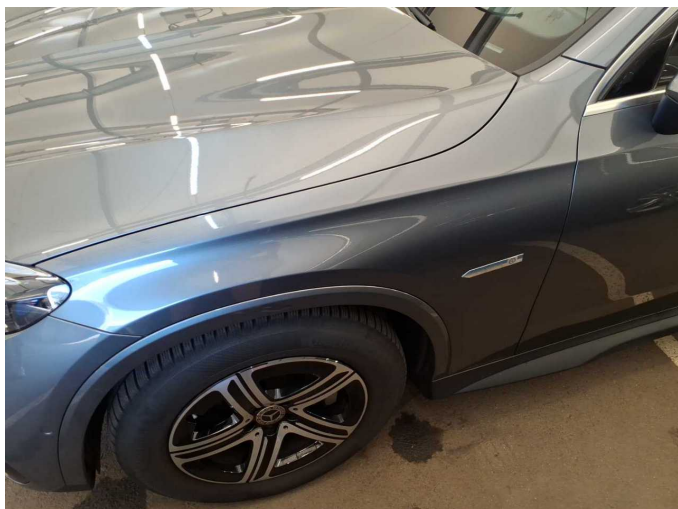
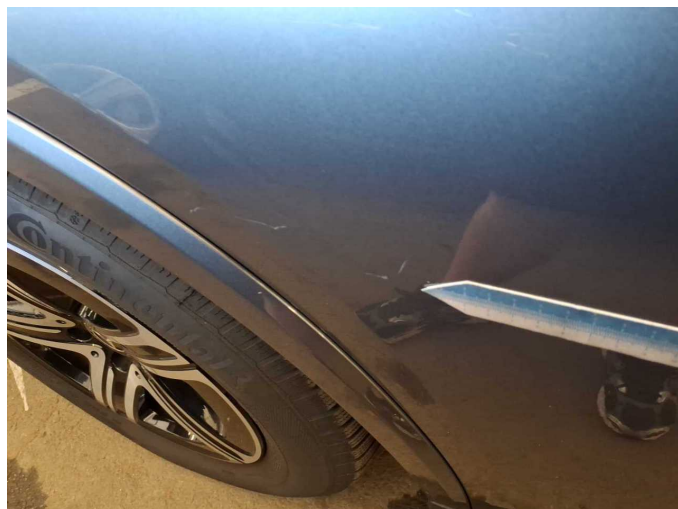
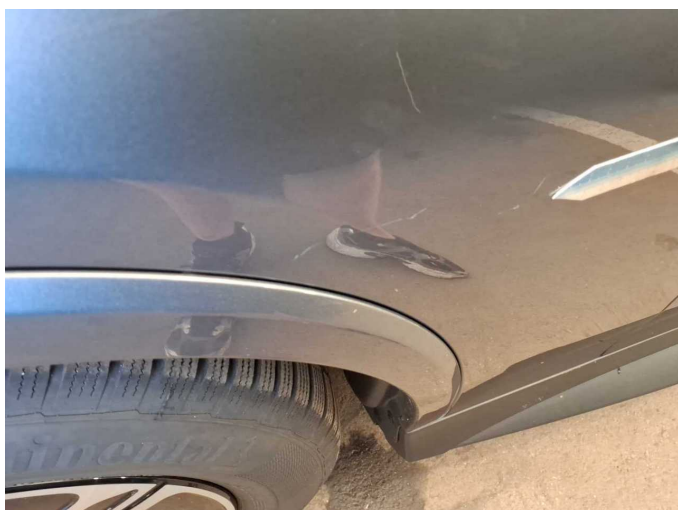
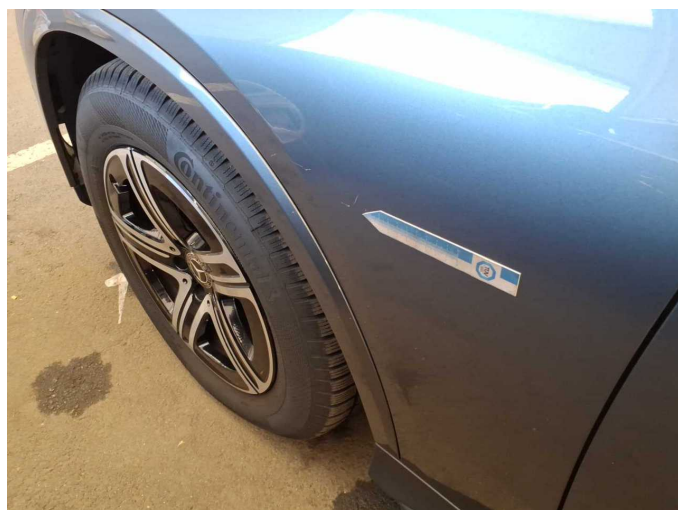
| No. | Component group | Description |
|---|---|---|
| 4 | Mudguard - left side | Mudguard - left side - Scratch(es) - Paint |

**Damage 4:** Mudguard - left side: Mudguard - left side - Scratch(es) - Paint

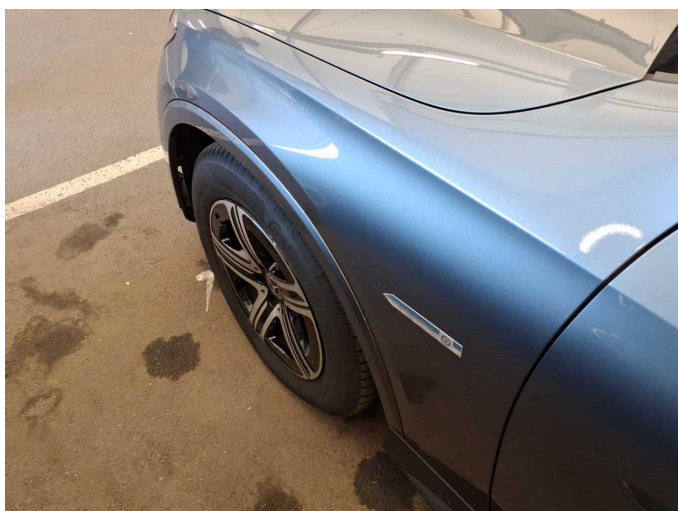
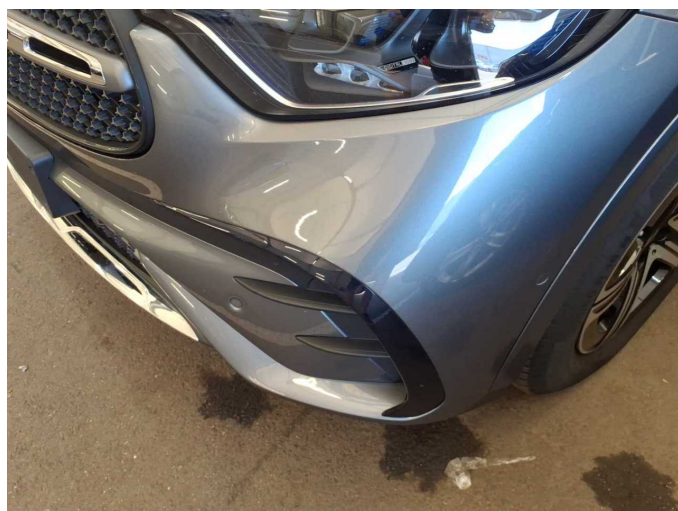
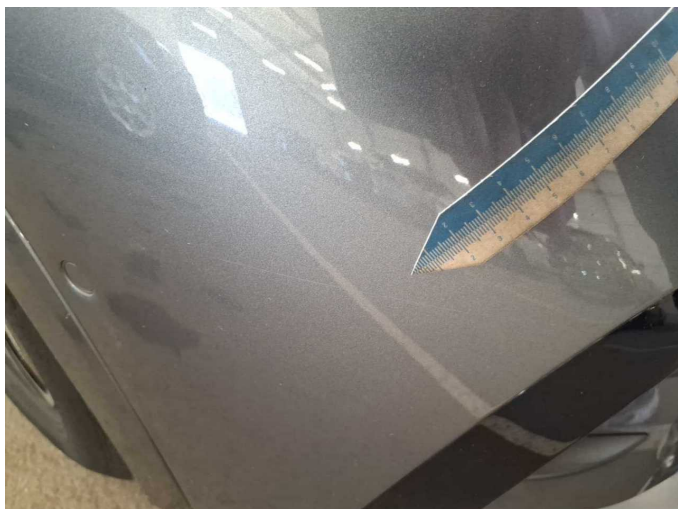
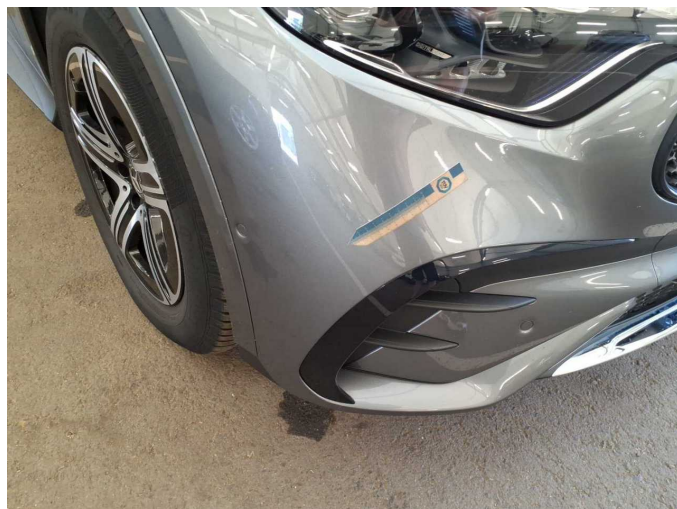
| No. | Component group | Description |
|---|---|---|
| 5 | Front bumper | Front bumper - Scratch(es) - Paint |

**Damage 5:** Front bumper: Front bumper - Scratch(es) - Paint

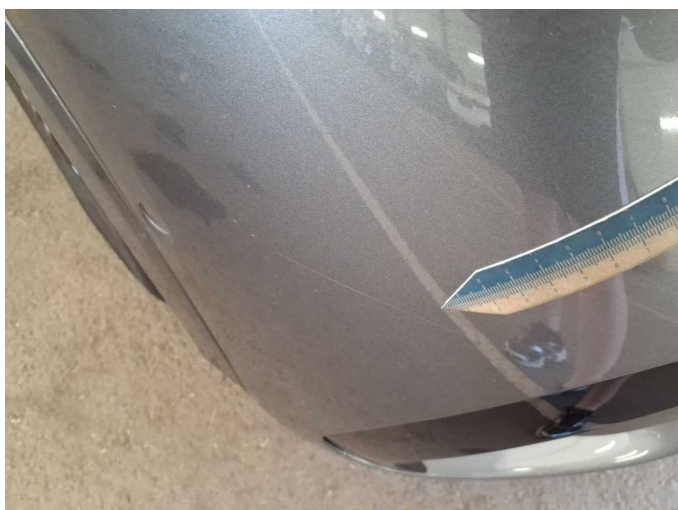
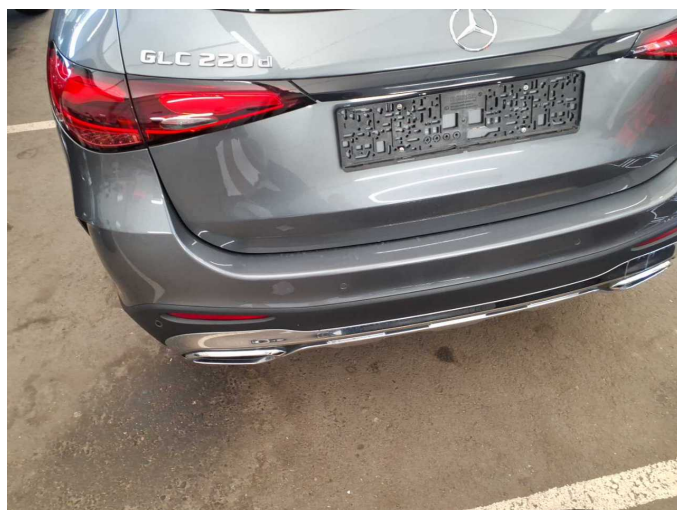
| No. | Component group | Description |
|---|---|---|
| 2 | Rear bumper | Rear bumper - Scratch(es) - No deduction |

**Wear and tear 2:** Rear bumper: Rear bumper - Scratch(es) - No deduction

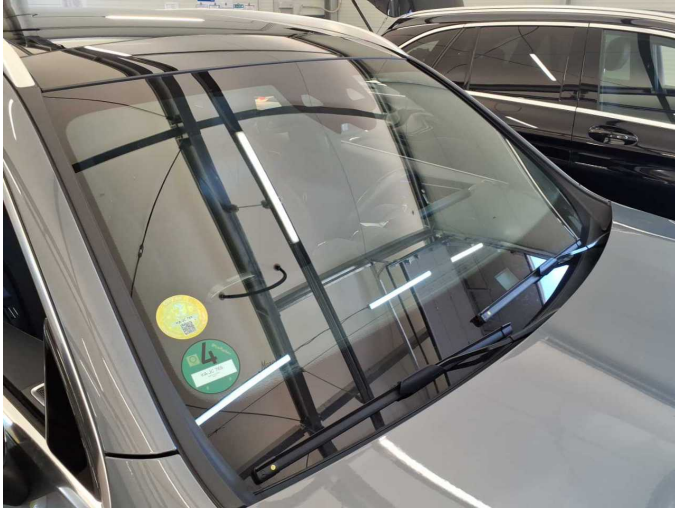
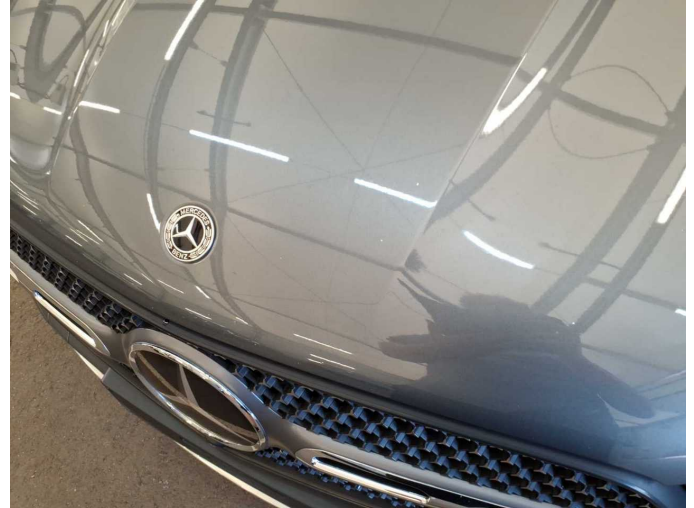
| No. | Component group | Description |
|---|---|---|
| 4 | Bonnet | Bonnet - Stone chips - No deduction |

**Wear and tear 4:** Bonnet: Bonnet - Stone chips - No deduction
