Expertise

Protocol number: 46918517  
Order No. / Reference: 26676167  
Inspection date: 6 Aug 2026

Manufacturer: Volkswagen

Model: Tiguan Allspace 2.0 TDI SCR 4Motion DSG R-Line

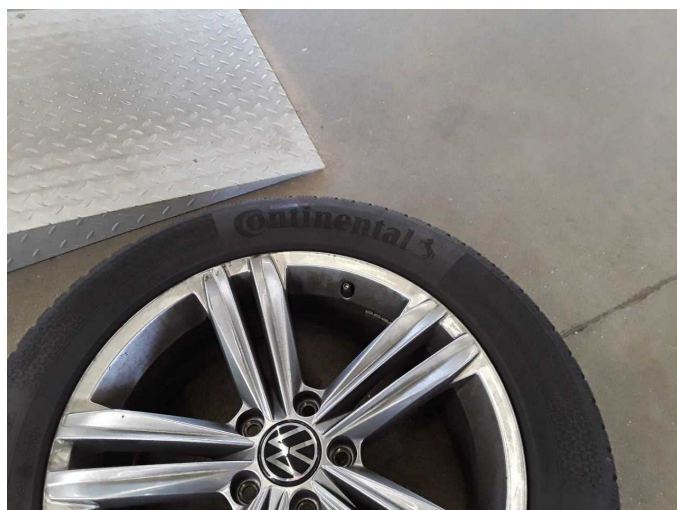
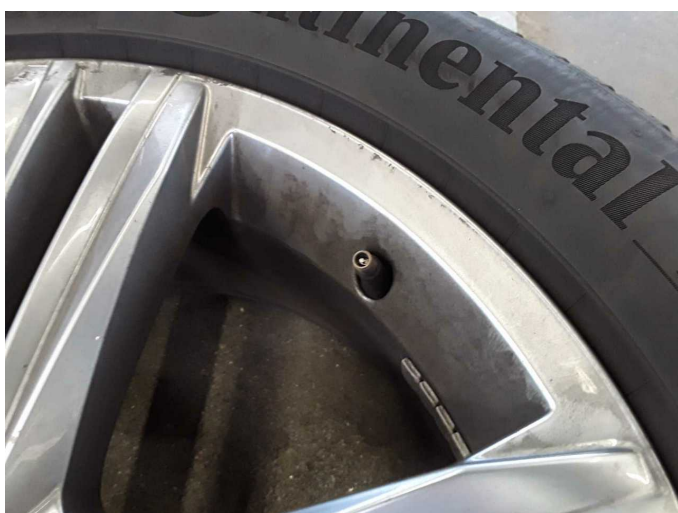
| No. | Component group | Description |
|---|---|---|
| 1 | Wheel / tyres | Valve (Reifen HR) - Missing - Replace |

**Damage 1:** Wheel / tyres: Valve (Reifen HR) - Missing - Replace

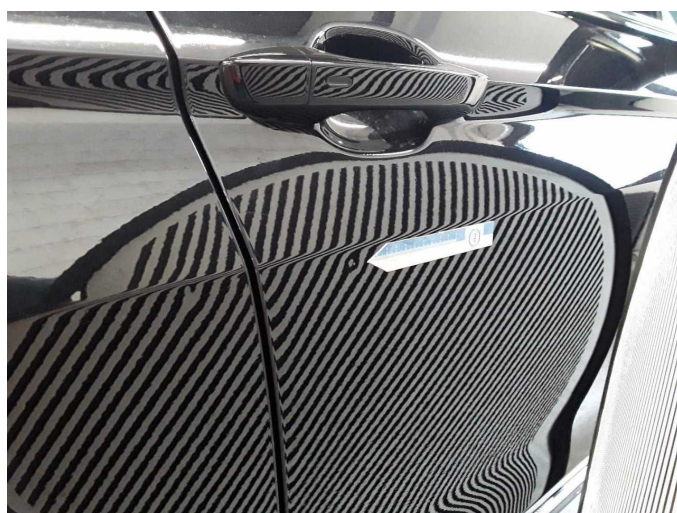
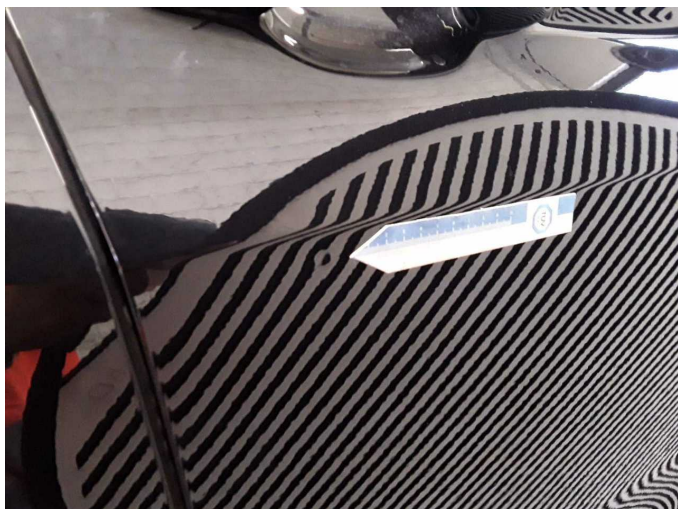
| No. | Component group | Description |
|---|---|---|
| 2 | Door - front right side | Door - dent(s) - Smooth repair work |

**Damage 2:** Door - front right side: Door - dent(s) - Smooth repair work

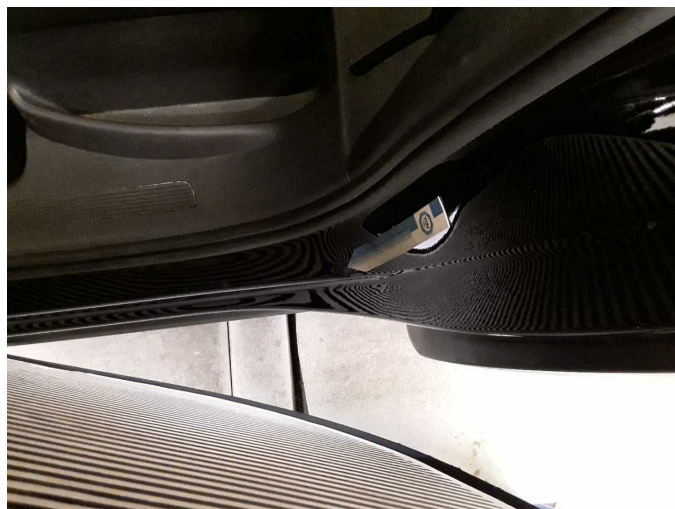
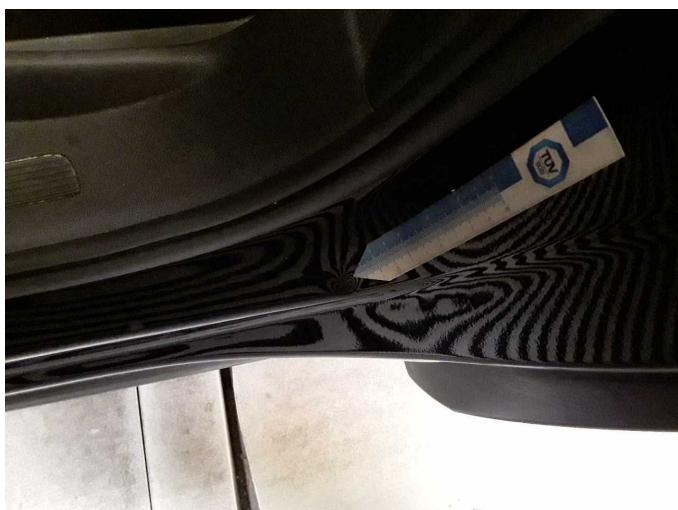
| No. | Component group | Description |
|---|---|---|
| 3 | Side panel - rear left side | Sill - dent(s) - Smooth repair work |

**Damage 3:** Side panel - rear left side: Sill - dent(s) - Smooth repair work

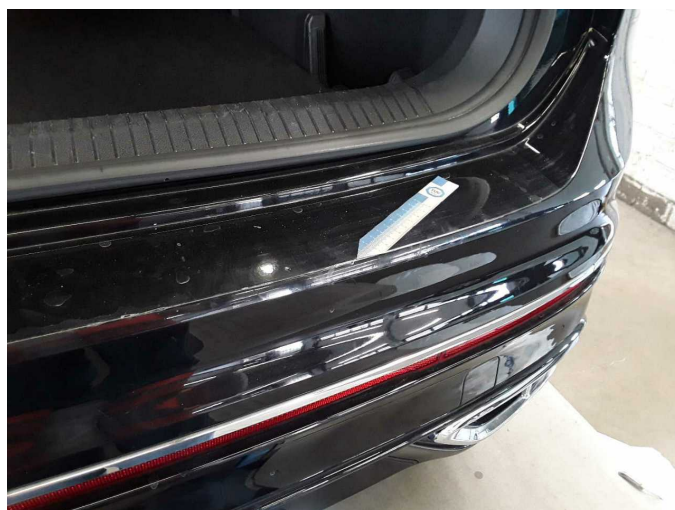
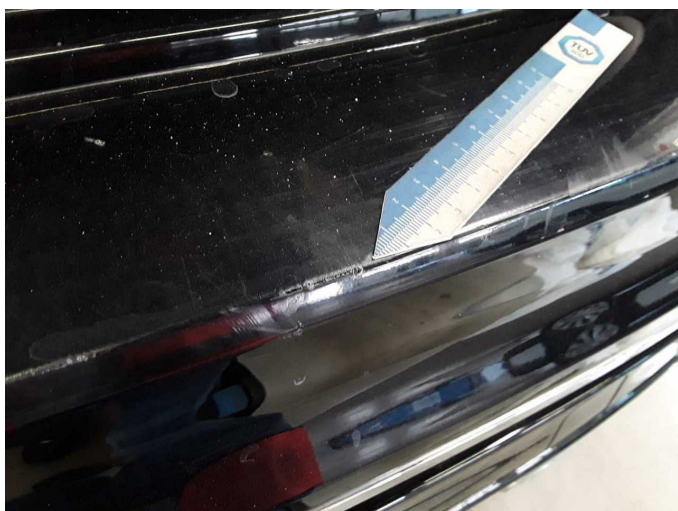
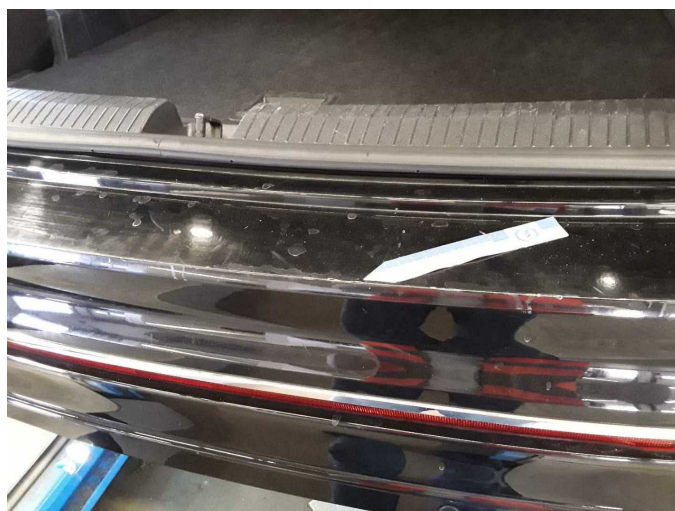
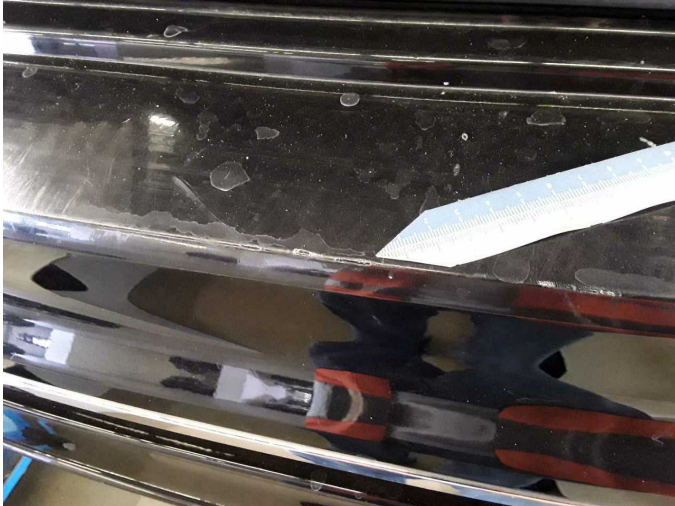
| No. | Component group | Description |
|---|---|---|
| 4 | Rear bumper | Rear bumper - Scratched - Smart repair |

**Damage 4:** Rear bumper: Rear bumper - Scratched - Smart repair

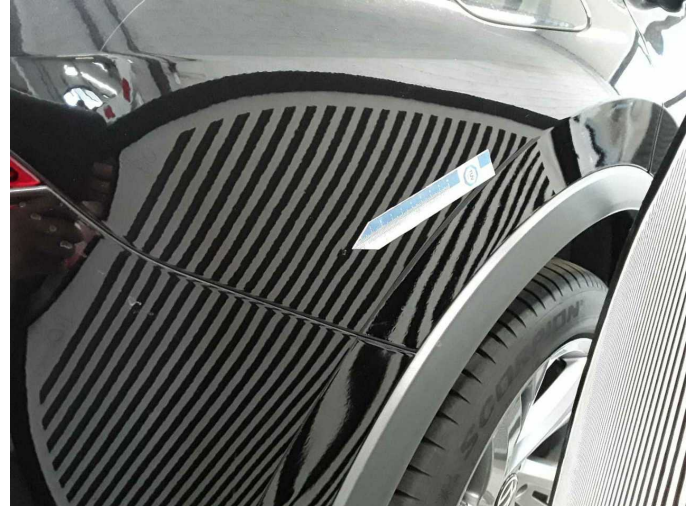
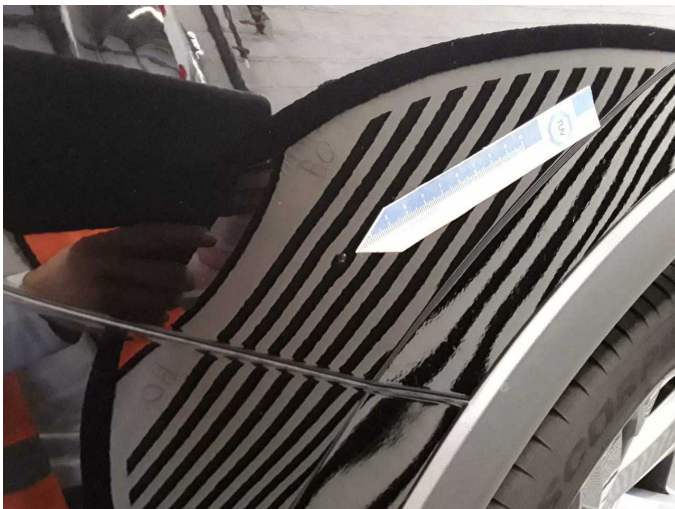
| No. | Component group | Description |
|---|---|---|
| 5 | Side panel - rear right side | Side panel - Dent / paintcoat damage - Smart repair |

**Damage 5:** Side panel - rear right side: Side panel - Dent / paintcoat damage - Smart repair

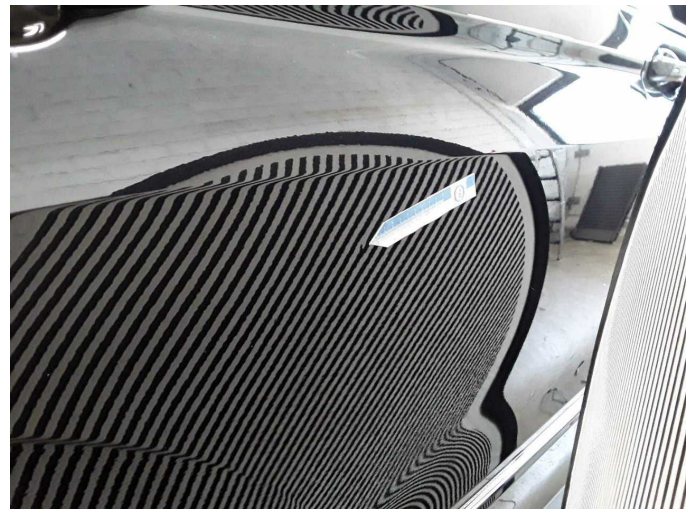
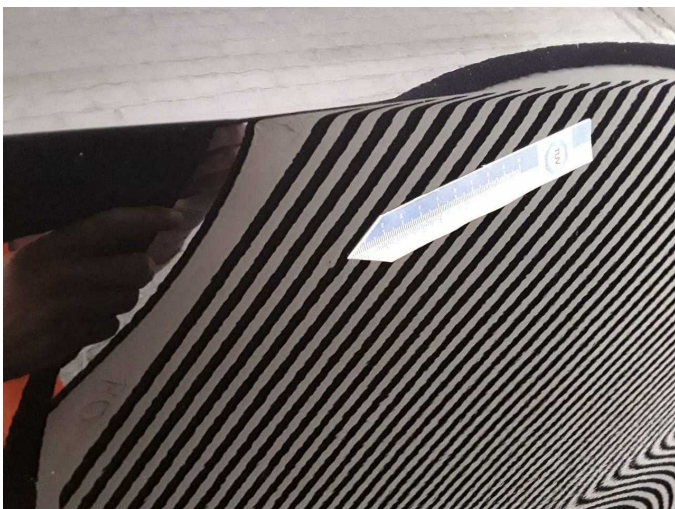
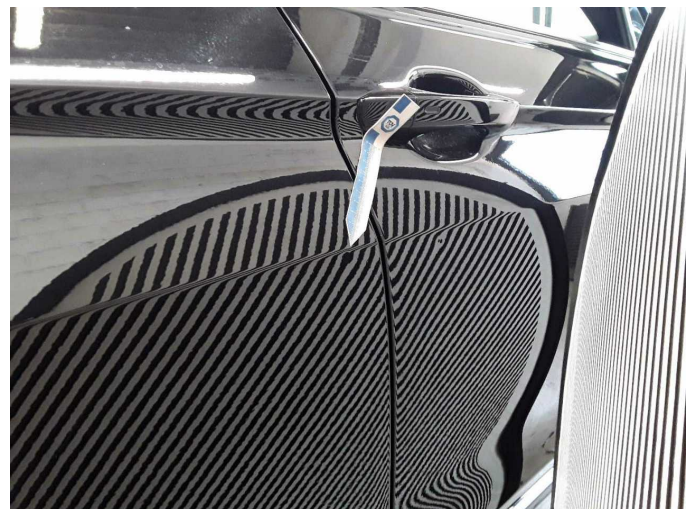
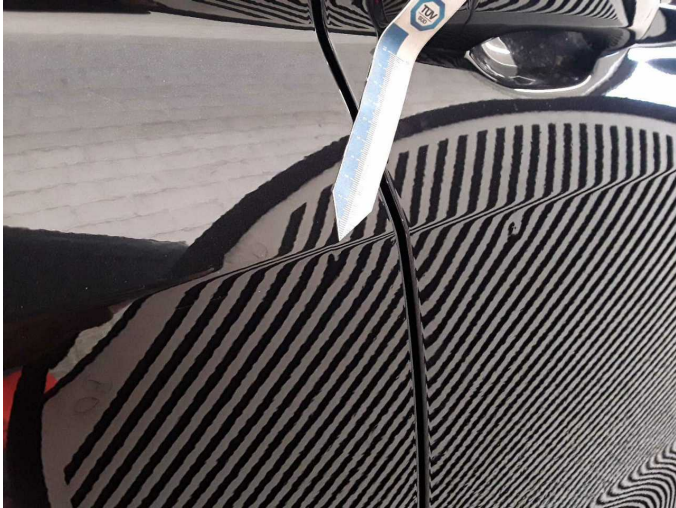
| No. | Component group | Description |
|---|---|---|
| 6 | Door - rear right side | Door - dent(s) - Smooth repair work |

**Damage 6:** Door - rear right side: Door - dent(s) - Smooth repair work

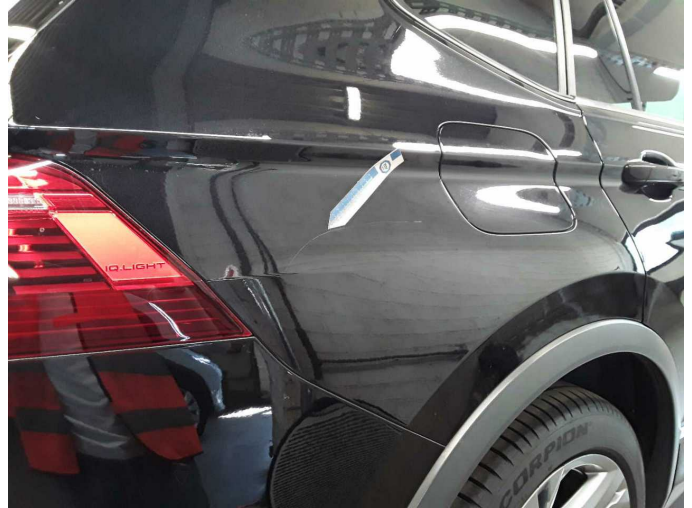
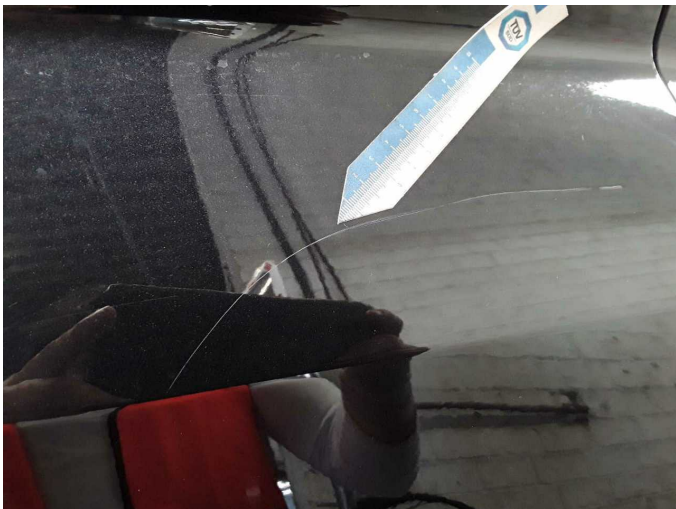
| No. | Component group | Description |
|---|---|---|
| 7 | Side panel - rear right side | Side panel - Scratch(es) - Paint |

**Damage 7:** Side panel - rear right side: Side panel - Scratch(es) - Paint

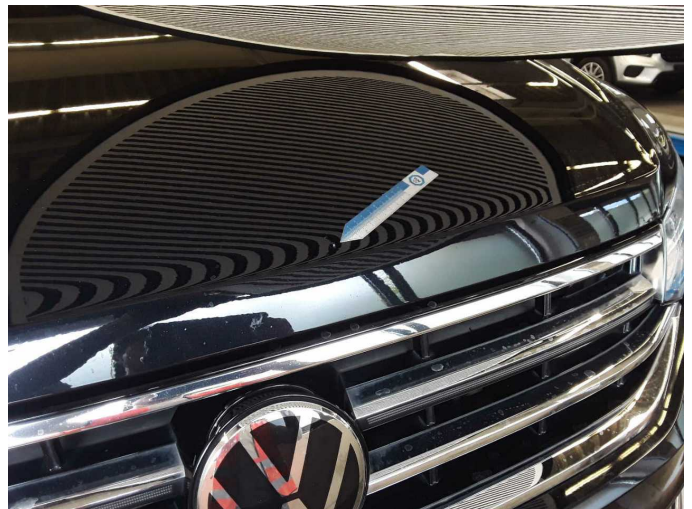
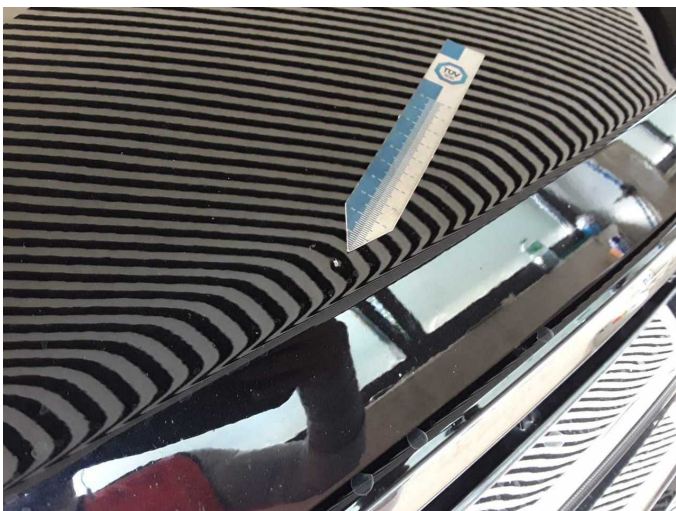
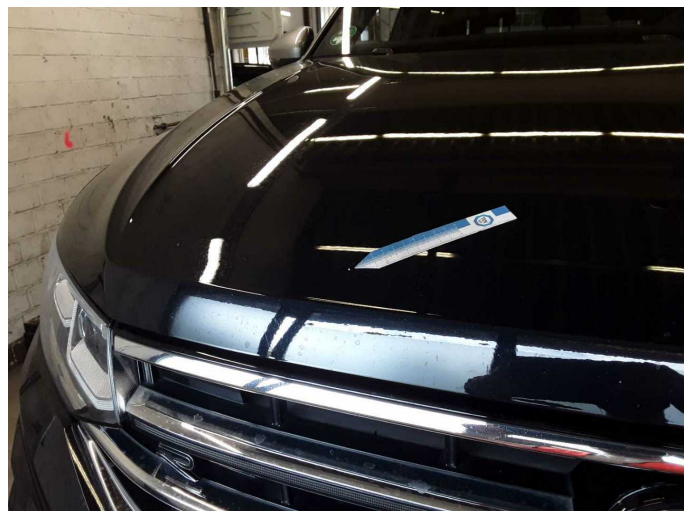
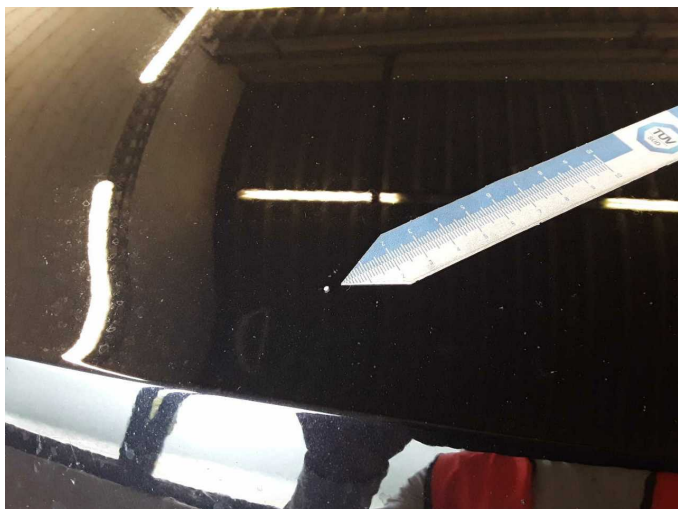
| No. | Component group | Description |
|---|---|---|
| 8 | Bonnet | Bonnet - Dent / paintcoat damage - Repair and paint |

**Damage 8:** Bonnet: Bonnet - Dent / paintcoat damage - Repair and paint

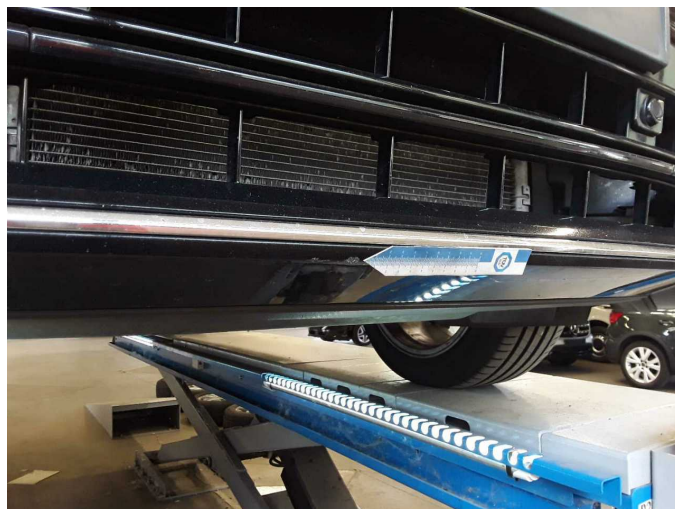
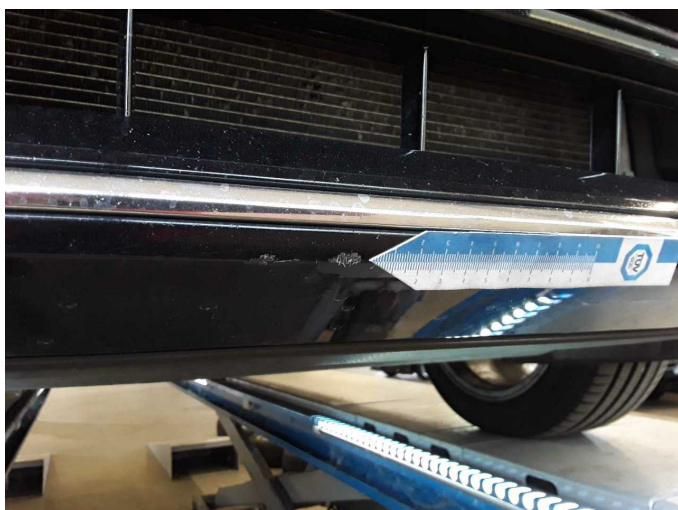
| No. | Component group | Description |
|---|---|---|
| 1 | Front bumper | Front bumper - Scratched - No deduction |

**Wear and tear 1:** Front bumper: Front bumper - Scratched - No deduction

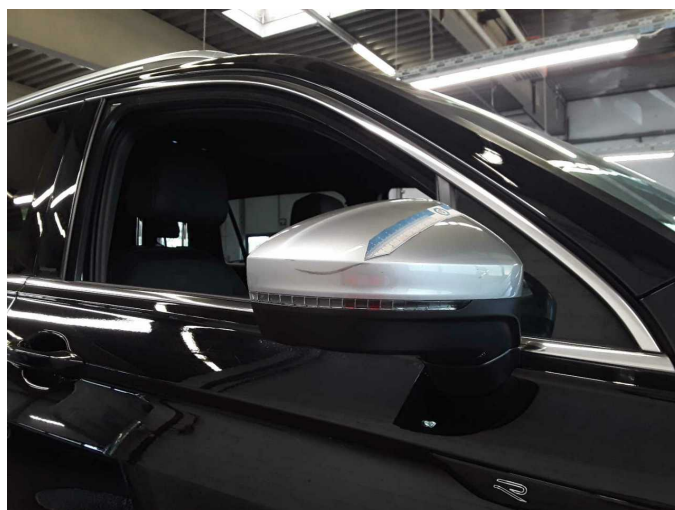
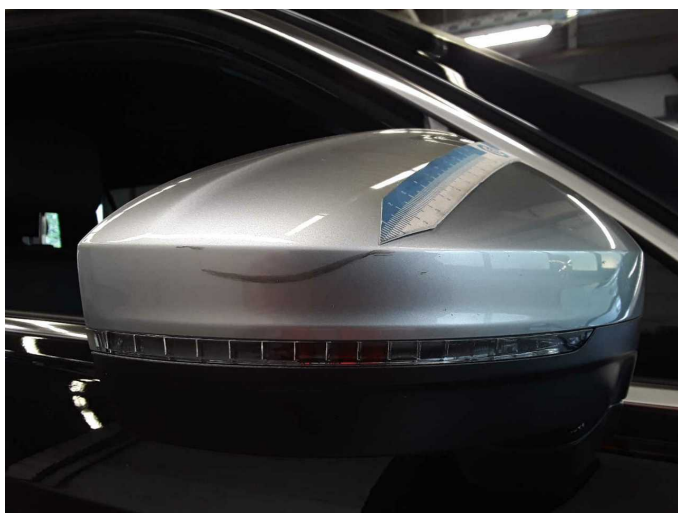
| No. | Component group | Description |
|---|---|---|
| 2 | Wing mirror - right side | Mirror housing - Abrasion - No deduction |

**Wear and tear 2:** Wing mirror - right side: Mirror housing - Abrasion - No deduction

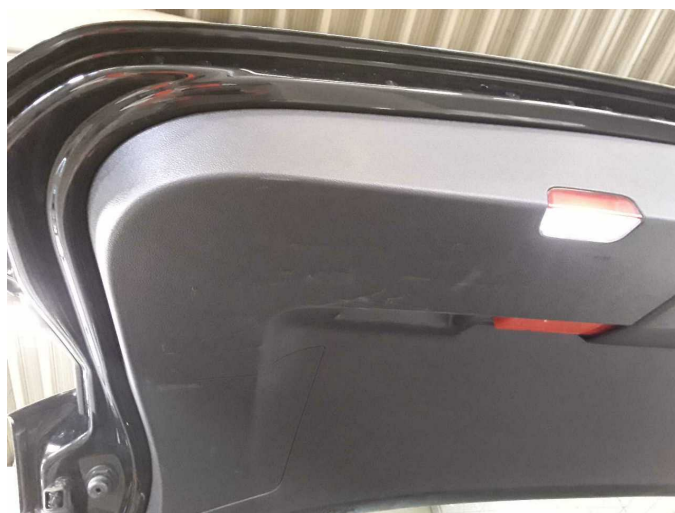
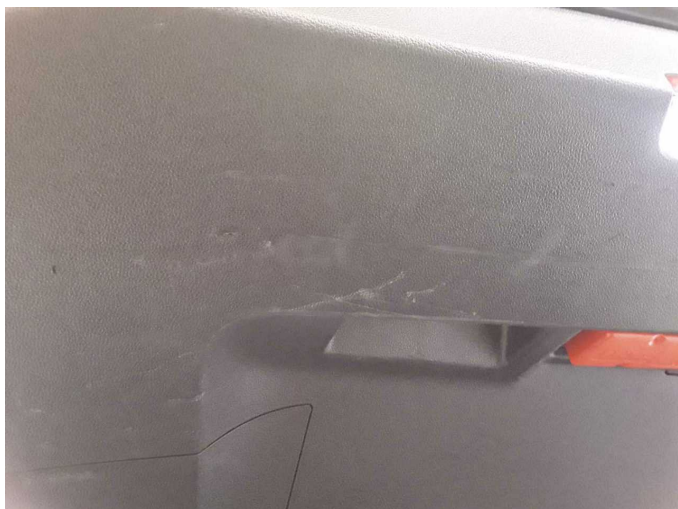
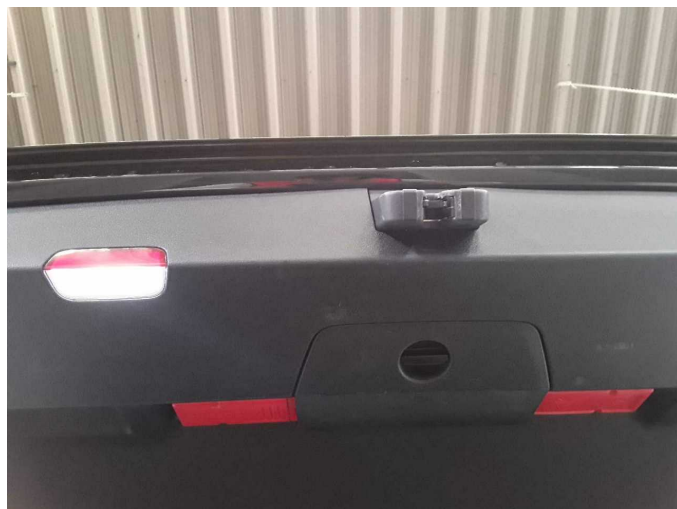
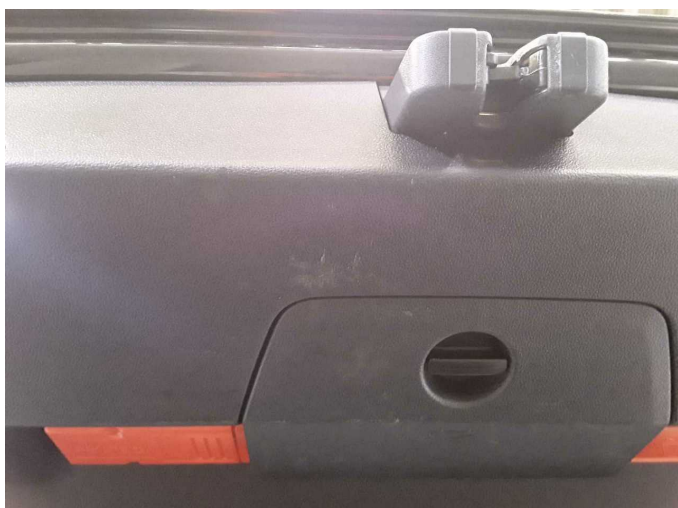
| No. | Component group | Description |
|---|---|---|
| 3 | Boot lid / rear door | Trim - standard - lower - Scratched - No deduction |

**Wear and tear 3:** Boot lid / rear door: Trim - standard - lower - Scratched - No deduction

**Wear and tear 3:** Boot lid / rear door: Trim - standard - lower - Scratched  
- No deduction

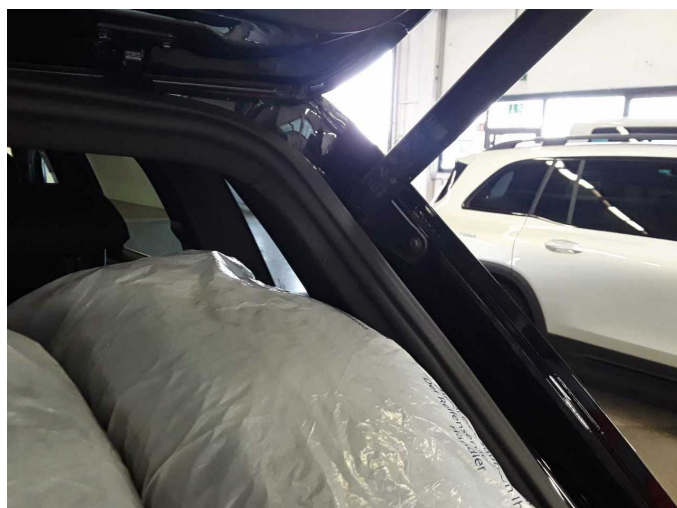
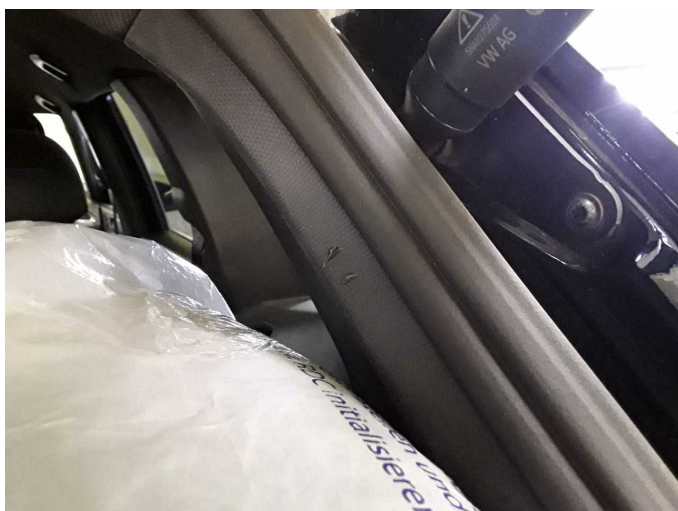
| No. | Component group | Description |
|---|---|---|
| 4 | Trim / covers | Cargo area - lining - right side - Scratched - No deduction |

**Wear and tear 4:** Trim / covers: Cargo area - lining - right side -  
Scratched - No deduction
