Expertise

Protocol number: 46090920  
Order No. / Reference: 26469373  
Inspection date: 22 Jun 2026

Manufacturer: Audi

Model: Q3 35 TDI S tronic S line

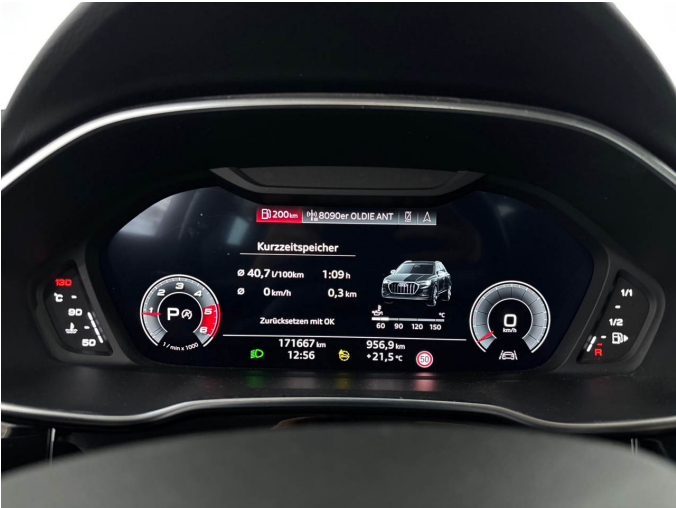
Figure 7: Instrument cluster

| Vehicle details | |
|---|---|
| Mileage (Read) | 171,667 km |

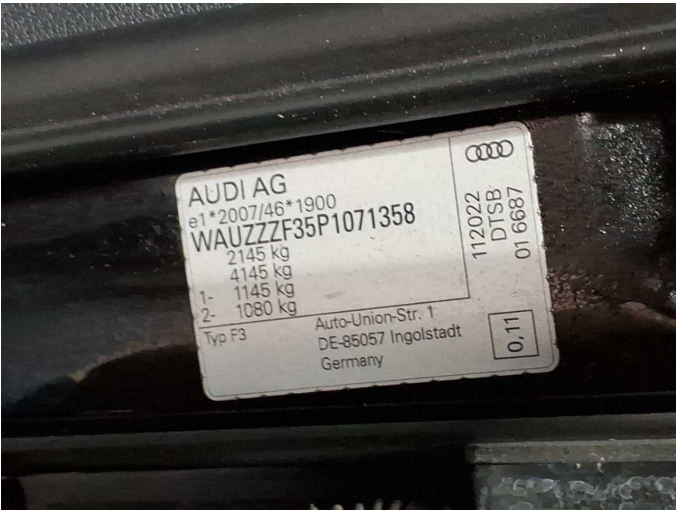
Figure 11: VIN

| VIN comparison | The vehicle identification number (VIN) was read from the vehicle and its conformity with the submitted documents was confirmed by the undersigned during the inspection. |

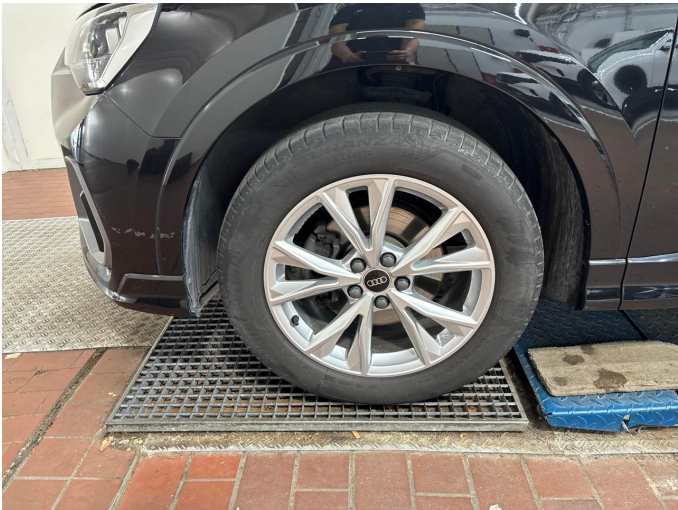
Figure 12: Mounted tyres

| # | Tyre size | Type of tyre | Manufacturer | Tread depth |
|---|---|---|---|---|
| 1) | 235/55 R18 100Y | Summer tyres on Light alloy | Bridgestone | 4mm / 4mm |
| 2) | 235/55 R18 100Y | Summer tyres on Light alloy | Bridgestone | 4mm / 4mm |

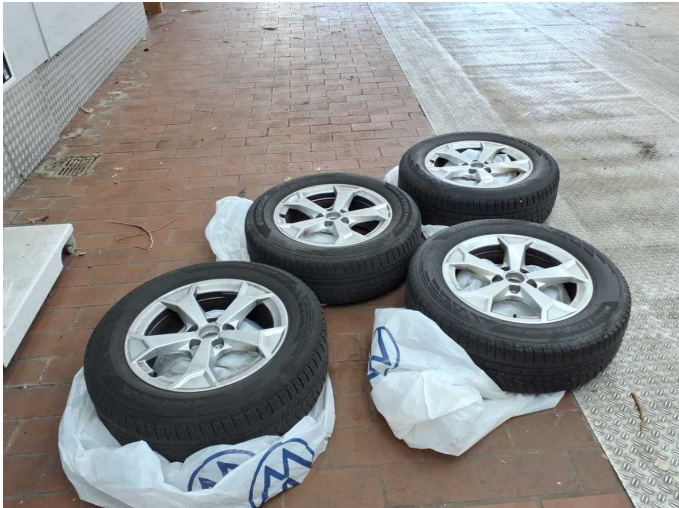
Figure 16: Additional tyres

| # | Tyre size | Type of tyre | Manufacturer | Tread depth |
|---|---|---|---|---|
| 1) | 215/65 R17 99H | Winter tyres on Light alloy | Hankook | 5mm / 5mm |
| 2) | 215/65 R17 99H | Winter tyres on Light alloy | Hankook | 6mm / 6mm |

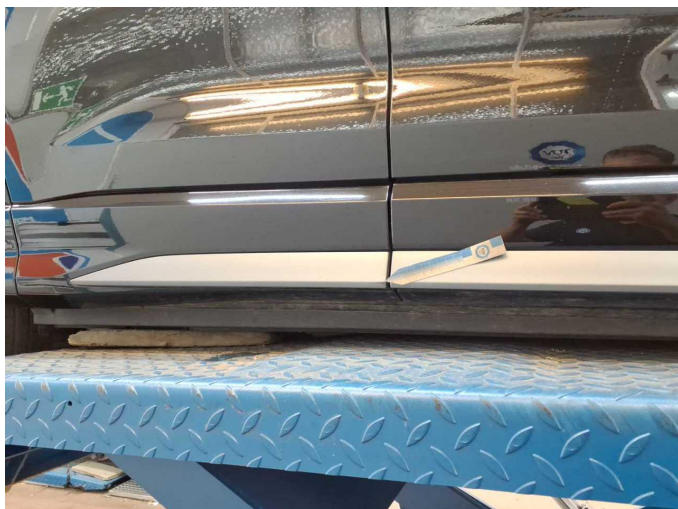
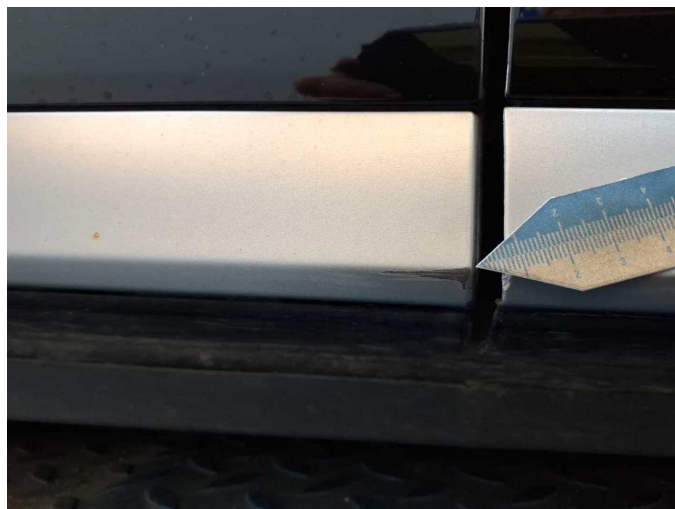
| No. | Component group | Description |
|---|---|---|
| 1 | Door - rear right side | Brightware - lower - Scratch(es) - Loss in value |

**Damage 1:** Door - rear right side: Brightware - lower - Scratch(es) - Loss in value

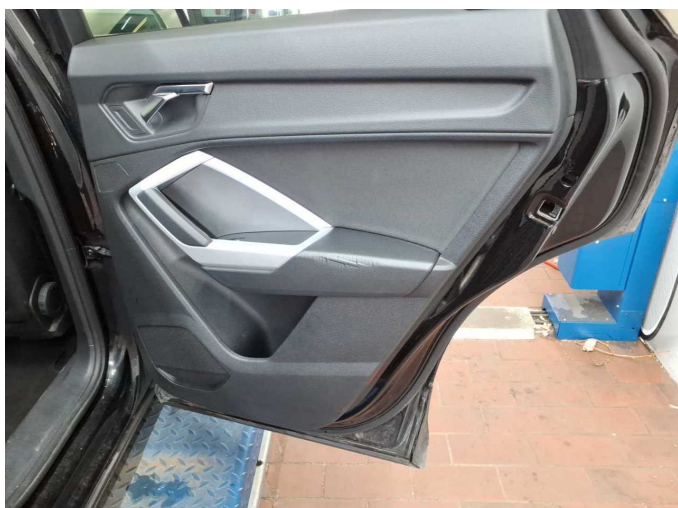
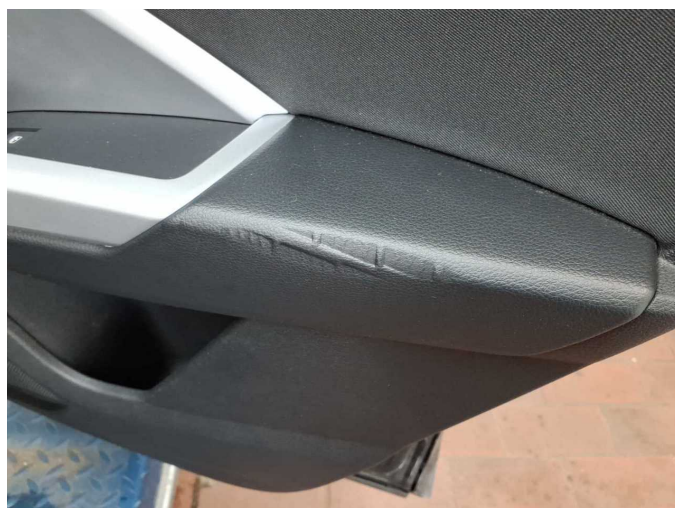
| No. | Component group | Description |
|---|---|---|
| 2 | Trim / covers | Door trim - rear right side - Deformed - Loss in value |

**Damage 2:** Trim / covers: Door trim - rear right side - Deformed - Loss in value

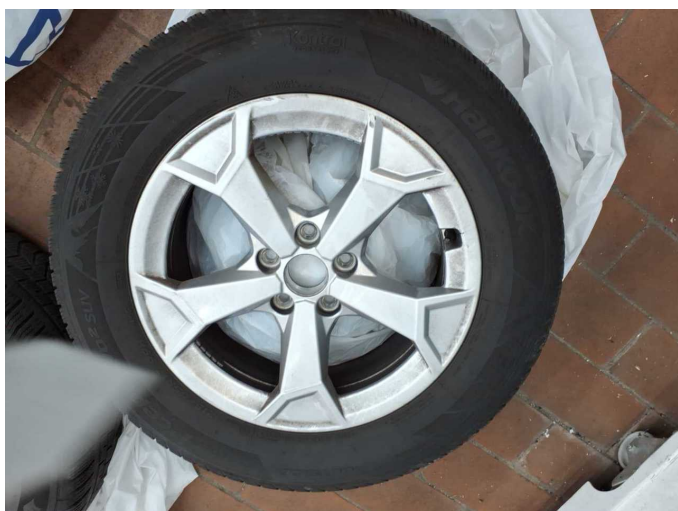
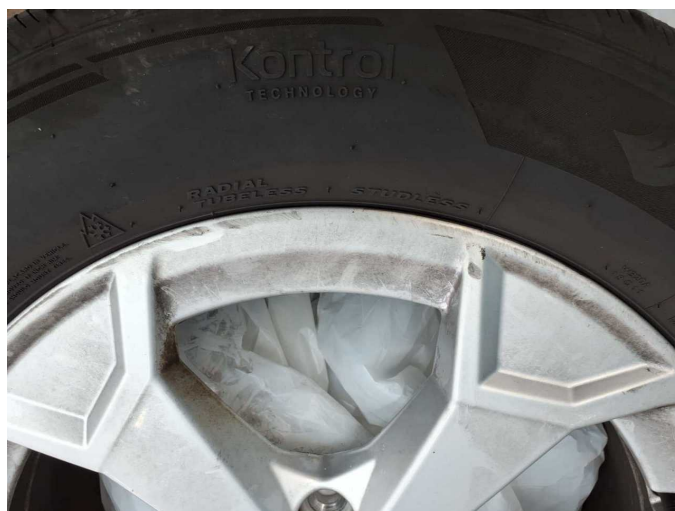
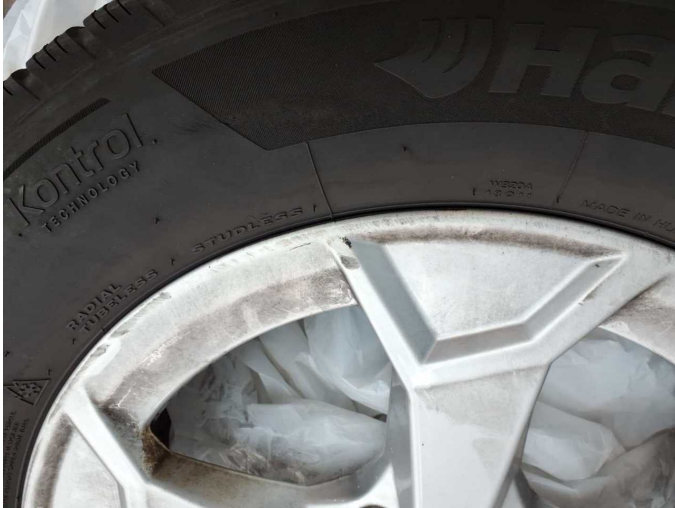
| No. | Component group | Description |
|---|---|---|
| 3 | 2nd wheel set | 1 alloy rim - Scratch(es) - Loss in value |

**Damage 3:** 2nd wheel set: 1 alloy rim - Scratch(es) - Loss in value

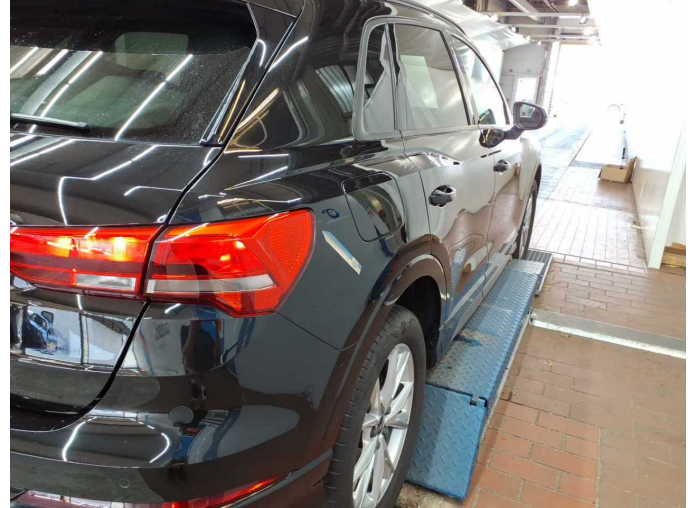
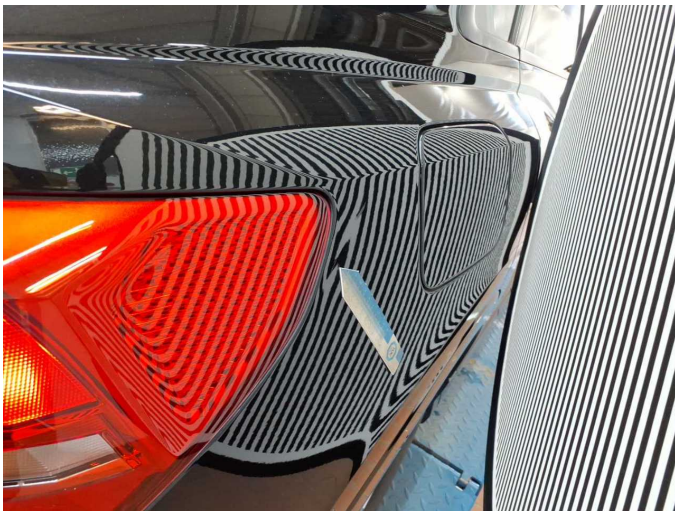
| No. | Component group | Description |
|---|---|---|
| 4 | Side panel - rear left side | Side panel - Deformed - Repair and paint |

**Damage 4:** Side panel - rear left side: Side panel - Deformed - Repair and paint

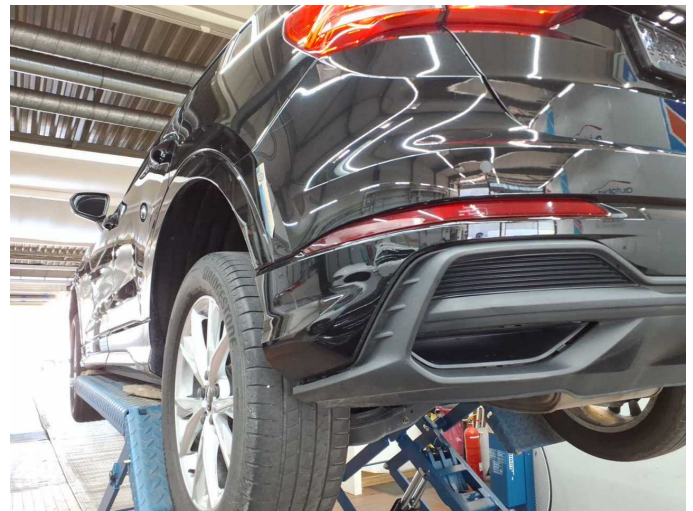
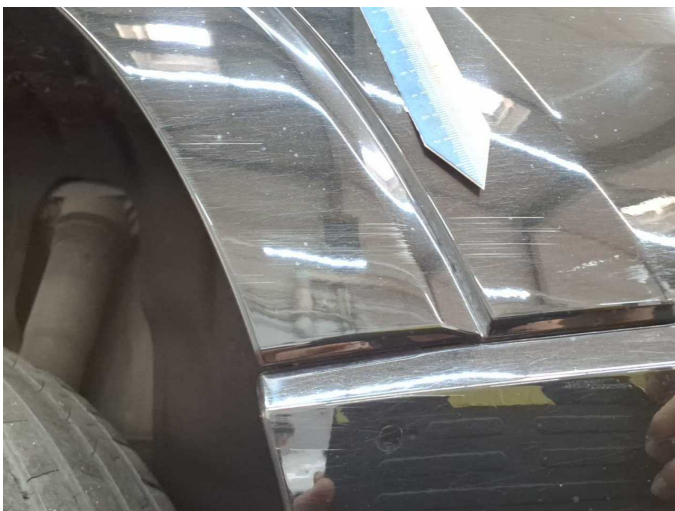
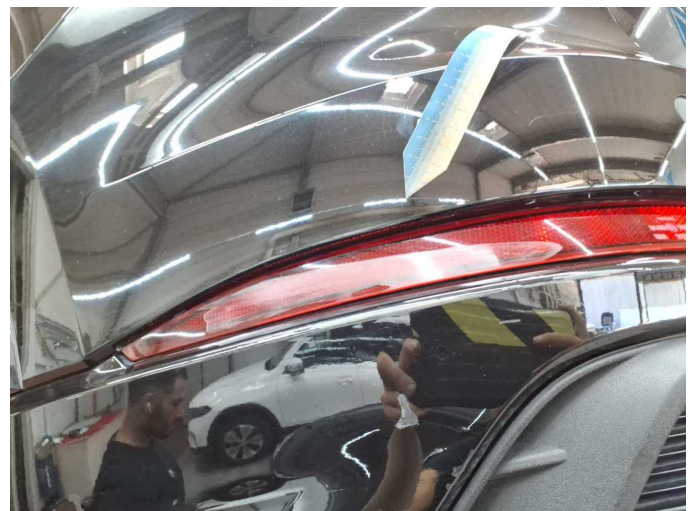
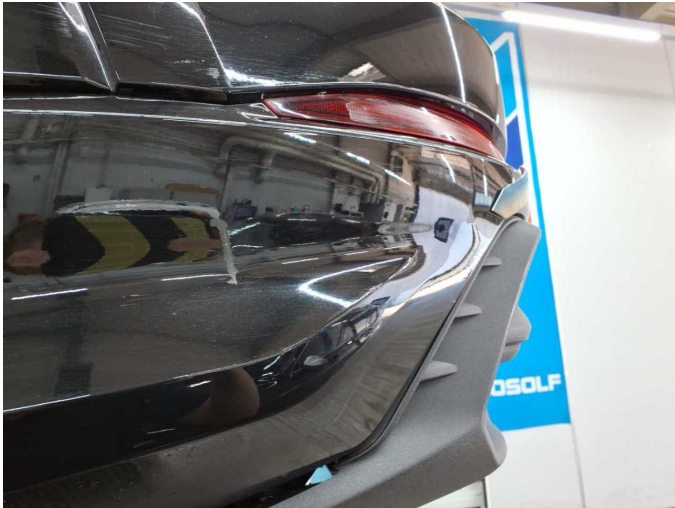
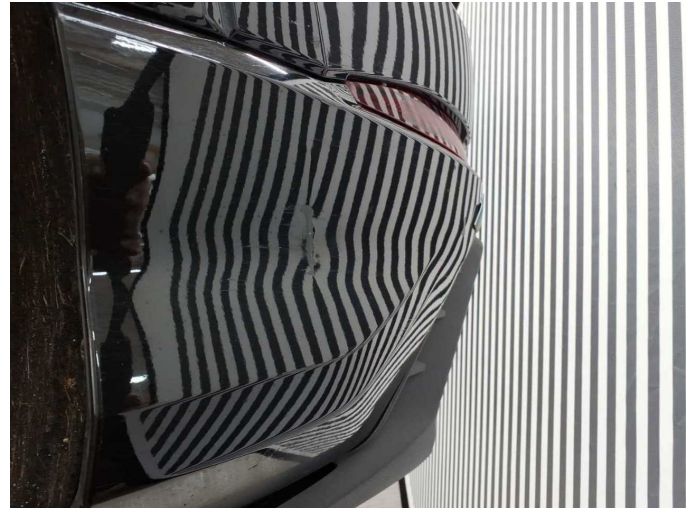
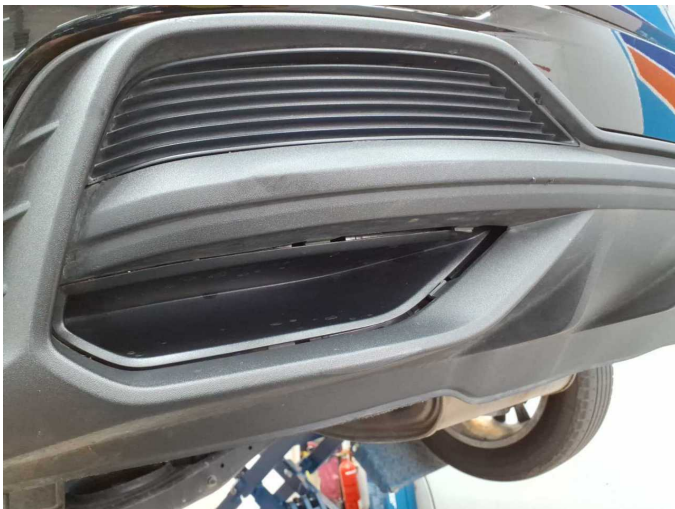
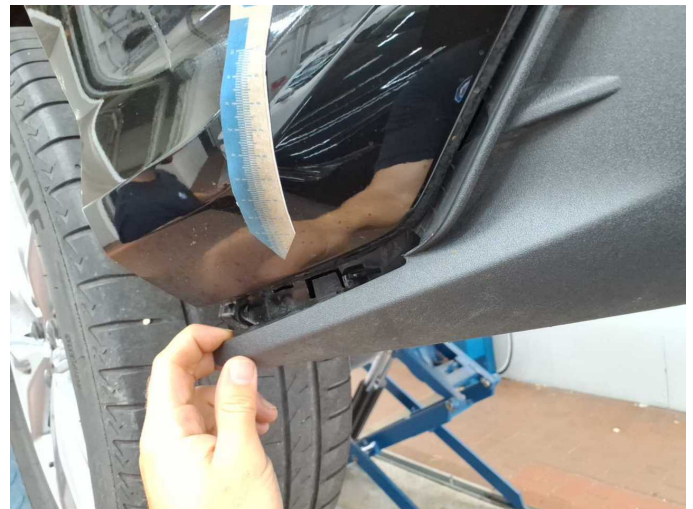
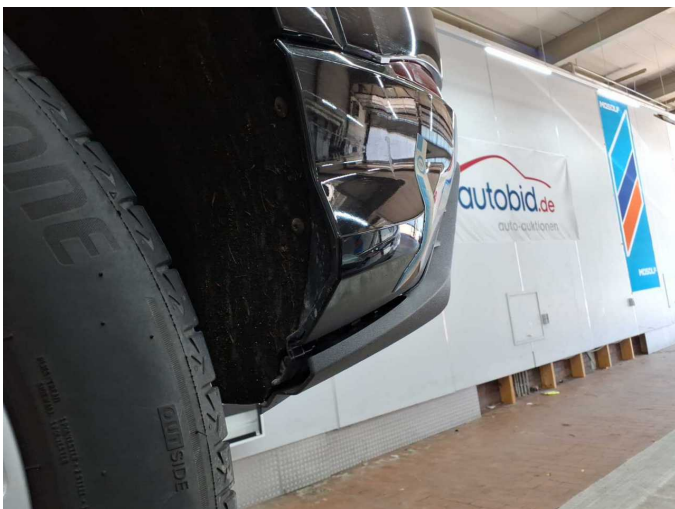
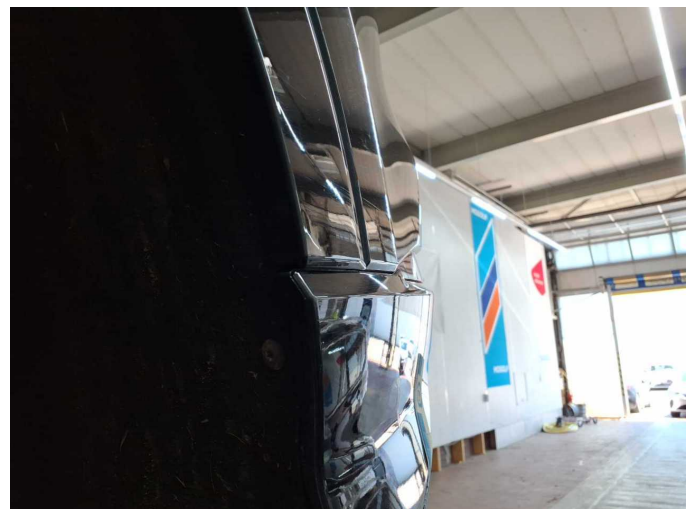
- 1 Rear, Side - left
- 2 Front, Side right

Non-repaired previous damages were found at the vehicle. The necessary repair costs are listed in the expert report or if necessary, are listed in detail in a separately enclosed repair cost calculation.

**Accident 1:** Rear, Side - left

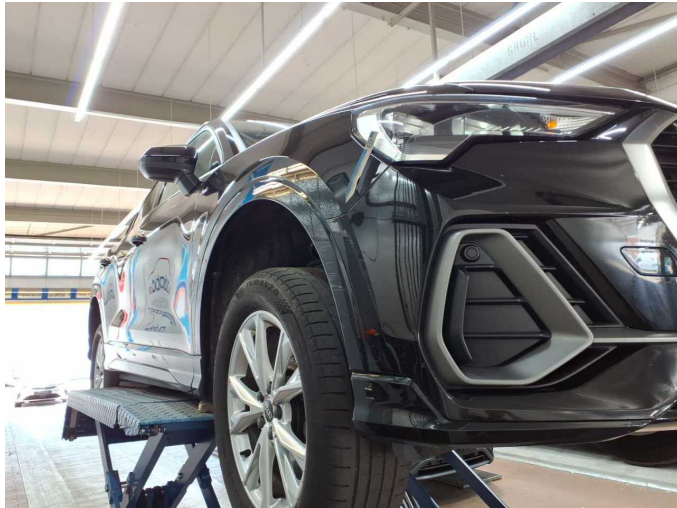
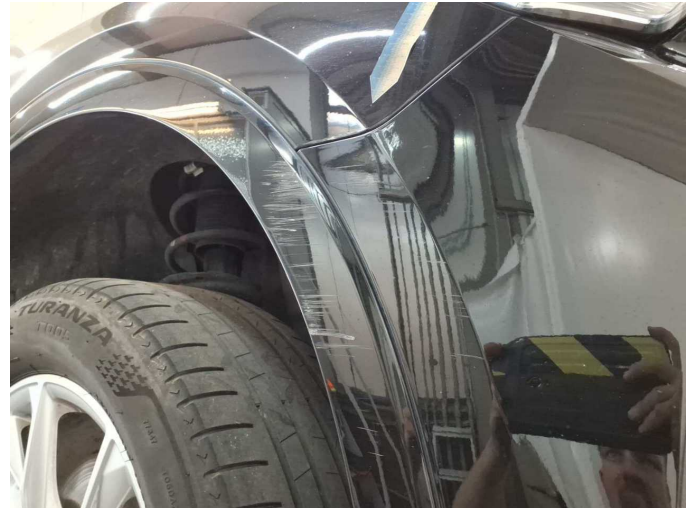
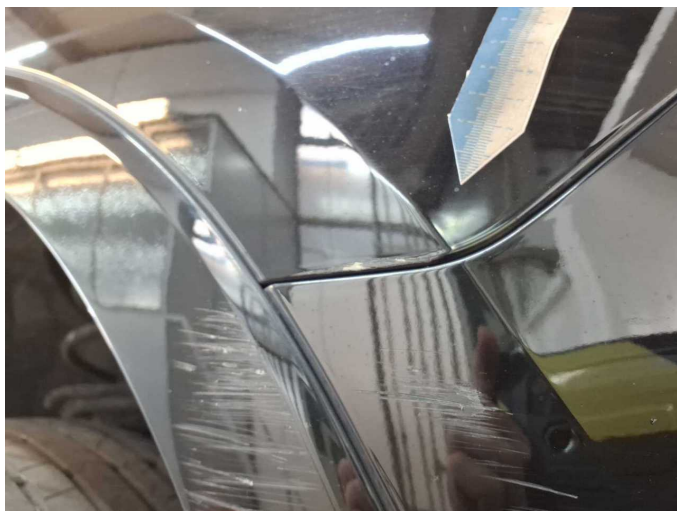
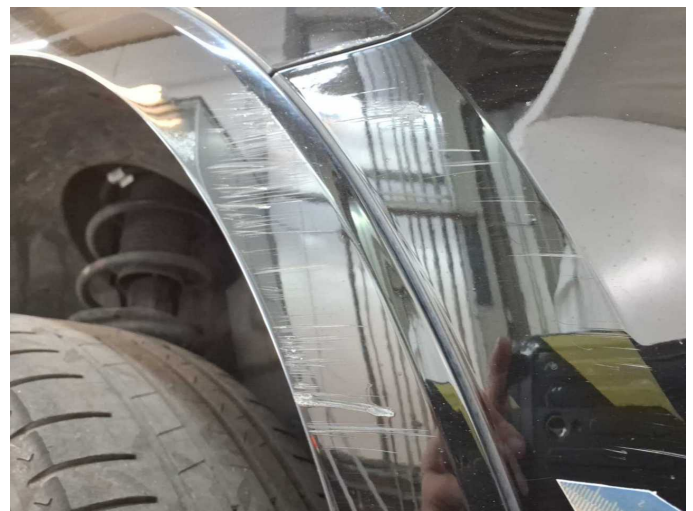
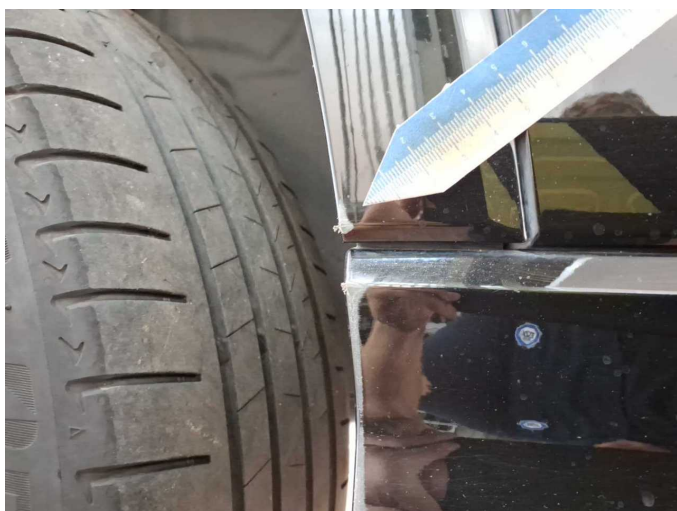
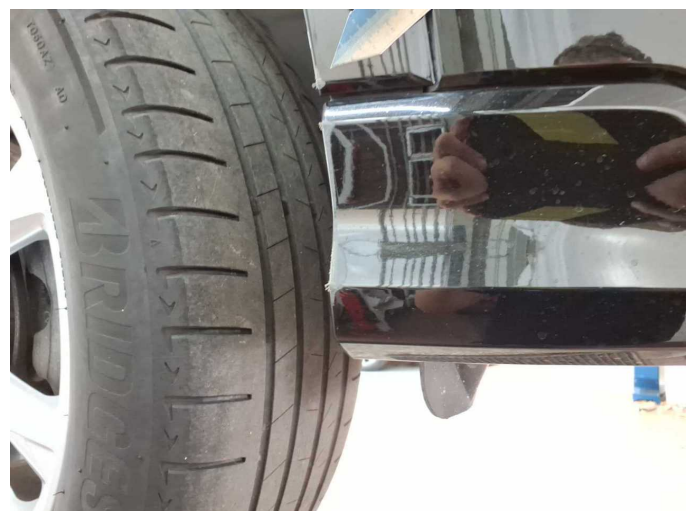
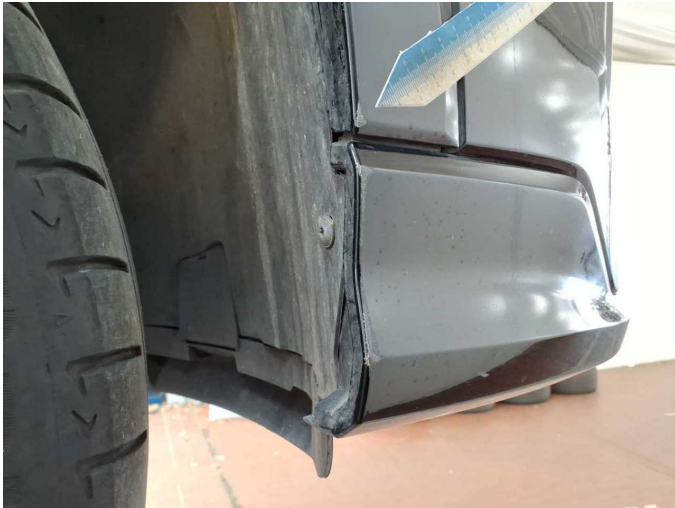
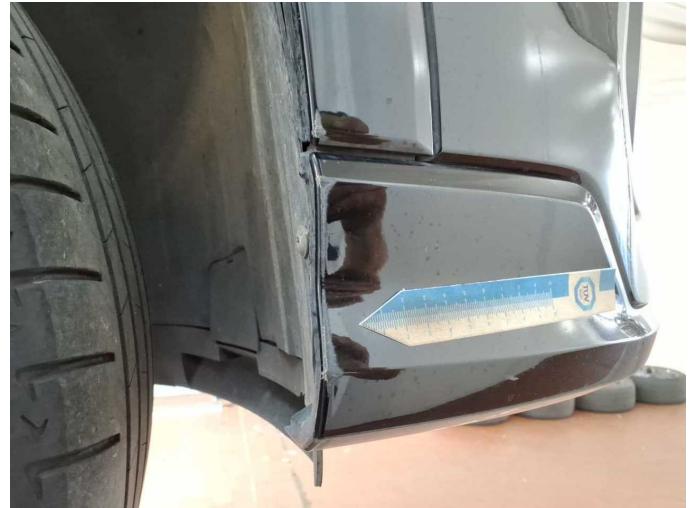
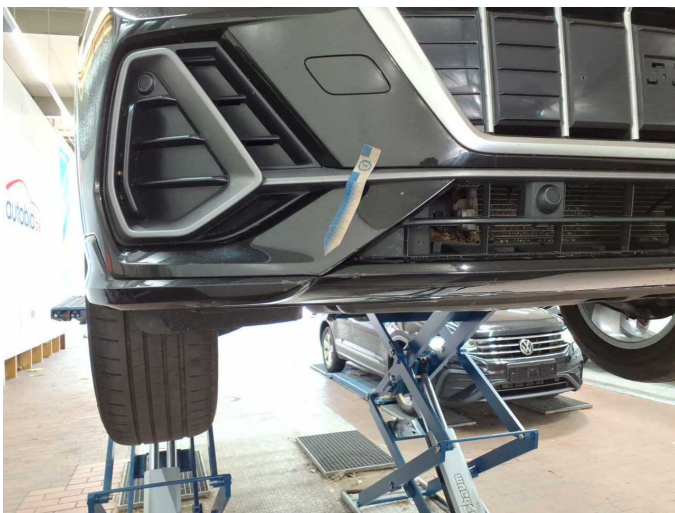
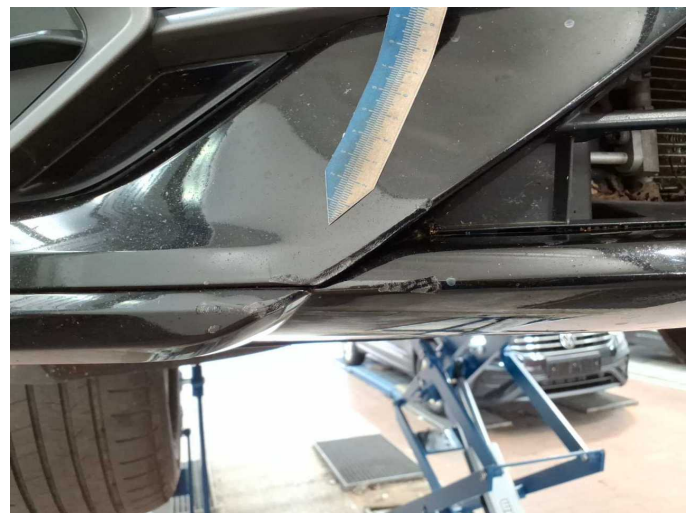
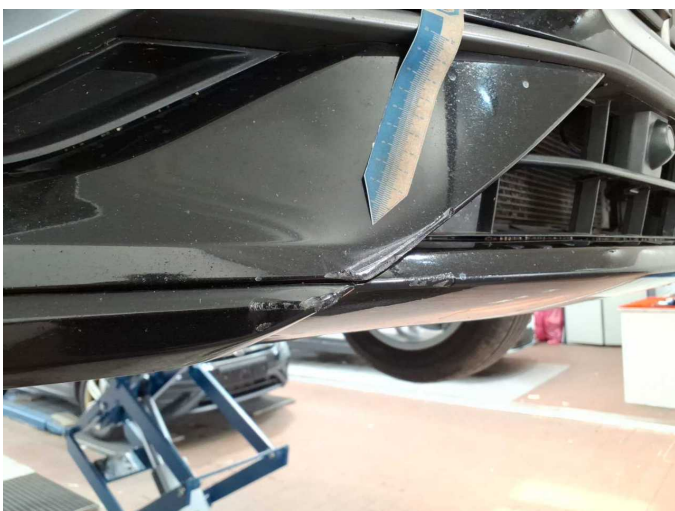
**Accident 2: Front, Side right**
