Expertise

Protocol number: 46802129  
Order No. / Reference: 26844377  
Inspection date: 30 Jul 2026

Manufacturer: Volkswagen

Model: Passat Variant 2.0 TDI SCR DSG Business

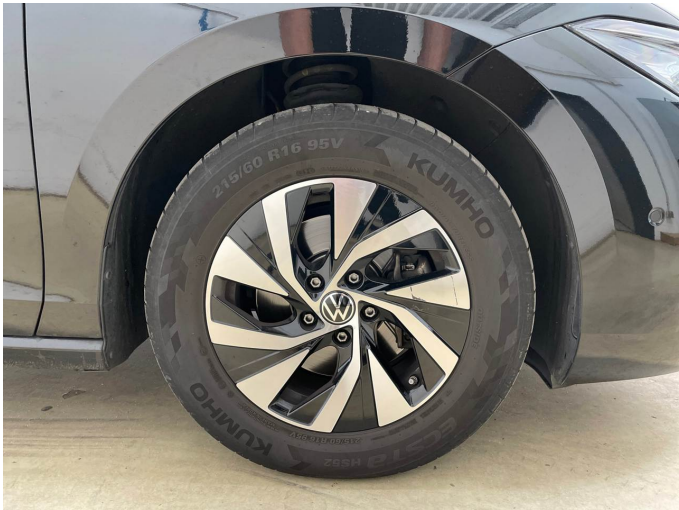
Figure 12: Mounted tyres

| Tyres | | | | |
|---|---|---|---|---|
| 1) | 215/60 R16 95V | Summer tyres on Light alloy | Kumho | 3mm / 3mm |
| 2) | 215/60 R16 95V | Summer tyres on Light alloy | Kumho | 3mm / 3mm |

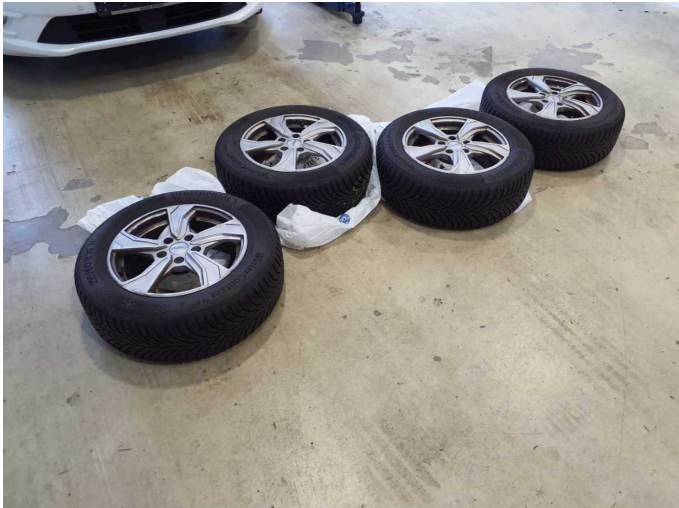
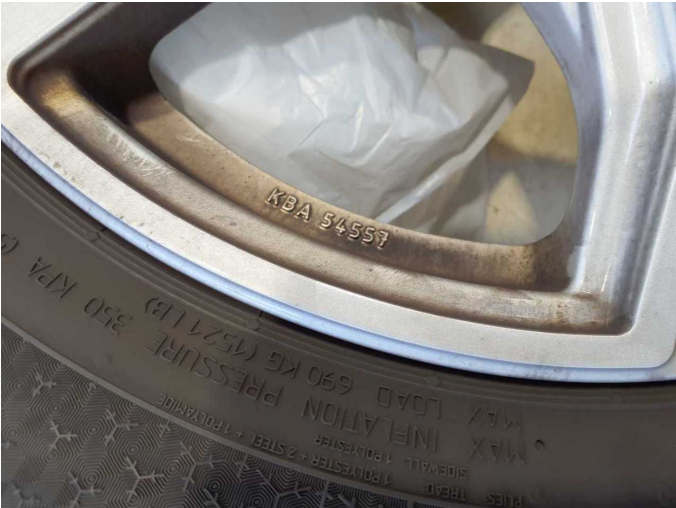
Figure 14: Additional tyres

| Tyres | | | | |
|---|---|---|---|---|
| 1) | 215/60 R16 95H | Winter tyres on Light alloy | Continental | 6mm / 6mm |
| 2) | 215/60 R16 95H | Winter tyres on Light alloy | Continental | 6mm / 6mm |

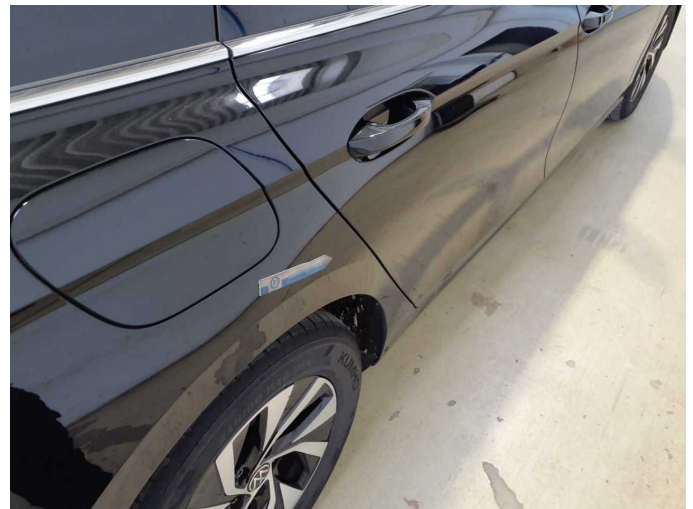
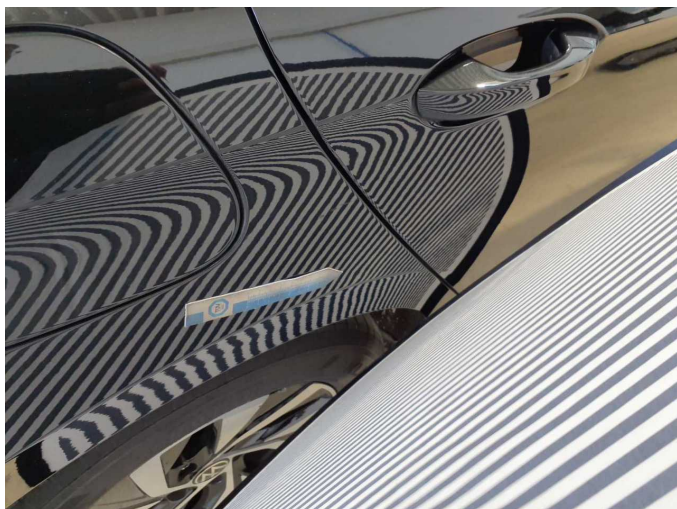
| No. | Component group | Description |
|---|---|---|
| 1 | Side panel - rear right side | Side panel - dent(s) - Smooth repair work |

**Damage 1:** Side panel - rear right side: Side panel - dent(s) - Smooth repair work

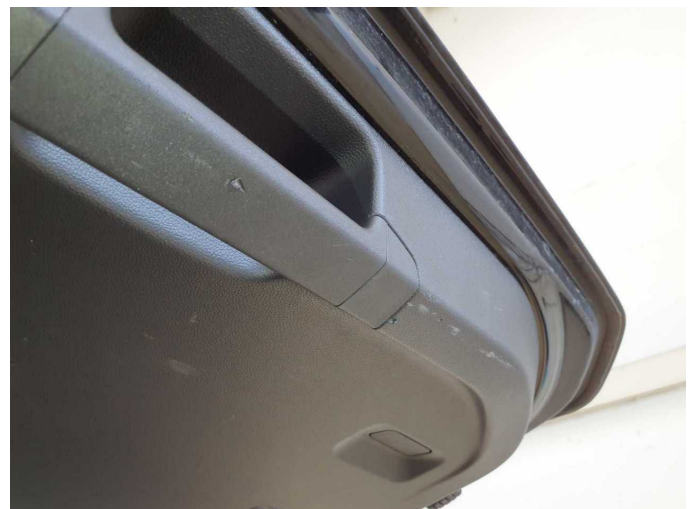
| No. | Component group | Description |
|---|---|---|
| 2 | Trim / covers | Boot lid - interior trim - Scratch(es) - Smart repair |

**Damage 2:** Trim / covers: Boot lid - interior trim - Scratch(es) - Smart repair

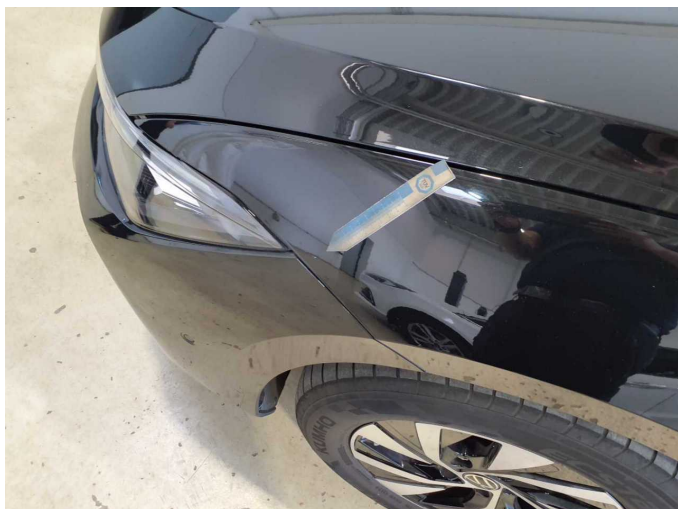
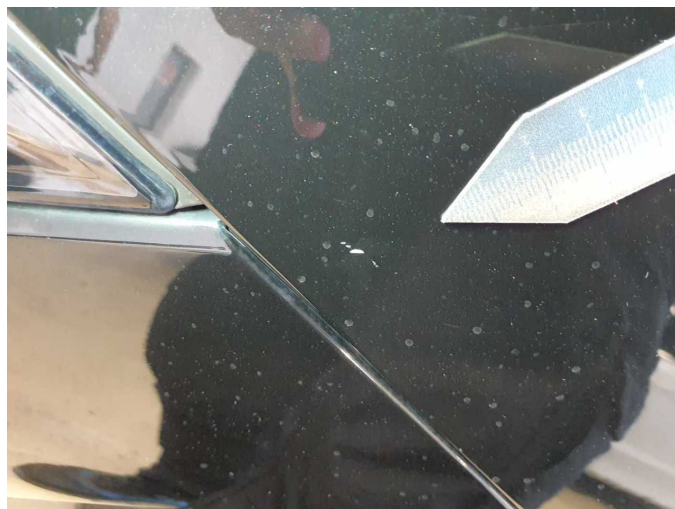
| No. | Component group | Description |
|---|---|---|
| 3 | Mudguard - left side | Mudguard - left side - Scratch(es) - Smart repair |

**Damage 3:** Mudguard - left side: Mudguard - left side - Scratch(es) - Smart repair

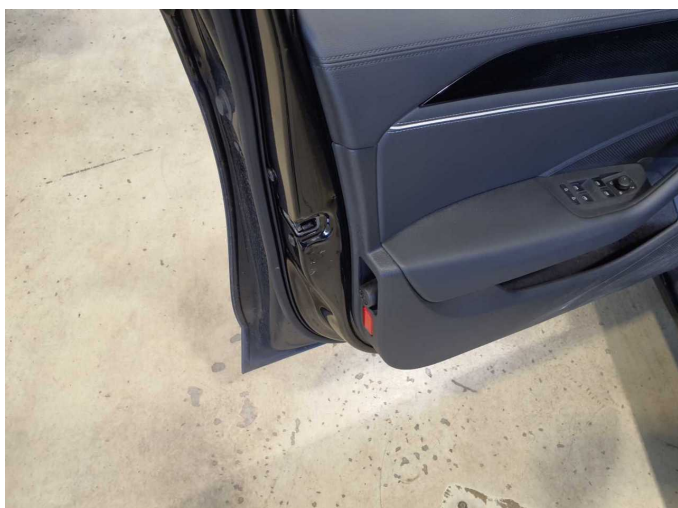
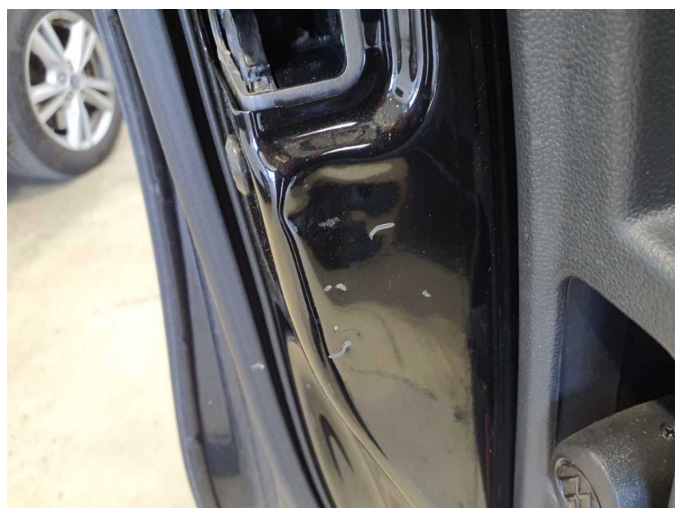
| No. | Component group | Description |
|---|---|---|
| 4 | Door - front left side | Door - Dent / paintcoat damage - Smart repair |

**Damage 4:** Door - front left side: Door - Dent / paintcoat damage - Smart repair

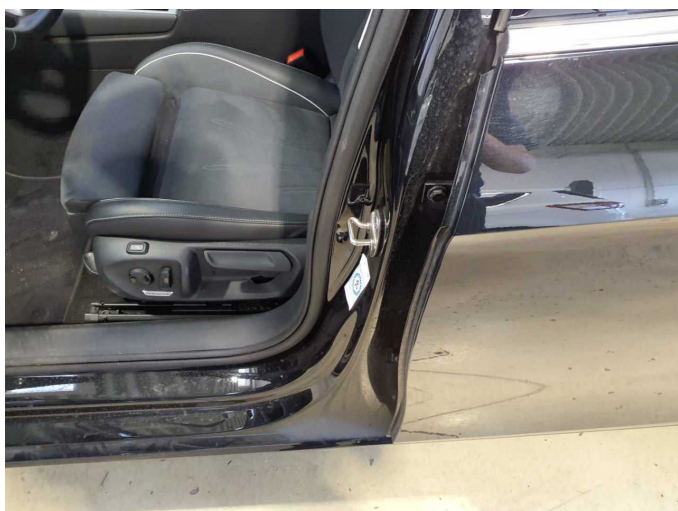
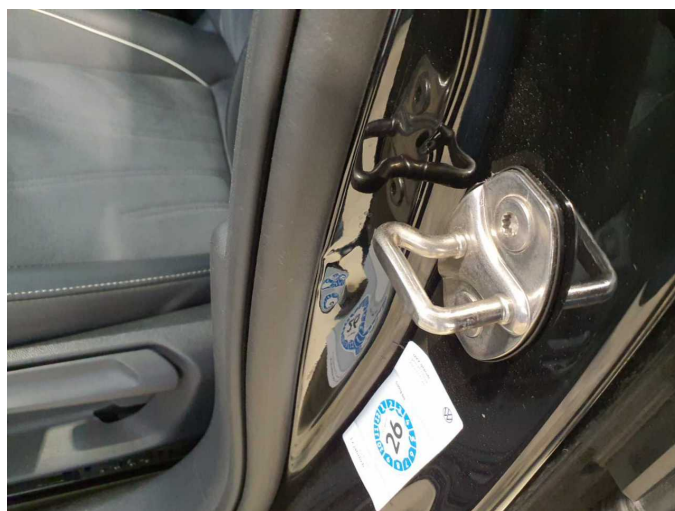
| No. | Component group | Description |
|---|---|---|
| 5 | Sill - left side | Sill - dent(s) - Smart repair |

**Damage 5:** Sill - left side: Sill - dent(s) - Smart repair

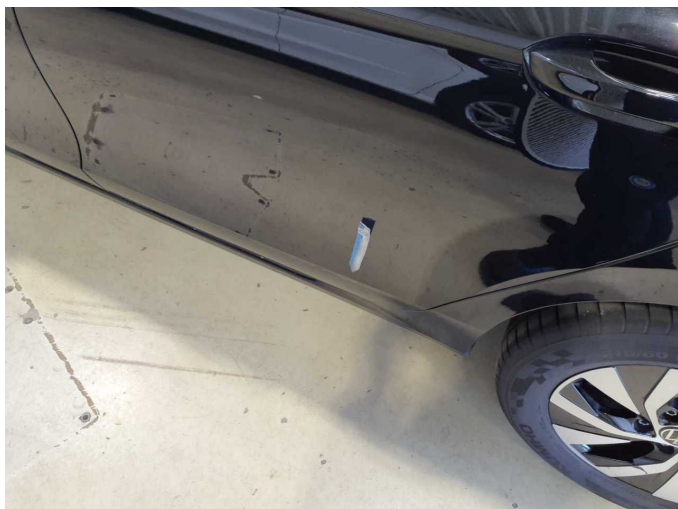
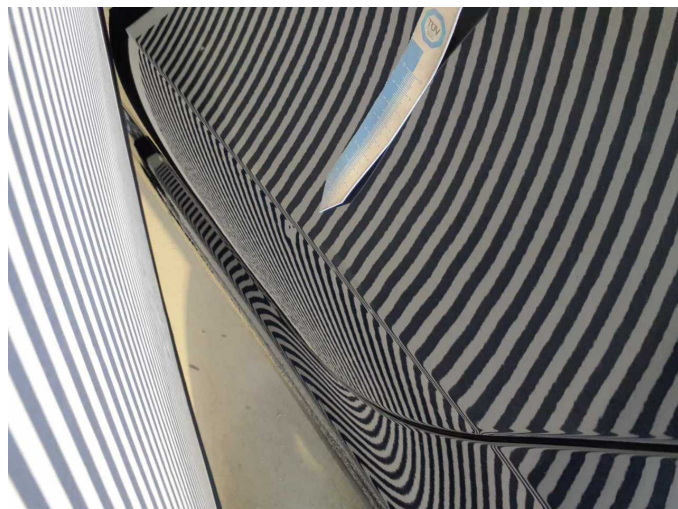
| No. | Component group | Description |
|---|---|---|
| 6 | Door - rear left side | Door - Dent / paintcoat damage - Smart repair |

**Damage 6:** Door - rear left side: Door - Dent / paintcoat damage - Smart repair

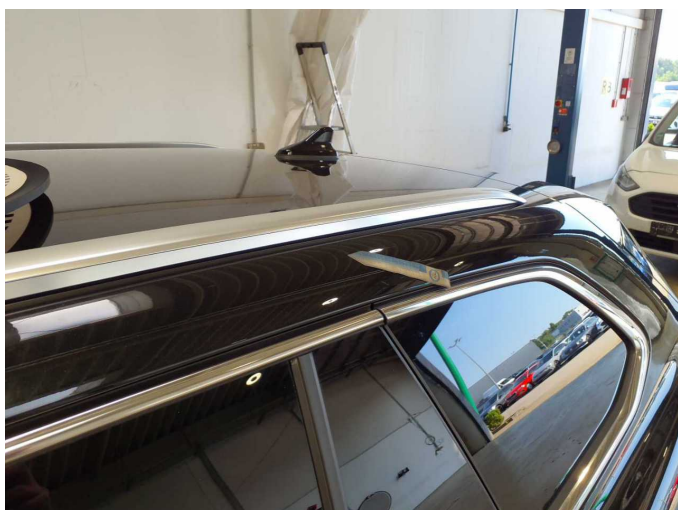
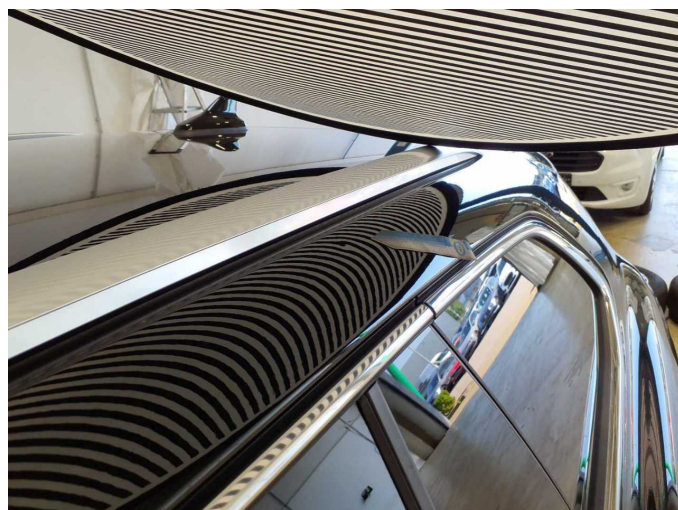
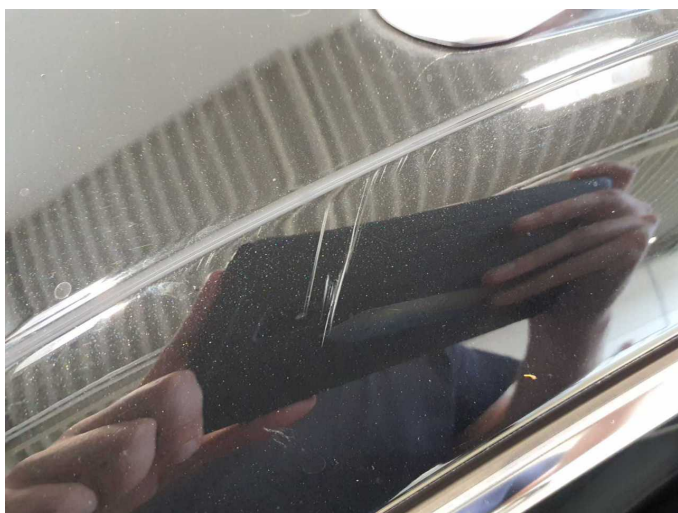
| No. | Component group | Description |
|---|---|---|
| 7 | Roof | Roof rail - left side - Dent / paintcoat damage - Repair and paint |

**Damage 7:** Roof: Roof rail - left side - Dent / paintcoat damage - Repair and paint

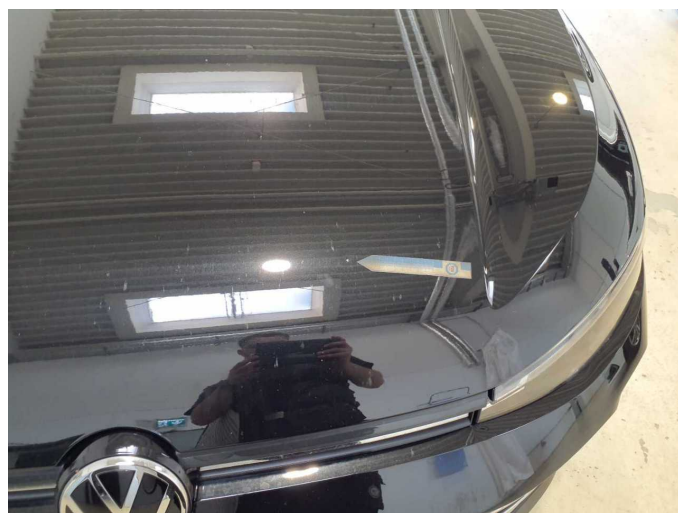
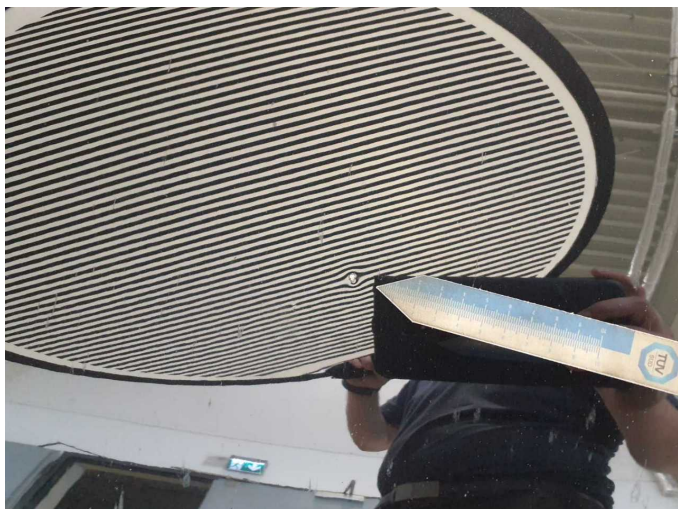
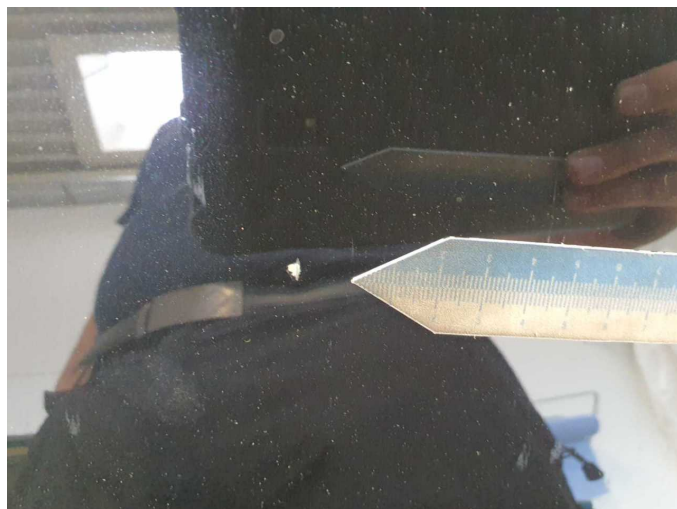
| No. | Component group | Description |
|---|---|---|
| 8 | Bonnet | Bonnet - Dent / paintcoat damage - Repair and paint |

**Damage 8:** Bonnet: Bonnet - Dent / paintcoat damage - Repair and paint

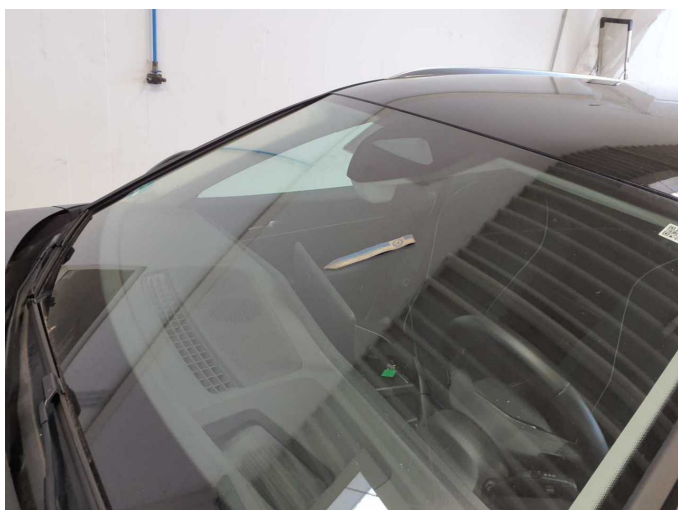
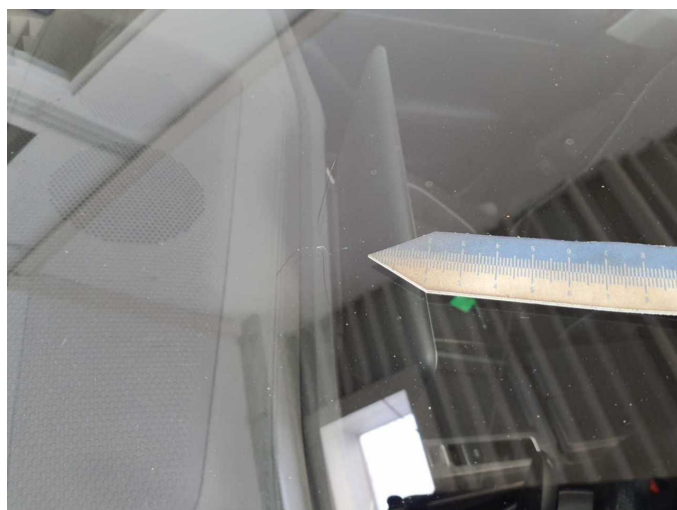
| No. | Component group | Description |
|---|---|---|
| 9 | Vehicle glazing | Windscreen - Broken / torn - repair according to calculation |

**Damage 9:** Vehicle glazing: Windscreen - Broken / torn - repair according to calculation
