Expertise

Protocol number: 46155031
Order No. / Reference: 26525021
Inspection date: 17 Jun 2026

Model: GLC 300 d 4Matic 9G-TRONIC Edition AMG Line

VIN: W1NKM0HB2SF347826

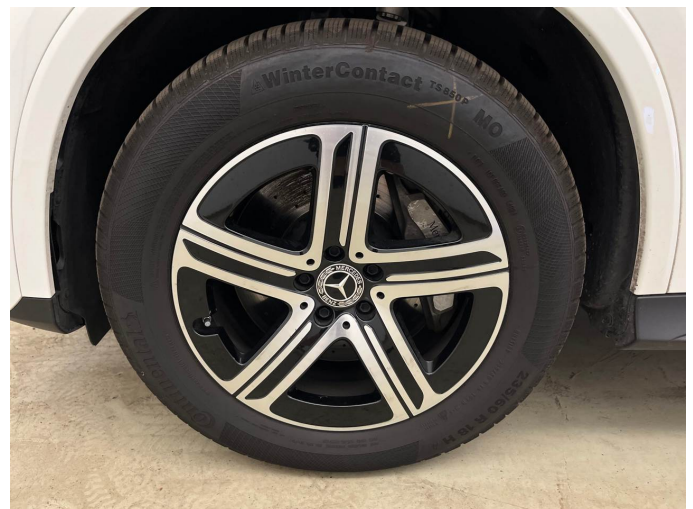
Figure 12: Mounted tyres

#	Tyre size	Type of tyre	Manufacturer	Tread depth
1)	235/60 R18 103H	Winter tyres on Light alloy	Continental	8mm / 8mm
2)	235/60 R18 103H	Winter tyres on Light alloy	Continental	8mm / 8mm

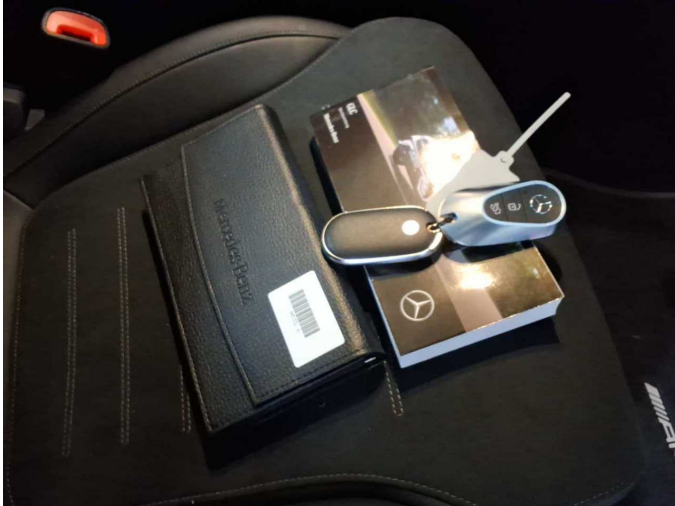
Figure 13: Documents

Documents submitted	At the time of the inspection, the vehicle registration certificate Part 2 (title) was available, but the vehicle registration certificate Part 1 (document) was not. (Copy)
VIN comparison	The vehicle identification number (VIN) was read from the vehicle and its conformity with the submitted documents was confirmed by the undersigned during the inspection.
Inspection	The inspection conditions were sufficient for the assessment of the vehicle. Lifting equipment and/or a pit were available for examining the vehicle.
Test drive	No test drive/shunting maneuver was carried out during the inspection of the vehicle.
Engine function test	An engine test run was performed.
readiness to drive	The vehicle was roadworthy at the time of inspection.

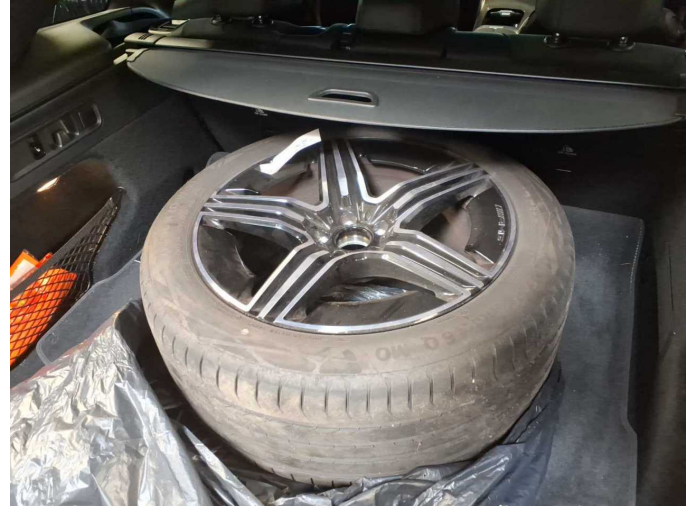
Figure 14: Additional tyres

#	Tyre size	Type of tyre	Manufacturer	Tread depth
1)	285/40 R20 108W	Summer tyres on Light alloy	Continental	5 mm

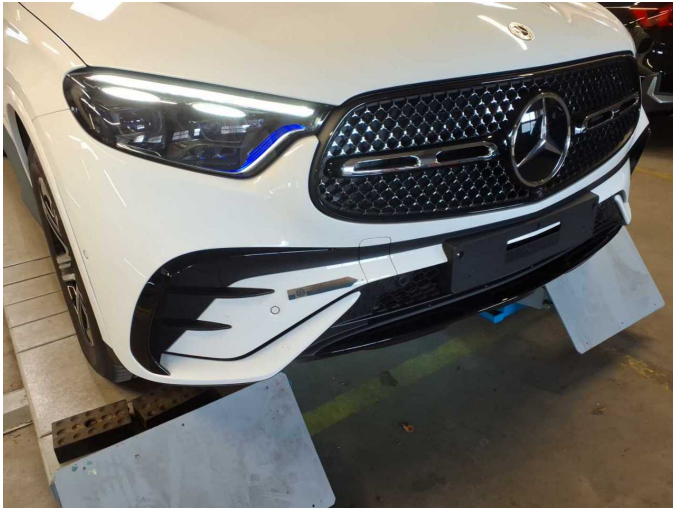
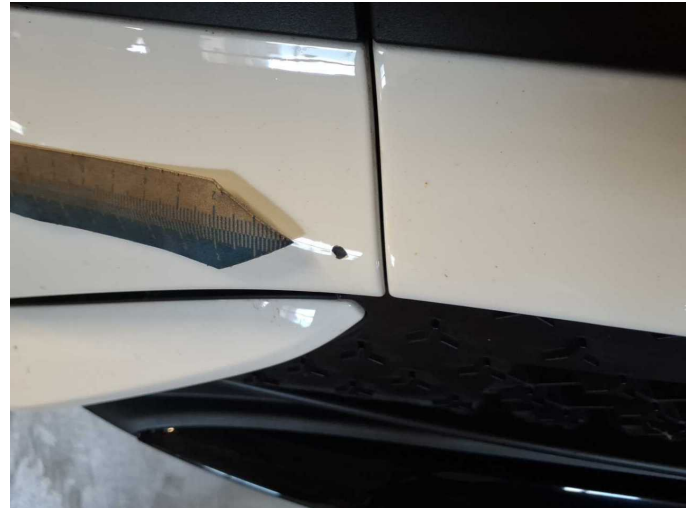
Damage 1: Front bumper: Front bumper - Stone chips - Smart repair

No.	Component group	Description
1	Front bumper	Front bumper - Stone chips - Smart repair
2	Misc.	Inspection / maintenance - Due - Perform

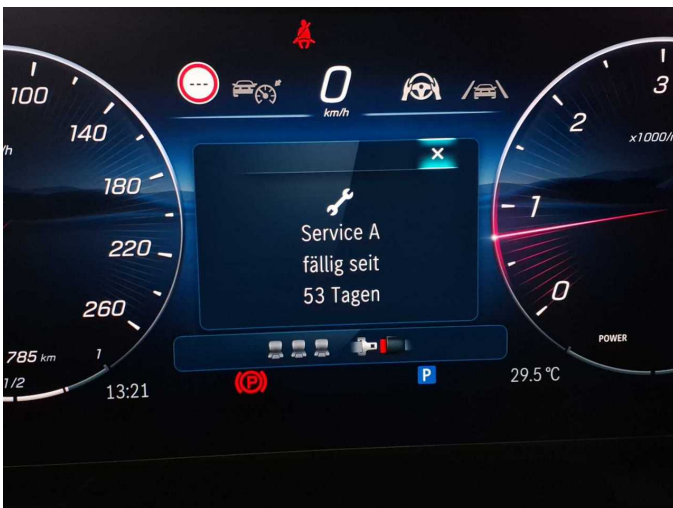
Damage 2: Misc.: Inspection / maintenance - Due - Perform

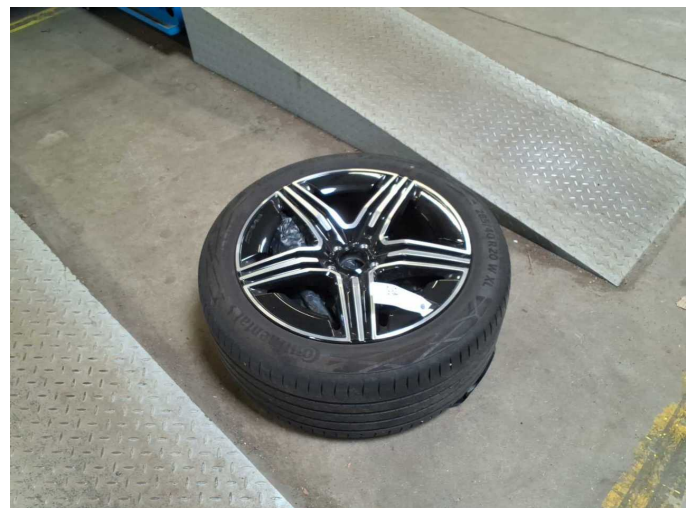
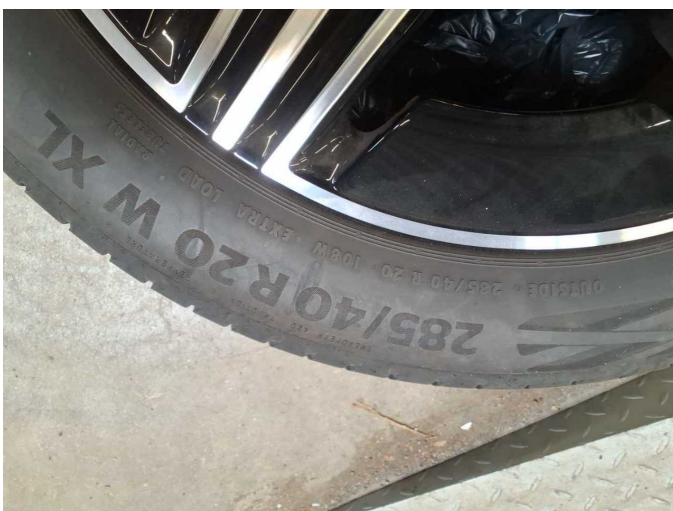
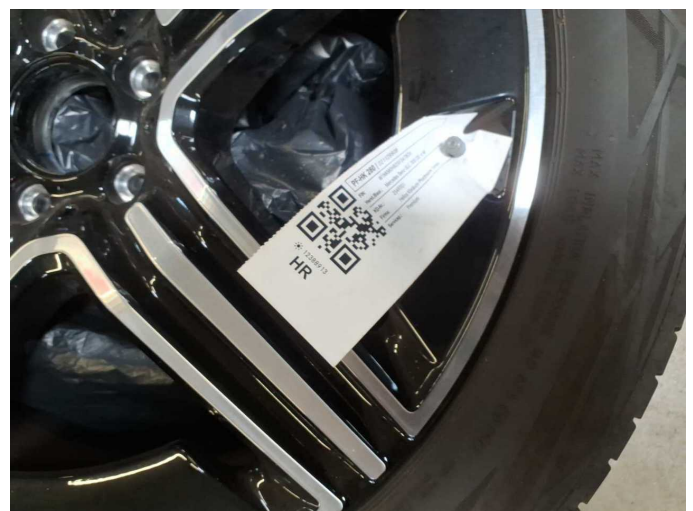
Missing part 1: 2nd wheel set: 2nd wheel set (3 Räder fehlen) - Missing - Replace

2nd wheel set - 2nd wheel set (3 Räder fehlen)
