Expertise

Protocol number: 46449051  
Order No. / Reference: 26693992  
Inspection date: 9 Jul 2026

Manufacturer: Ford

Model: Galaxy 2.0 EcoBlue S&S Aut. TITANIUM

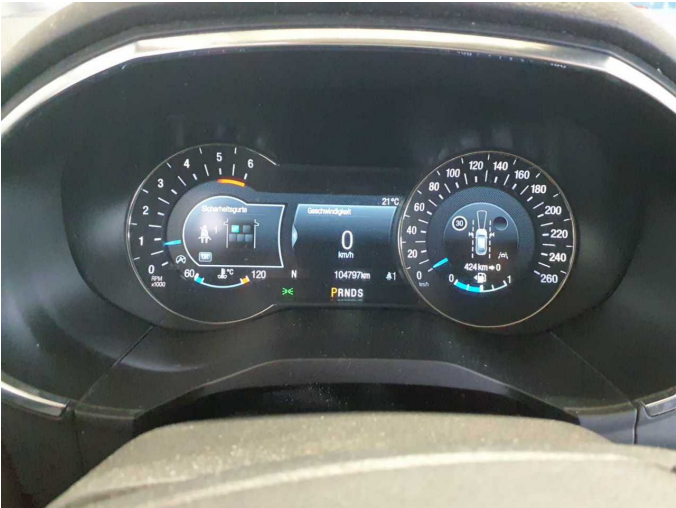
Figure 7: Instrument cluster

| Vehicle details | |
|---|---|
| Mileage (Read) | 104,797 km |

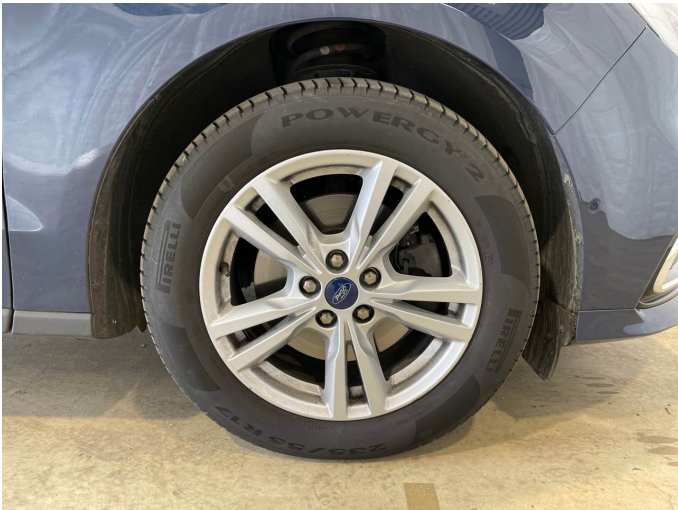
Figure 12: Mounted tyres

| Tyres | | | | |
|---|---|---|---|---|
| 1) | 235/55 R17 103Y | Summer tyres on Light alloy | Pirelli | 6mm / 6mm |
| 2) | 235/55 R17 103V | Summer tyres on Light alloy | Continental | 5mm / 5mm |

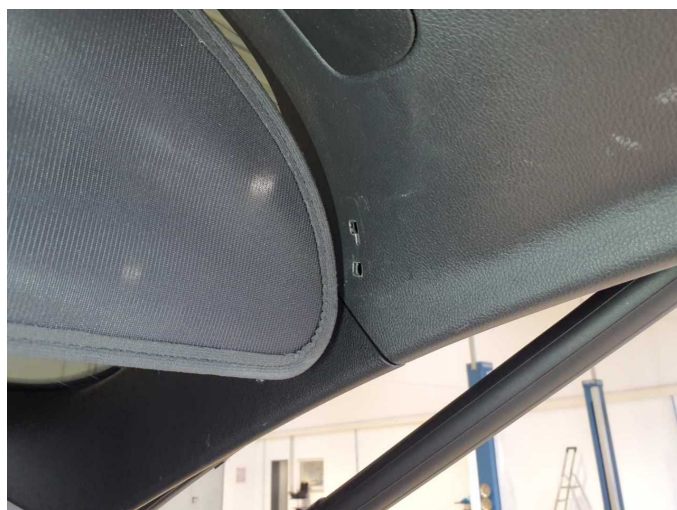
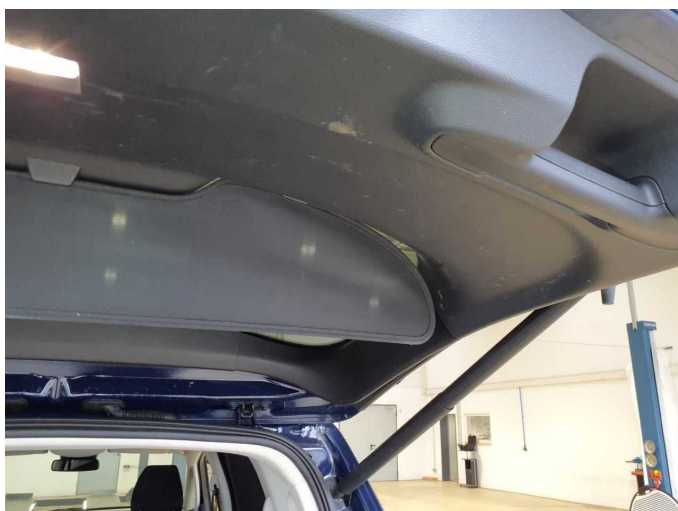
| No. | Component group | Description |
|---|---|---|
| 1 | Trim / covers | Trim / covers - Missing - Replace |

**Damage 1:** Trim / covers: Trim / covers - Missing - Replace

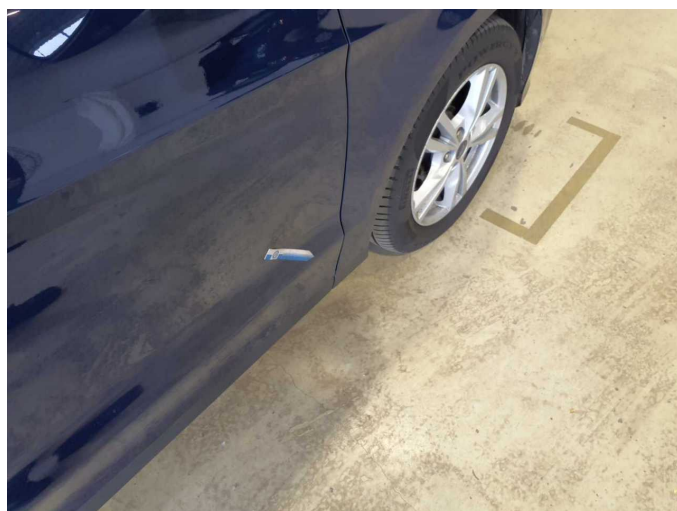
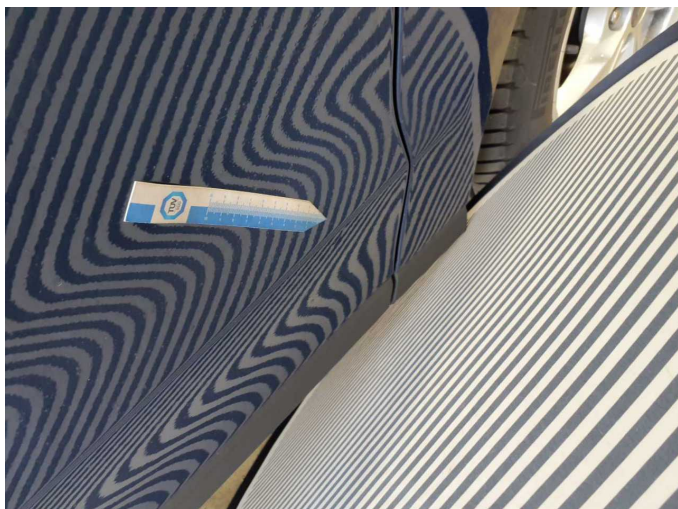
| No. | Component group | Description |
|---|---|---|
| 2 | Door - front right side | Door - dent(s) - Smooth repair work |

**Damage 2:** Door - front right side: Door - dent(s) - Smooth repair work

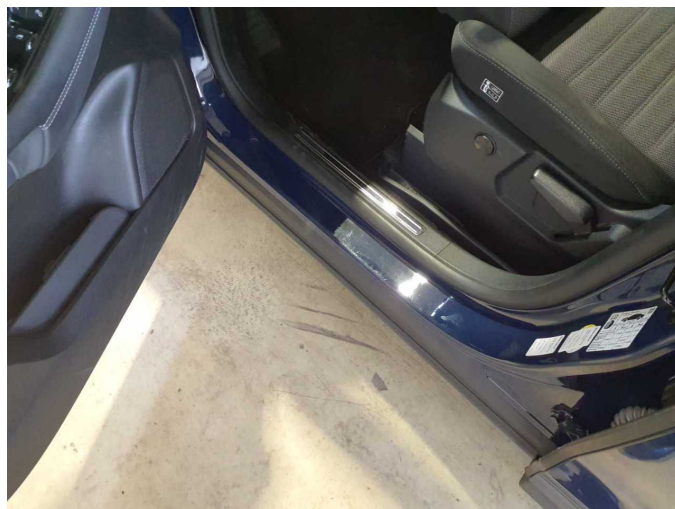
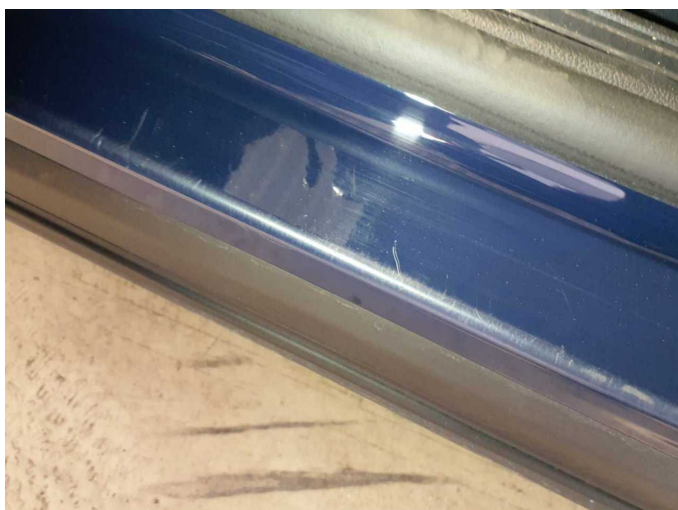
| No. | Component group | Description |
|---|---|---|
| 3 | Sill - left side | Sill - Scratch(es) - Smart repair |

**Damage 3:** Sill - left side: Sill - Scratch(es) - Smart repair

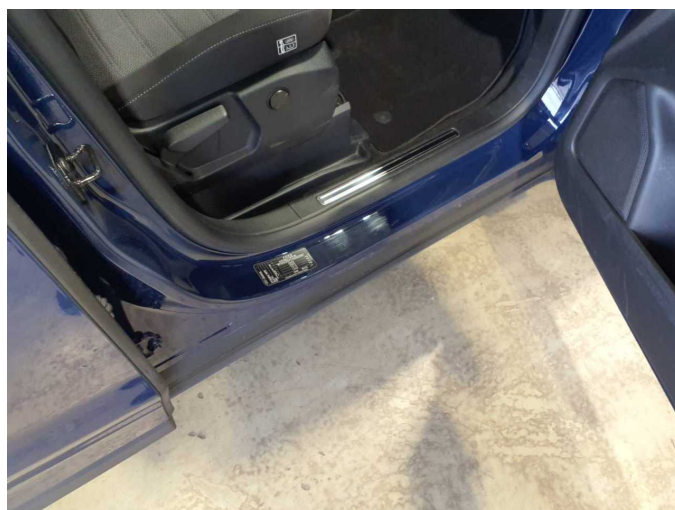
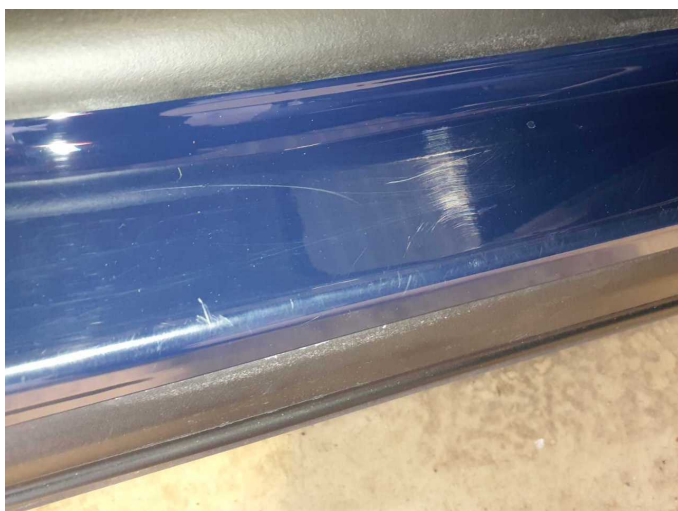
| No. | Component group | Description |
|---|---|---|
| 4 | Sill - right side | Sill - Scratch(es) - Smart repair |

**Damage 4:** Sill - right side: Sill - Scratch(es) - Smart repair

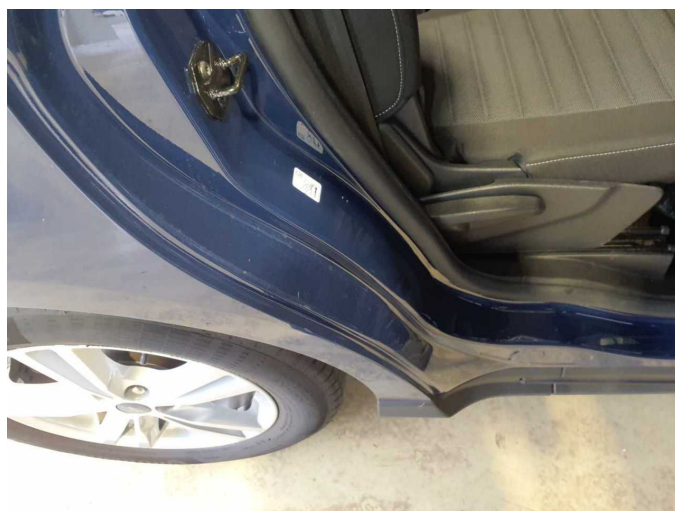
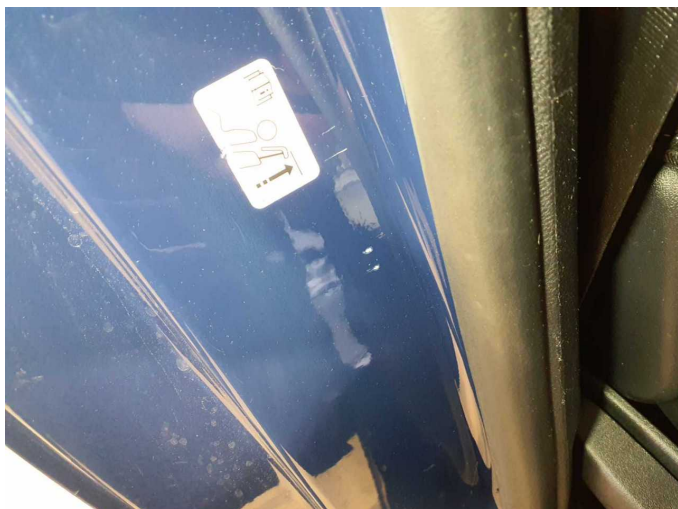
| No. | Component group | Description |
|---|---|---|
| 5 | Side panel - rear right side | Sill - Scratch(es) - Smart repair |

**Damage 5:** Side panel - rear right side: Sill - Scratch(es) - Smart repair

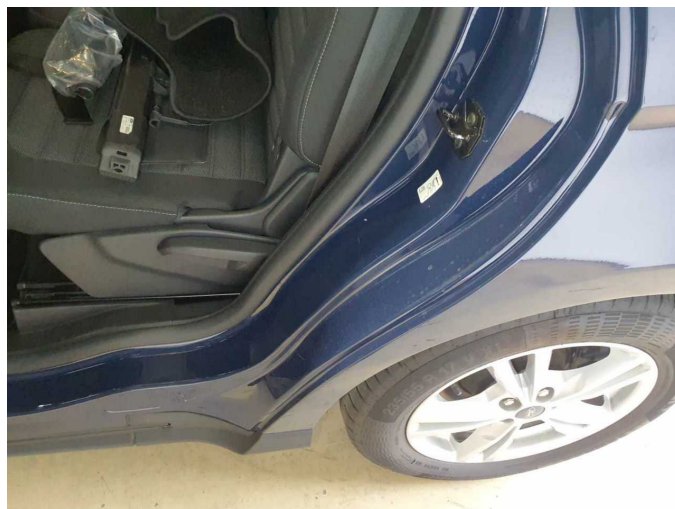
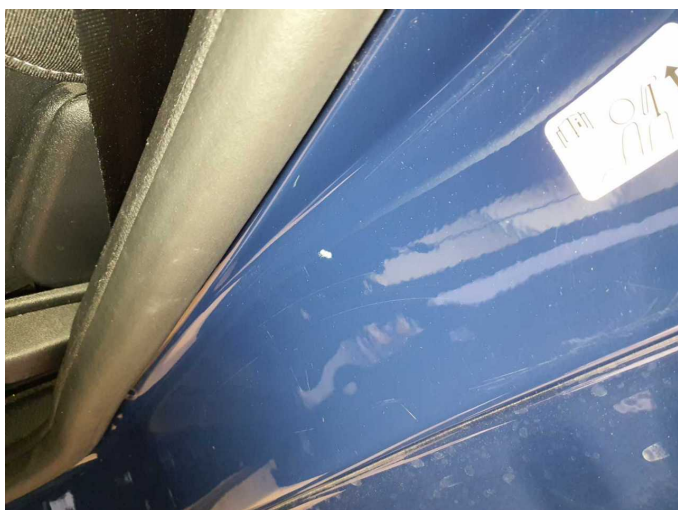
| No. | Component group | Description |
|---|---|---|
| 6 | Side panel - rear left side | Sill - Dent / paintcoat damage - Smart repair |

**Damage 6:** Side panel - rear left side: Sill - Dent / paintcoat damage - Smart repair

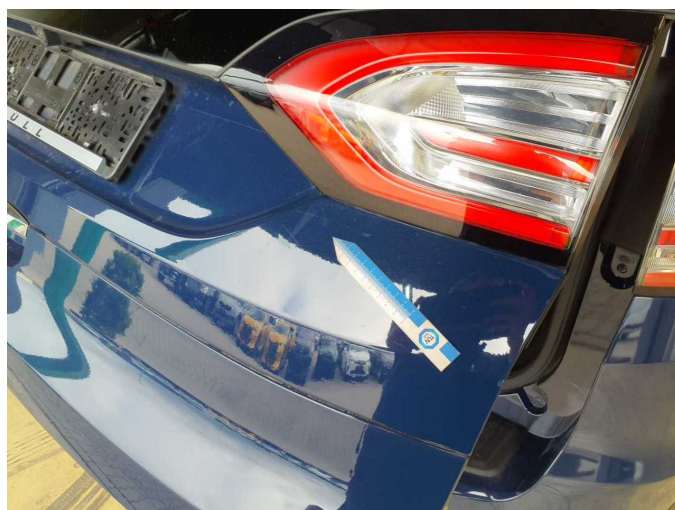
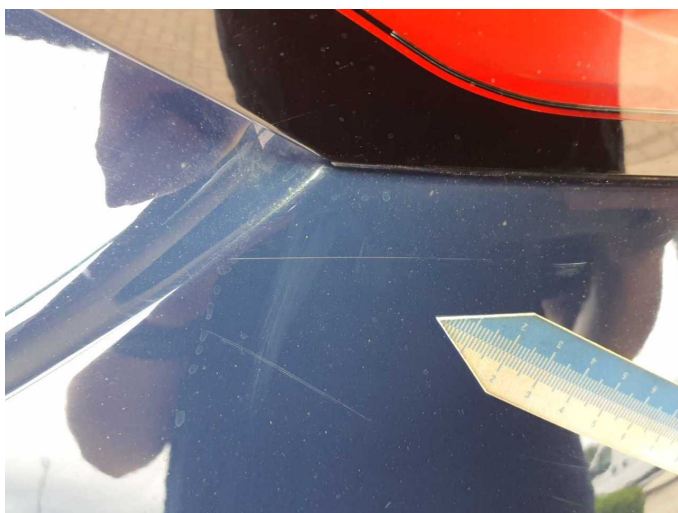
| No. | Component group | Description |
|---|---|---|
| 7 | Boot lid / rear door | Boot lid - Scratch(es) - Smart repair |

**Damage 7:** Boot lid / rear door: Boot lid - Scratch(es) - Smart repair

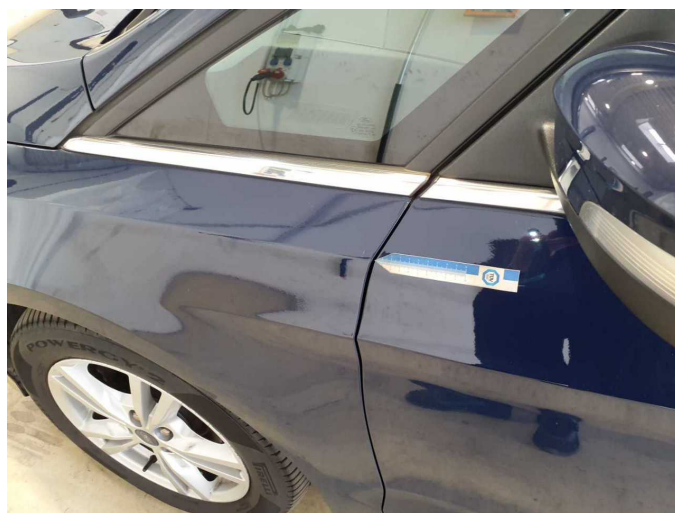
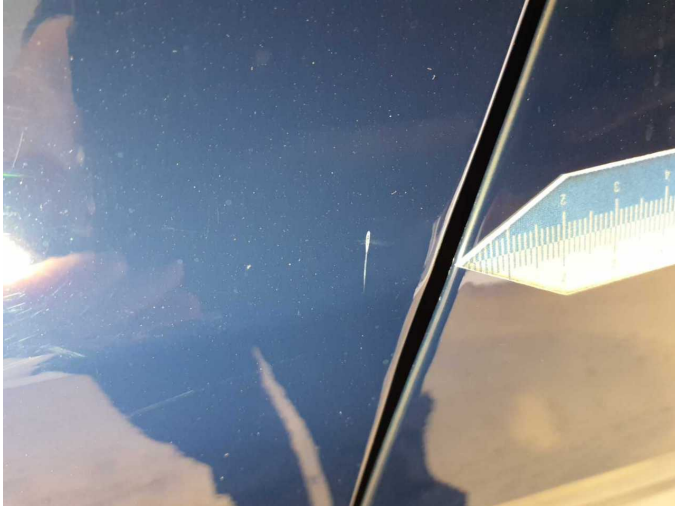
| No. | Component group | Description |
|---|---|---|
| 8 | Mudguard - left side | Mudguard - left side - Scratch(es) - Smart repair |

**Damage 8:** Mudguard - left side: Mudguard - left side - Scratch(es) - Smart repair

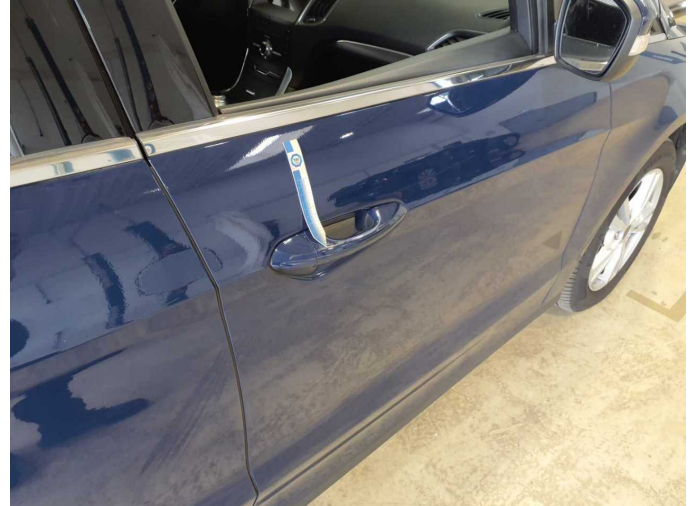
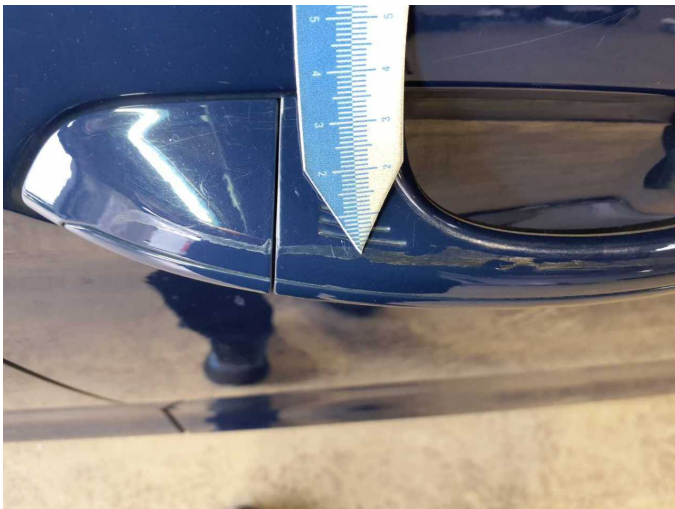
| No. | Component group | Description |
|---|---|---|
| 9 | Door - front right side | Door handle - outside - Scratch(es) - Paint |

**Damage 9:** Door - front right side: Door handle - outside - Scratch(es) - Paint

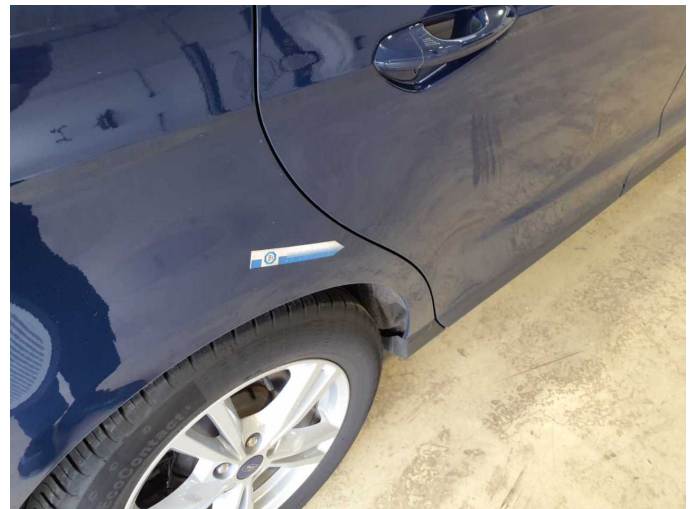
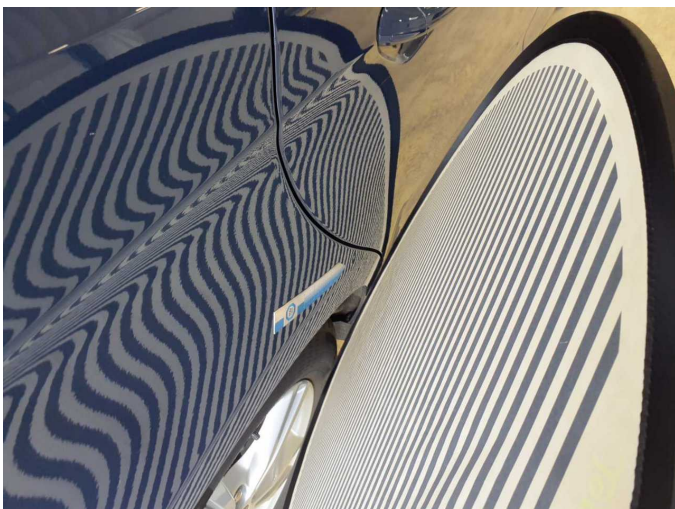
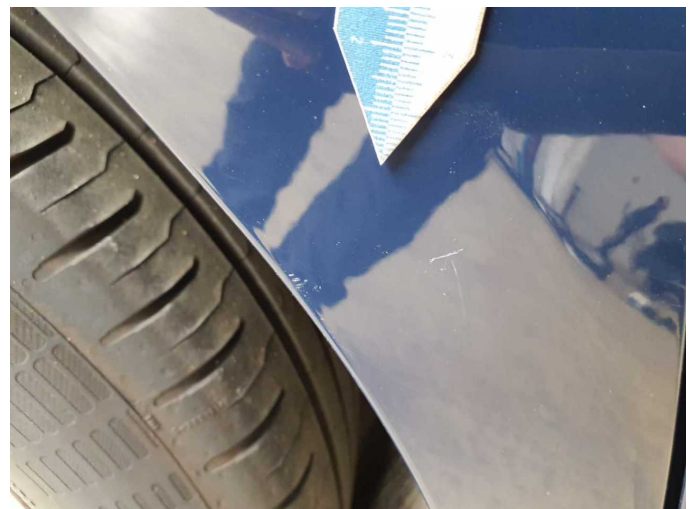
| No. | Component group | Description |
|---|---|---|
| 10 | Side panel - rear right side | Side panel - dent(s) - Smart repair |

**Damage 10:** Side panel - rear right side: Side panel - dent(s) - Smart repair

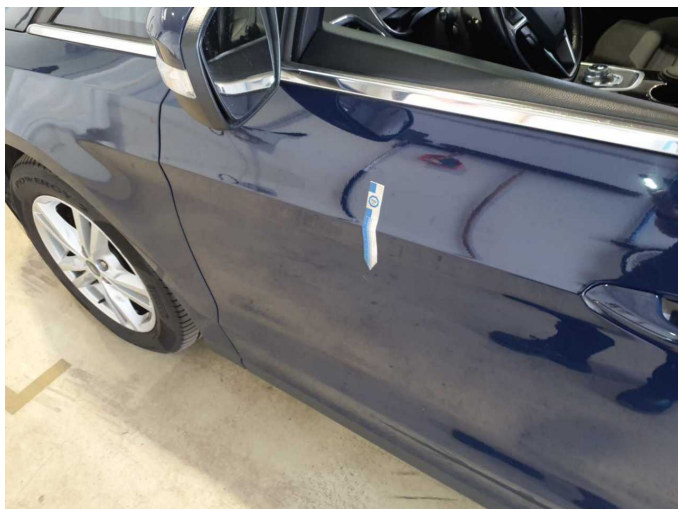
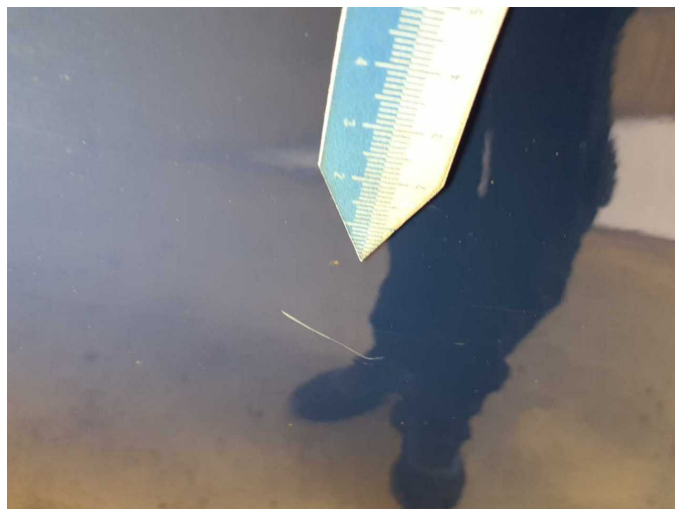
| No. | Component group | Description |
|---|---|---|
| 11 | Door - front left side | Door - Scratch(es) - Paint |

**Damage 11:** Door - front left side: Door - Scratch(es) - Paint

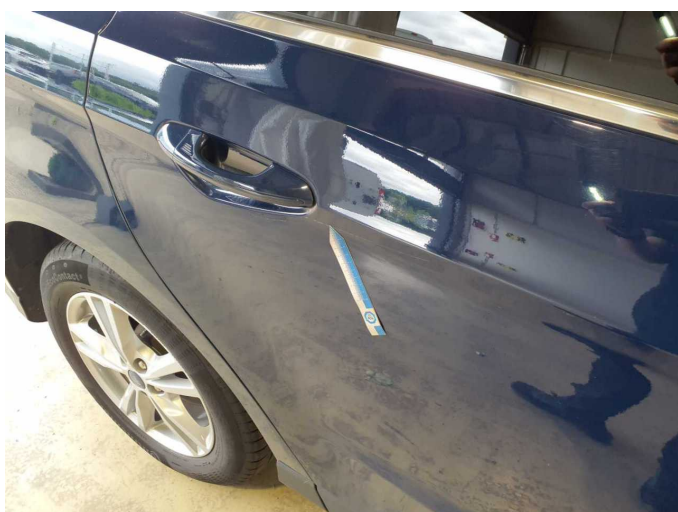
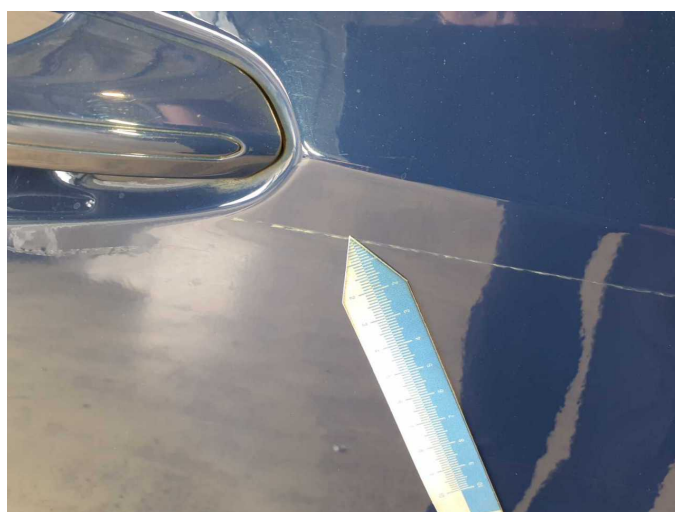
| No. | Component group | Description |
|---|---|---|
| 12 | Door - rear right side | Door - Scratch(es) - Paint |

**Damage 12:** Door - rear right side: Door - Scratch(es) - Paint

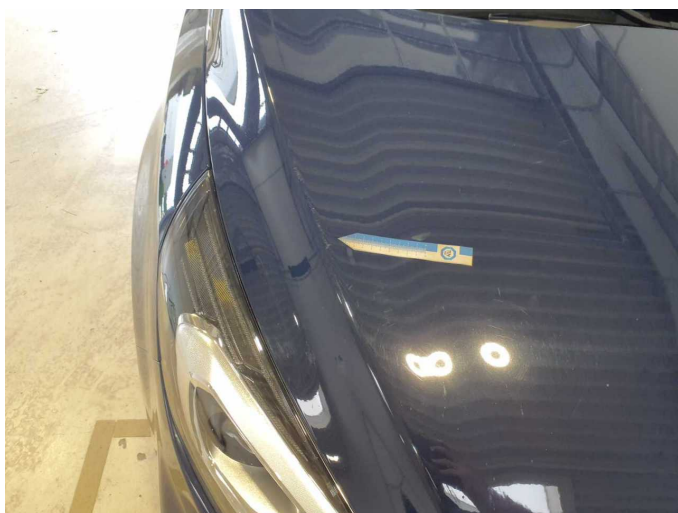
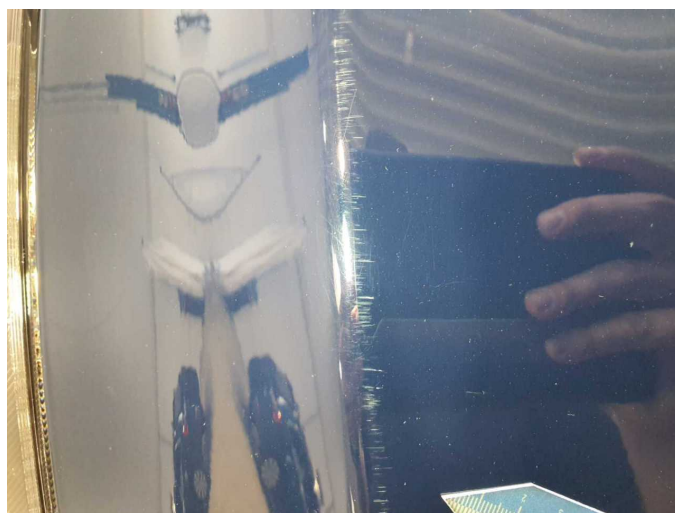
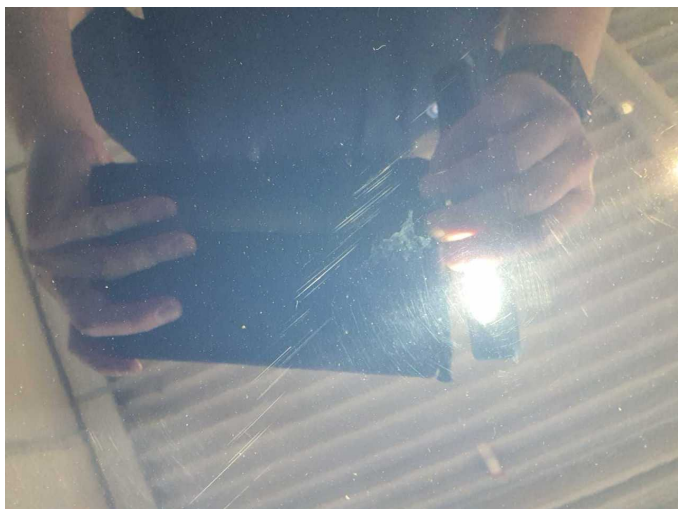
| No. | Component group | Description |
|---|---|---|
| 13 | Bonnet | Bonnet - Scratch(es) - Paint |

**Damage 13:** Bonnet: Bonnet - Scratch(es) - Paint

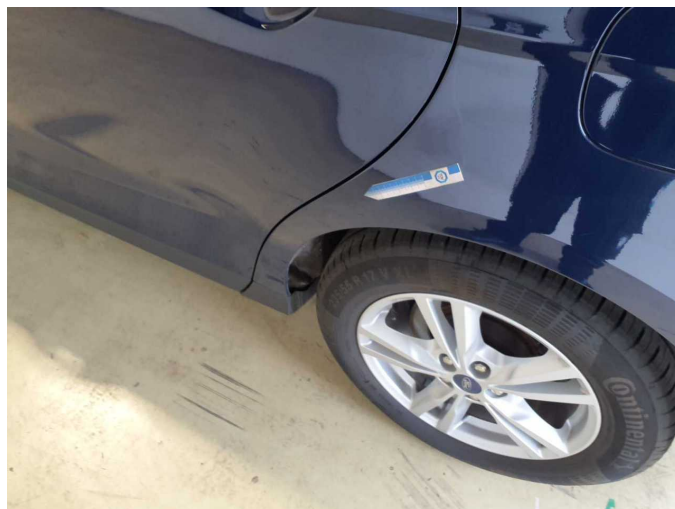
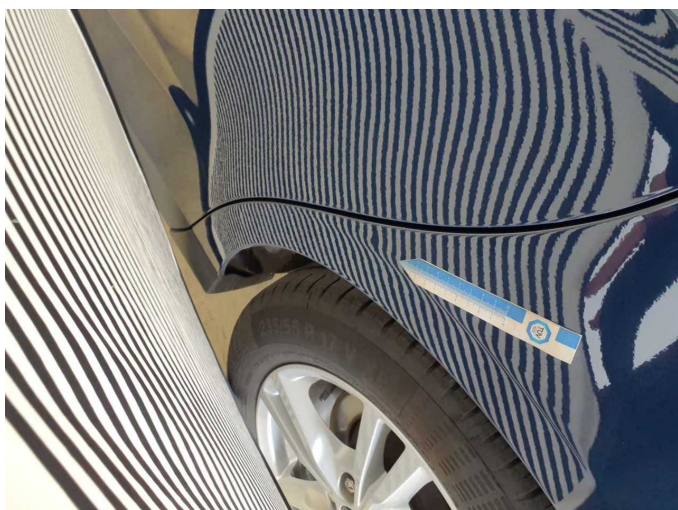
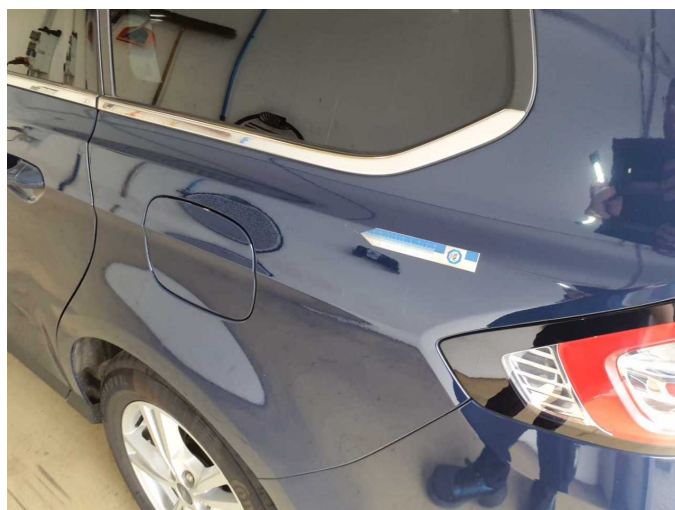
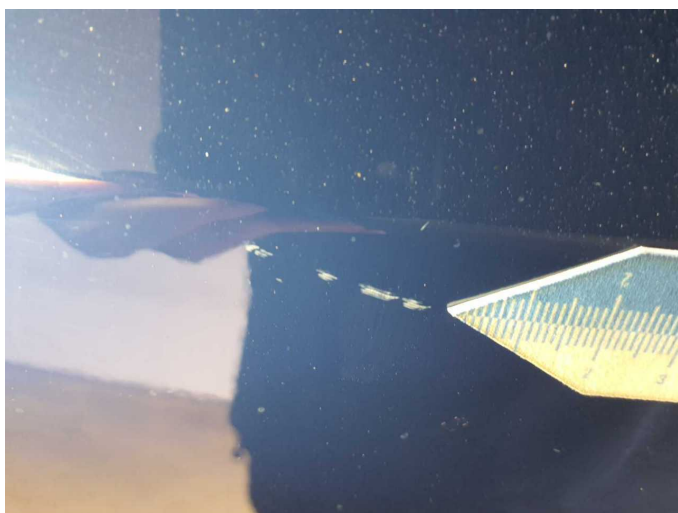
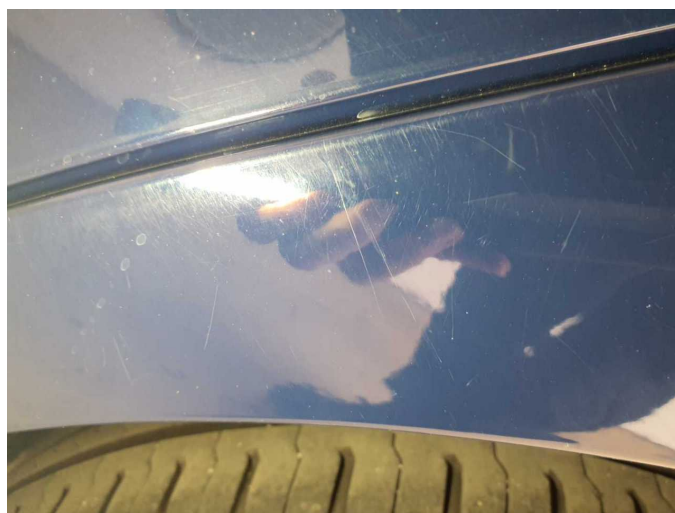
| No. | Component group | Description |
|---|---|---|
| 14 | Side panel - rear left side | Side panel - Dent / paintcoat damage - Repair and paint |

**Damage 14:** Side panel - rear left side: Side panel - Dent / paintcoat damage - Repair and paint

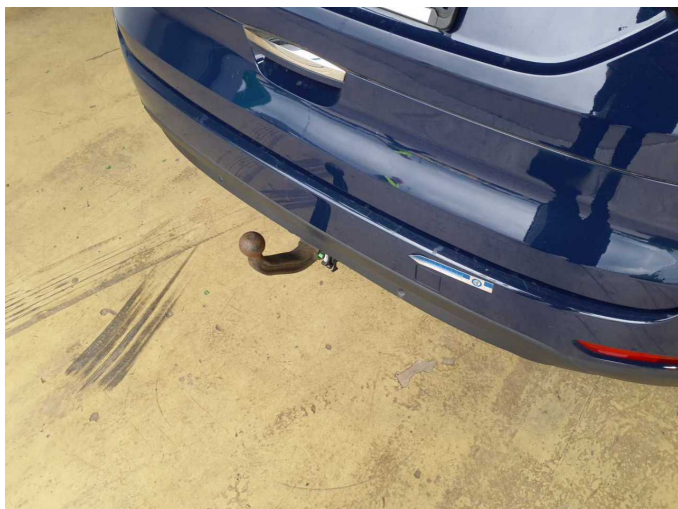
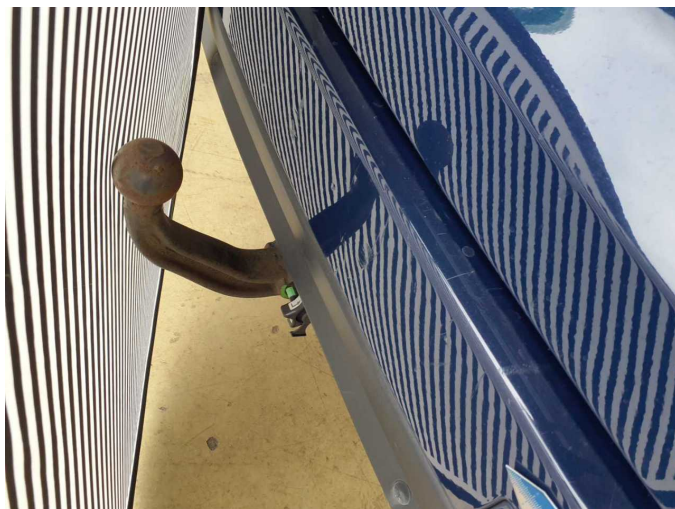
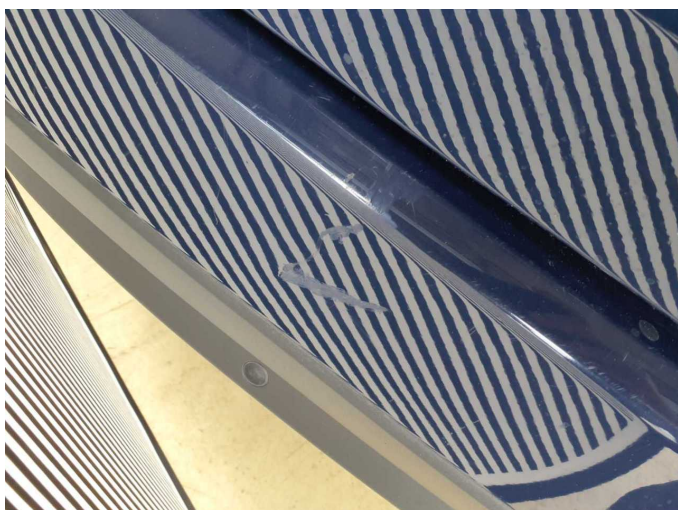
| No. | Component group | Description |
|---|---|---|
| 15 | Rear bumper | Rear bumper - Dent / paintcoat damage - Repair and paint |

**Damage 15:** Rear bumper: Rear bumper - Dent / paintcoat damage - Repair and paint

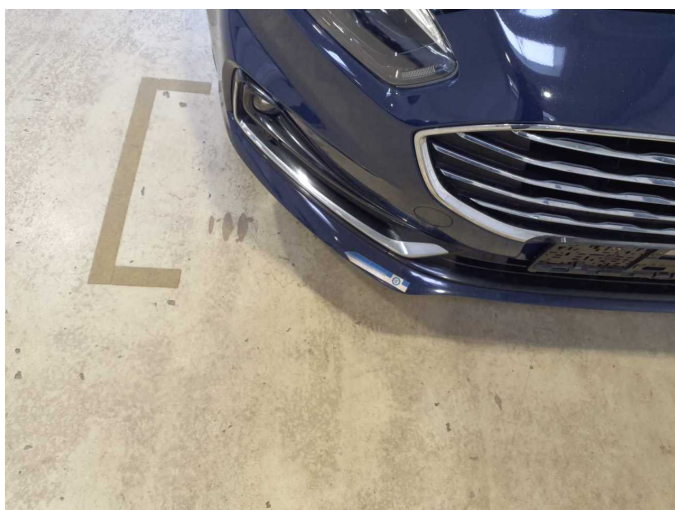
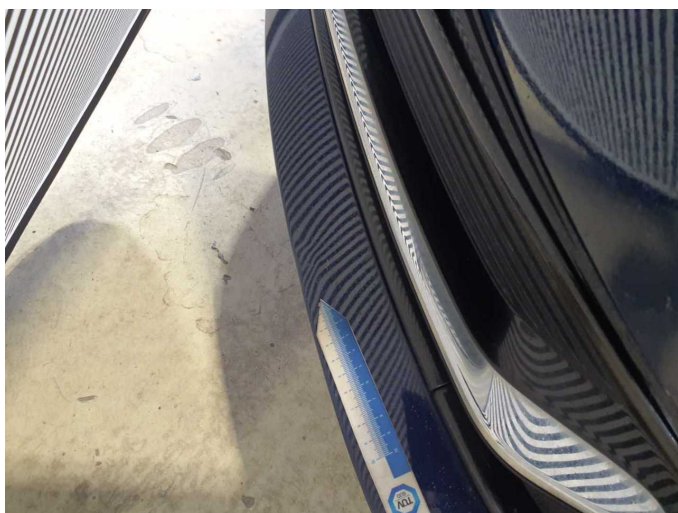
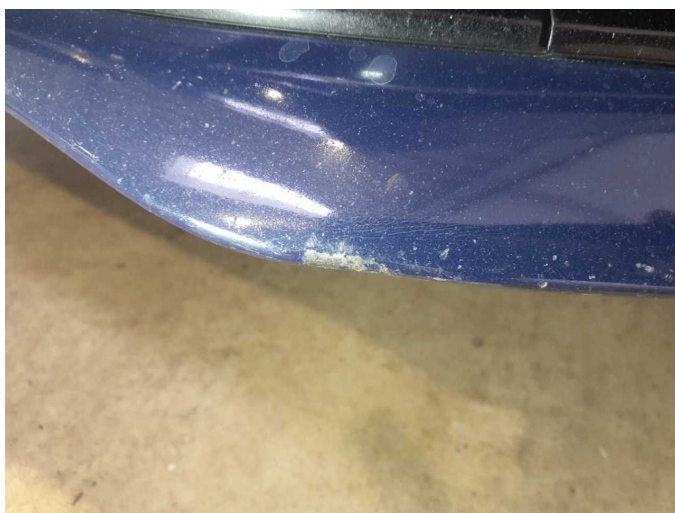
| No. | Component group | Description |
|---|---|---|
| 16 | Front bumper | Front bumper - Dent / paintcoat damage - Repair and paint |

**Damage 16:** Front bumper: Front bumper - Dent / paintcoat damage - Repair and paint
