Expertise

Protocol number: 46525356  
Order No. / Reference: 26681245  
Inspection date: 15 Jul 2026

Model: Kuga 2.0 EcoBlue 4x4 Aut. ST-LINE X

VIN: WF0FXXWPMFLT26148

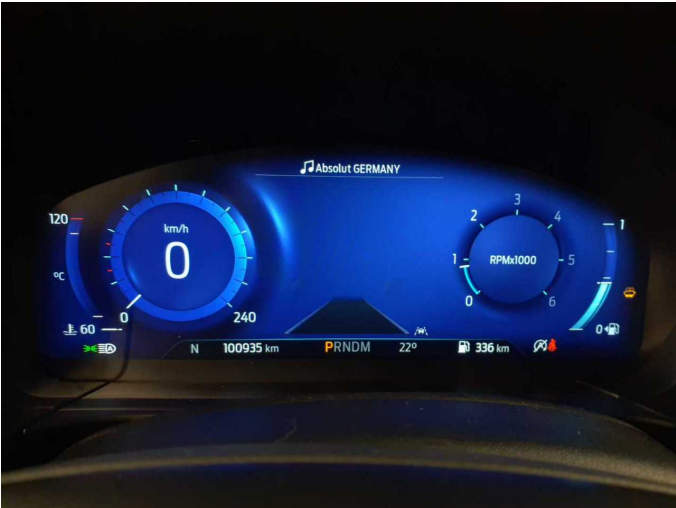
Figure 7: Instrument cluster

| Vehicle details | |
|---|---|
| Mileage (Read) | 100,935 km |

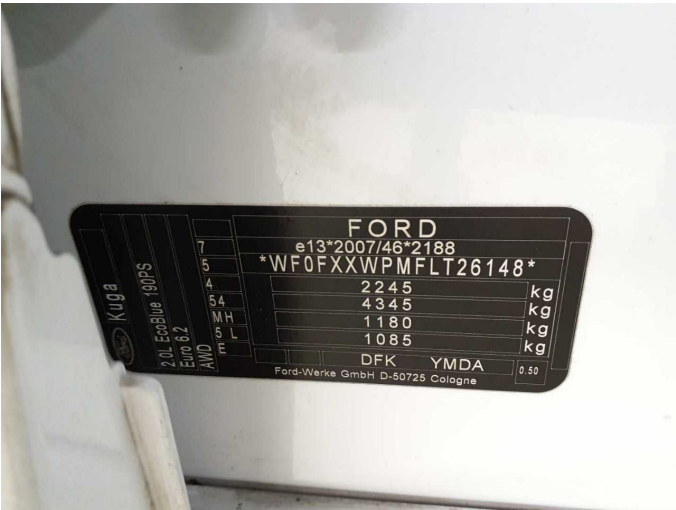
Figure 11: VIN

| VIN comparison | The vehicle identification number (VIN) was read from the vehicle and its conformity with the submitted documents was confirmed by the undersigned during the inspection. |

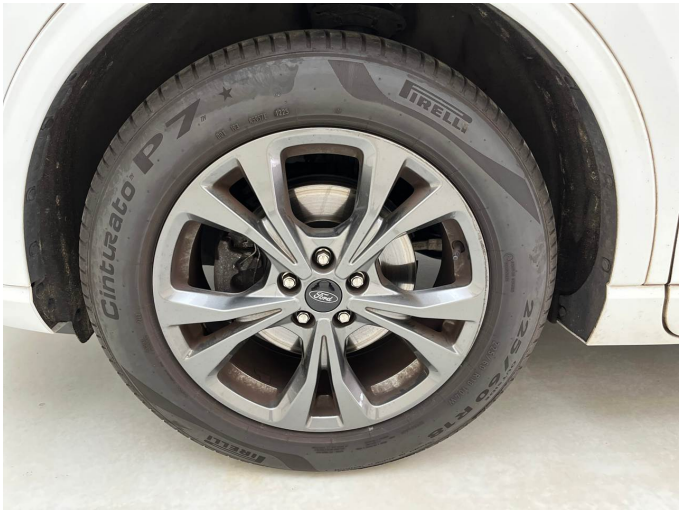
Figure 12: Mounted tyres

| # | Tyre size | Type of tyre | Manufacturer | Tread depth |
|---|---|---|---|---|
| 1) | 225/60 R18 104W | Summer tyres on Light alloy | Pirelli | 5mm / 5mm |
| 2) | 225/60 R18 104W | Summer tyres on Light alloy | Pirelli | 5mm / 5mm |

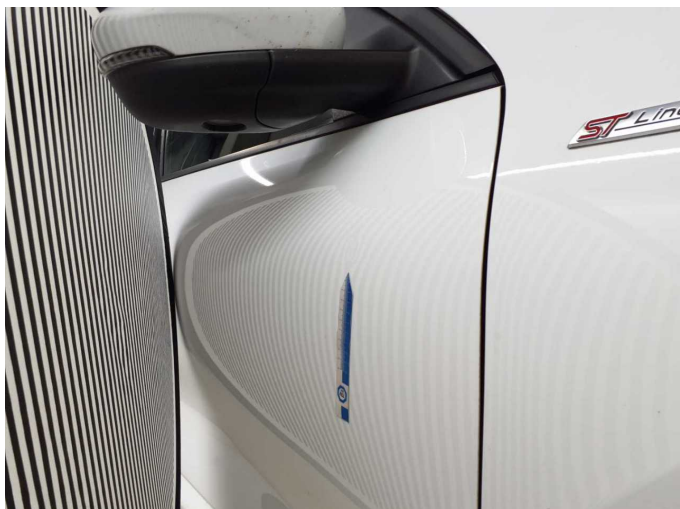
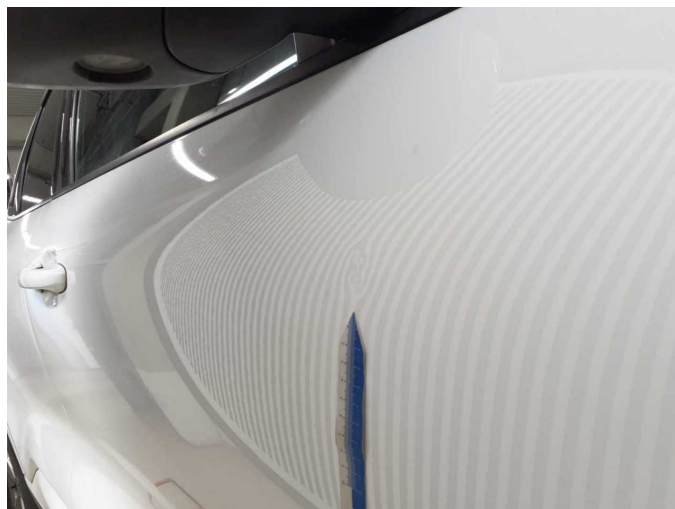
| No. | Component group | Description |
|---|---|---|
| 1 | Door - front right side | Door - dent(s) - Smart repair |

**Damage 1:** Door - front right side: Door - dent(s) - Smart repair

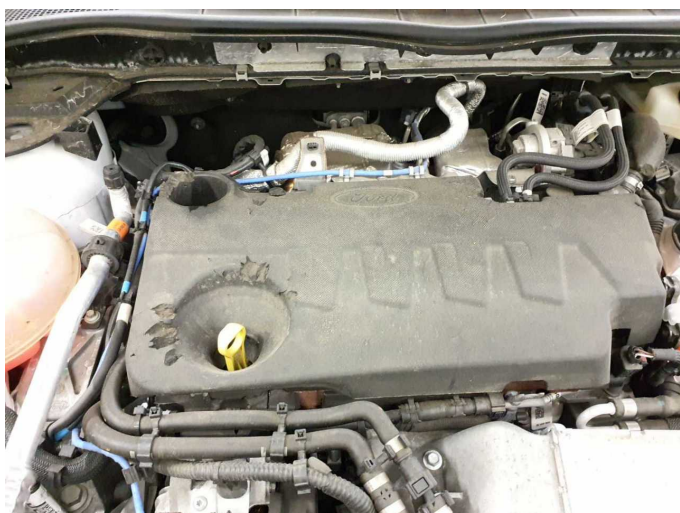
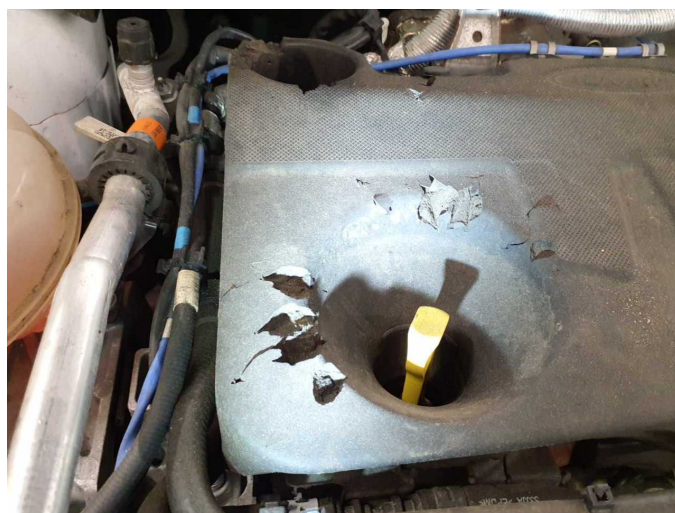
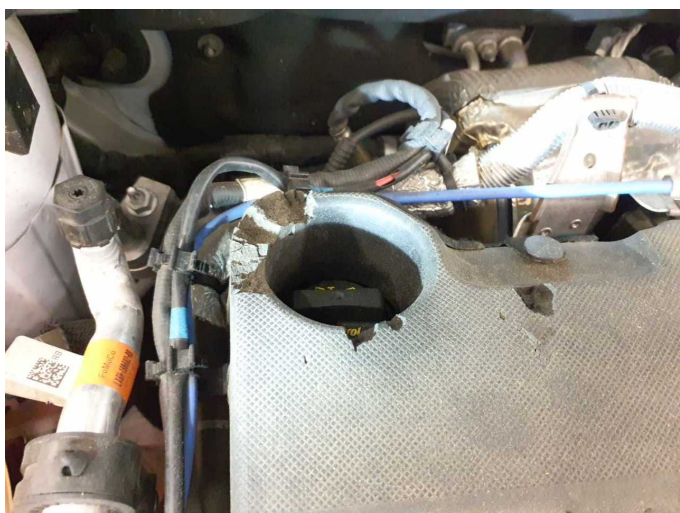
| No. | Component group | Description |
|---|---|---|
| 2 | Engine | Engine cowling - Broken / torn - Replace |

**Damage 2:** Engine: Engine cowling - Broken / torn - Replace

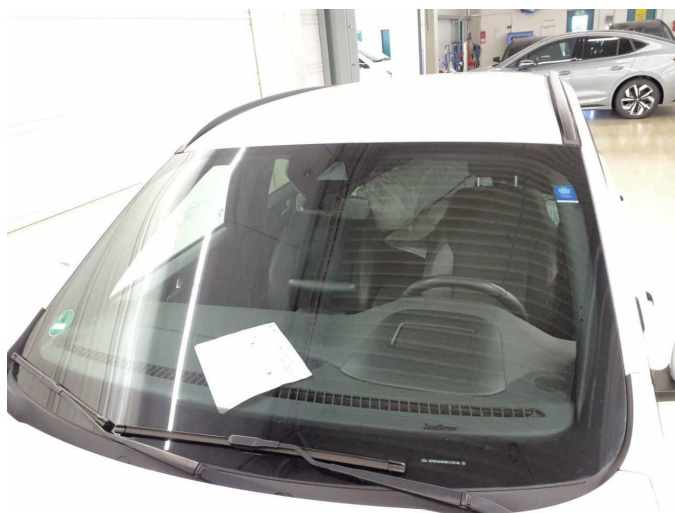
| No. | Component group | Description |
|---|---|---|
| 1 | Vehicle glazing | Windscreen - Stone chips - No deduction |

**Wear and tear 1:** Vehicle glazing: Windscreen - Stone chips - No deduction
