Expertise

Protocol number: 46729449  
Order No. / Reference: 26716717  
Inspection date: 28 Jul 2026

Manufacturer: Volkswagen

Model: Caddy 2.0 TDI BMT (5-Si.) DSG Style

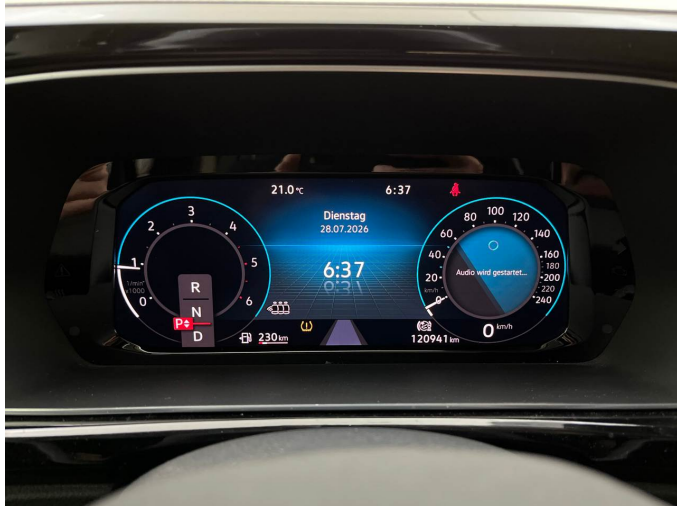
Figure 7: Instrument cluster

| Vehicle details | |
|---|---|
| Mileage (Read) | 120,941 km |

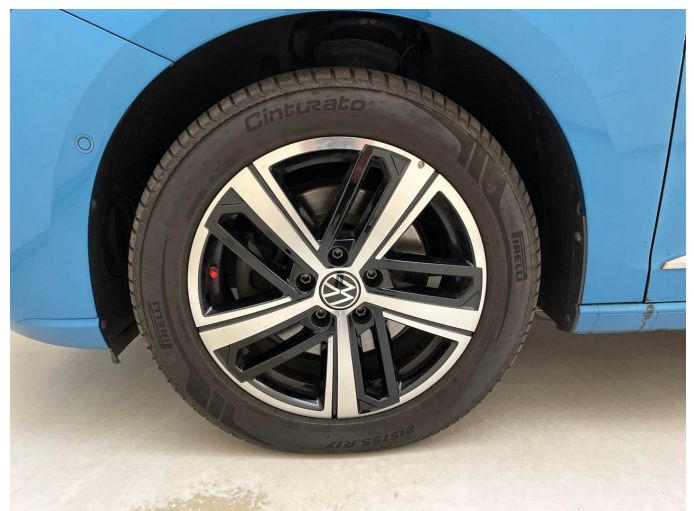
Figure 12: Mounted tyres

| # | Tyre size | Type of tyre | Manufacturer | Tread depth |
|---|---|---|---|---|
| 1) | 215/55 R17 98W | Summer tyres on Light alloy | Pirelli | 5mm / 5mm |
| 2) | 215/55 R17 98W | Summer tyres on Light alloy | Pirelli | 6mm / 6mm |

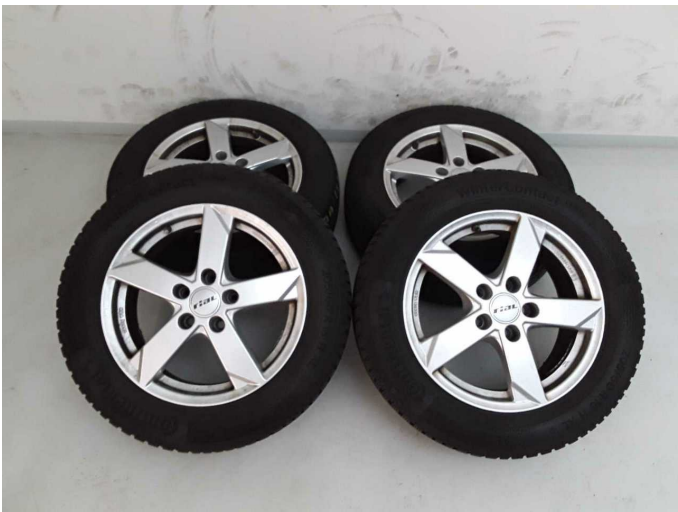
Figure 18: Additional tyres

| # | Tyre size | Type of tyre | Manufacturer | Tread depth |
|---|---|---|---|---|
| 1) | 205/60 R16 96H | Winter tyres on Light alloy | Continental | 6mm / 6mm |
| 2) | 205/60 R16 96H | Winter tyres on Light alloy | Continental | 7mm / 7mm |

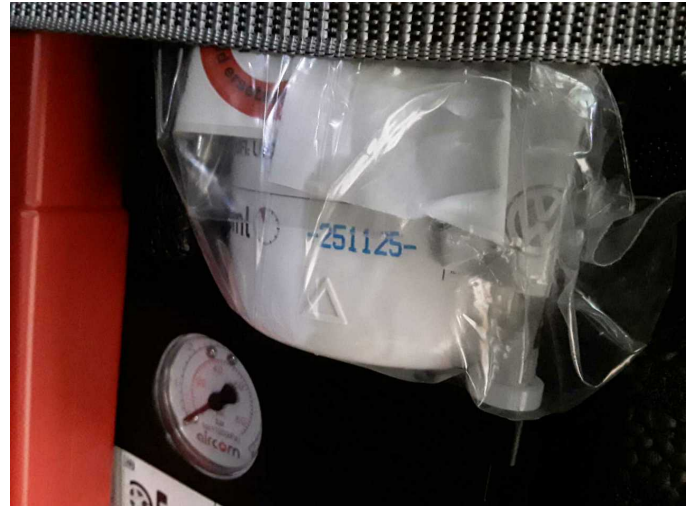
| No. | Component group | Description |
|---|---|---|
| 1 | Equipment | Tirefit filler - Expired - Replace |

**Damage 1:** Equipment: Tirefit filler - Expired - Replace

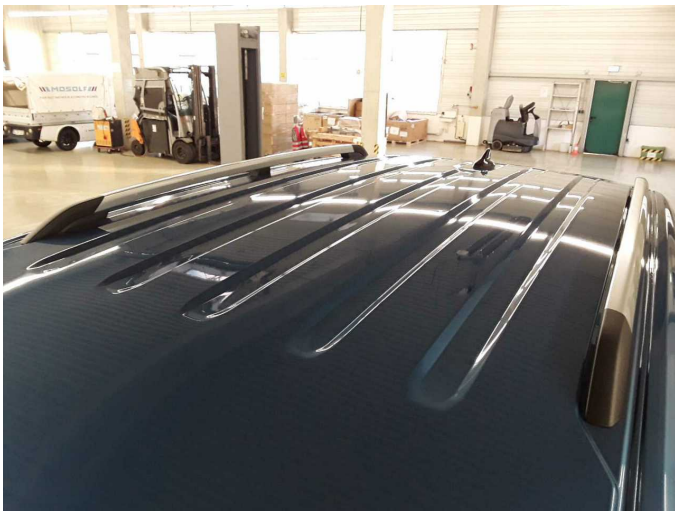
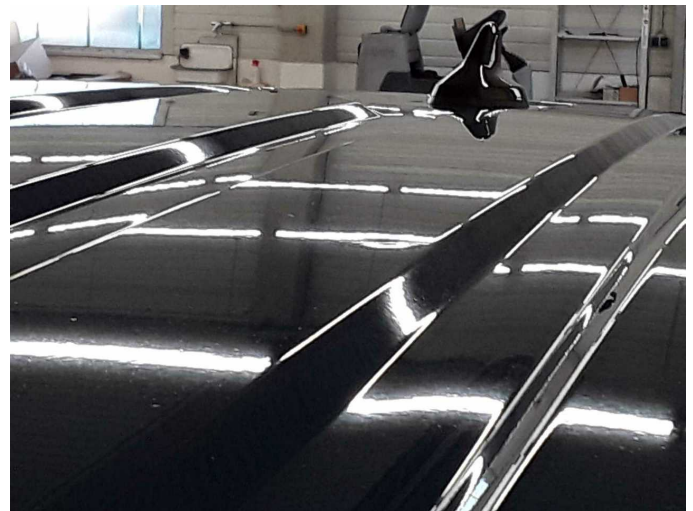
| No. | Component group | Description |
|---|---|---|
| 2 | Roof | Roof - dent(s) - Smart repair |

**Damage 2:** Roof: Roof - dent(s) - Smart repair

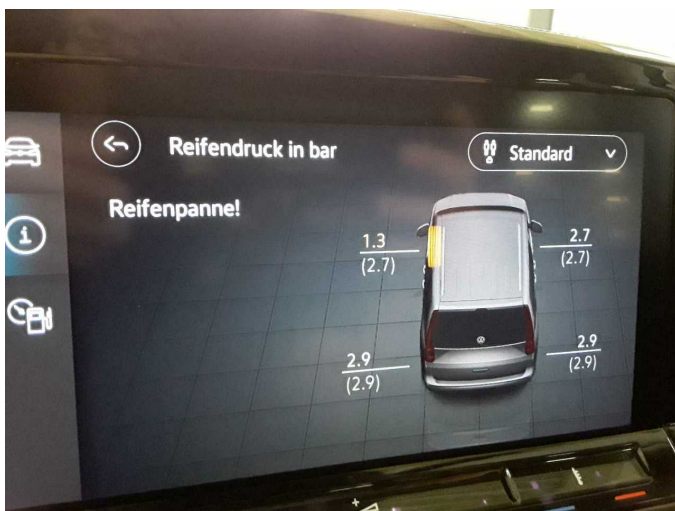
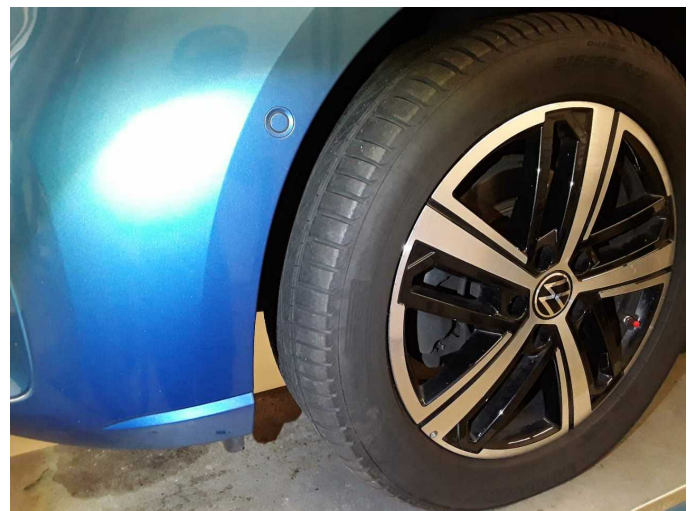
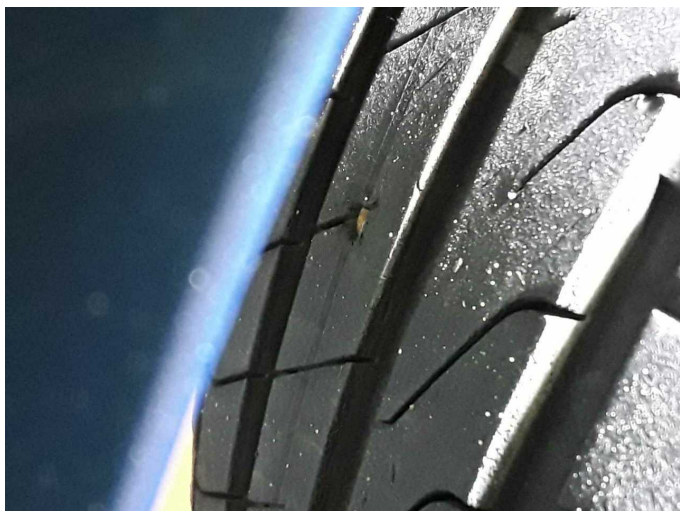
| No. | Component group | Description |
|---|---|---|
| 3 | Wheel / tyres | Tyre - front left side - Leaking - Replace |

**Damage 3:** Wheel / tyres: Tyre - front left side - Leaking - Replace

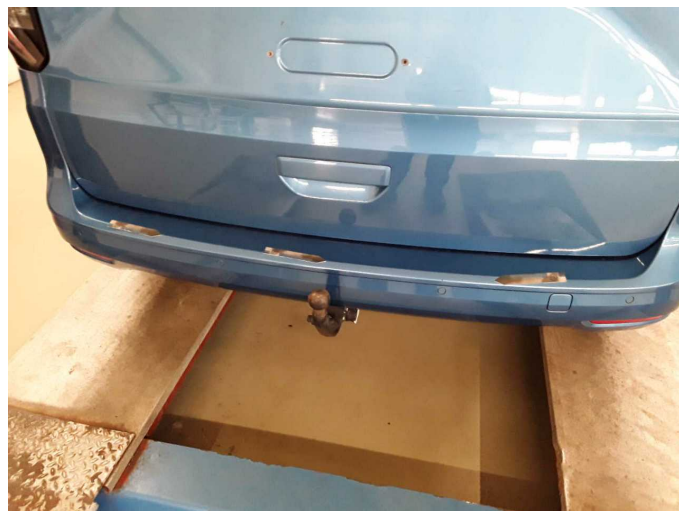
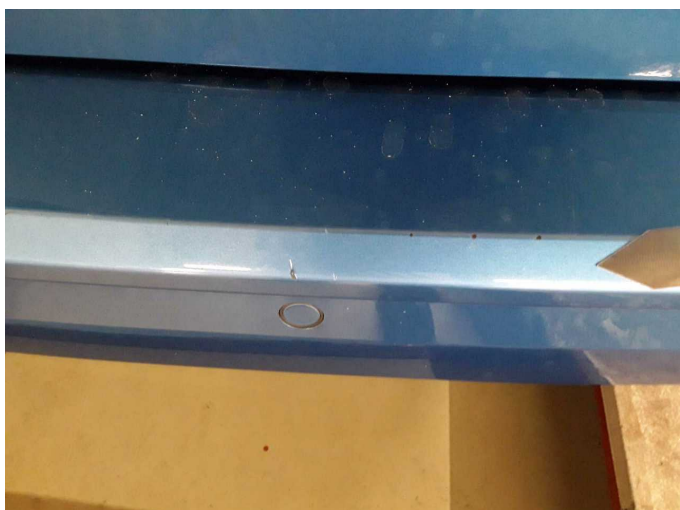
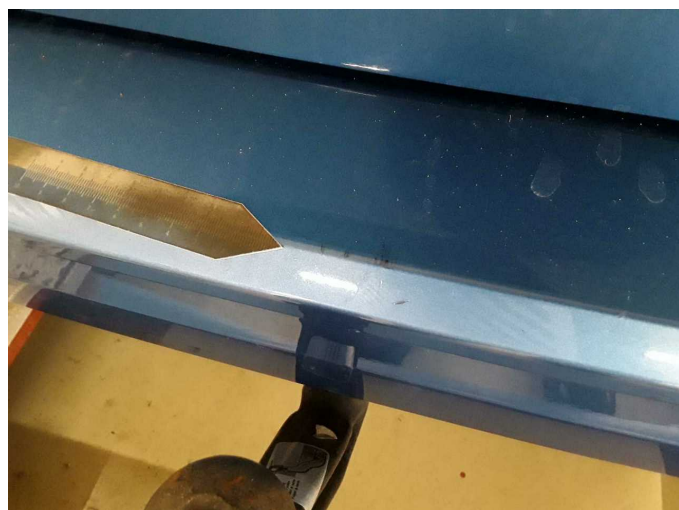
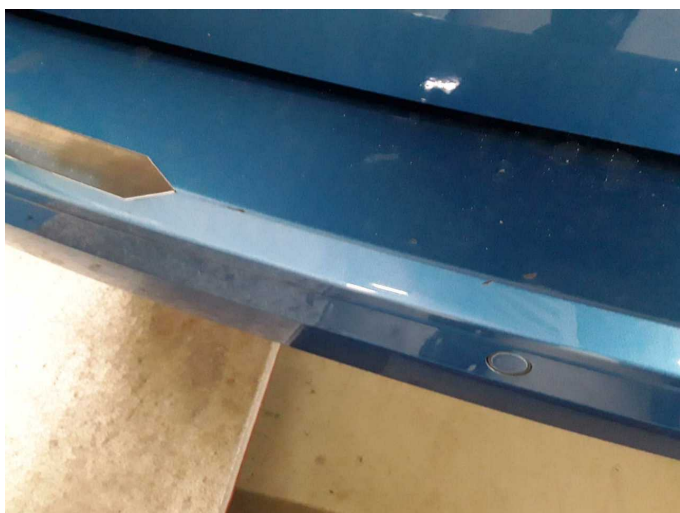
| No. | Component group | Description |
|---|---|---|
| 4 | Rear bumper | Bumper with Parktronic - Scratch(es) - Paint |

**Damage 4:** Rear bumper: Bumper with Parktronic - Scratch(es) - Paint

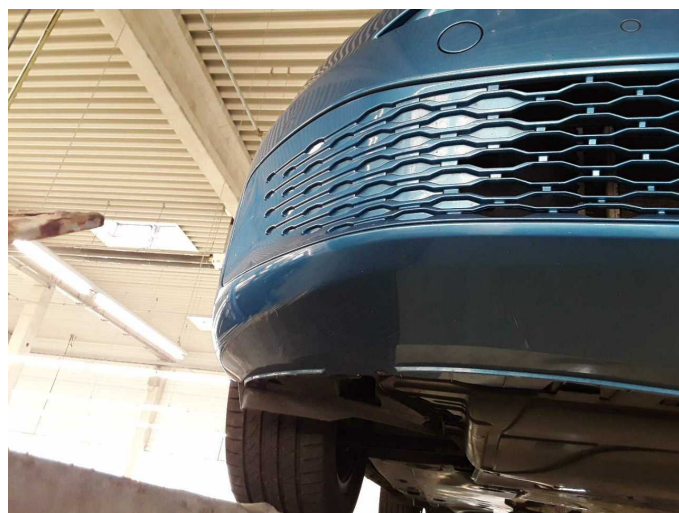
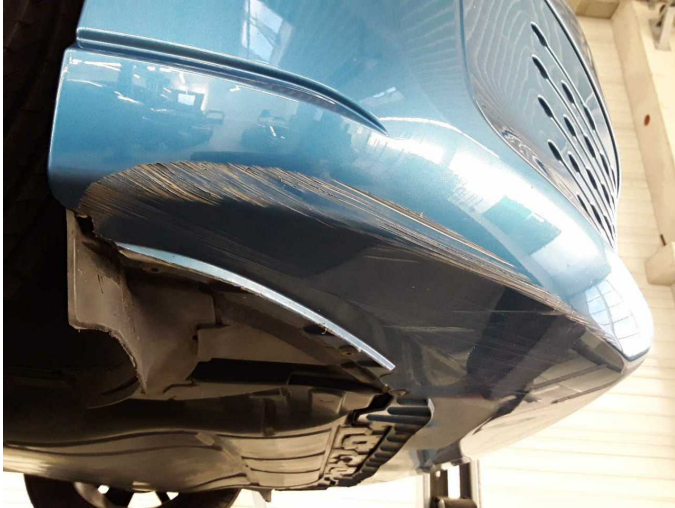
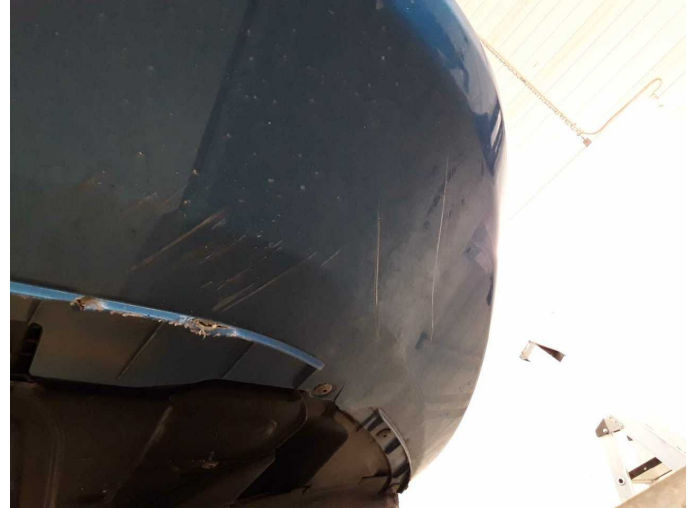
| No. | Component group | Description |
|---|---|---|
| 5 | Front bumper | Bumper with Parktronic - Scratched - Repair and paint |

**Damage 5:** Front bumper: Bumper with Parktronic - Scratched - Repair and paint
