Expertise

Protocol number: 46238990
Order No. / Reference: 26449218
Inspection date: 30 Jun 2026

Manufacturer: Opel

Model: Grandland 1.5 D Automatik Elegance

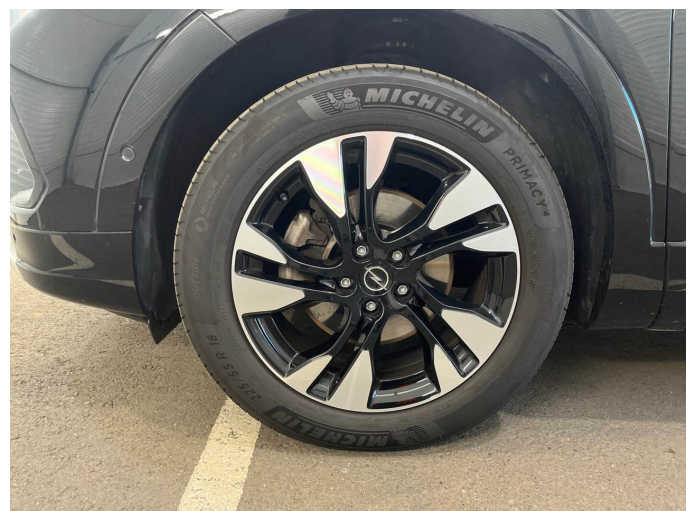
Figure 12: Mounted tyres

#	Tyre size	Type of tyre	Manufacturer	Tread depth
1)	225/55 R18 102V	Summer tyres on Light alloy	Michelin	5mm / 5mm
2)	225/55 R18 102V	Summer tyres on Light alloy	Michelin	5mm / 5mm

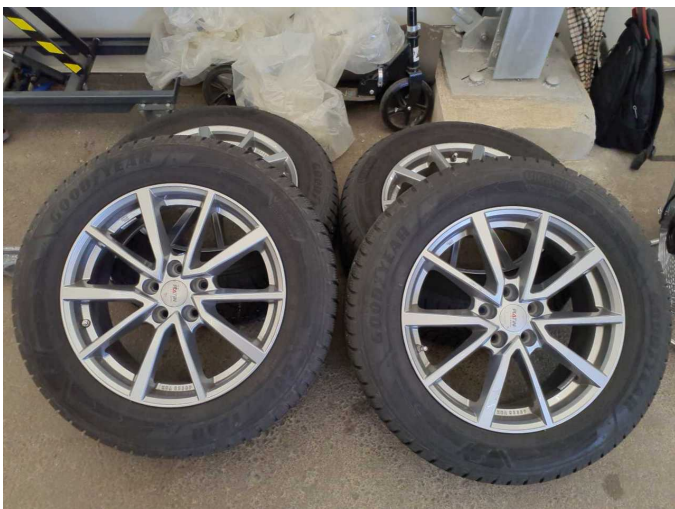
Figure 17: Additional tyres

#	Tyre size	Type of tyre	Manufacturer	Tread depth
1)	215/65 R17 99V	Winter tyres on Light alloy	Goodyear	5mm / 5mm
2)	215/65 R17 99V	Winter tyres on Light alloy	Goodyear	6mm / 6mm

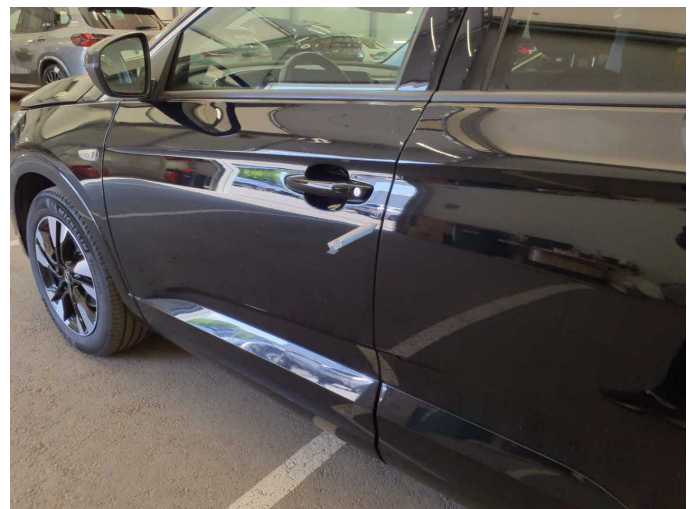
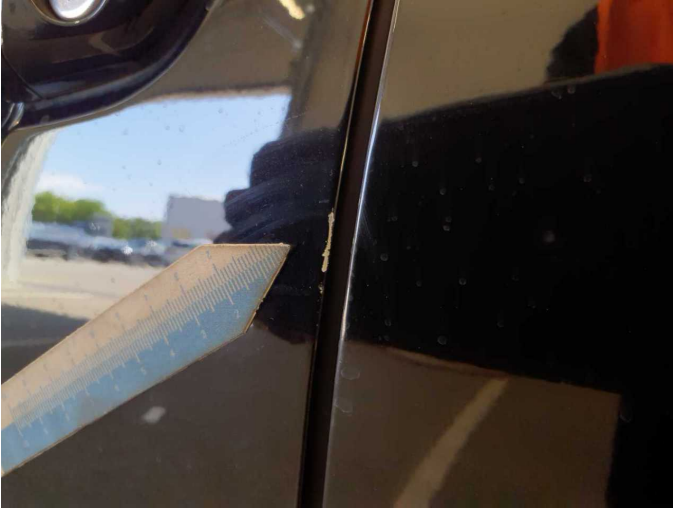
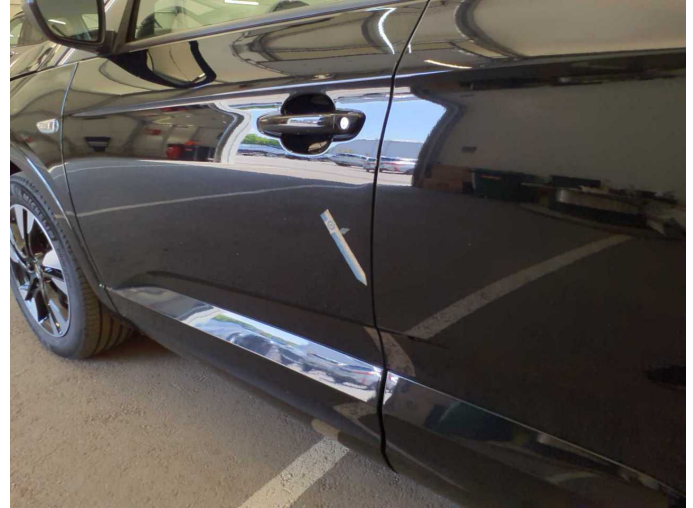
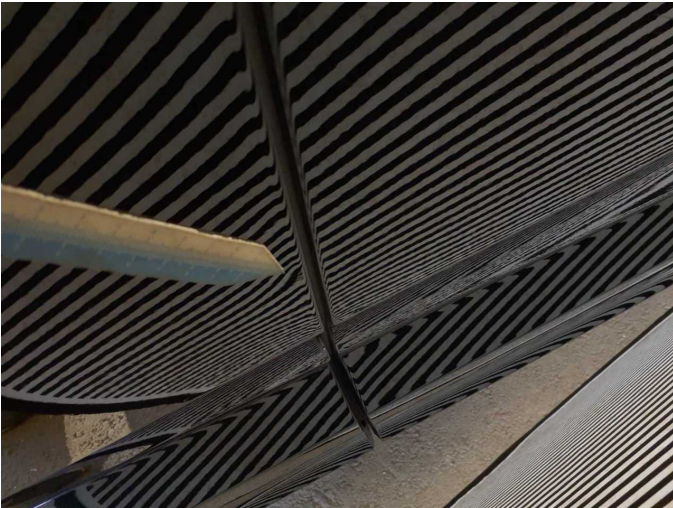
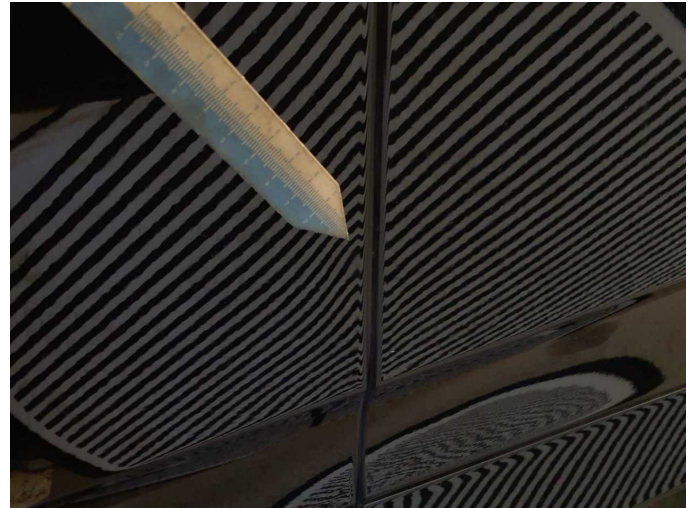
Damage 1: Door - front left side: Door - Dent / paintcoat damage - Smart repair

No.	Component group	Description
1	Door - front left side	Door - Dent / paintcoat damage - Smart repair
2	Vehicle glazing	Windscreen with lane departure assistant - Broken / torn - Replace

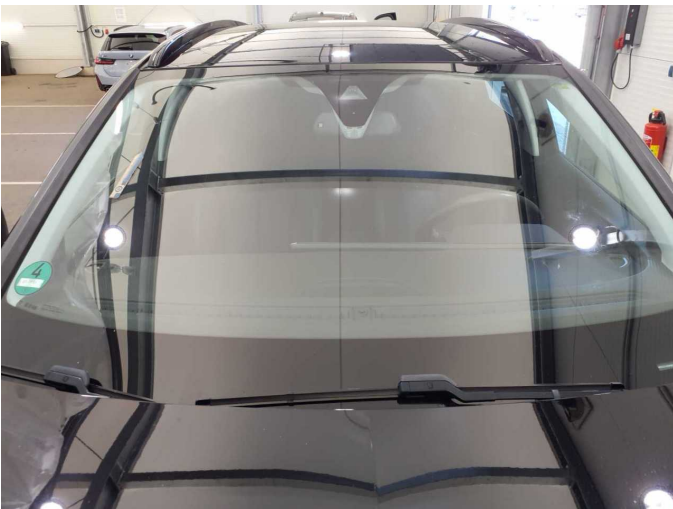
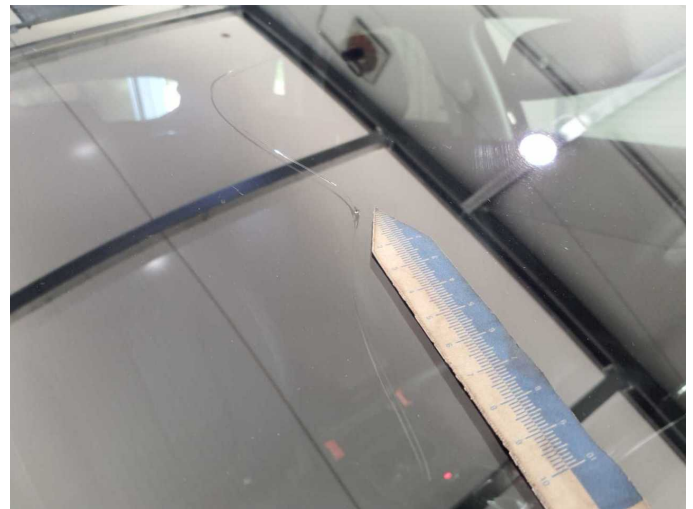
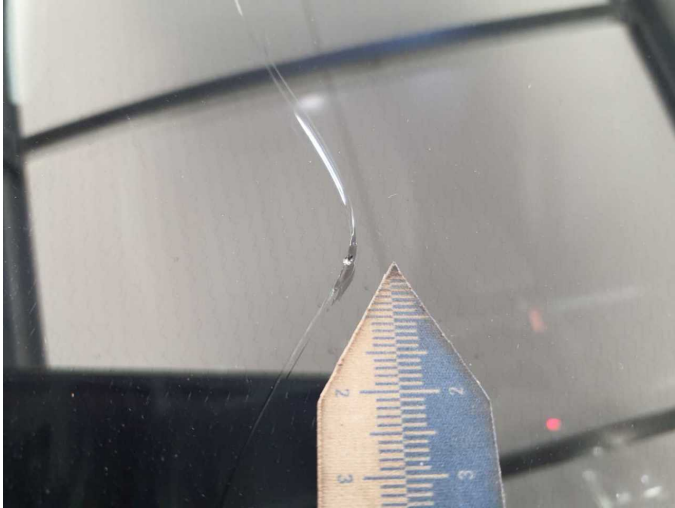
Damage 2: Vehicle glazing: Windscreen with lane departure assistant - Broken / torn - Replace
