Expertise

Protocol number: 46894888  
Order No. / Reference: 26728780  
Inspection date: 5 Aug 2026

Manufacturer: Volkswagen

Model: Tiguan Allspace 2.0 TDI SCR 4Motion DSG Elegance

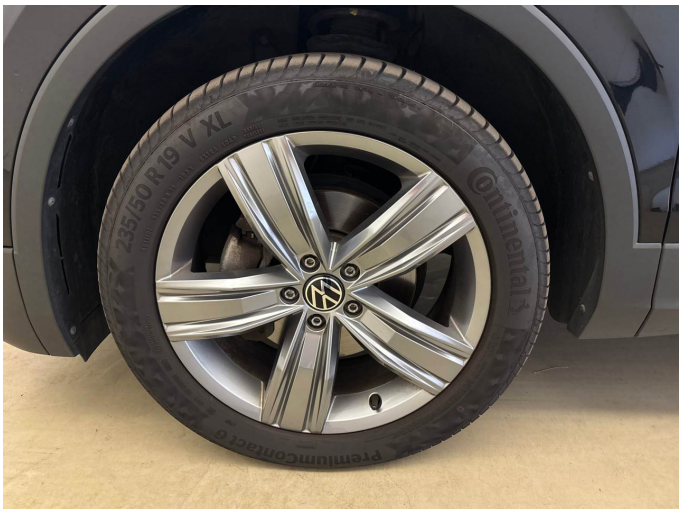
Figure 12: Mounted tyres

| # | Tyre size | Type of tyre | Manufacturer | Tread depth |
|---|---|---|---|---|
| 1) | 235/50 R19 103V | Summer tyres on Light alloy | Continental | 6mm / 6mm |
| 2) | 235/50 R19 103V | Summer tyres on Light alloy | Continental | 6mm / 6mm |

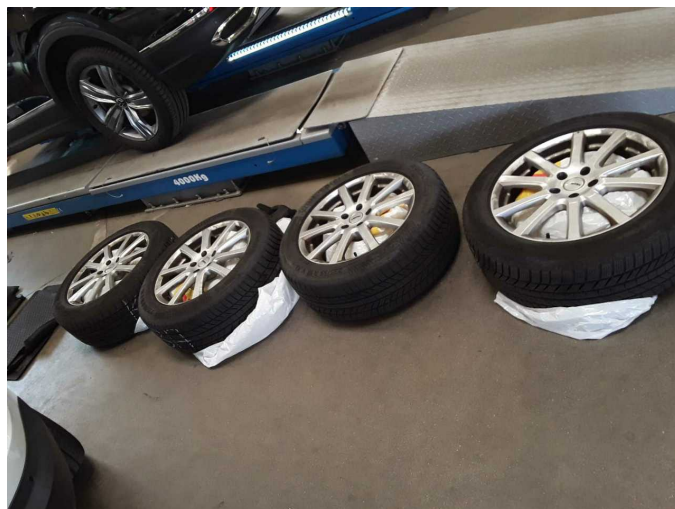
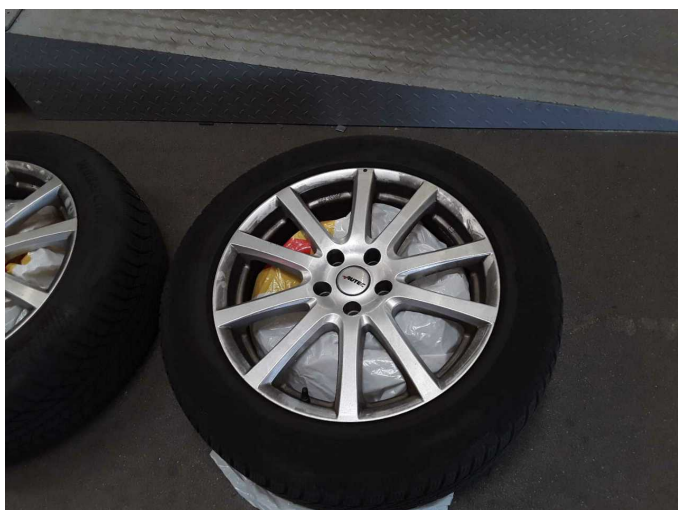
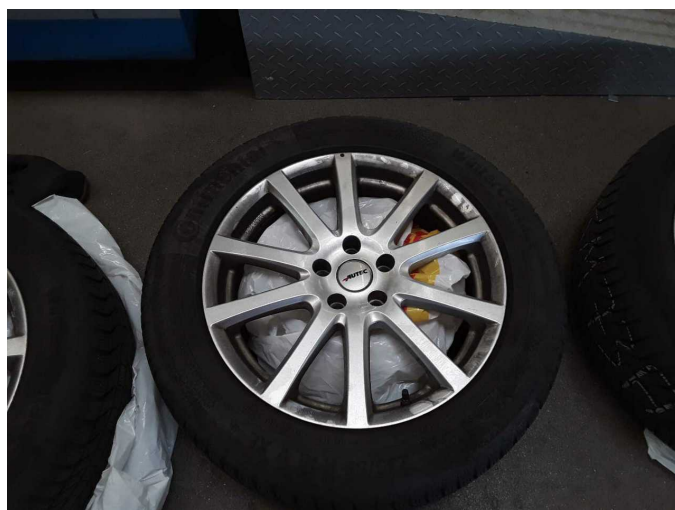
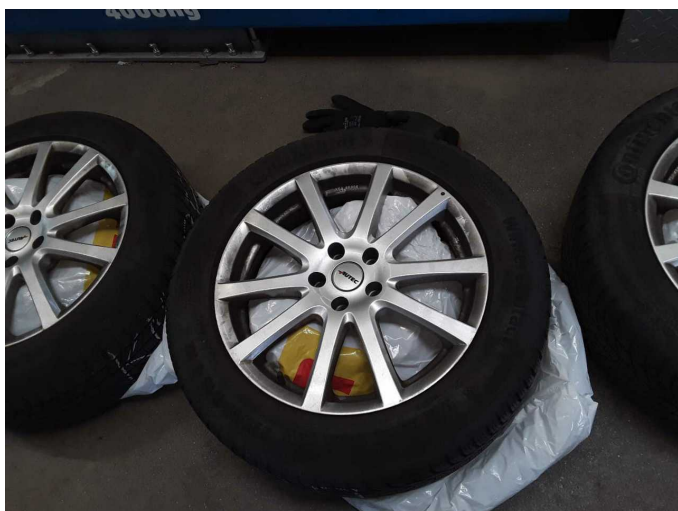
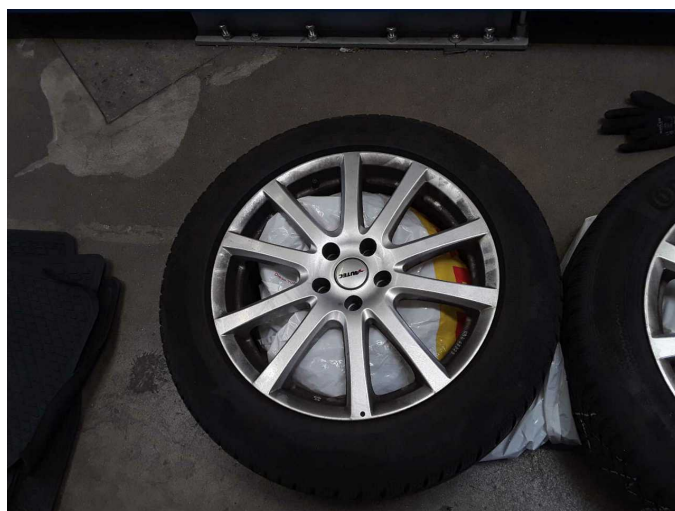
Figure 14: Additional tyres

| # | Tyre size | Type of tyre | Manufacturer | Tread depth |
|---|---|---|---|---|
| 1) | 235/55 R18 104V | Winter tyres on Light alloy | Continental | 5mm / 5mm |
| 2) | 235/55 R18 104V | Winter tyres on Light alloy | Continental | 5mm / 5mm |

Der beiliegende Winterradsatz ist nicht Bestandteil der Ausstattung.

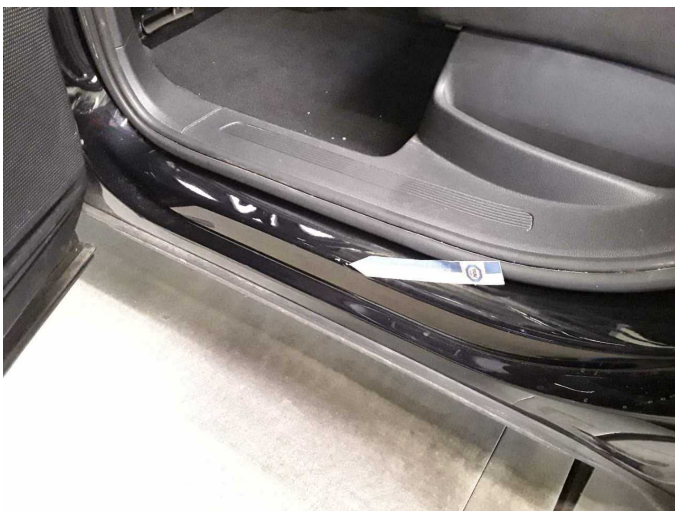
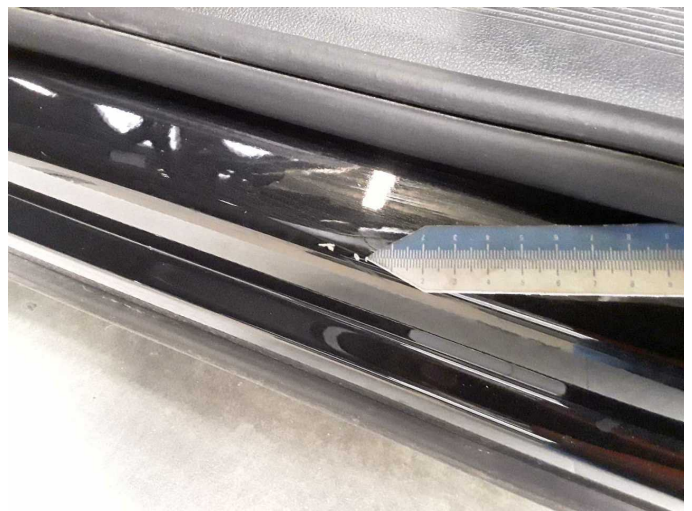
| No. | Component group | Description |
|---|---|---|
| 1 | Side panel - rear left side | Sill - Scratched - Smart repair |

Damage 1: Side panel - rear left side: Sill - Scratched - Smart repair

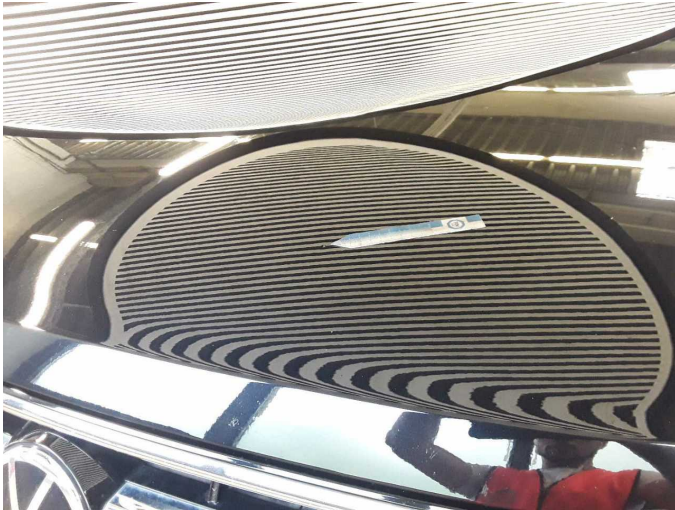
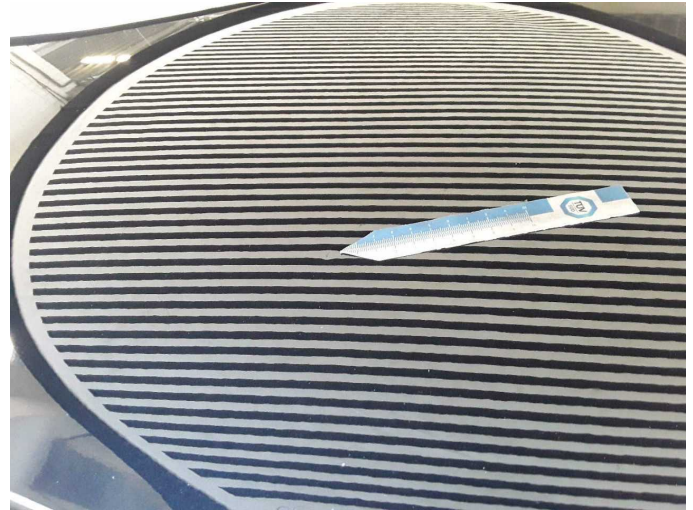
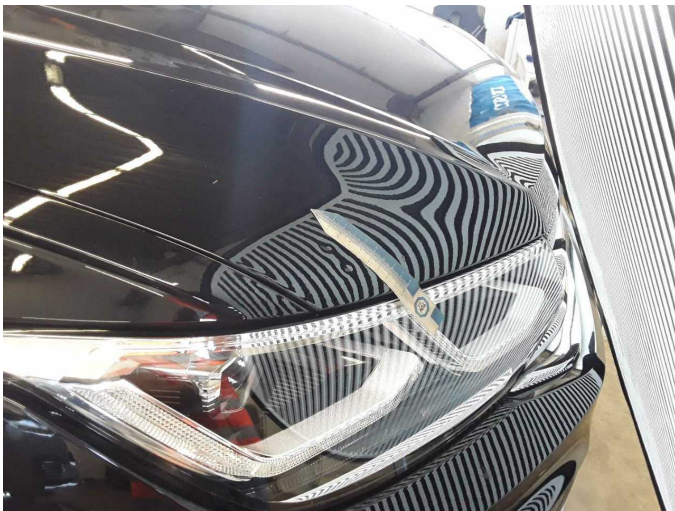
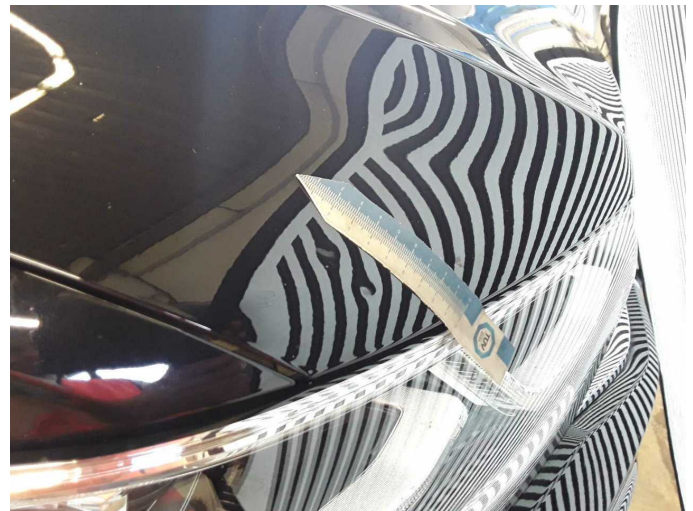
| No. | Component group | Description |
|---|---|---|
| 2 | Bonnet | Bonnet - dent(s) - Smooth repair work |

**Damage 2:** Bonnet: Bonnet - dent(s) - Smooth repair work

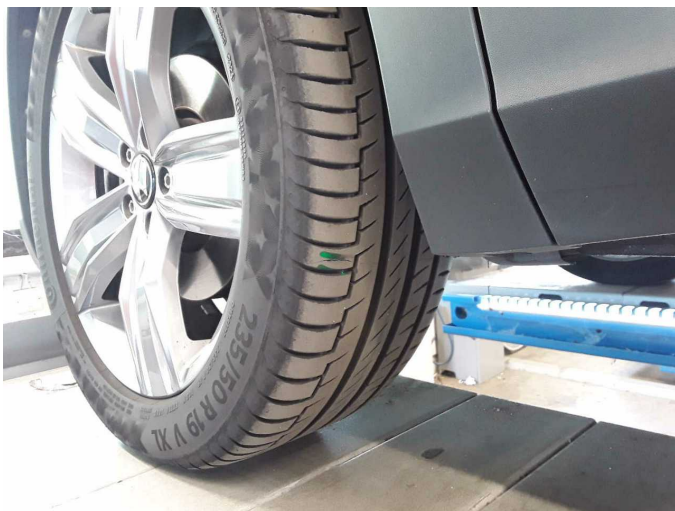
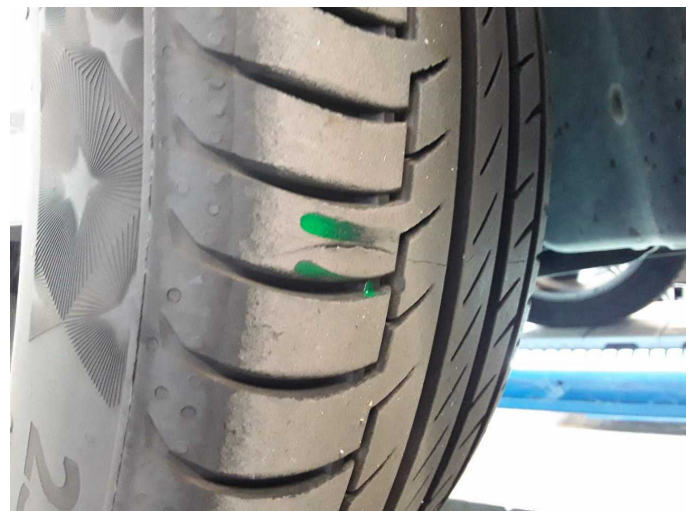
| No. | Component group | Description |
|---|---|---|
| 3 | Wheel / tyres | Tyre - front left side - Damaged - Replace |

**Damage 3:** Wheel / tyres: Tyre - front left side - Damaged - Replace
