Expertise

Protocol number: 45527352
Order No. / Reference: 26384625
Inspection date: 18 May 2026

Manufacturer: Mercedes-Benz

Model: 317 CDI Sprinter Kompakt HA 9G-TRONIC

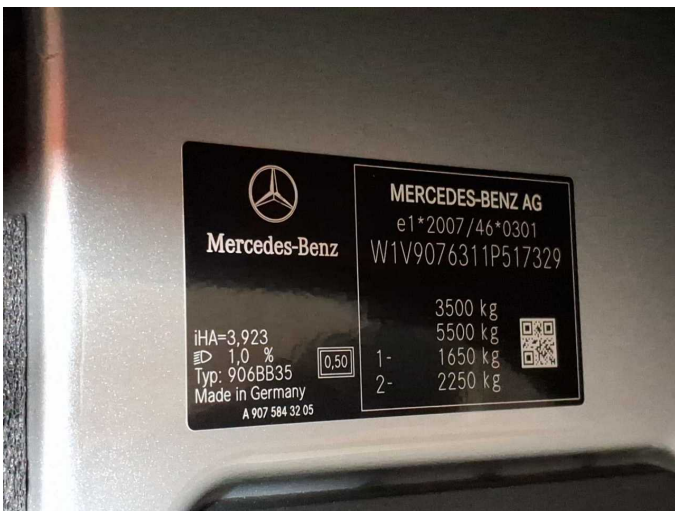
Figure 11: VIN

Documents submitted	At the time of the inspection, the vehicle registration certificate Part 2 (title) was available, but the vehicle registration certificate Part 1 (document) was not. (Copy)
VIN comparison	The vehicle identification number (VIN) was read from the vehicle and its conformity with the submitted documents was confirmed by the undersigned during the inspection.
Inspection	The inspection conditions were sufficient for the assessment of the vehicle. Lifting equipment and/or a pit were available for examining the vehicle.
Test drive	No test drive/shunting maneuver was carried out during the inspection of the vehicle.
Engine function test	An engine test run was performed.

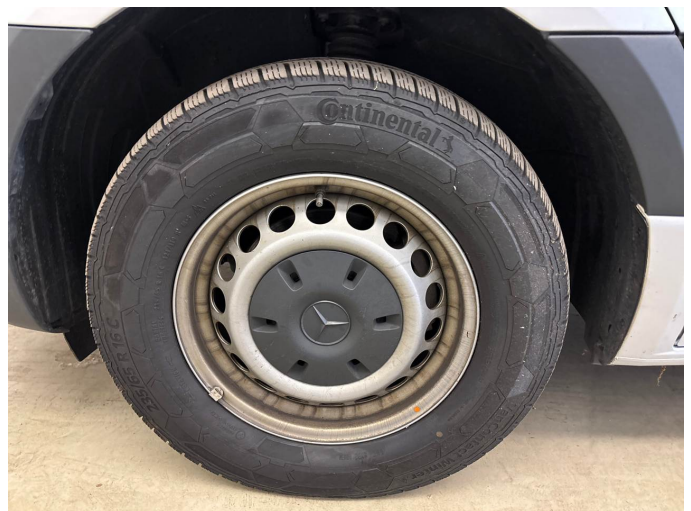
Figure 12: Mounted tyres

#	Tyre size	Type of tyre	Manufacturer	Tread depth
1)	235/65 R16 121R	Winter tyres on Steel	Continental	6mm / 6mm
2)	235/65 R16 121R	Winter tyres on Steel	Continental	7mm / 7mm

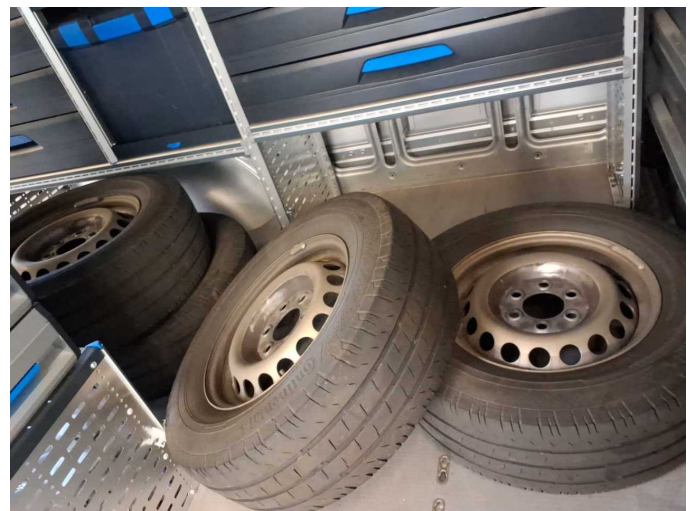
Figure 16: Additional tyres

#	Tyre size	Type of tyre	Manufacturer	Tread depth
1)	235/65 R16 121R	Summer tyres on Steel	Continental	6mm / 6mm
2)	235/65 R16 121R	Summer tyres on Steel	Continental	6mm / 6mm

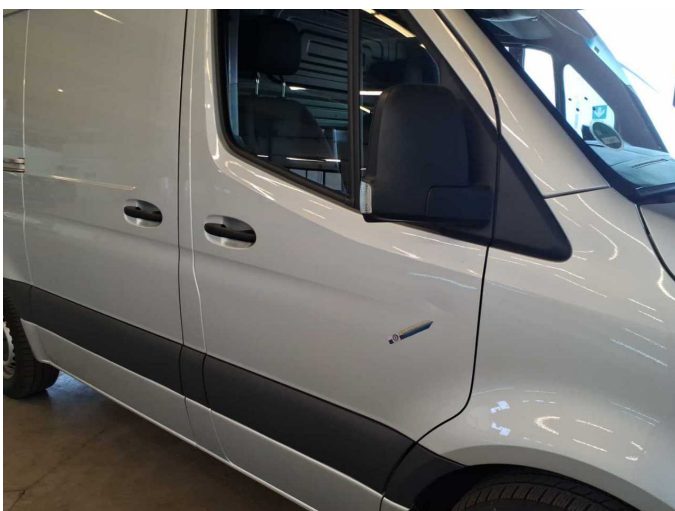
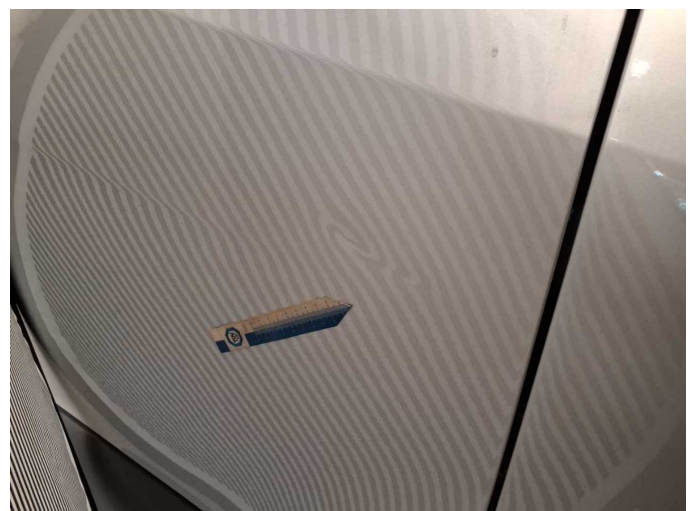
Damage 3: Door - front right side: Door - dent(s) - Smooth repair work

No.	Component group	Description
1	Misc.	Inspection / maintenance - No evidence - No deduction
2	Misc.	Main inspection - No evidence - No deduction
3	Door - front right side	Door - dent(s) - Smooth repair work
4	Boot lid / rear door	Rear door - left side - dent(s) - Smooth repair work
5	Sliding door, right	Sliding door - dent(s) - Smooth repair work

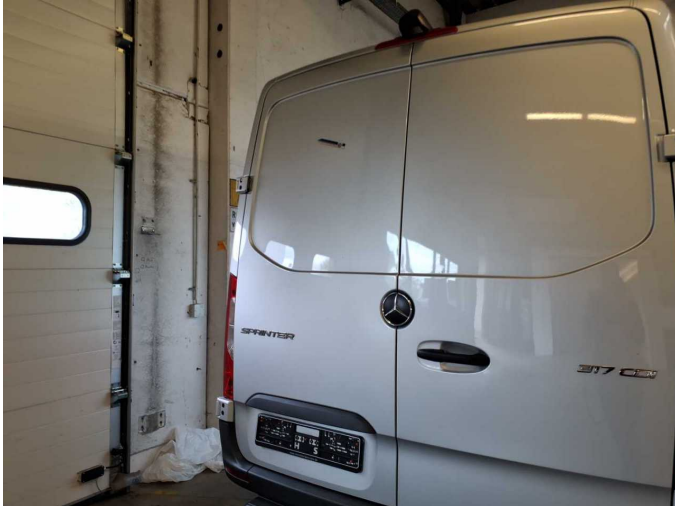
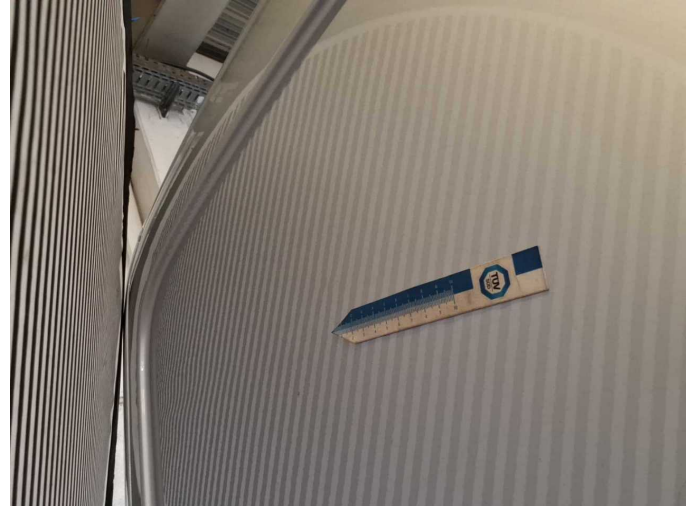
Damage 4: Boot lid / rear door: Rear door - left side - dent(s) - Smooth repair work

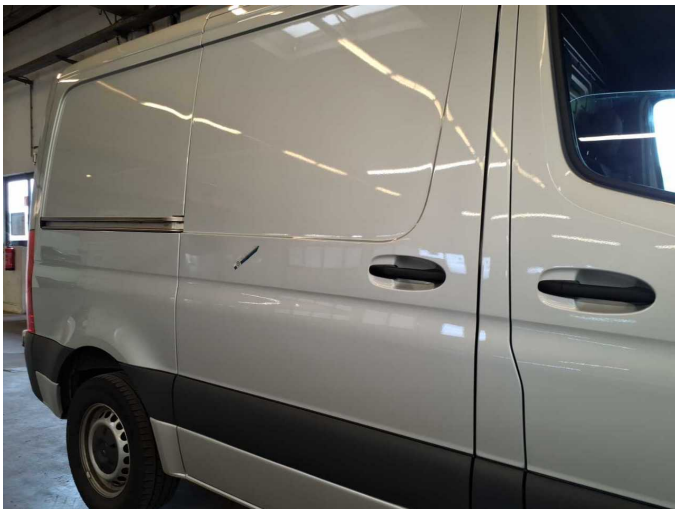
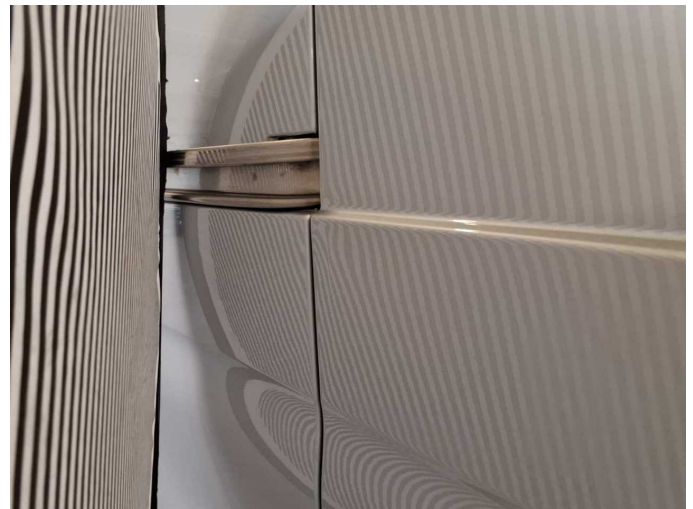
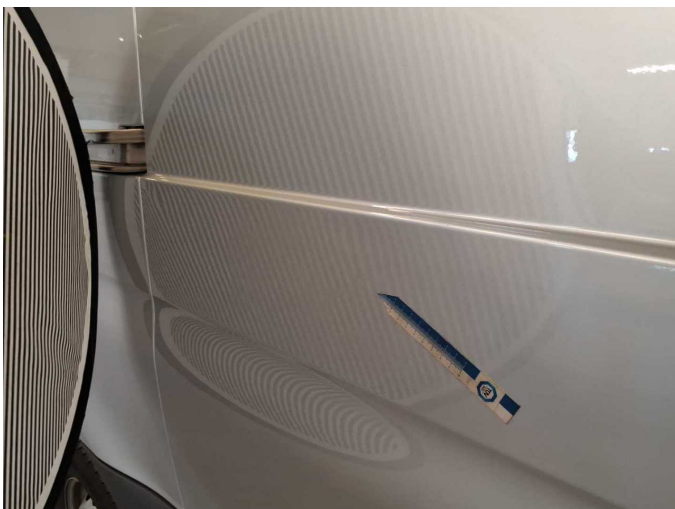
Damage 5: Sliding door, right: Sliding door - dent(s) - Smooth repair work

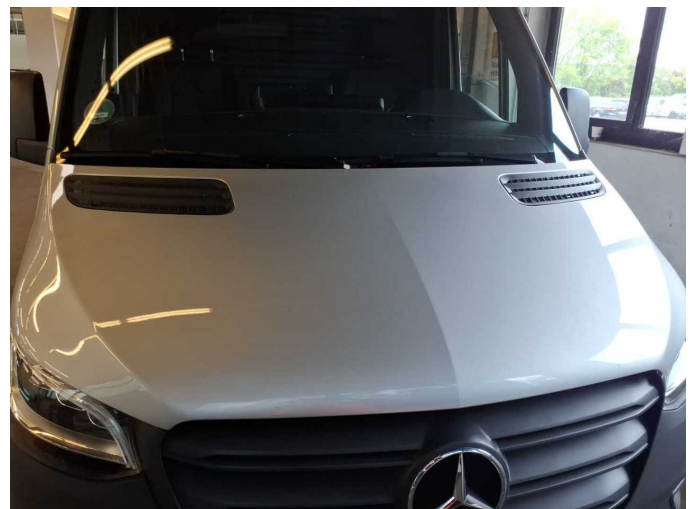
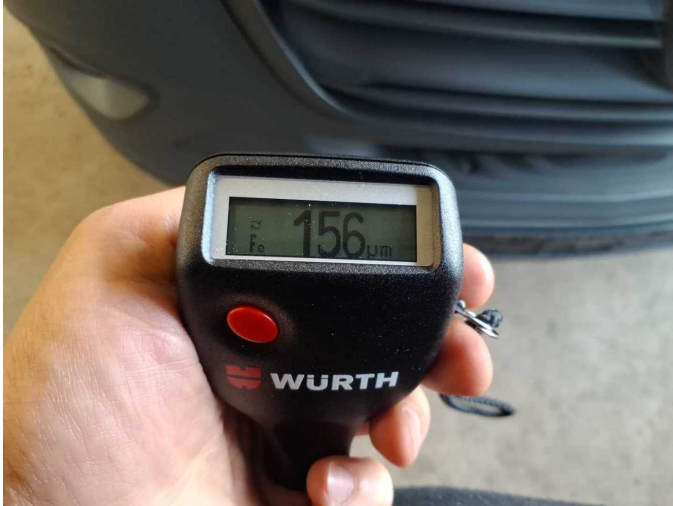
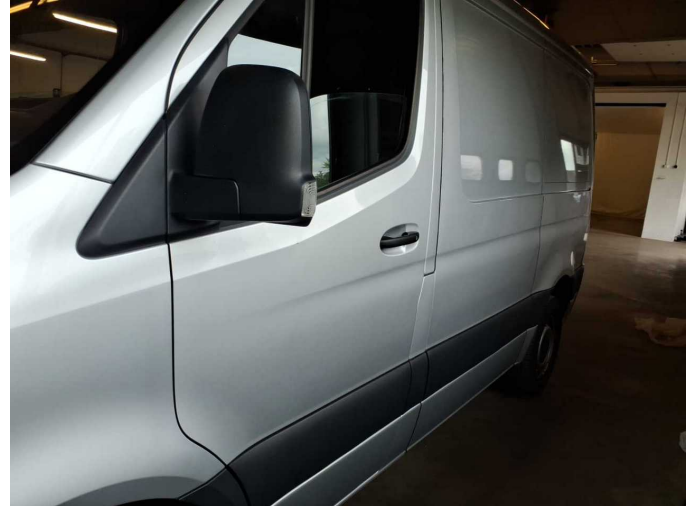
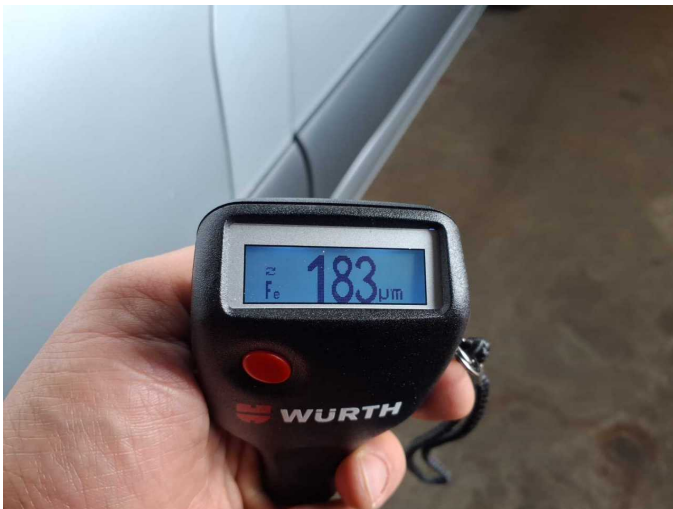
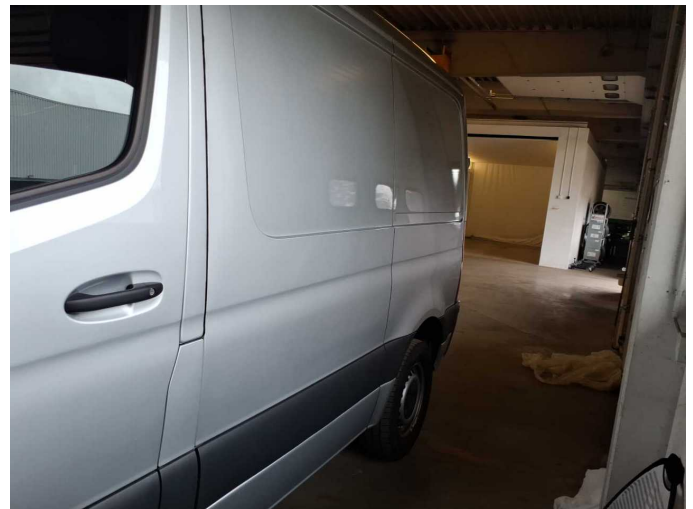
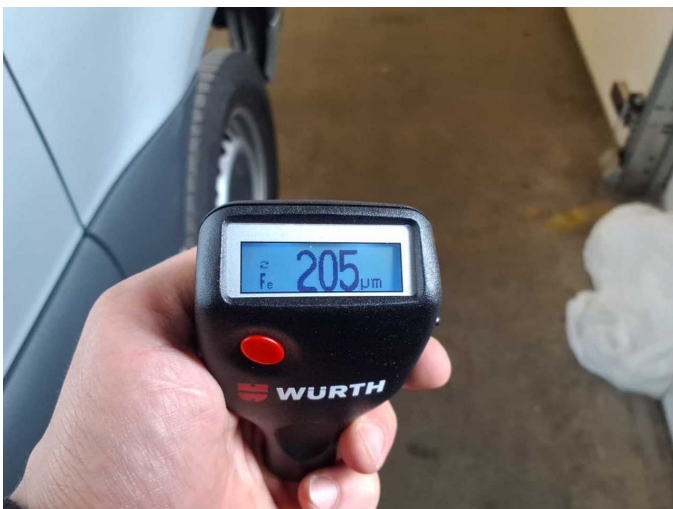
Bonnet	156 µm	Side panel - rear left side	204 µm
Door - front left side	181 µm

Repainting 1: Bonnet, Side panel - rear left side, Door - front left side
