Expertise

Manufacturer: Ford

Model: Focus Turnier 1.5 EcoBlue Start-Stopp-System Aut.  
COOL&CONNECT

VIN: WF0PXXGCHPNB00446

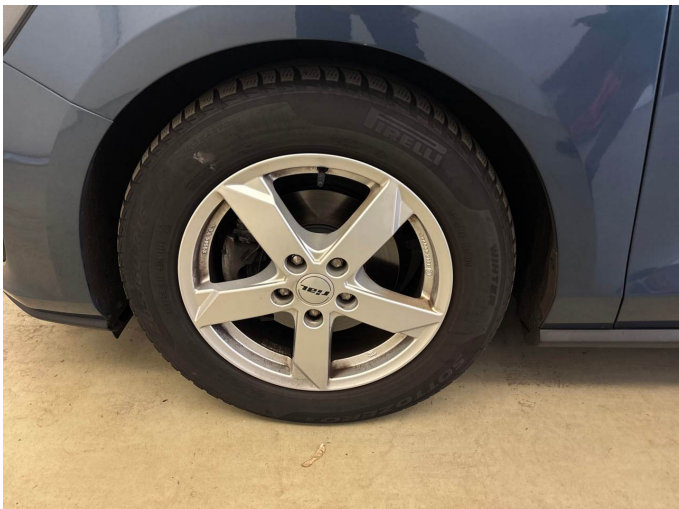
| # | Tyre size | Type of tyre | Manufacturer | Tread depth |
|---|---|---|---|---|
| 1) | 205/60 R16 96H | Winter tyres on Light alloy | Pirelli | 4mm / 4mm |
| 2) | 205/60 R16 96H | Winter tyres on Light alloy | Pirelli | 4mm / 4mm |

Figure 12: Mounted tyres

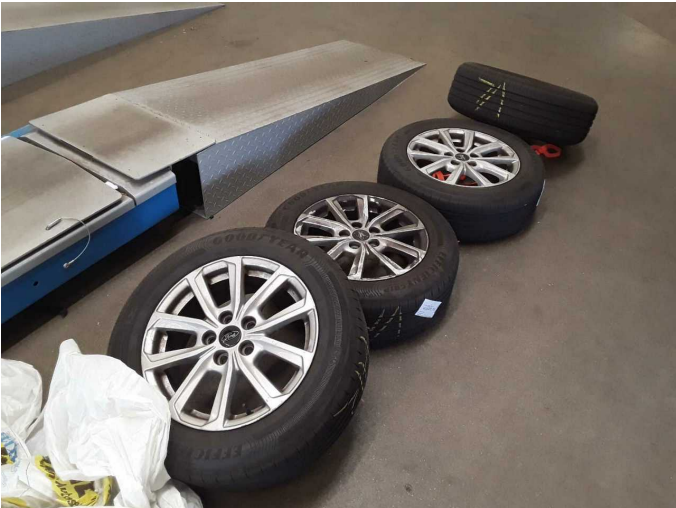
| # | Tyre size | Type of tyre | Manufacturer | Tread depth |
|---|---|---|---|---|
| 1) | 205/60 R16 92V | Summer tyres on Light alloy | Goodyear | 4mm / 4mm |
| 2) | 205/60 R16 92V | Summer tyres on Light alloy | Goodyear | 3mm / 3mm |

Figure 15: Additional tyres

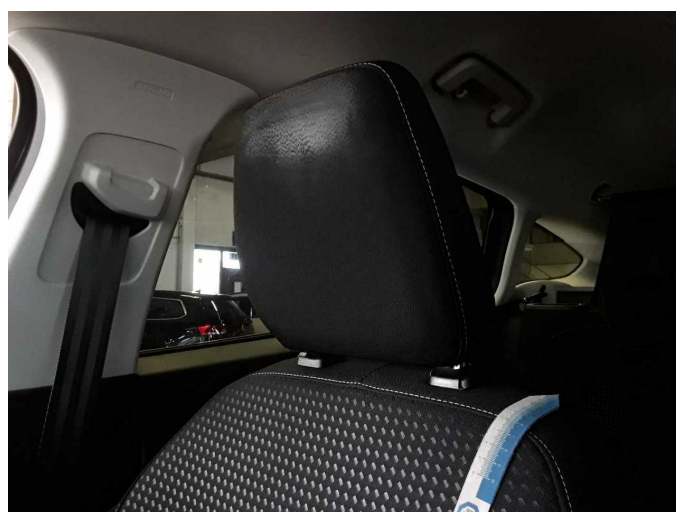
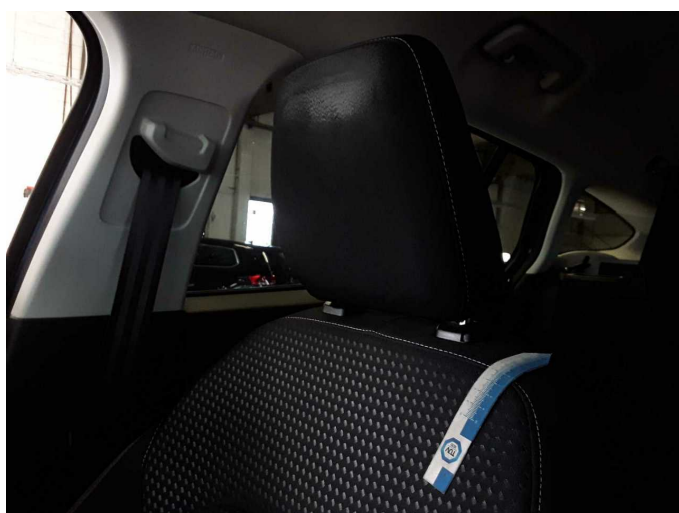
Damage 1: Seat - front: Headrest seat - right side - Soiled - Clean

| No. | Component group | Description |
|---|---|---|
| 1 | Seat - front | Headrest seat - right side - Soiled - Clean |

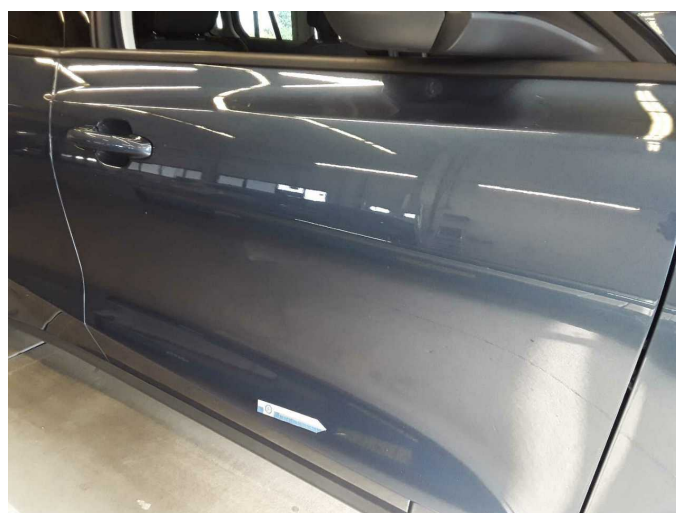
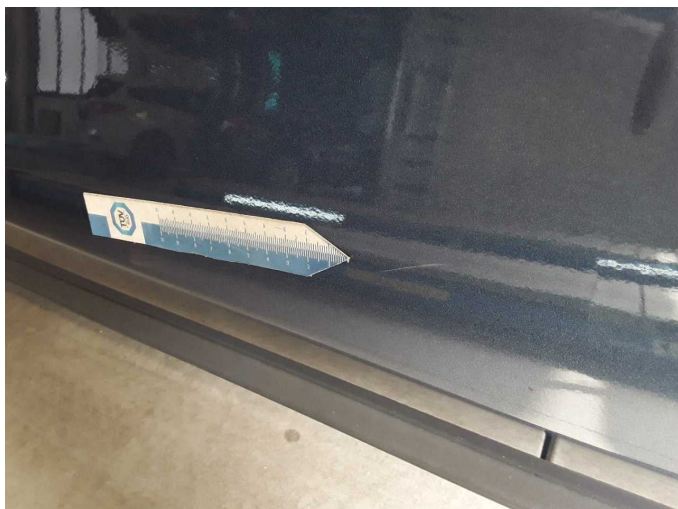
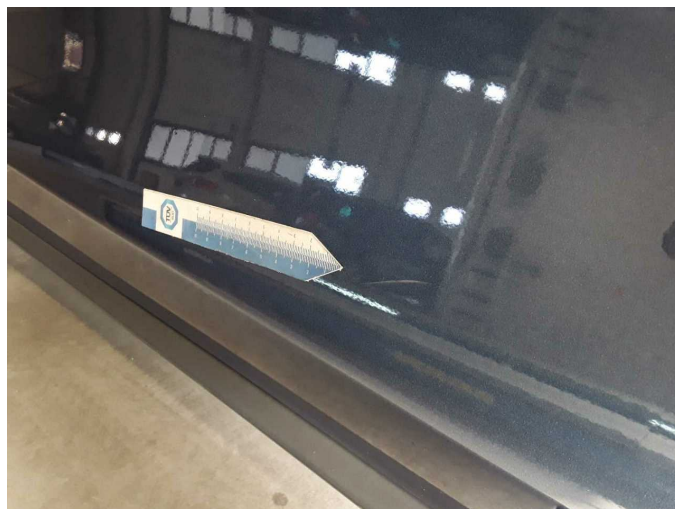
Damage 2: Door - front right side: Door - Scratch(es) - Smart repair

**Damage 2:** Door - front right side: Door - Scratch(es) - Smart repair

| No. | Component group | Description |
|---|---|---|
| 2 | Door - front right side | Door - Scratch(es) - Smart repair |

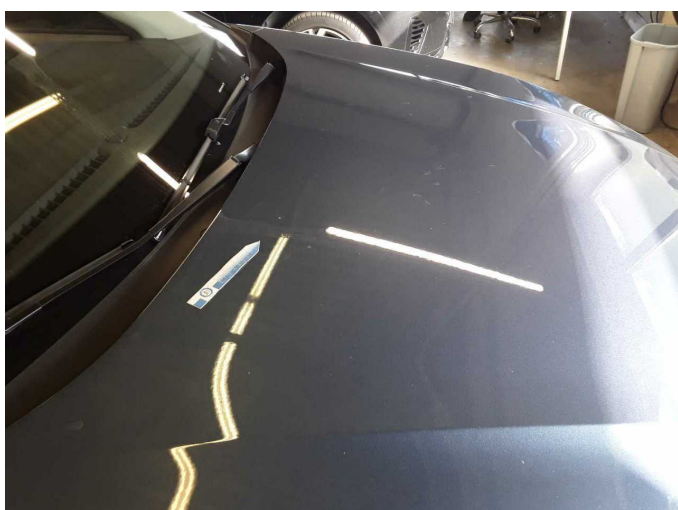
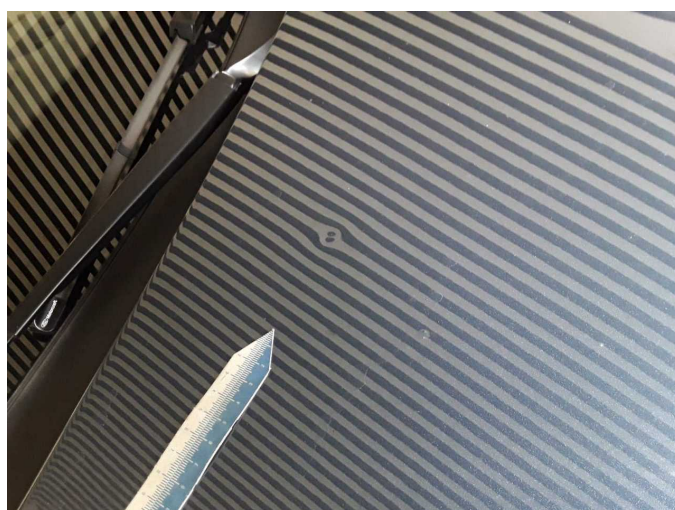
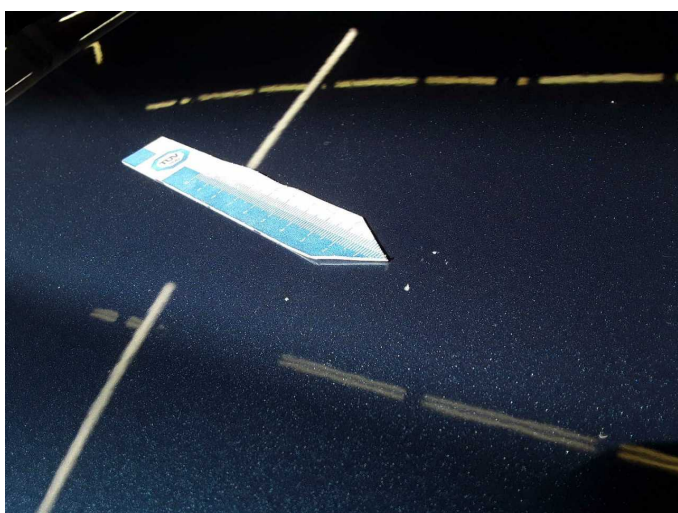
**Damage 3:** Bonnet: Bonnet - Dent / paintcoat damage - Repair and paint

| No. | Component group | Description |
|---|---|---|
| 3 | Bonnet | Bonnet - Dent / paintcoat damage - Repair and paint |

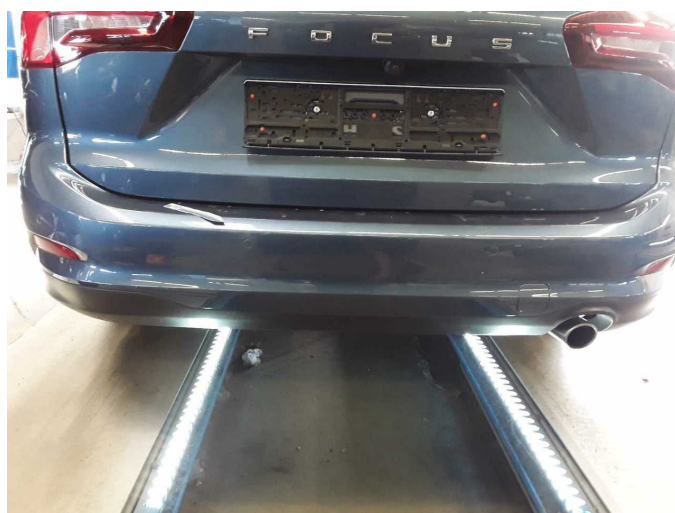
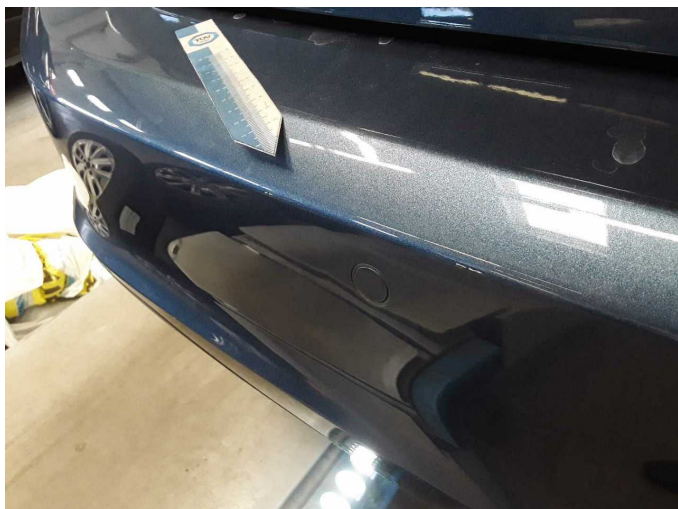
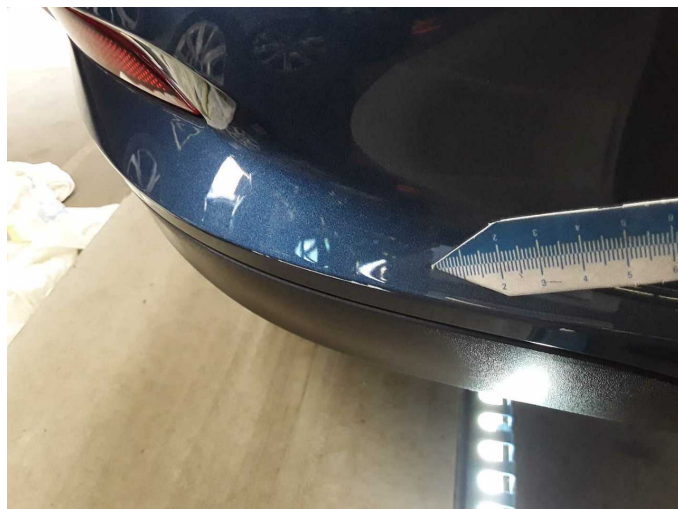
**Damage 4:** Rear bumper: Rear bumper - Scratch(es) - Paint

| No. | Component group | Description |
|---|---|---|
| 4 | Rear bumper | Rear bumper - Scratch(es) - Paint |

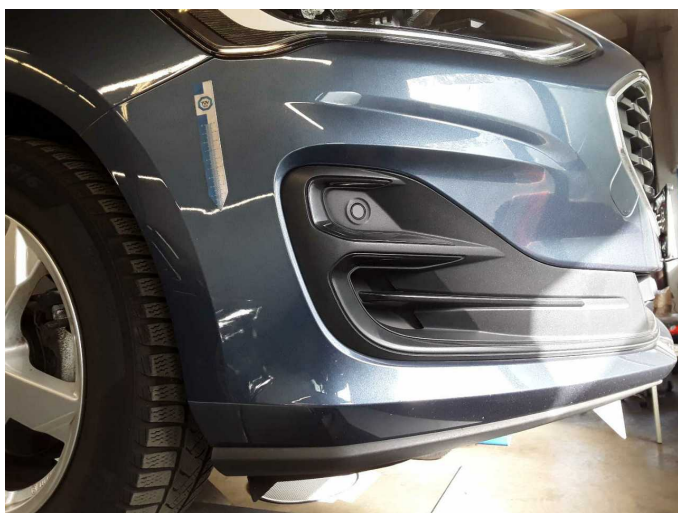
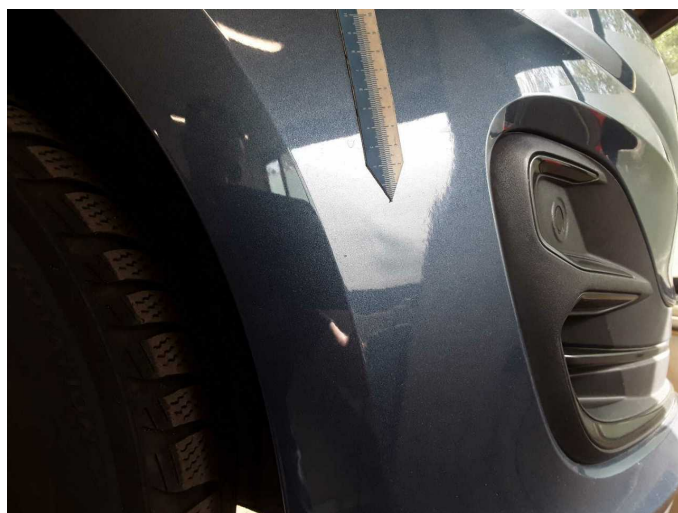
| No. | Component group | Description |
|---|---|---|
| 1 | Front bumper | Front bumper - Stone chips - No deduction |

**Wear and tear 1:** Front bumper: Front bumper - Stone chips - No deduction

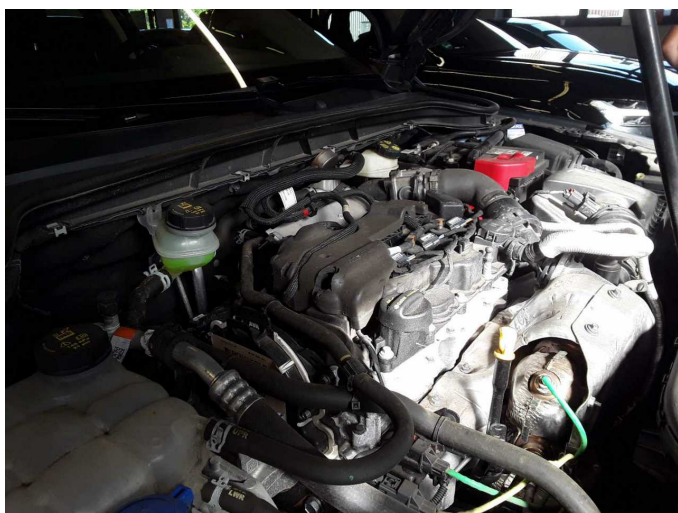
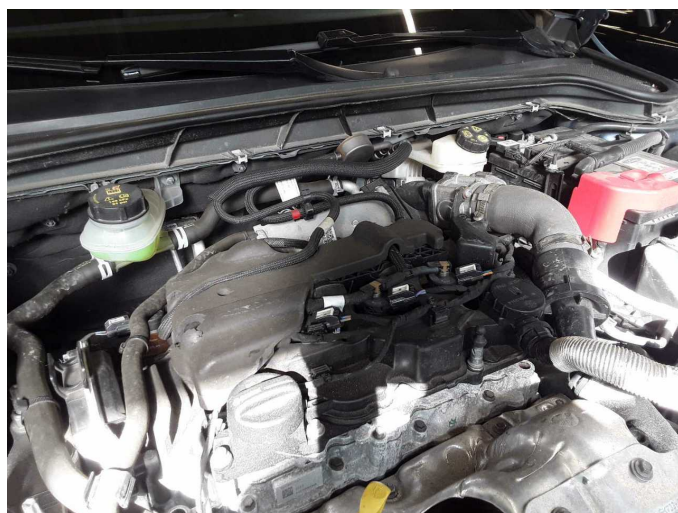
Engine - Engine cover

**Missing part 1:** Engine: Engine cover - Missing - Replace

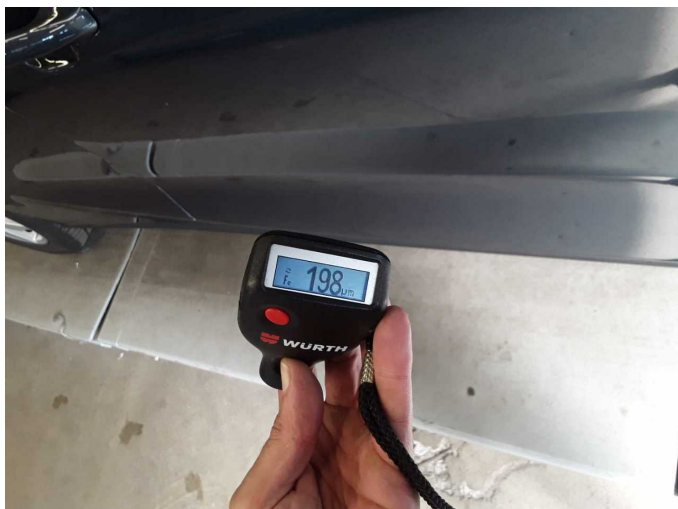
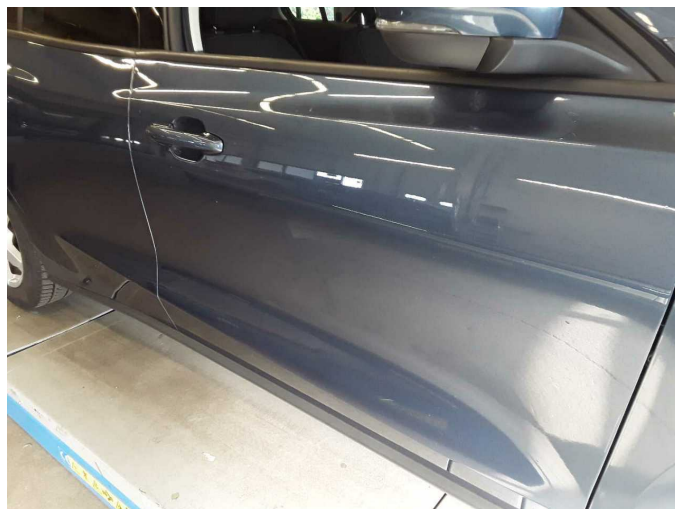
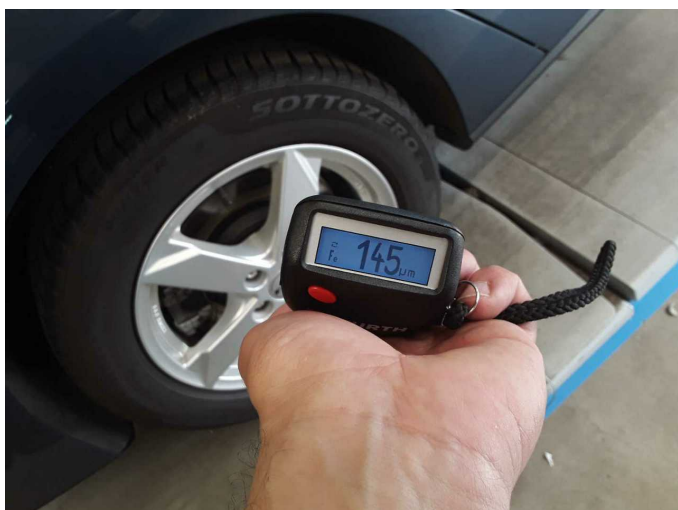
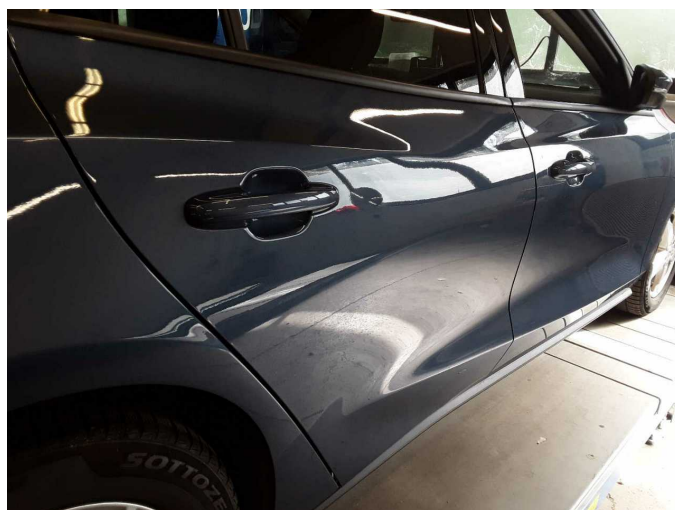
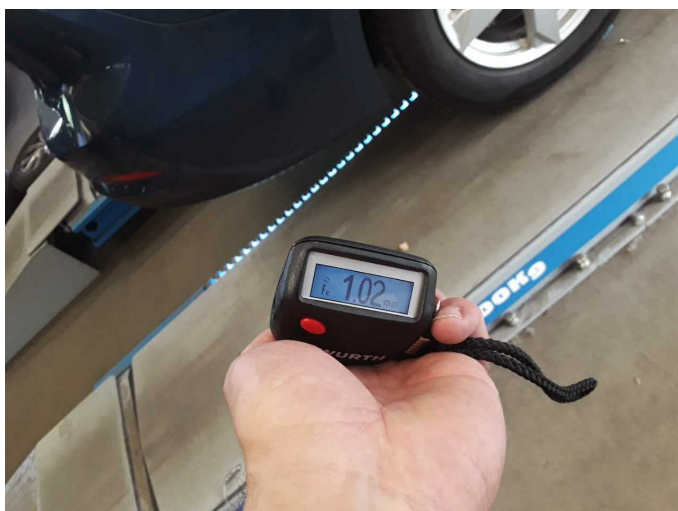
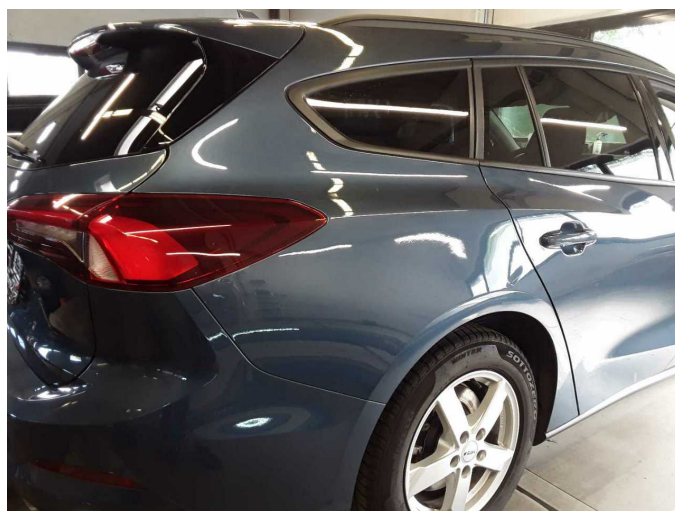
1 Side panel - rear right side, Door - rear right side, Door - front right side, Professionally carried out, Invoice of repair done Non-existent

| Side panel - rear right side | 1,002<br>µm | Door - rear right side | 145 µm |
| Door - front right side | 198 µm | | |

**Repainting 1:** Side panel - rear right side, Door - rear right side, Door - front right side
