Expertise

Protocol number: 46584109  
Order No. / Reference: 26664201  
Inspection date: 17 Jul 2026

Manufacturer: Volkswagen

Model: Passat Variant 2.0 TDI SCR DSG Business

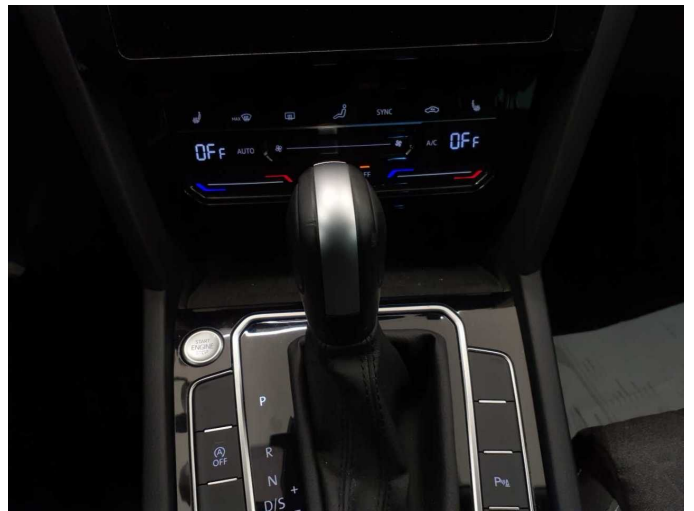
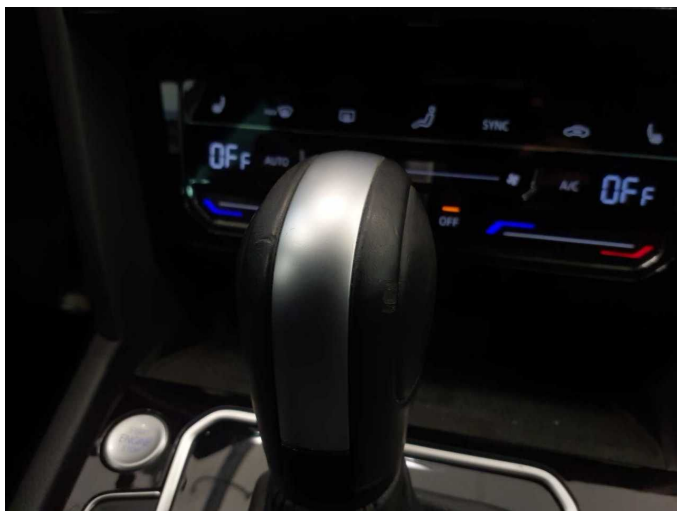
| No. | Component group | Description |
|---|---|---|
| 1 | Gearbox | Gear knob - Abrasion - Loss in value |

Damage 1: Gearbox: Gear knob - Abrasion - Loss in value

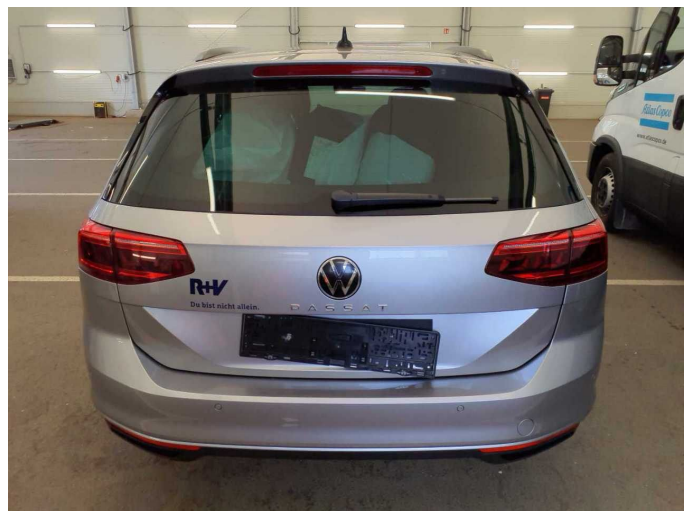
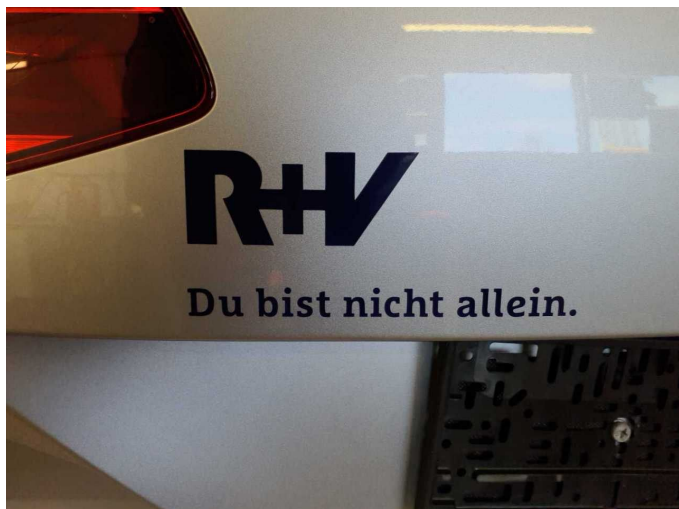
| No. | Component group | Description |
|---|---|---|
| 2 | Boot lid / rear door | Boot lid - Glued / labelled - De-glue / neutralise |

Damage 2: Boot lid / rear door: Boot lid - Glued / labelled - De-glue / neutralise

**Damage 2:** Boot lid / rear door: Boot lid - Glued / labelled - De-glue / neutralise

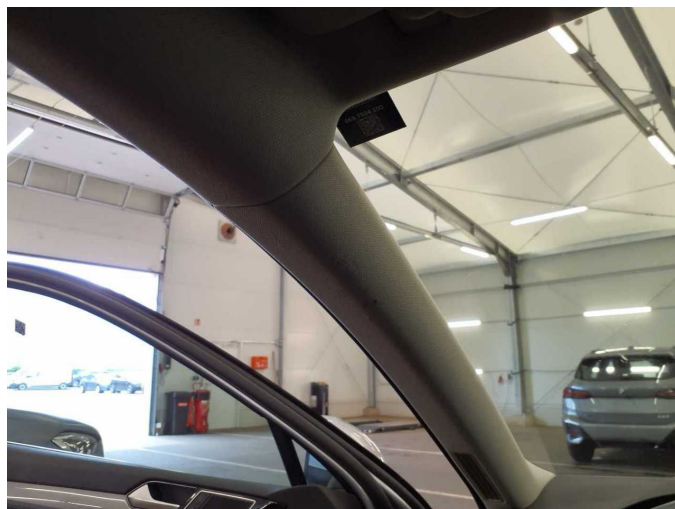
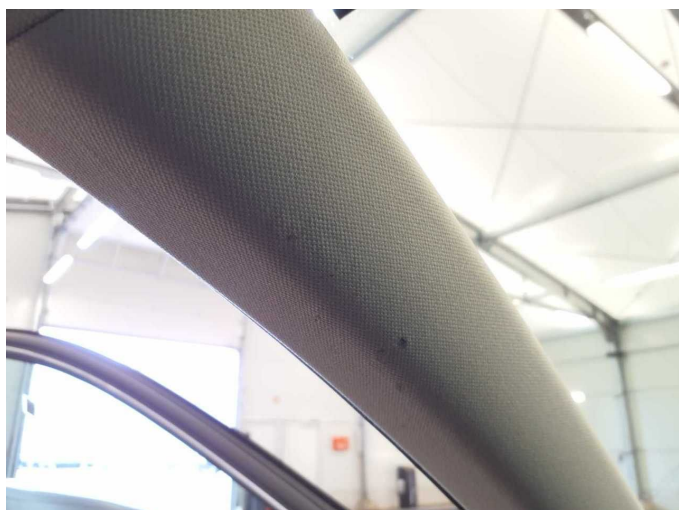
| No. | Component group | Description |
|---|---|---|
| 3 | Trim / covers | Roof lining - Burn hole (cigarettes) - Smart repair |

**Damage 3:** Trim / covers: Roof lining - Burn hole (cigarettes) - Smart repair

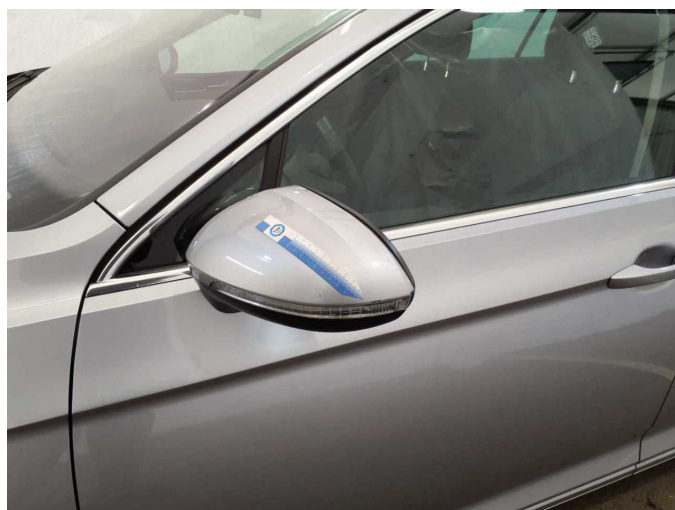
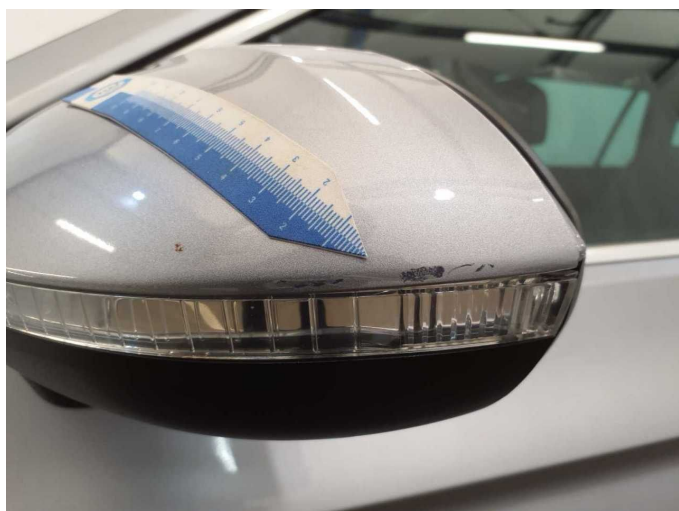
| No. | Component group | Description |
|---|---|---|
| 4 | Wing mirror - left side | Cap - Scratch(es) - Smart repair |

**Damage 4:** Wing mirror - left side: Cap - Scratch(es) - Smart repair

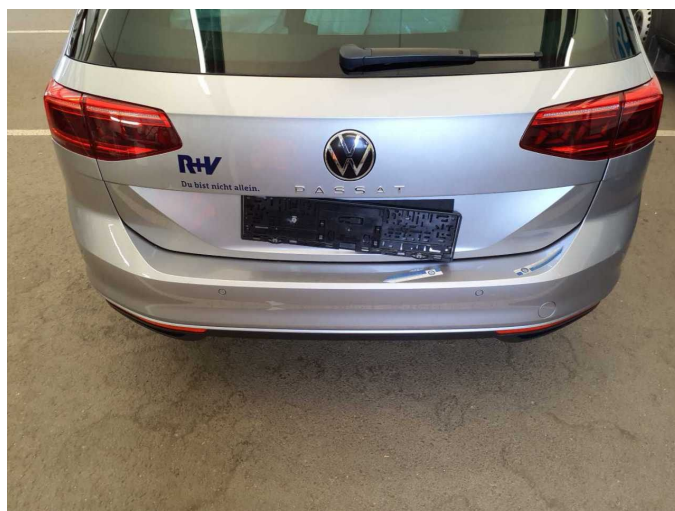
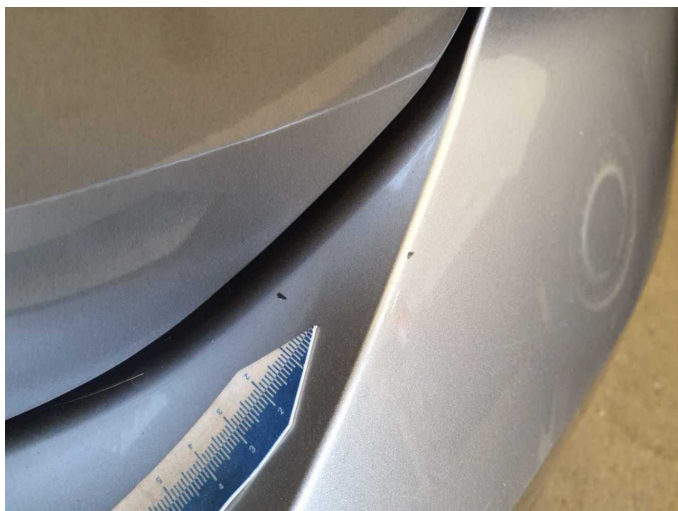
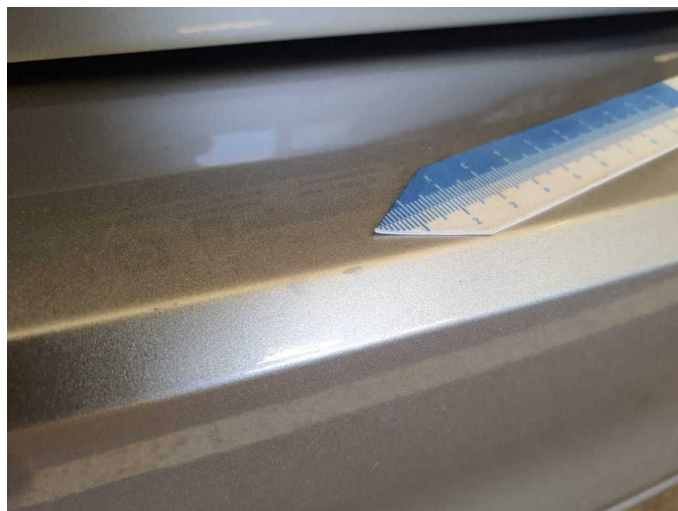
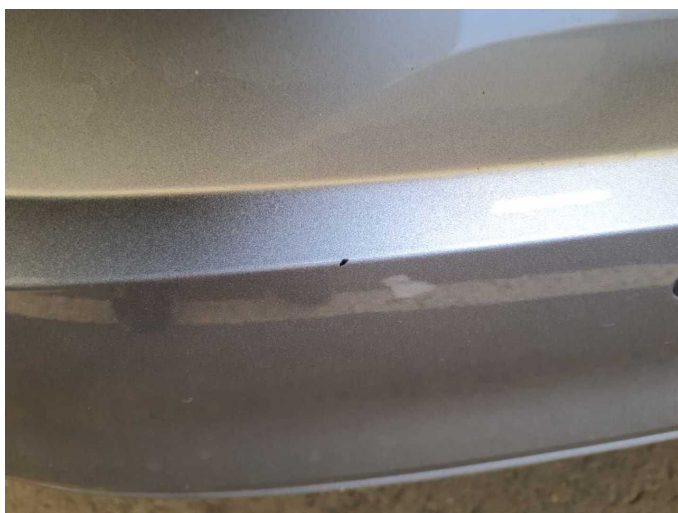
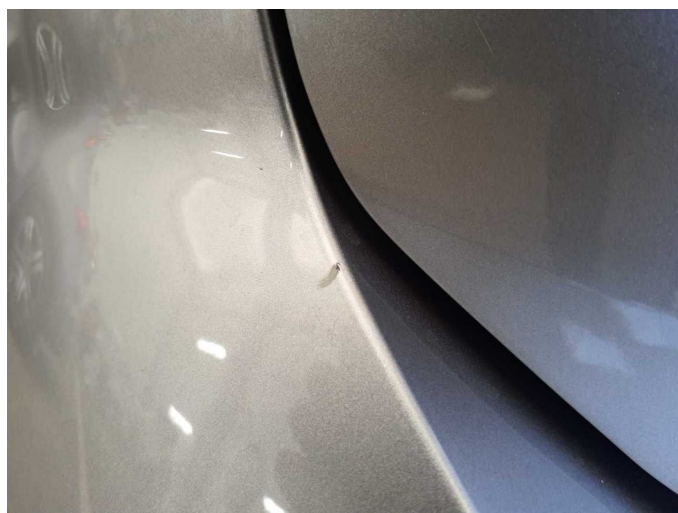
| No. | Component group | Description |
|---|---|---|
| 5 | Rear bumper | Rear bumper - Scratch(es) - Smart repair |

**Damage 5:** Rear bumper: Rear bumper - Scratch(es) - Smart repair

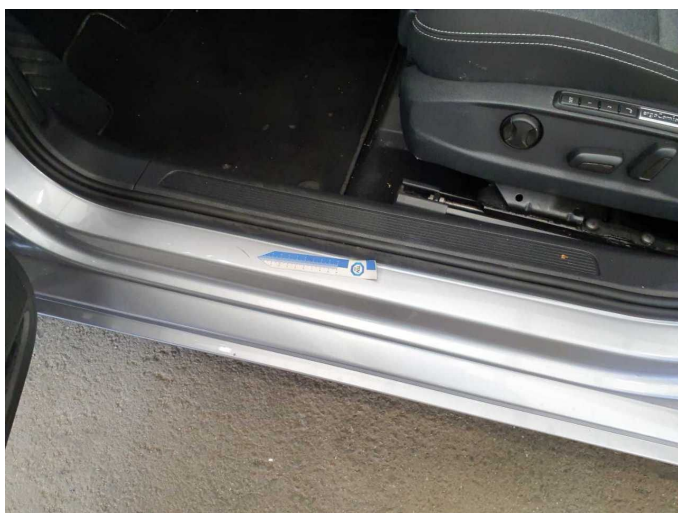
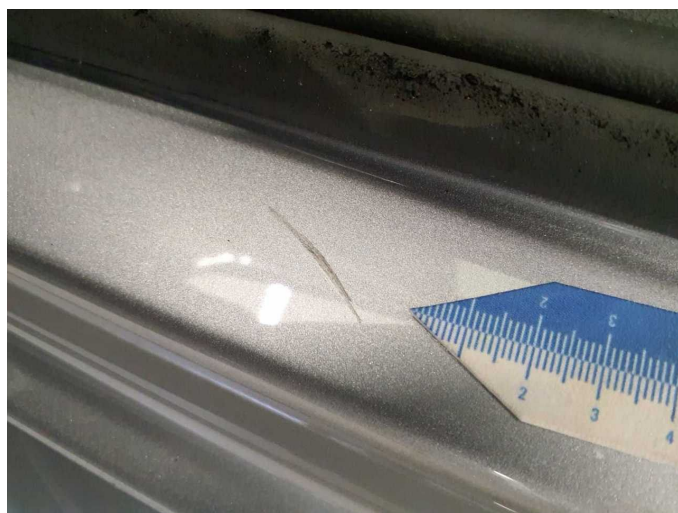
| No. | Component group | Description |
|---|---|---|
| 6 | Sill - left side | Sill - Scratch(es) - Smart repair |

**Damage 6:** Sill - left side: Sill - Scratch(es) - Smart repair

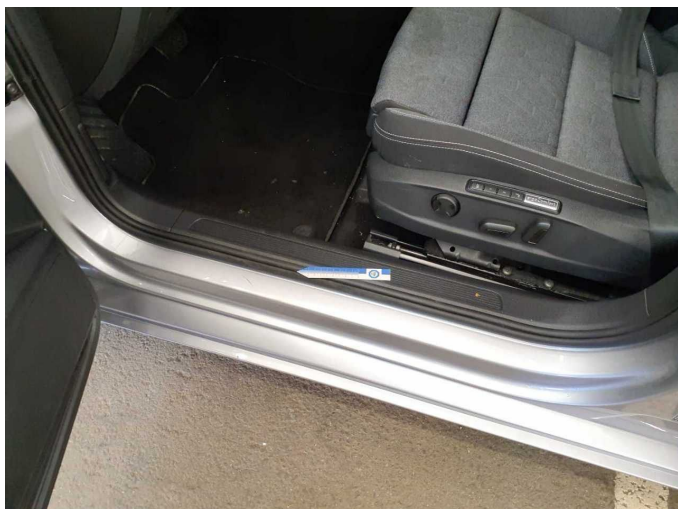
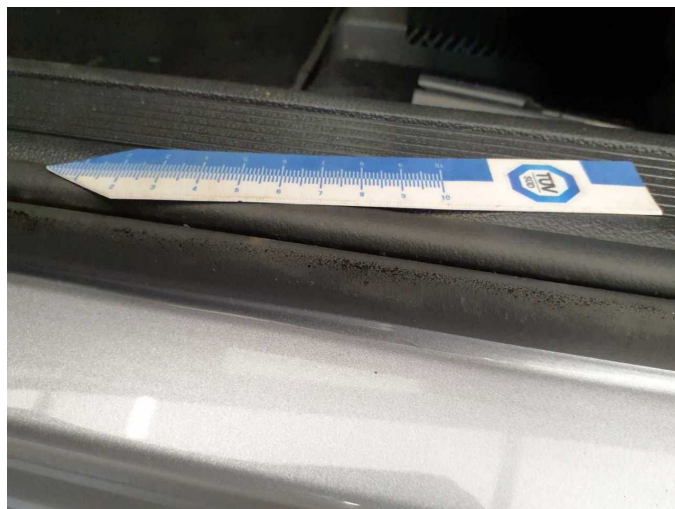
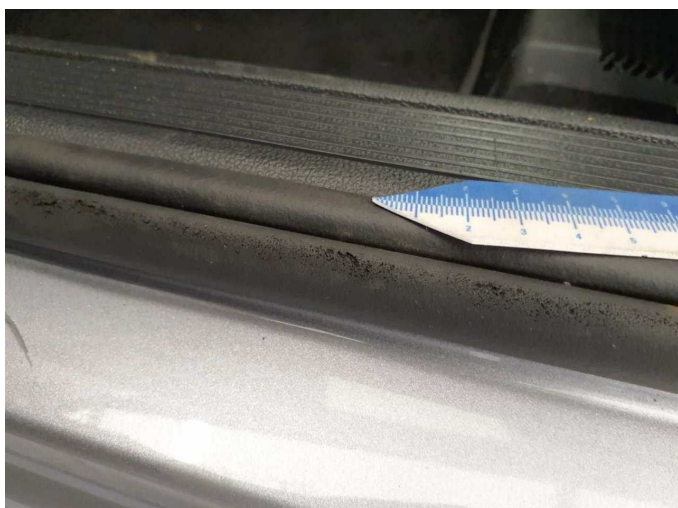
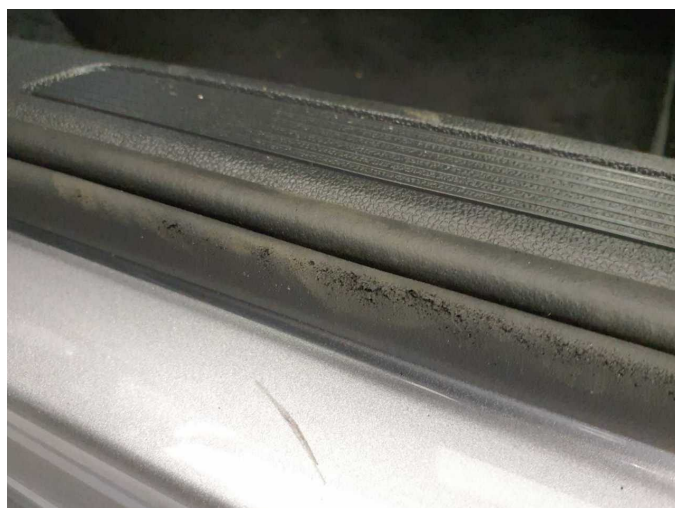
| No. | Component group | Description |
|---|---|---|
| 8 | Door - front left side | Door seal - Porous / cracked - Replace |

**Damage 8:** Door - front left side: Door seal - Porous / cracked - Replace

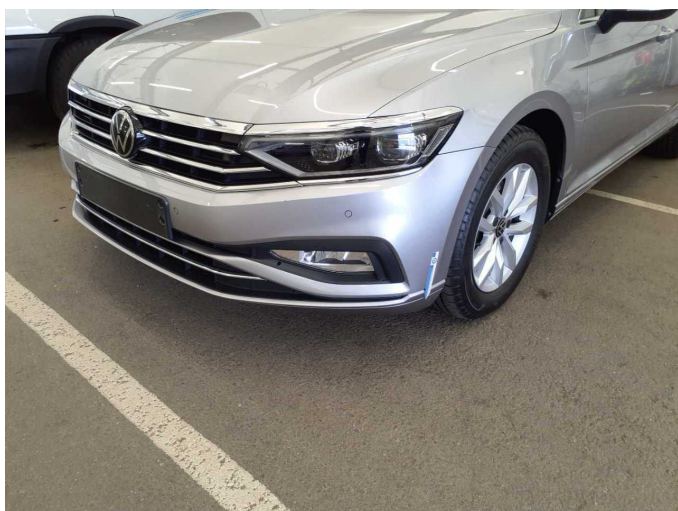
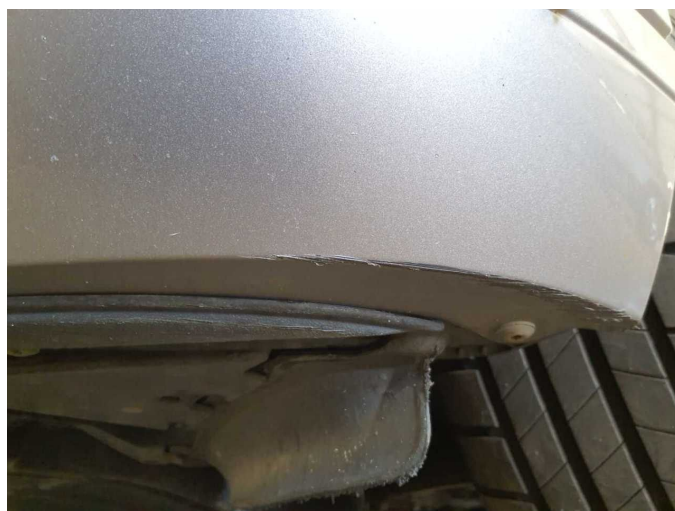
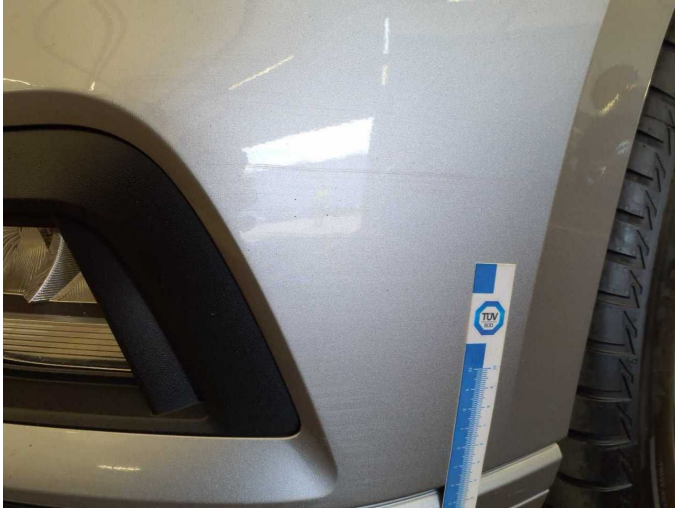
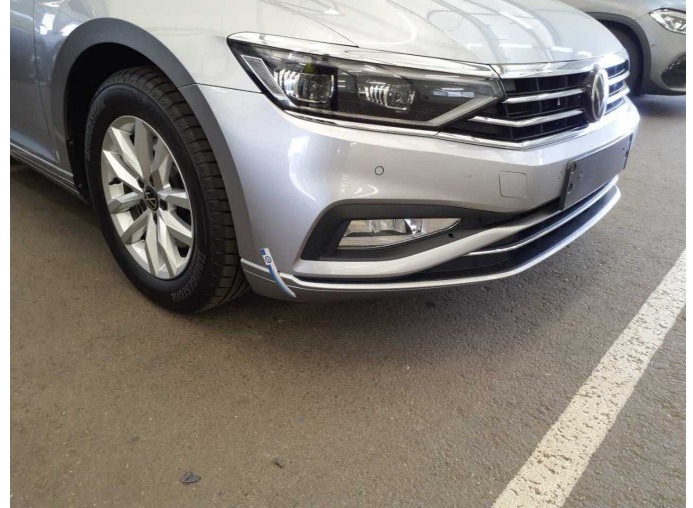
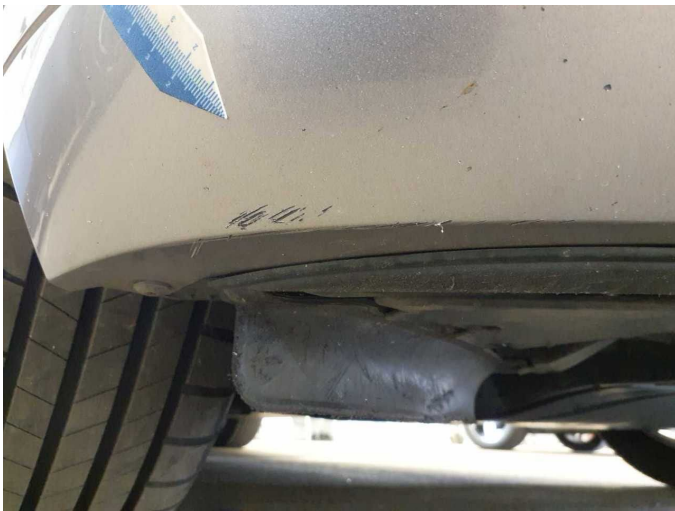
| No. | Component group | Description |
|---|---|---|
| 9 | Front bumper | Front bumper - Scratch(es) - Paint |

**Damage 9:** Front bumper: Front bumper - Scratch(es) - Paint
