Expertise

Protocol number: 46259248  
Order No. / Reference: 26598668  
Inspection date: 1 Jul 2026

Manufacturer: Skoda  
VIN: TMBAJ0NX6MY156395

Model: Octavia 2.0 TDI DSG Style

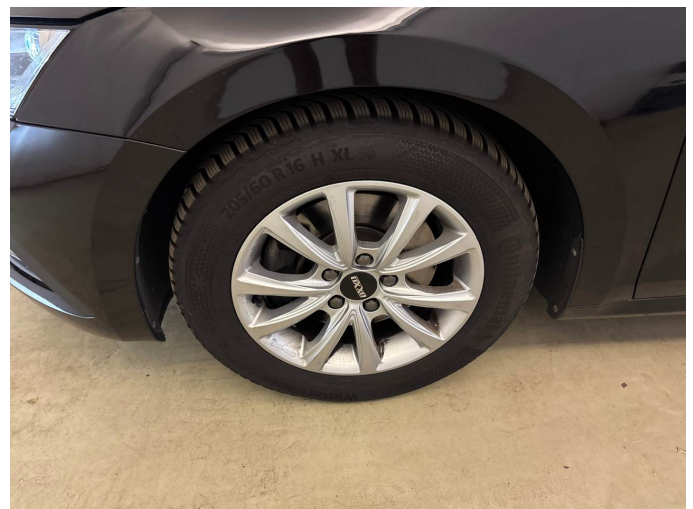
| # | Tyre size | Type of tyre | Manufacturer | Tread depth |
|---|---|---|---|---|
| 1) | 205/60 R16 96H | Winter tyres on Light alloy | Continental | 5mm / 5mm |
| 2) | 205/60 R16 96H | Winter tyres on Light alloy | Continental | 5mm / 5mm |

Figure 12: Mounted tyres

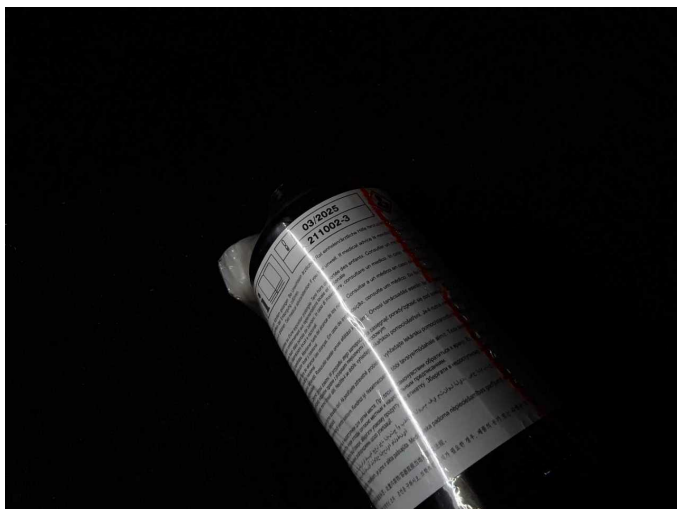
| No. | Component group | Description |
|---|---|---|
| 1 | Equipment | Tirefit filler - Expired - Replace |

Damage 1: Equipment: Tirefit filler - Expired - Replace

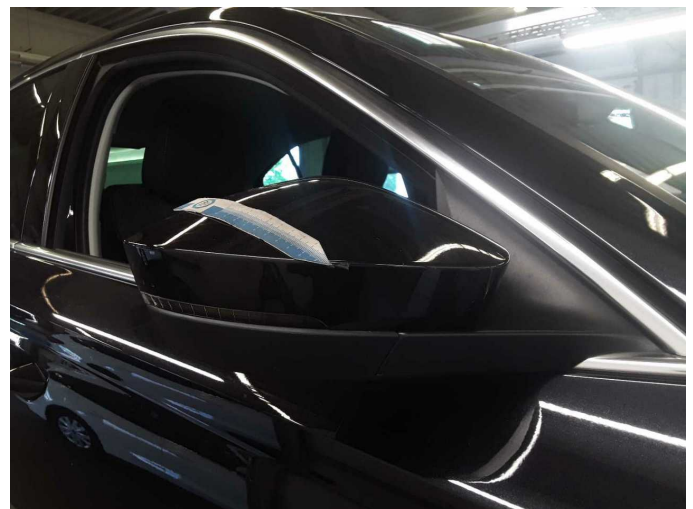
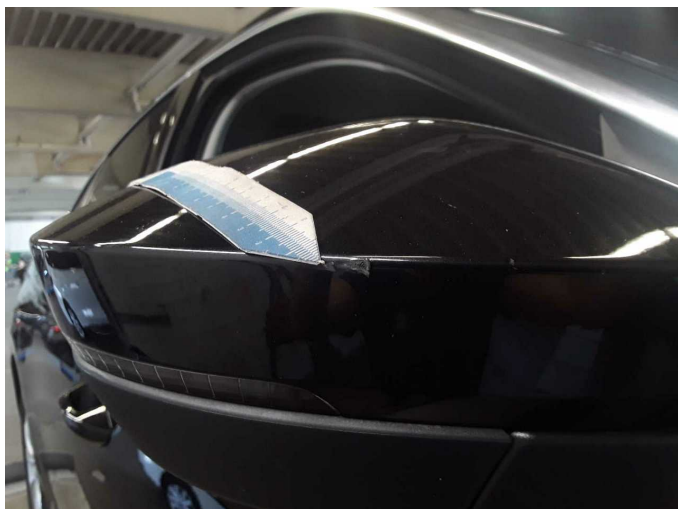
| No. | Component group | Description |
|---|---|---|
| 2 | Wing mirror - right side | Cap - Scratch(es) - Smart repair |

Damage 2: Wing mirror - right side: Cap - Scratch(es) - Smart repair

**Damage 2:** Wing mirror - right side: Cap - Scratch(es) - Smart repair

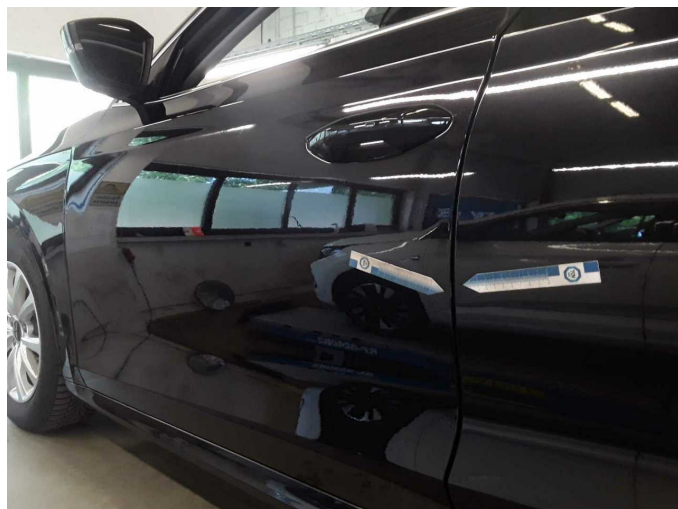
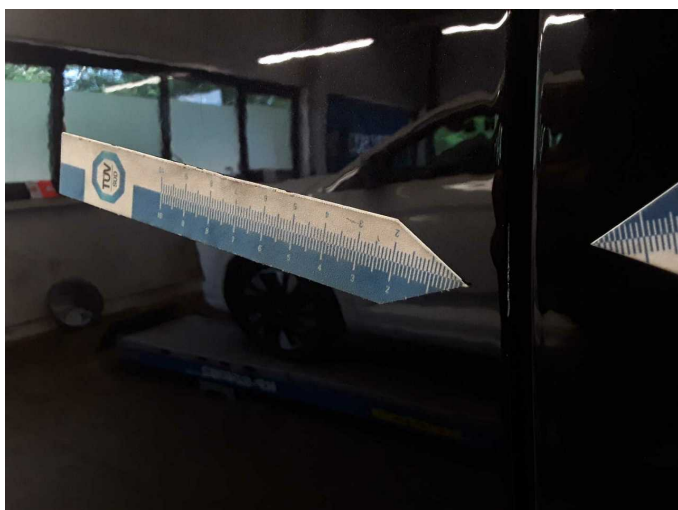
| No. | Component group | Description |
|---|---|---|
| 3 | Door - front left side | Door - Scratch(es) - Smart repair |

**Damage 3:** Door - front left side: Door - Scratch(es) - Smart repair

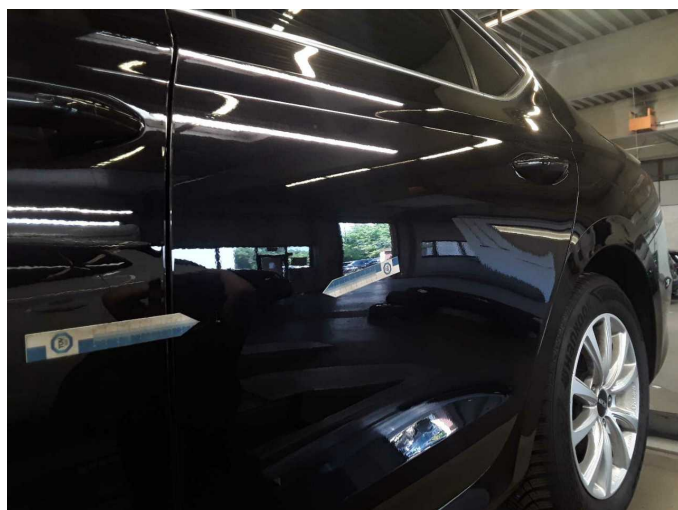
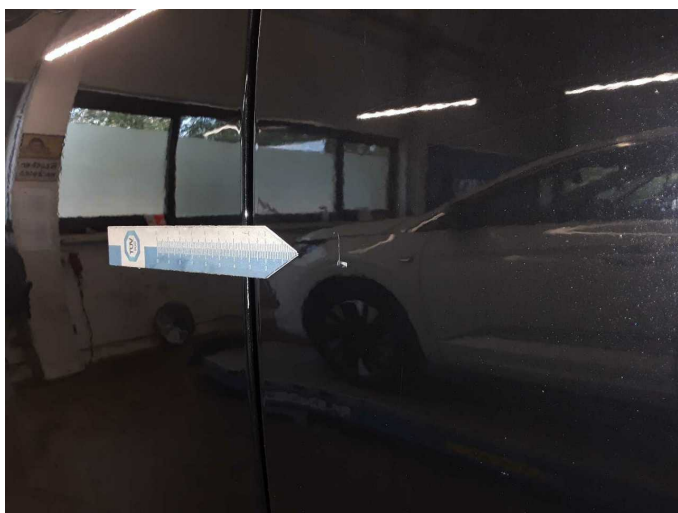
| No. | Component group | Description |
|---|---|---|
| 5 | Door - rear left side | Door - Scratch(es) - Paint |

**Damage 5:** Door - rear left side: Door - Scratch(es) - Paint

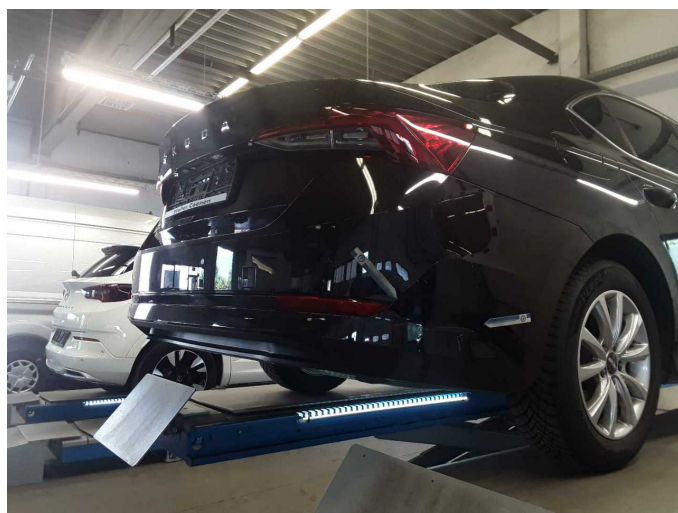
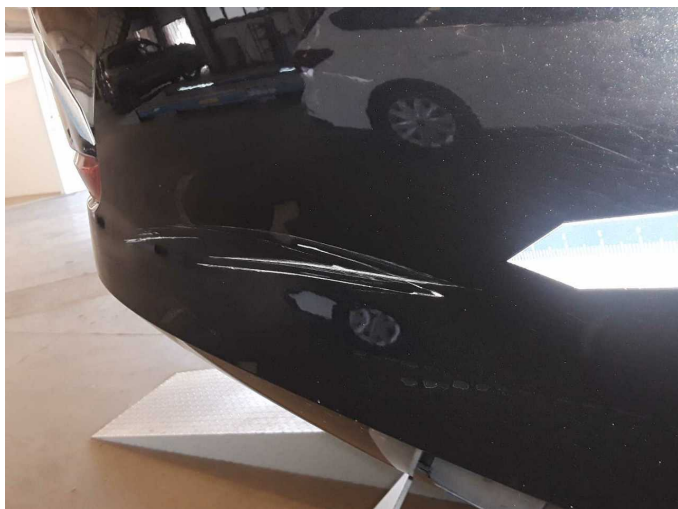
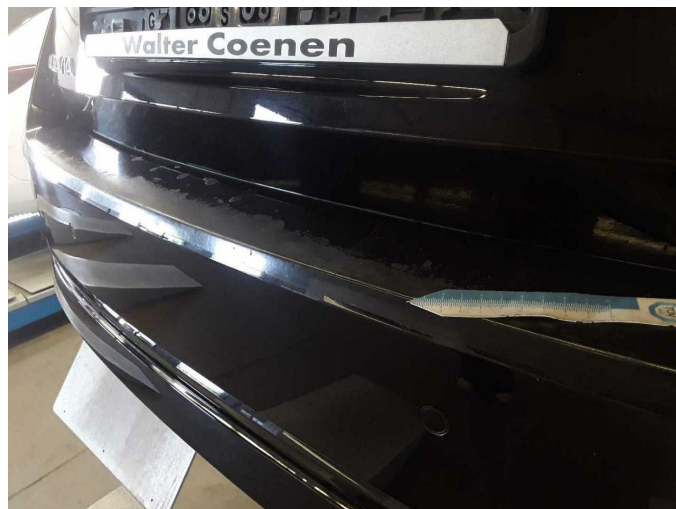
| No. | Component group | Description |
|---|---|---|
| 6 | Rear bumper | Rear bumper - Scratch(es) - Paint |

**Damage 6:** Rear bumper: Rear bumper - Scratch(es) - Paint

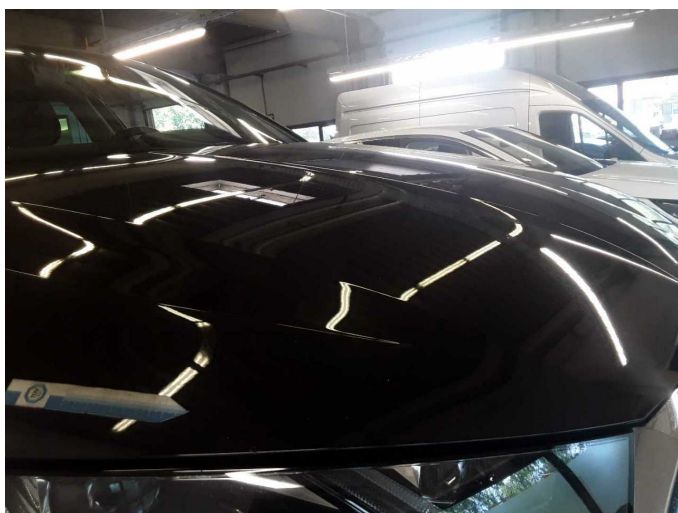
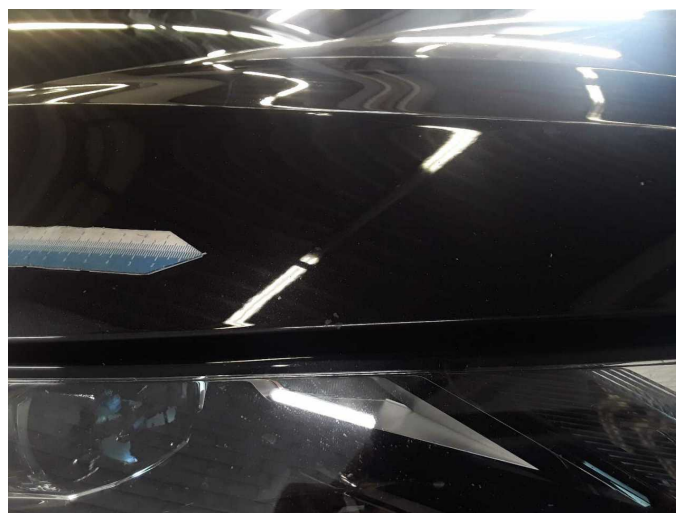
| No. | Component group | Description |
|---|---|---|
| 1 | Bonnet | Bonnet - Stone chips - No deduction |

**Wear and tear 1:** Bonnet: Bonnet - Stone chips - No deduction

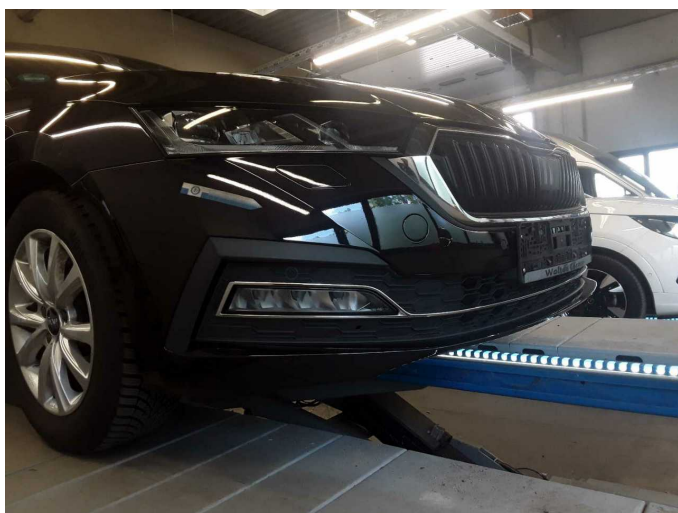
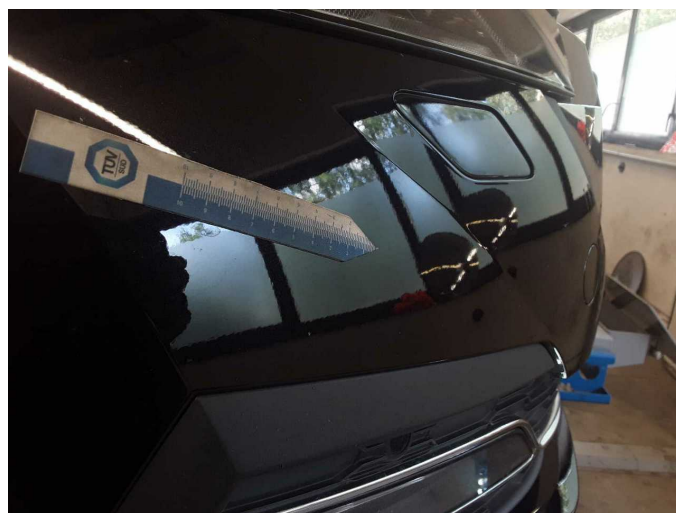
| No. | Component group | Description |
|---|---|---|
| 2 | Front bumper | Front bumper - Stone chips - No deduction |

**Wear and tear 2:** Front bumper: Front bumper - Stone chips - No deduction

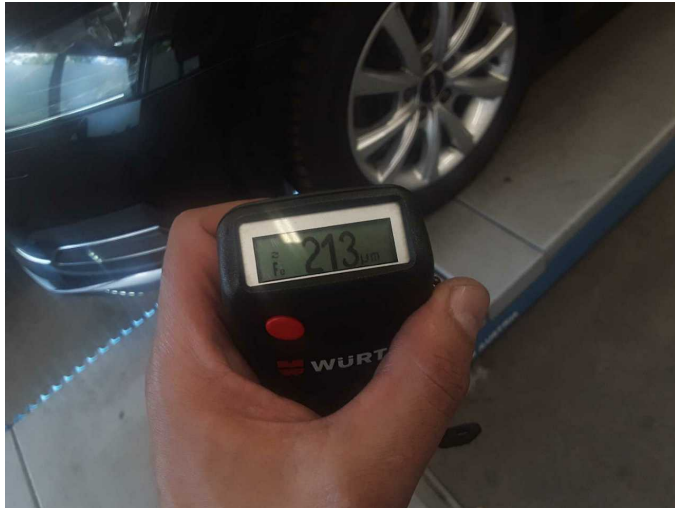
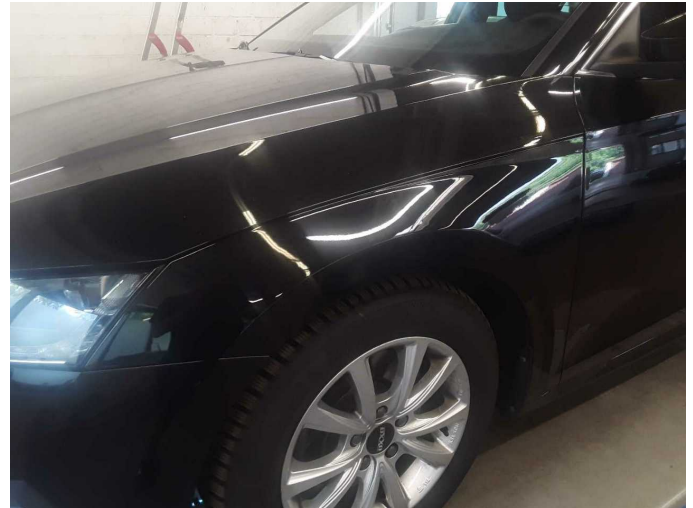
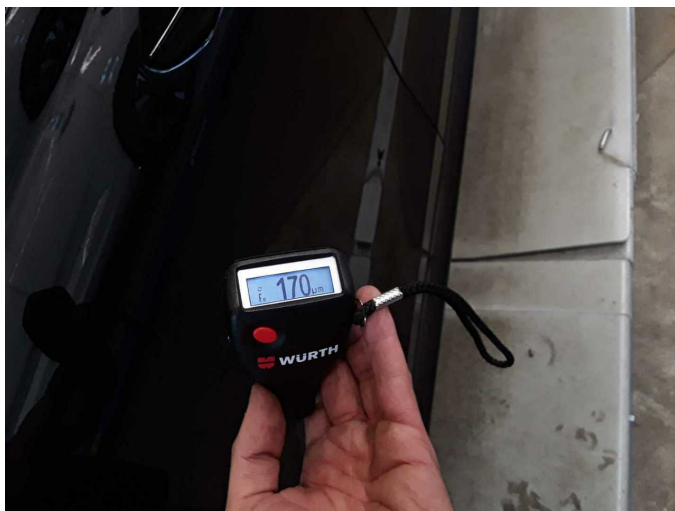
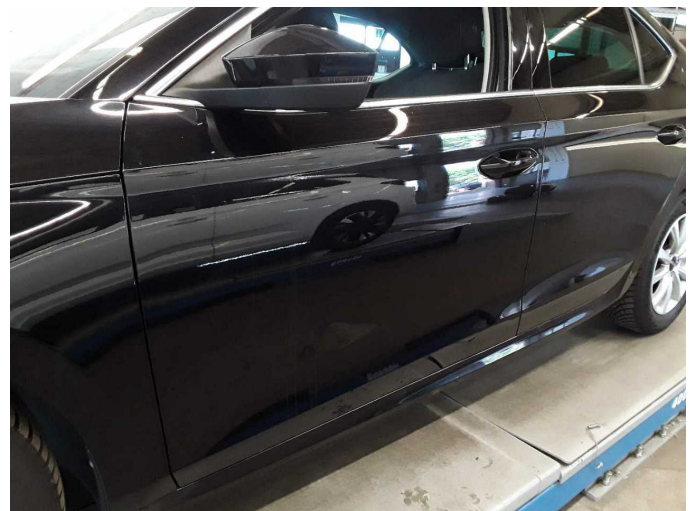
1 Mudguard - left side, Door - front left side, Professionally carried out, Invoice of repair done Non-existent

**Repainting 1:** Mudguard - left side, Door - front left side
