Expertise

Protocol number: 46139472  
Order No. / Reference: 26329210  
Inspection date: 24 Jun 2026

Manufacturer: Skoda  
VIN: TMBJW7NP8M7044309

Model: Superb Combi 1.4 TSI iV DSG L&K

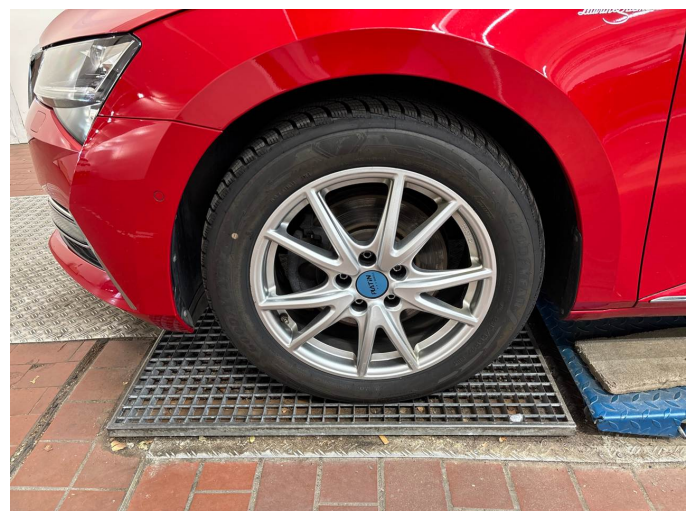
| Tyres | | | | |
|---|---|---|---|---|
| 1) | 215/55 R17 98V | Winter tyres on Light alloy | Goodyear | 5mm / 5mm |
| 2) | 215/55 R17 98V | Winter tyres on Light alloy | Goodyear | 6mm / 6mm |

Figure 12: Mounted tyres

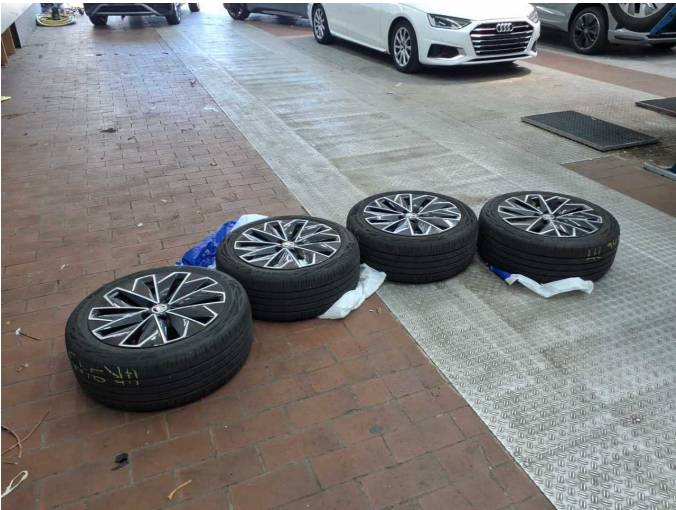
| Tyres | | | | |
|---|---|---|---|---|
| 1) | 235/45 R18 94W | Summer tyres on Light alloy | Continental | 5mm / 5mm |
| 2) | 235/45 R18 94W | Summer tyres on Light alloy | Continental | 6mm / 6mm |

Figure 17: Additional tyres

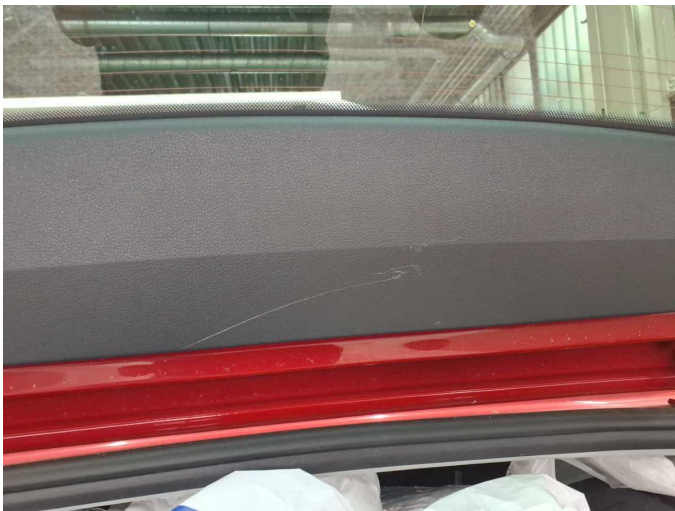
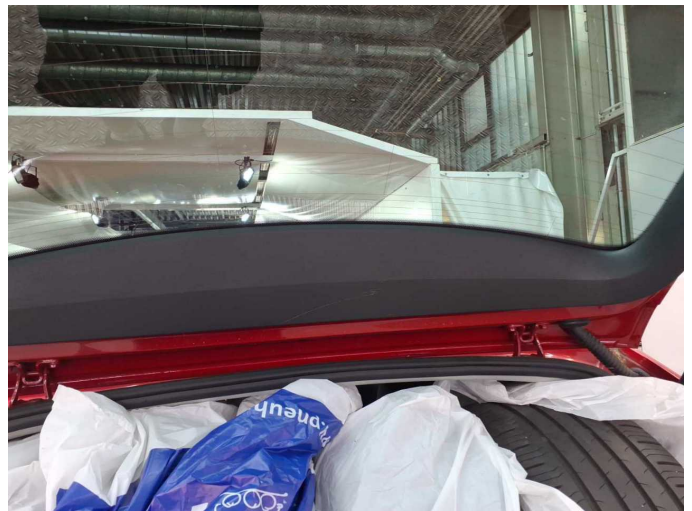
**Damage 1:** Trim / covers: Boot lid - interior trim - Scratch(es) - Loss in value

| No. | Component group | Description |
|---|---|---|
| 1 | Trim / covers | Boot lid - interior trim - Scratch(es) - Loss in value |

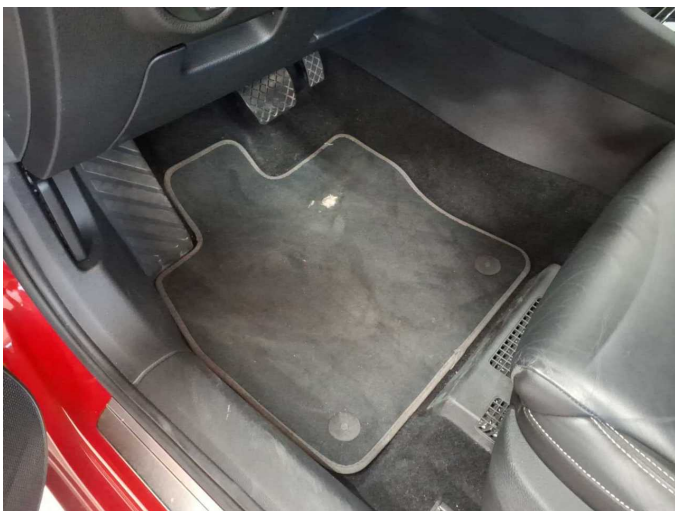
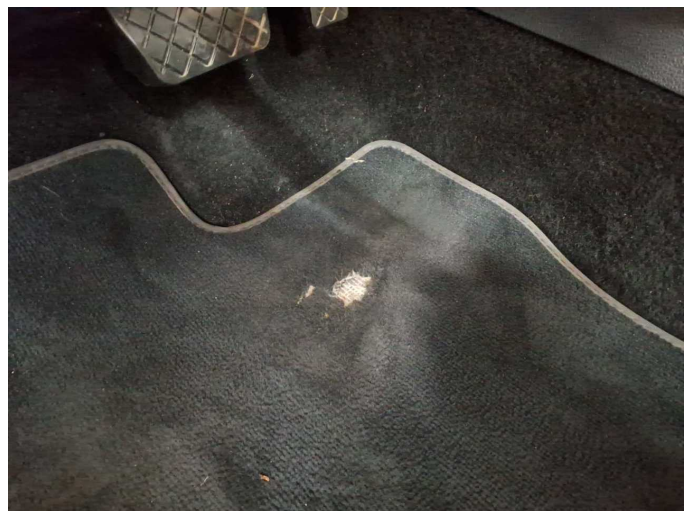
**Damage 2:** Trim / covers: Floor mats - Holes - Replace

| No. | Component group | Description |
|---|---|---|
| 2 | Trim / covers | Floor mats - Holes - Replace |

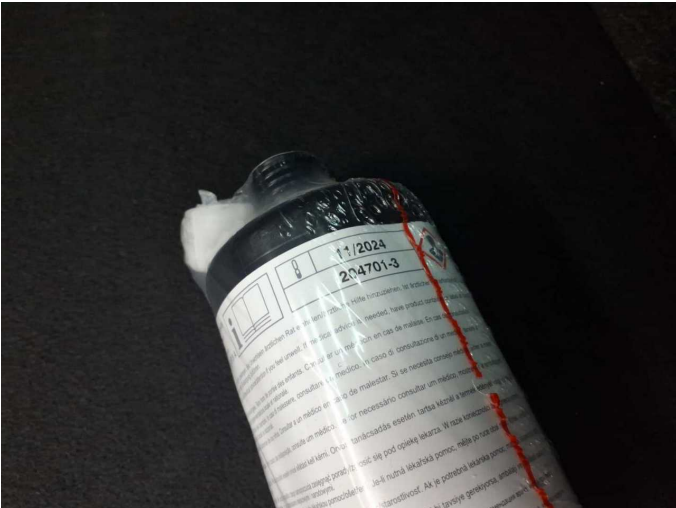
Damage 3: Equipment: Tirefit filler - Expired - Replace

| No. | Component group | Description |
|---|---|---|
| 3 | Equipment | Tirefit filler - Expired - Replace |

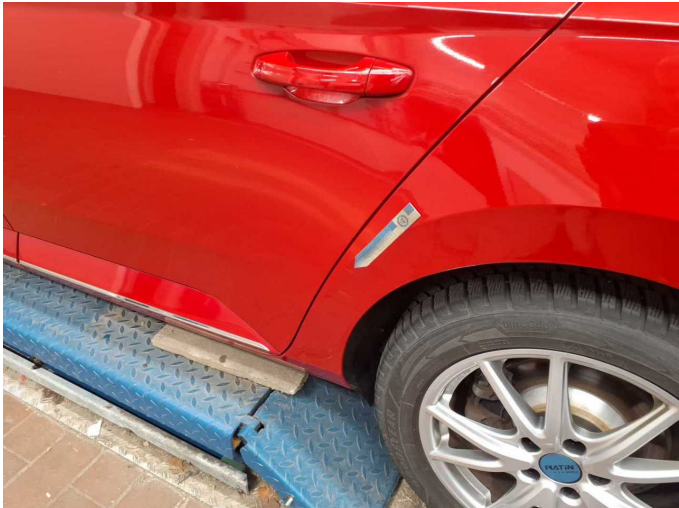
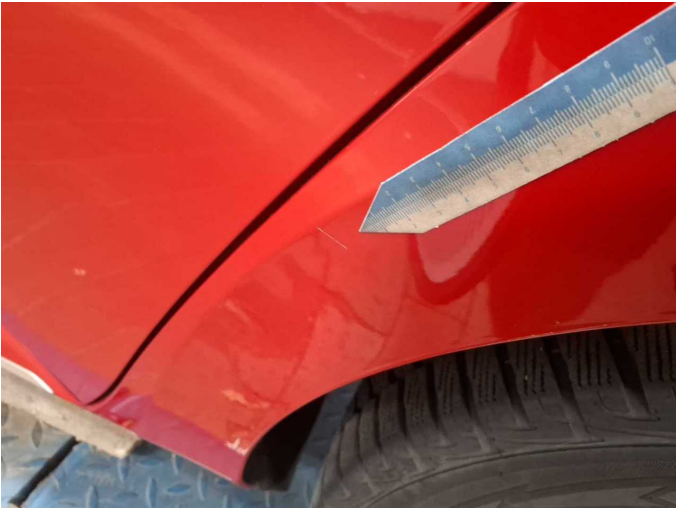
Damage 4: Side panel - rear left side: Side panel - Scratch(es) - Smart repair

| No. | Component group | Description |
|---|---|---|
| 4 | Side panel - rear left side | Side panel - Scratch(es) - Smart repair |

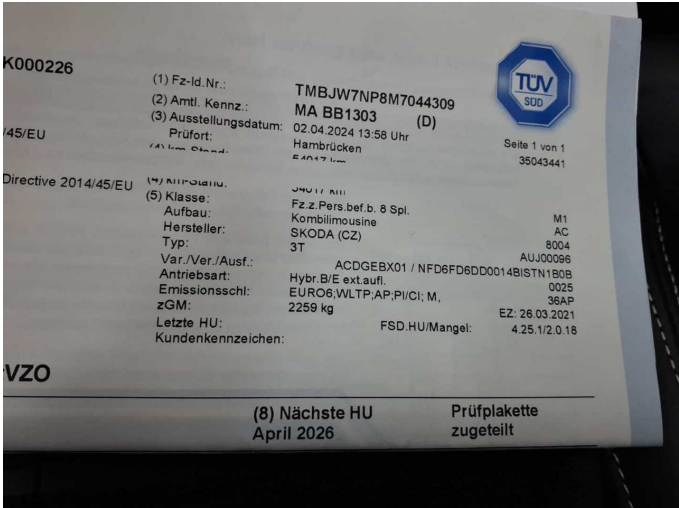
Damage 5: Misc.: Main inspection - Due - Perform

| No. | Component group | Description |
|---|---|---|
| 5 | Misc. | Main inspection - Due - Perform |

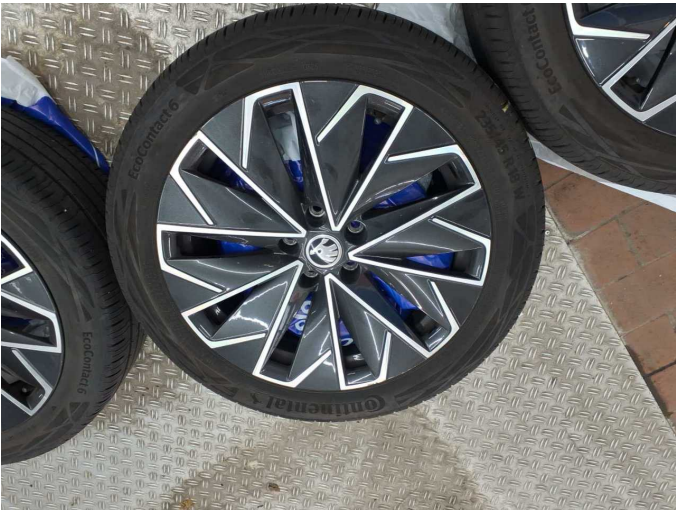
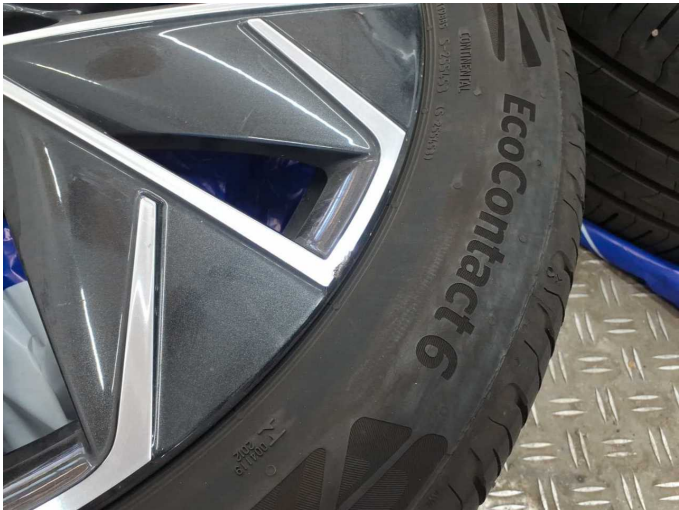
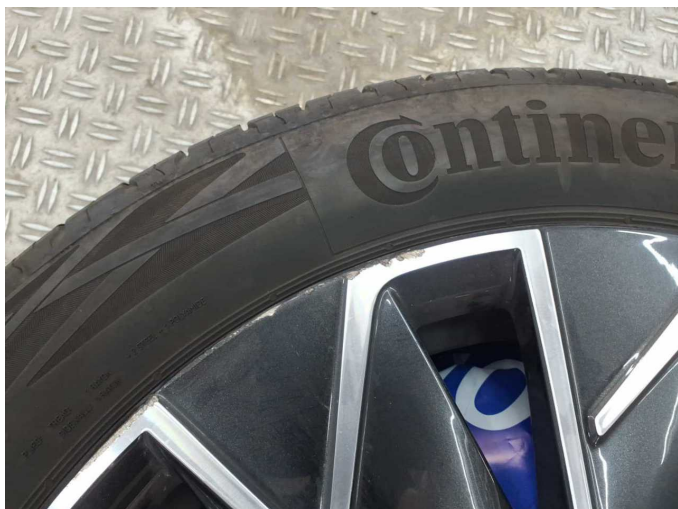
Damage 6: 2nd wheel set: 1 alloy rim - Scratch(es) - Loss in value

**Damage 6:** 2nd wheel set: 1 alloy rim - Scratch(es) - Loss in value

| No. | Component group | Description |
|---|---|---|
| 6 | 2nd wheel set | 1 alloy rim - Scratch(es) - Loss in value |

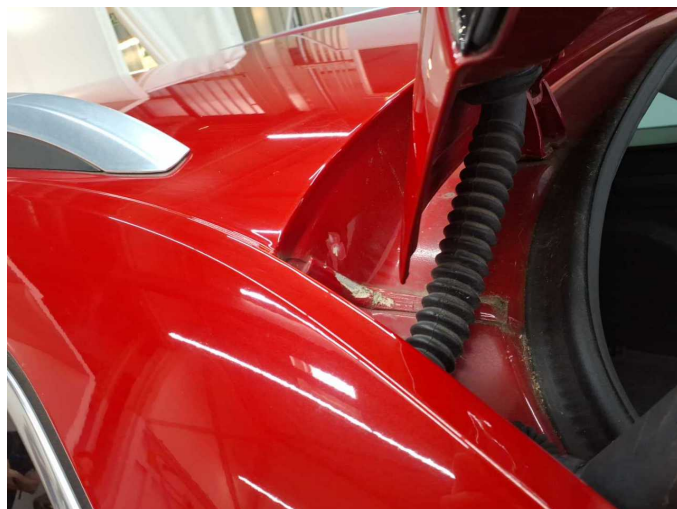
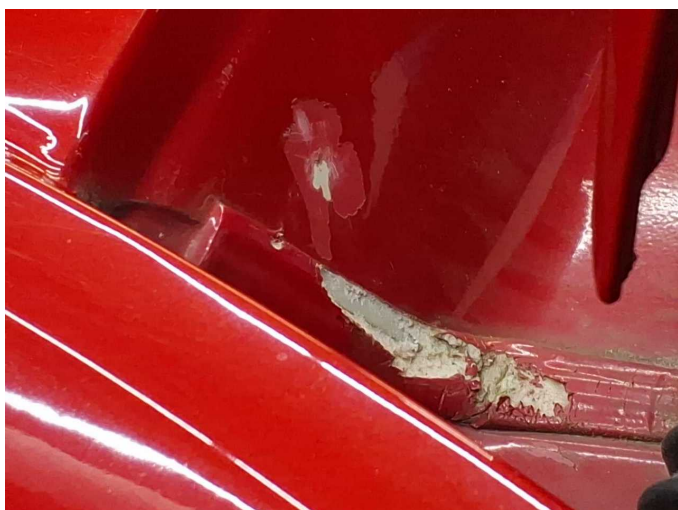
**Damage 7:** Roof: Roof - Scratched - Smart repair

| No. | Component group | Description |
|---|---|---|
| 7 | Roof | Roof - Scratched - Smart repair |

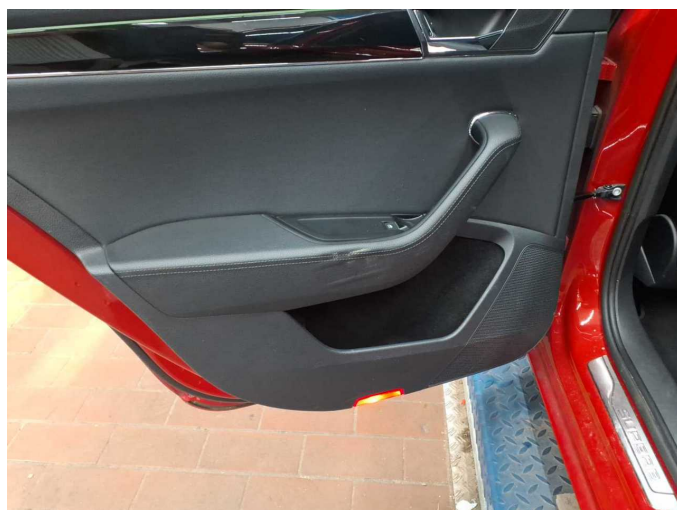
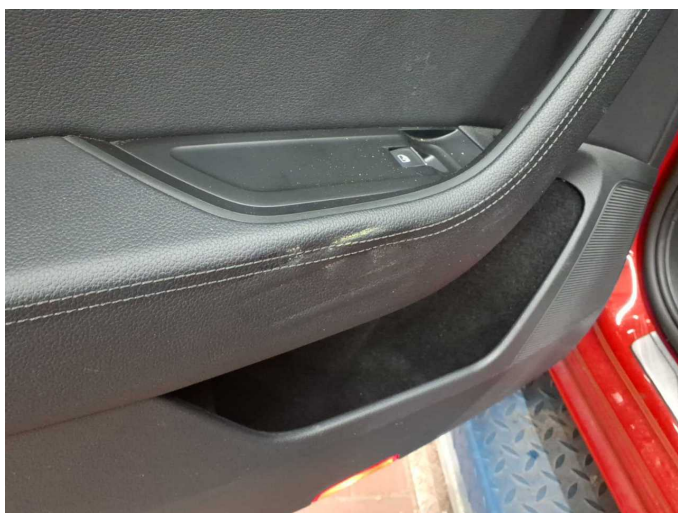
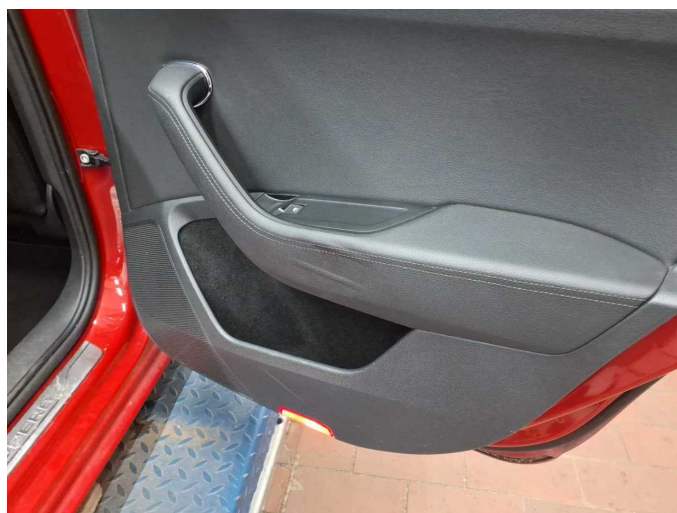
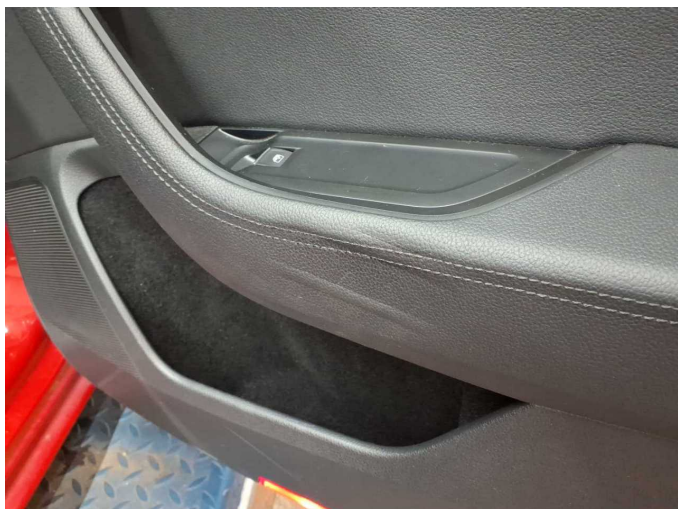
**Damage 8:** Trim / covers: Door trim - rear right side (Und links) - Deformed - Loss in value

| No. | Component group | Description |
|---|---|---|
| 8 | Trim / covers | Door trim - rear right side (Und links) - Deformed - Loss in value |

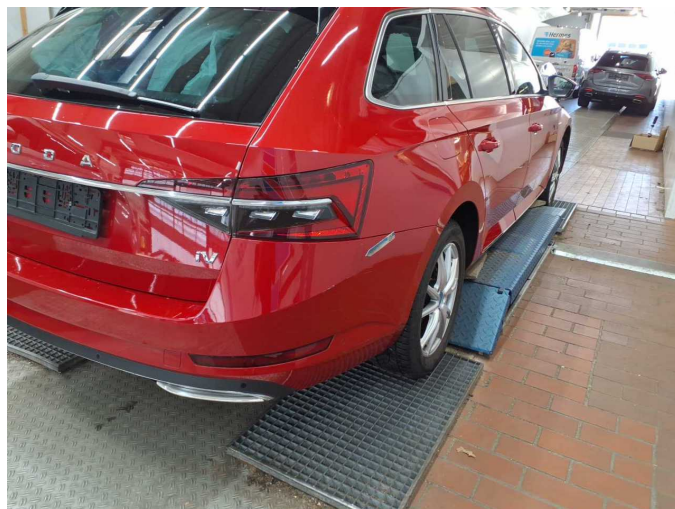
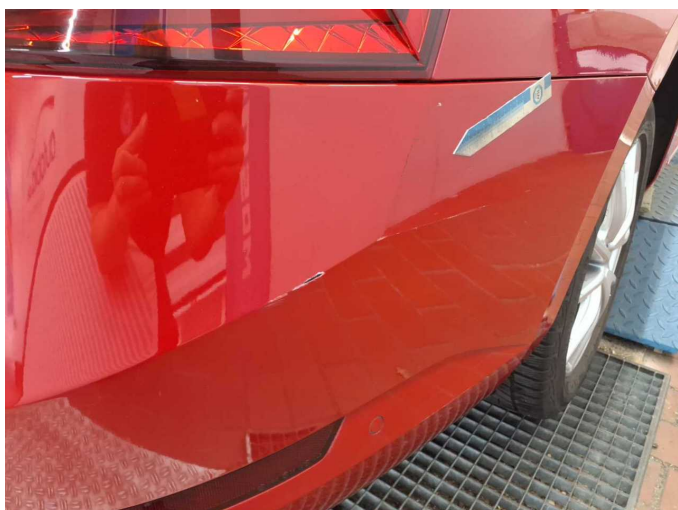
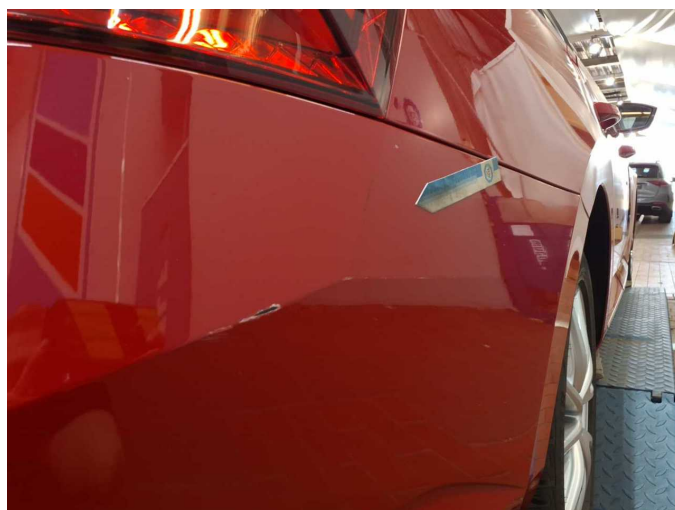
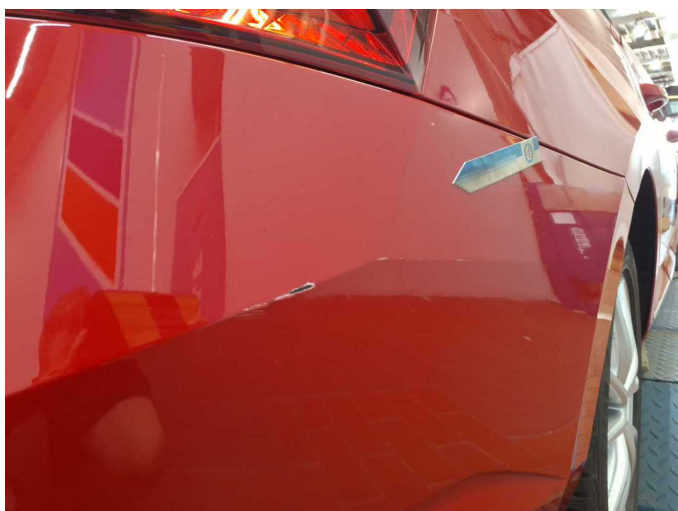
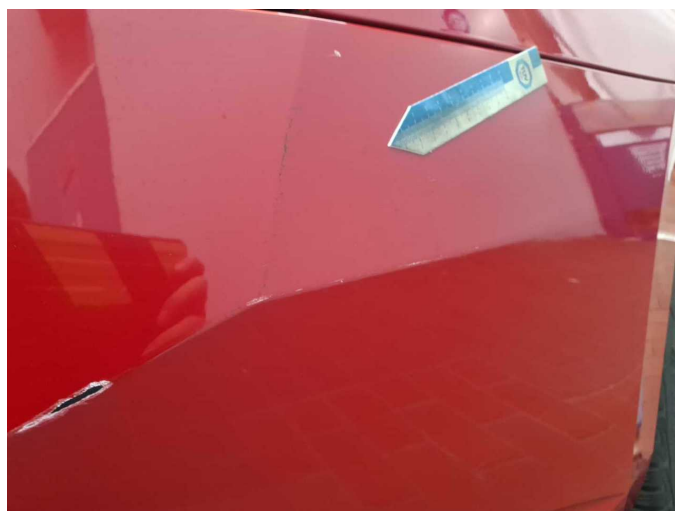
**Damage 9:** Rear bumper: Rear bumper - Scratch(es) - Paint

| No. | Component group | Description |
|---|---|---|
| 9 | Rear bumper | Rear bumper - Scratch(es) - Paint |

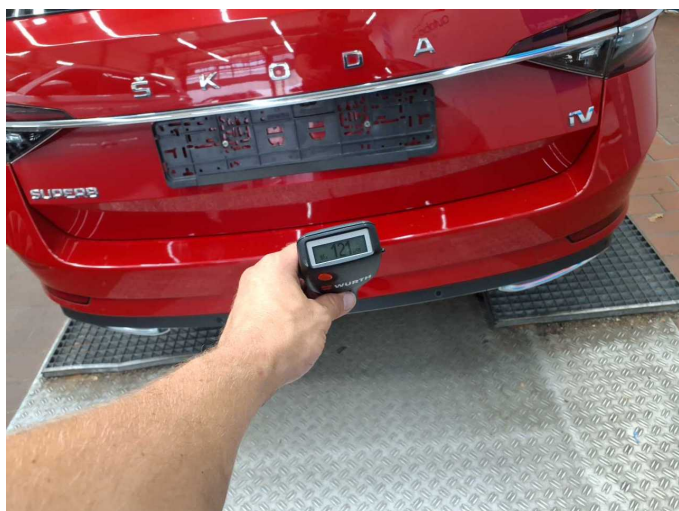
**Previous damage 1: Rear**

| No. | Previous damage | Extent of damage (Net) |
|---|---|---|
| 1 | Rear, Provided by user / customer, from 2 Apr 2023 | 1.093,19 € |

According to available information previous damages were repaired at the vehicle. Traces of repairs, which allow conclusions about the area of repair, were not recognizable during the inspection.

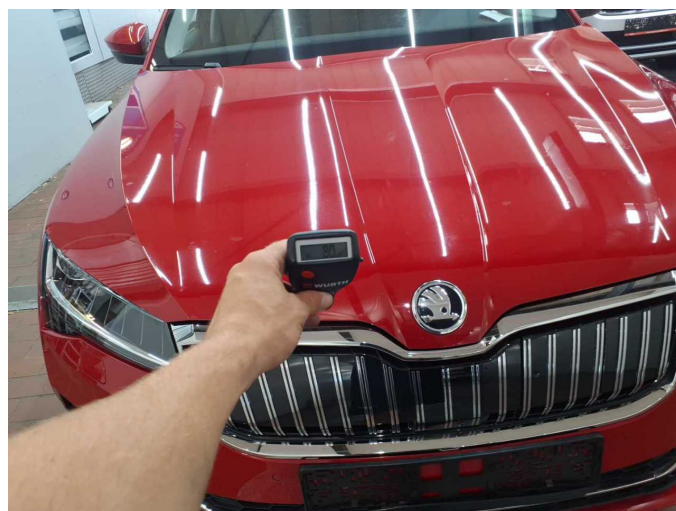
**Previous damage 2: Front**

| No. | Previous damage | Extent of damage (Net) |
|---|---|---|
| 2 | Front, Provided by user / customer, from 3 Apr 2024 | 5.727,11 € |
