Expertise

Protocol number: 46408656  
Order No. / Reference: 26625640  
Inspection date: 9 Jul 2026

Manufacturer: Ford

Model: Transit Connect 240 L2 LKW Trend

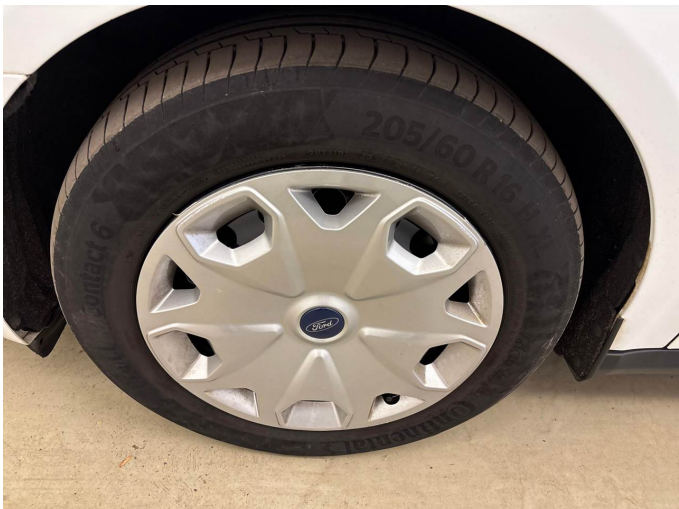
Figure 12: Mounted tyres

| Tyres | | | | |
|---|---|---|---|---|
| 1) | 205/60 R16 96H | Summer tyres on Steel rim with wheel cover | Continental | 3mm / 3mm |
| 2) | 205/60 R16 96H | Summer tyres on Steel rim with wheel cover | Continental | 4mm / 4mm |

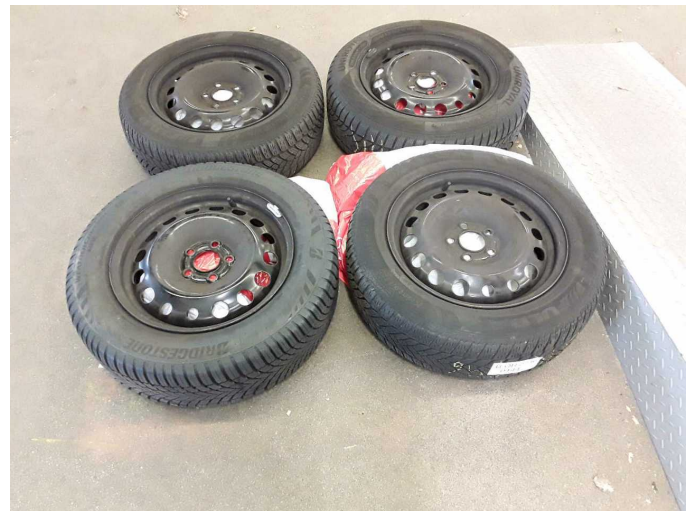
Figure 16: Additional tyres

| Tyres | | | | |
|---|---|---|---|---|
| 1) | 205/60 R16 96H | Winter tyres on Steel | Fulda | 5mm / 5mm |
| 2) | 205/60 R16 96H | Winter tyres on Steel | unterschiedliche Hersteller | 5mm / 5mm |

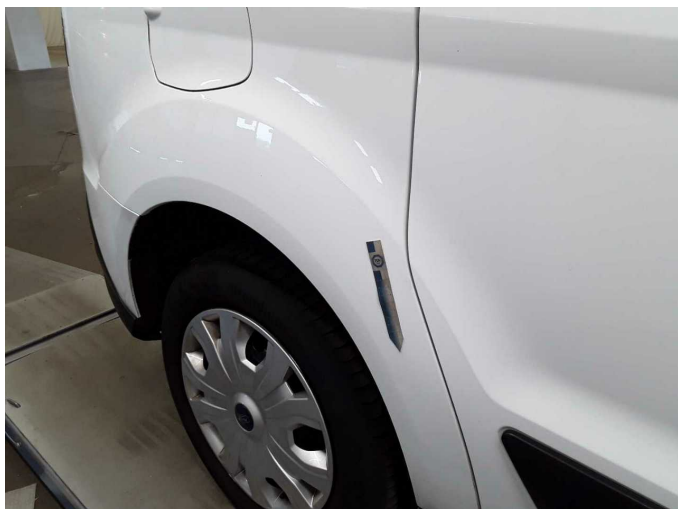
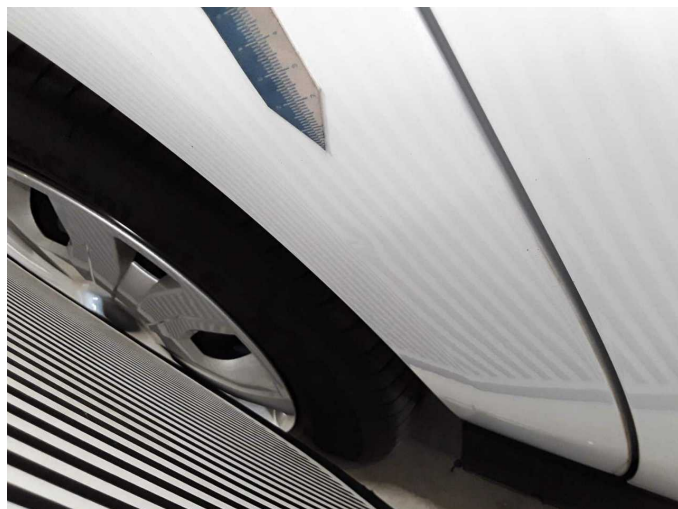
| No. | Component group | Description |
|---|---|---|
| 1 | Side panel - rear right side | Side panel - dent(s) - Smooth repair work |

**Damage 1:** Side panel - rear right side: Side panel - dent(s) - Smooth repair work

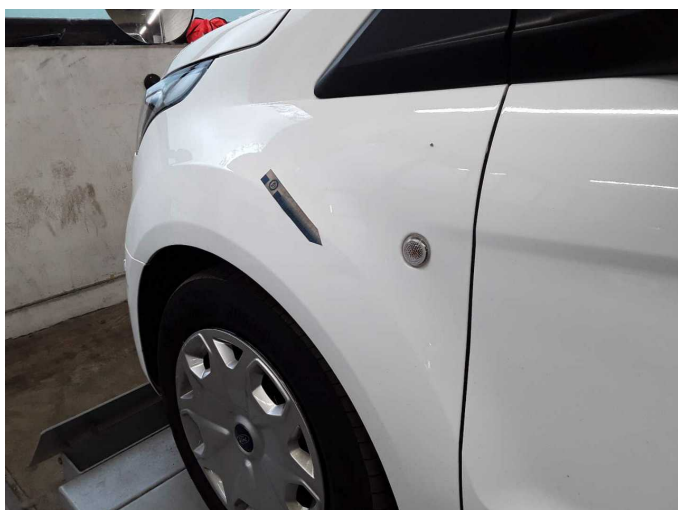
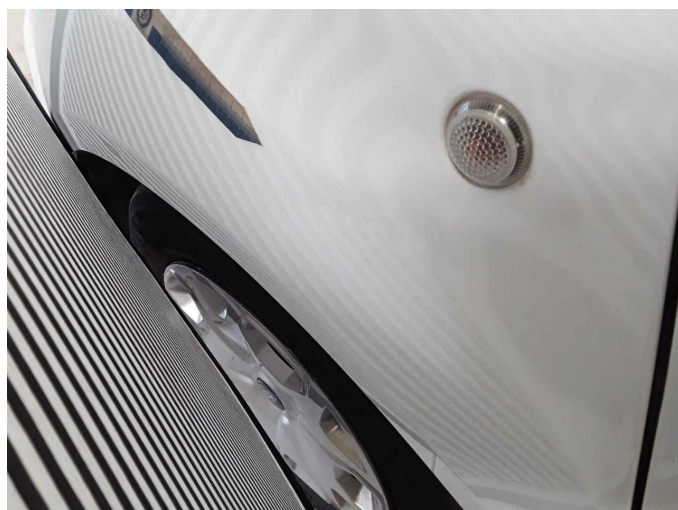
| No. | Component group | Description |
|---|---|---|
| 2 | Mudguard - left side | Mudguard - left side - dent(s) - Smooth repair work |

**Damage 2:** Mudguard - left side: Mudguard - left side - dent(s) - Smooth repair work

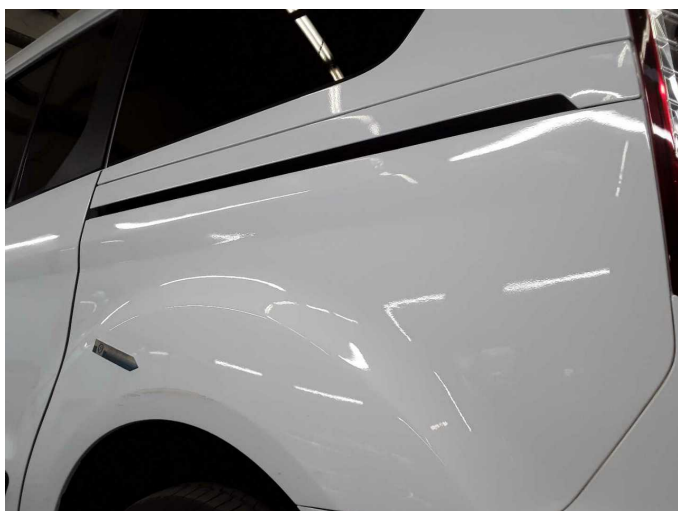
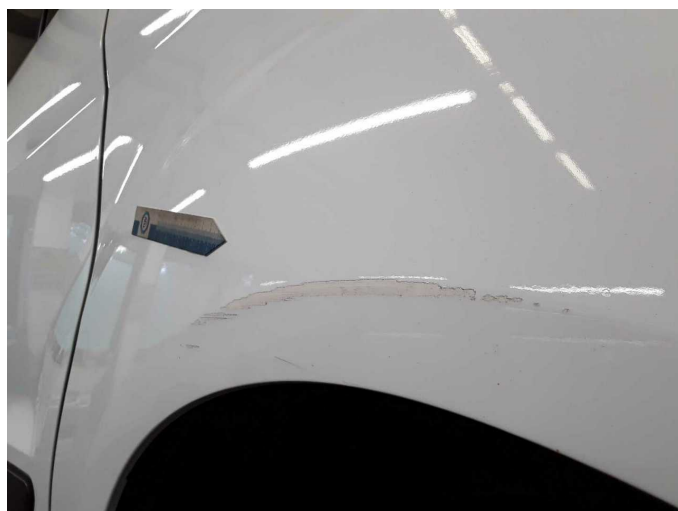
| No. | Component group | Description |
|---|---|---|
| 3 | Side panel - rear left side | Side panel - Scratched - Smart repair |

**Damage 3:** Side panel - rear left side: Side panel - Scratched - Smart repair

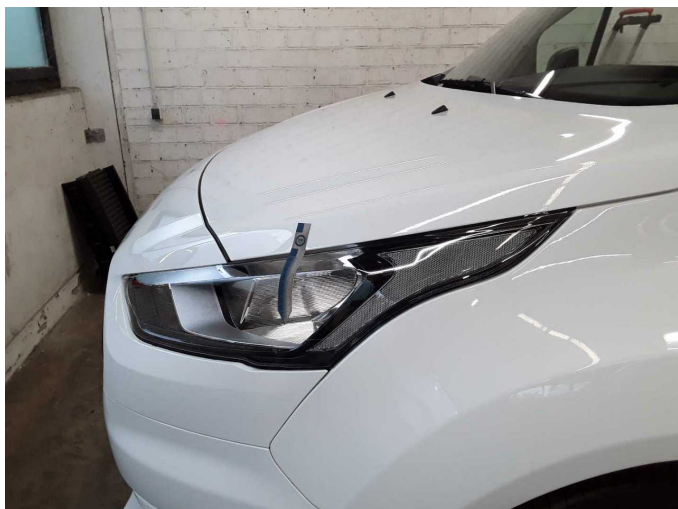
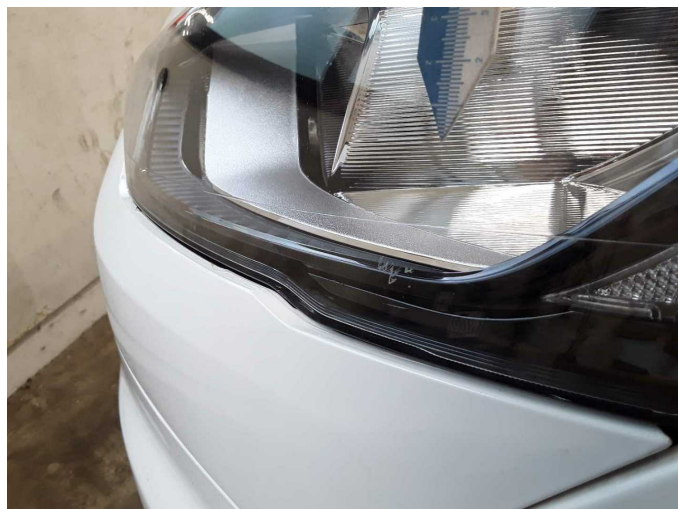
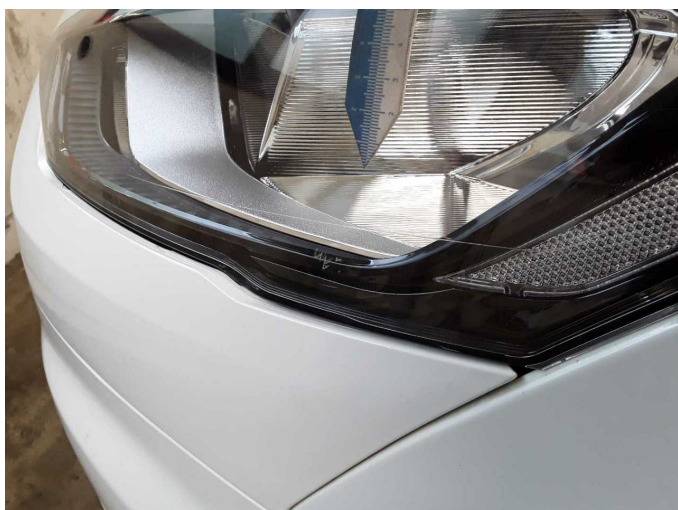
| No. | Component group | Description |
|---|---|---|
| 4 | Headlight | Headlight - left side - Scratch(es) - Replace |

**Damage 4:** Headlight: Headlight - left side - Scratch(es) - Replace

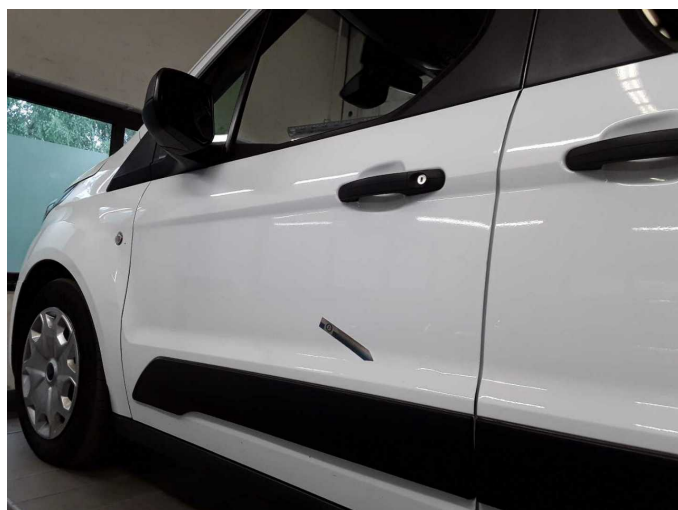
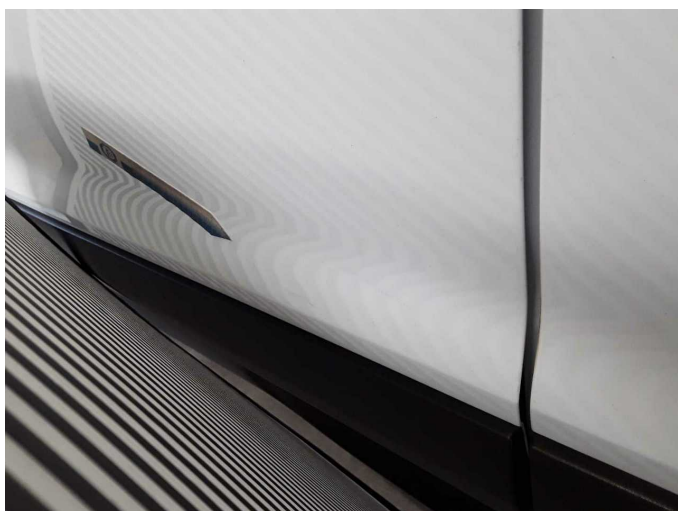
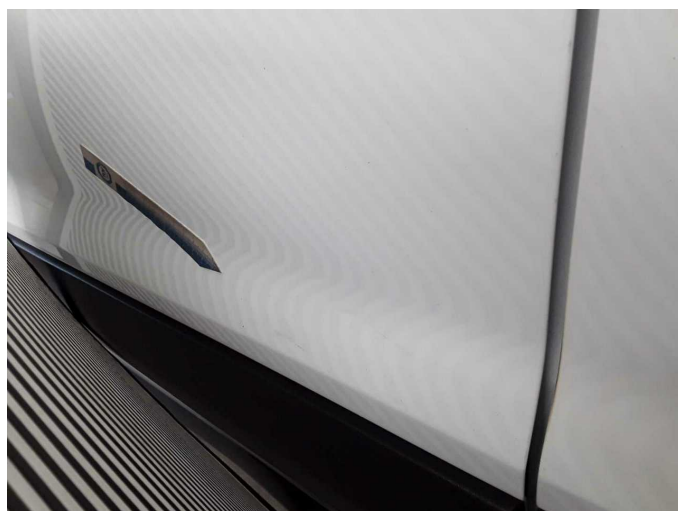
| No. | Component group | Description |
|---|---|---|
| 5 | Door - front left side | Door - Deformed - Repair and paint |

**Damage 5:** Door - front left side: Door - Deformed - Repair and paint

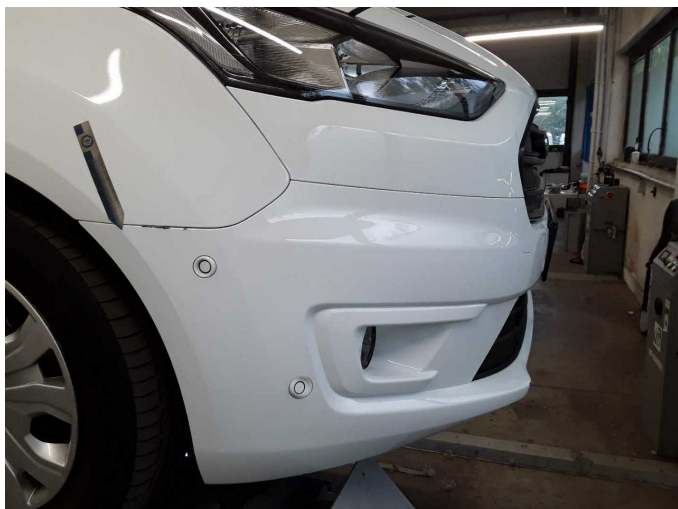
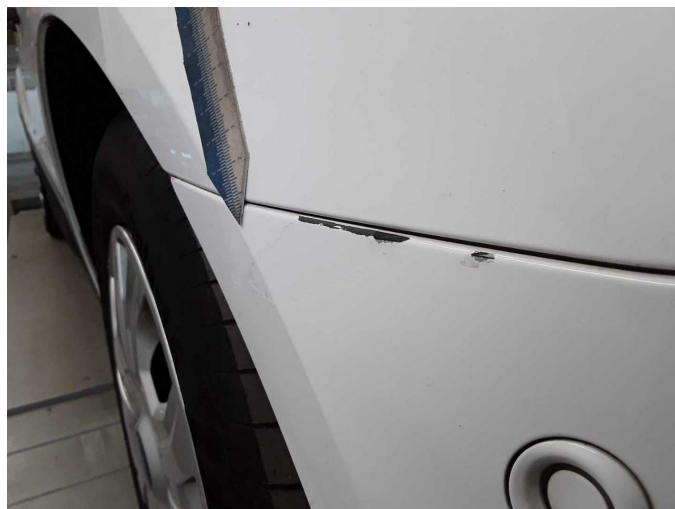
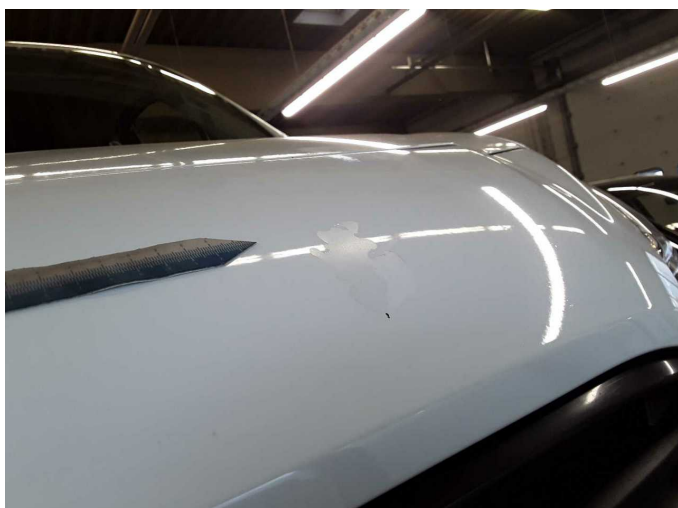
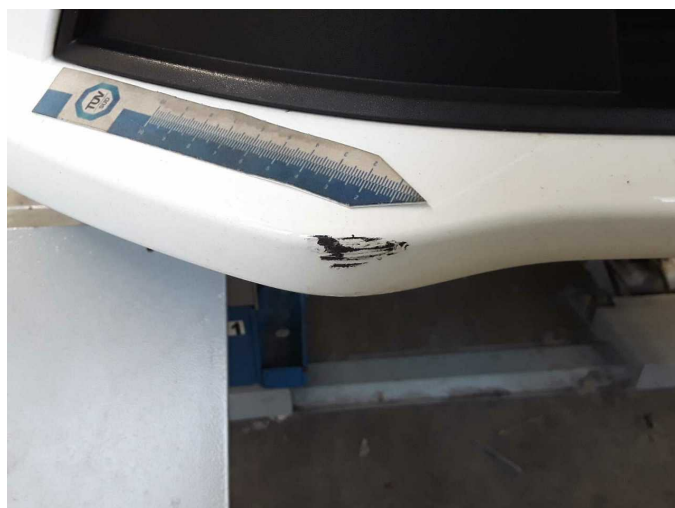
| No. | Component group | Description |
|---|---|---|
| 6 | Front bumper | Front bumper (Klarlack abgeblättert) - Paint defect - Repair and paint |

**Damage 6:** Front bumper: Front bumper (Klarlack abgeblättert) - Paint defect - Repair and paint

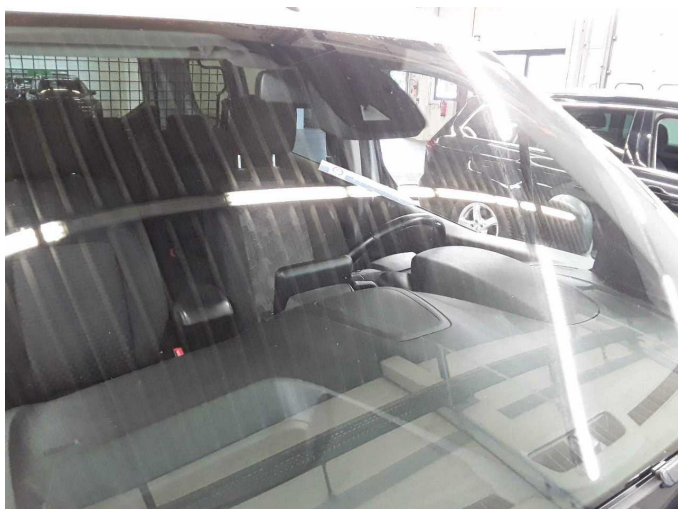
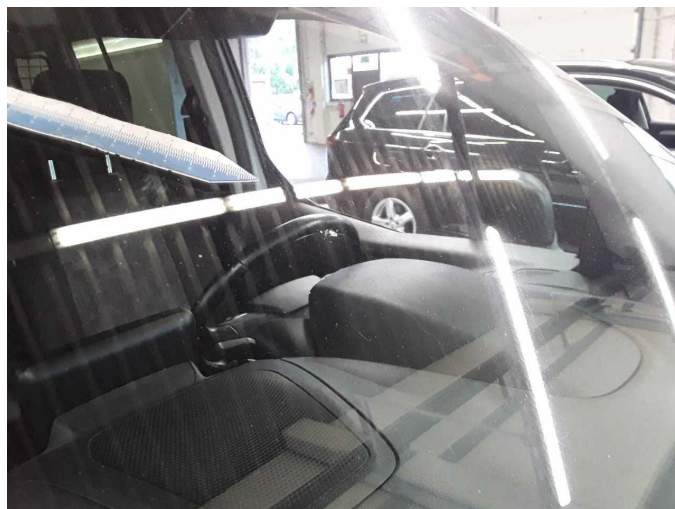
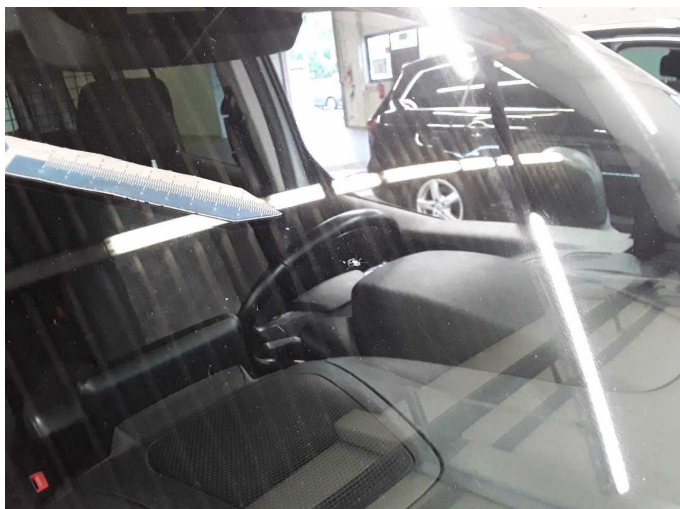
| No. | Component group | Description |
|---|---|---|
| 7 | Vehicle glazing | Windscreen (Rissbildung) - Stone chips - repair according to calculation |

**Damage 7:** Vehicle glazing: Windscreen (Rissbildung) - Stone chips - repair according to calculation

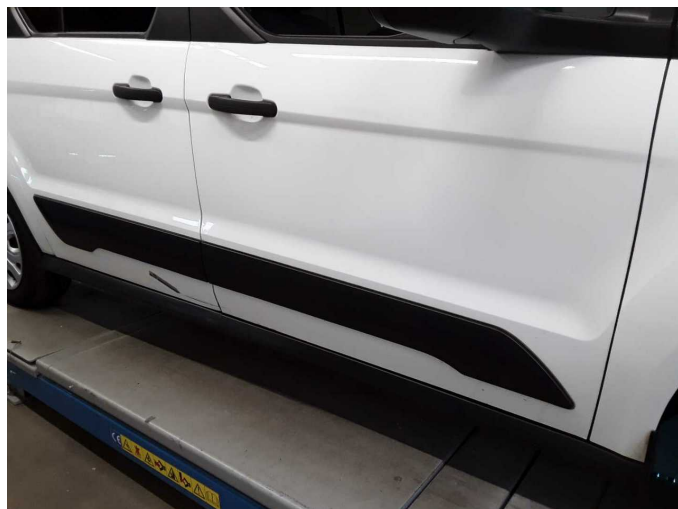
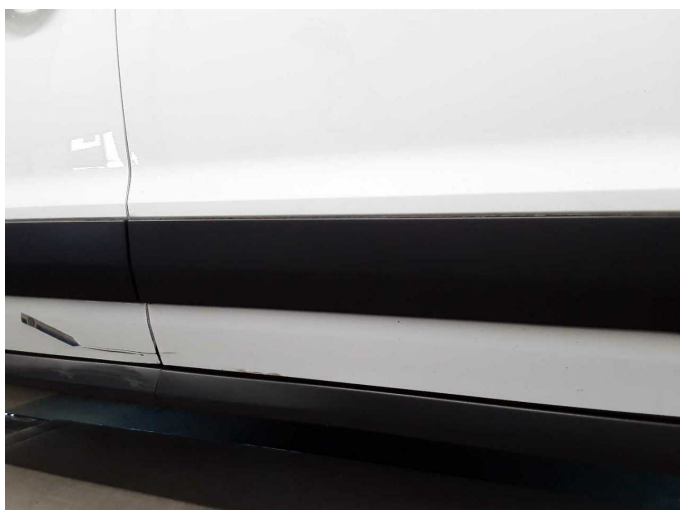
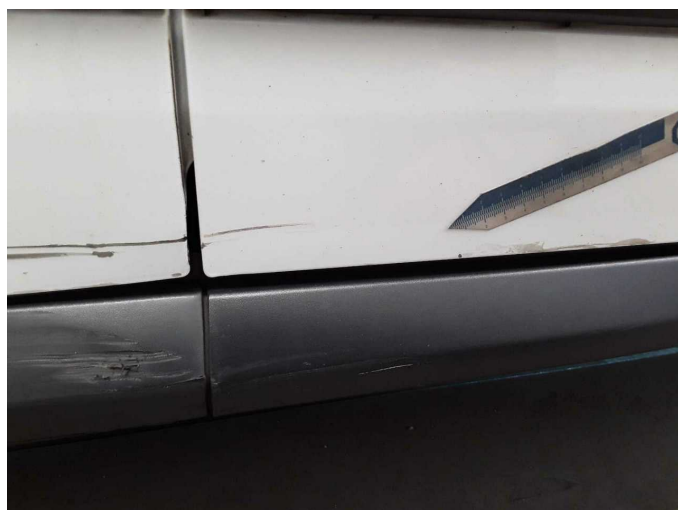
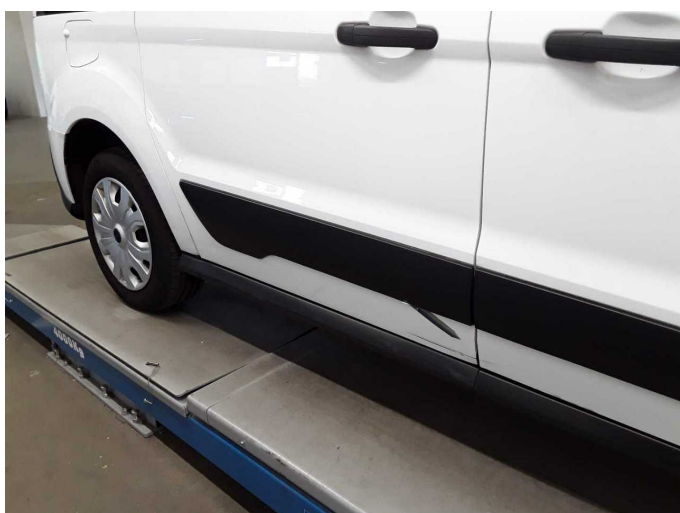
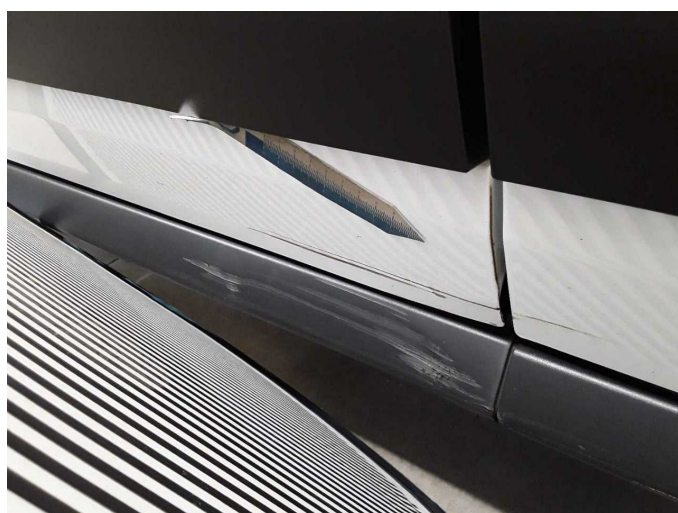
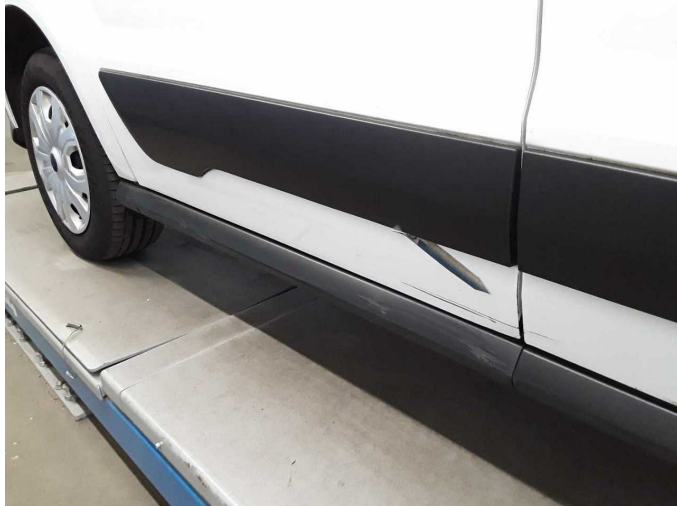
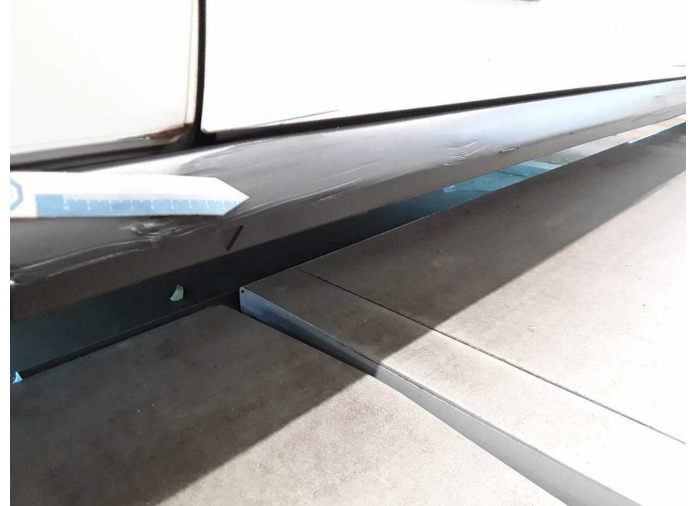
1 Side right

**Accident 1:** Side right

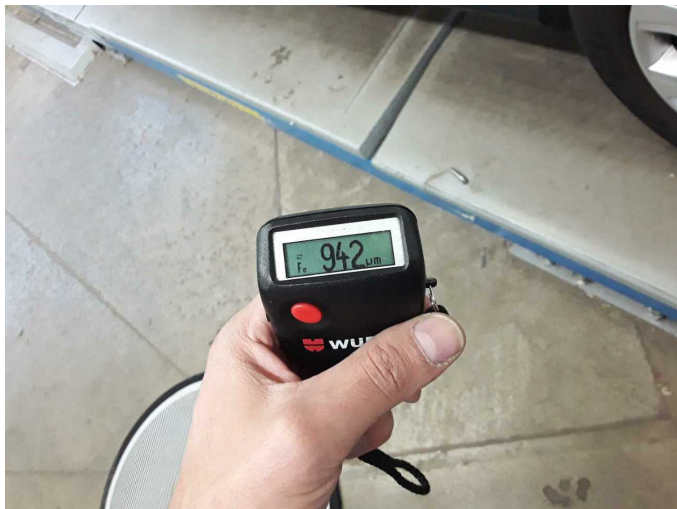
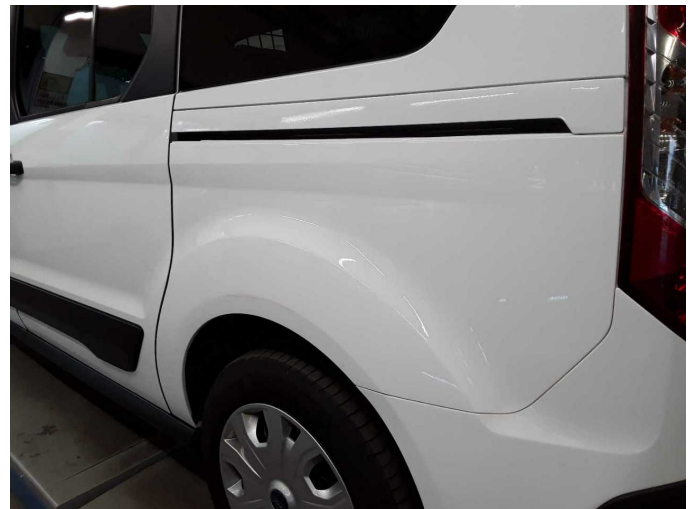
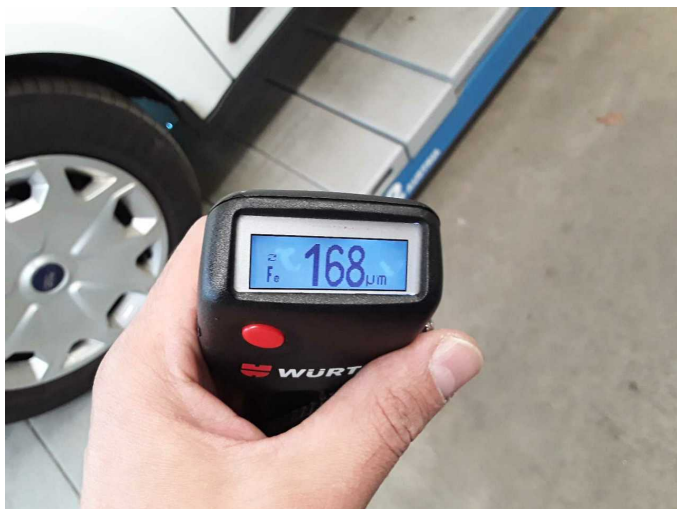
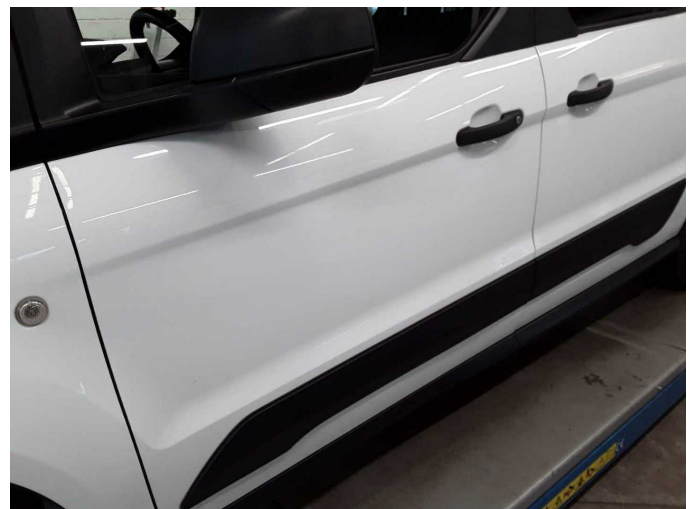
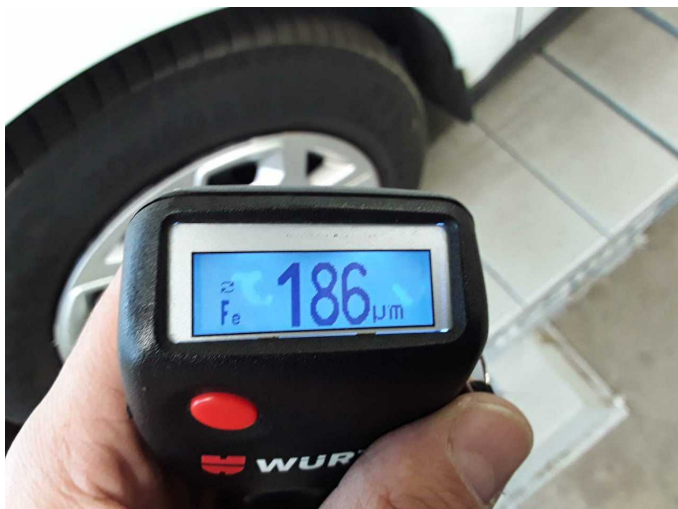
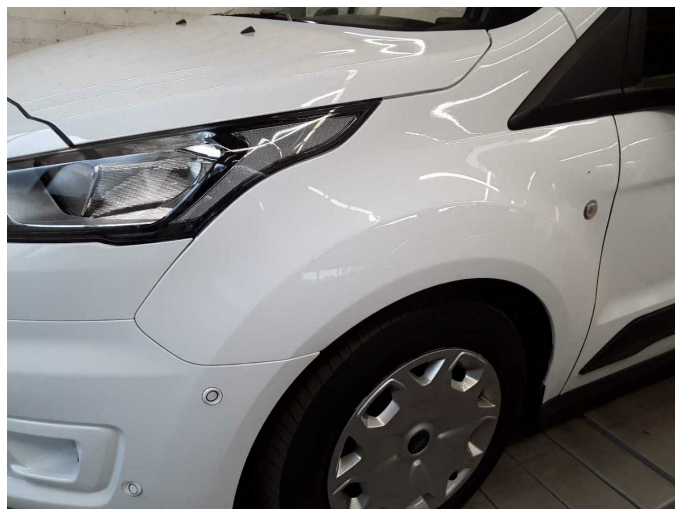
1 Mudguard - left side, Side panel - rear left side, Door - front left side, Professionally carried out, Invoice of repair done Non-existent

**Repainting 1:** Mudguard - left side, Side panel - rear left side, Door - front left side
