Expertise

Protocol number: 46094900  
Order No. / Reference: 26319967  
Inspection date: 22 Jun 2026

Manufacturer: Audi  
VIN: WAUZZZF44PN009533

Model: A4 Limousine 35 TDI S tronic

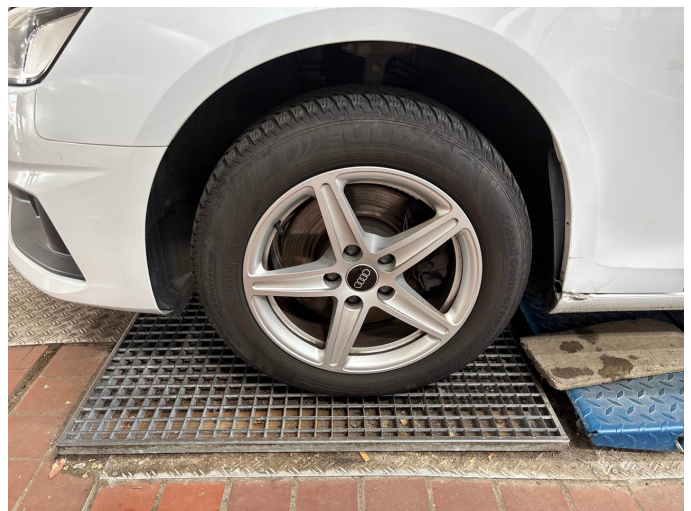
Figure 12: Mounted tyres

| # | Tyre size | Type of tyre | Manufacturer | Tread depth |
|---|---|---|---|---|
| 1) | 205/60 R16 96H | Winter tyres on Light alloy | Fulda | 5mm / 5mm |
| 2) | 205/60 R16 96H | Winter tyres on Light alloy | Goodyear | 7mm / 7mm |

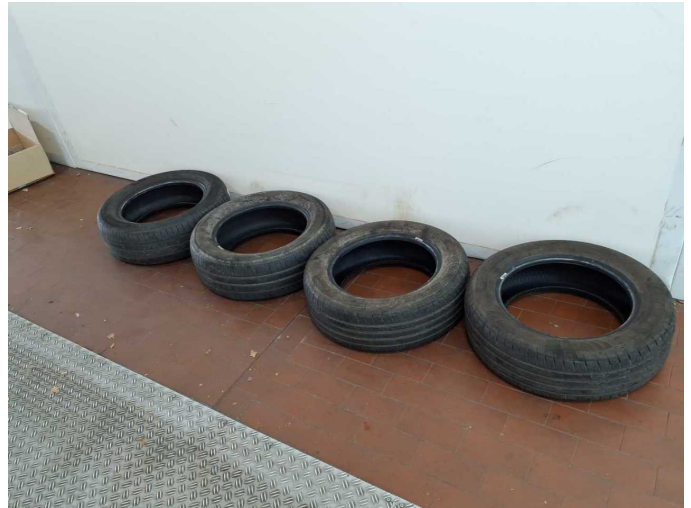
Figure 20: Additional tyres

| # | Tyre size | Type of tyre | Manufacturer | Tread depth |
|---|---|---|---|---|
| 1) | 205/60 R16 96V | Summer tyres (Without wheel rim) | Fulda | 6mm / 6mm |
| 2) | 205/60 R16 96V | Summer tyres (Without wheel rim) | Fulda | 6mm / 6mm |

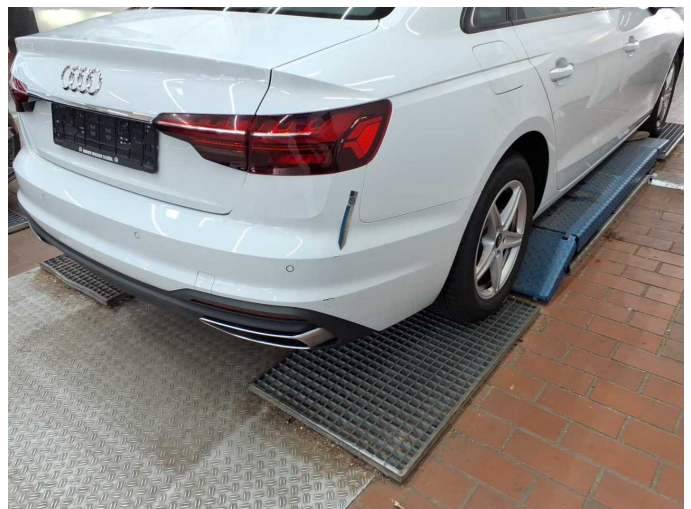
| No. | Component group | Description |
|---|---|---|
| 1 | Rear bumper | Rear bumper - Scratch(es) - Paint |

Damage 1: Rear bumper: Rear bumper - Scratch(es) - Paint

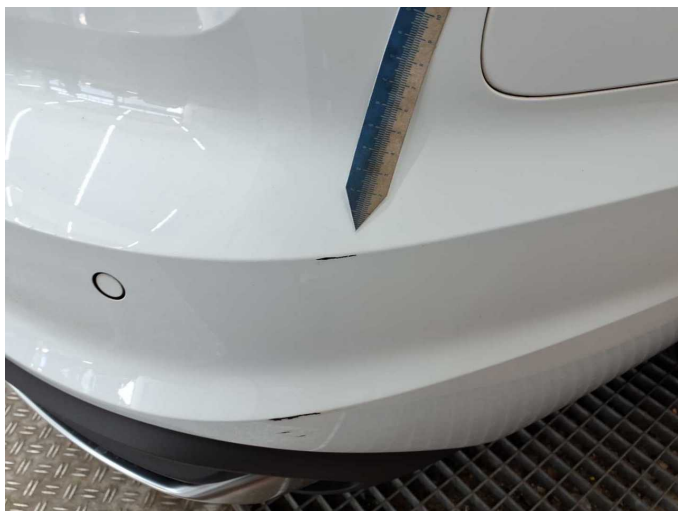
**Damage 1:** Rear bumper: Rear bumper - Scratch(es) - Paint

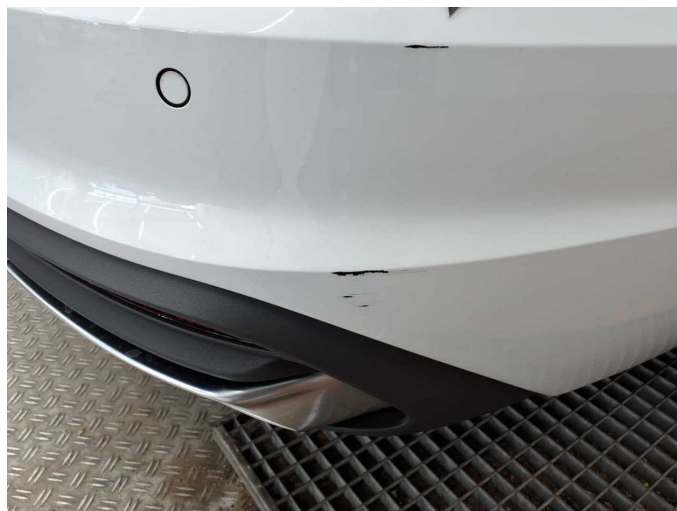
**Damage 1:** Rear bumper: Rear bumper - Scratch(es) - Paint

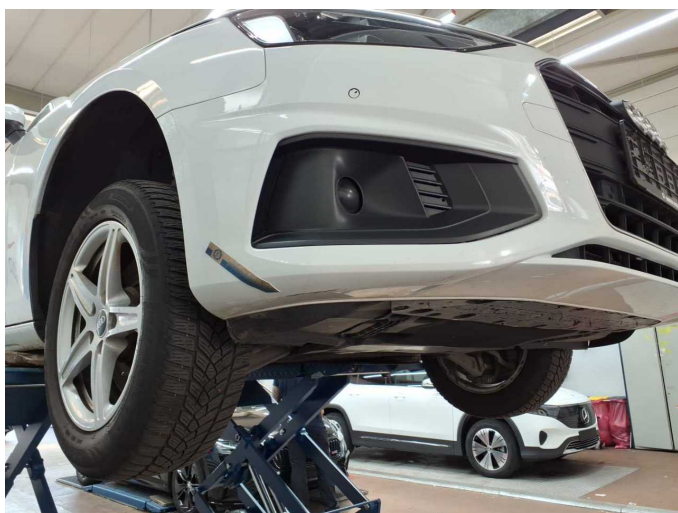
| No. | Component group | Description |
|---|---|---|
| 2 | Front bumper | Front bumper - Scratch(es) - Paint |

**Damage 2:** Front bumper: Front bumper - Scratch(es) - Paint

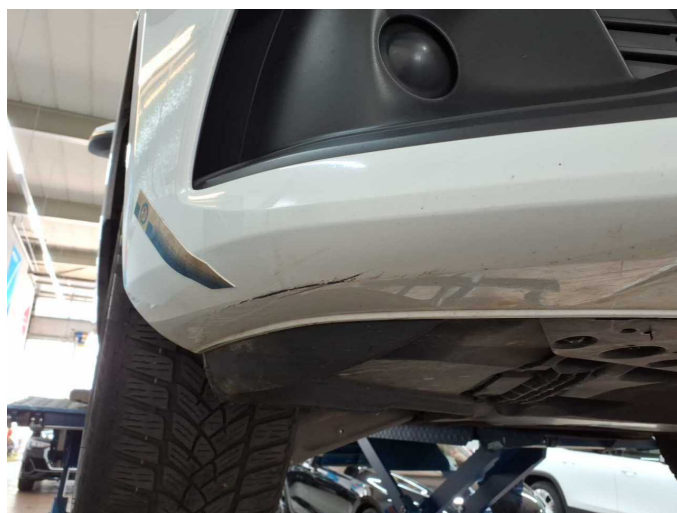
**Damage 2:** Front bumper: Front bumper - Scratch(es) - Paint

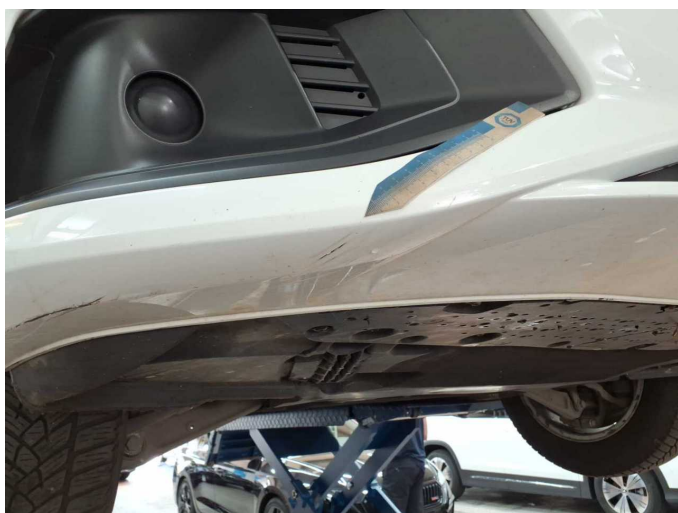
**Damage 2:** Front bumper: Front bumper - Scratch(es) - Paint

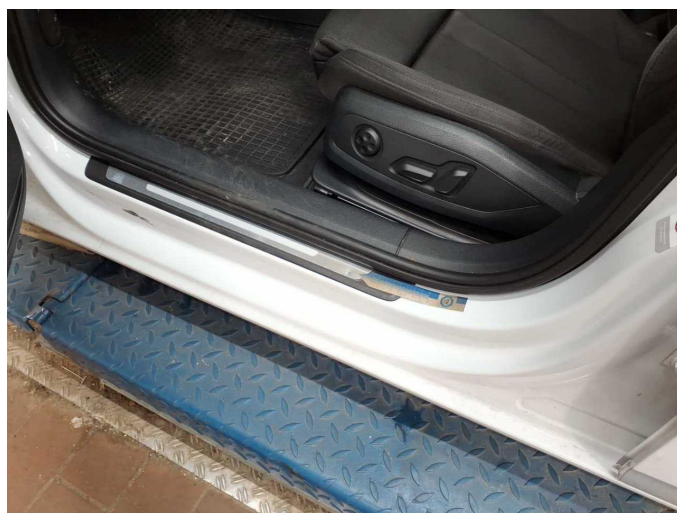
| No. | Component group | Description |
|---|---|---|
| 3 | Sill - left side | Sill (Zierleiste) - dent(s) - No deduction |

**Wear and tear 3:** Sill - left side: Sill (Zierleiste) - dent(s) - No deduction

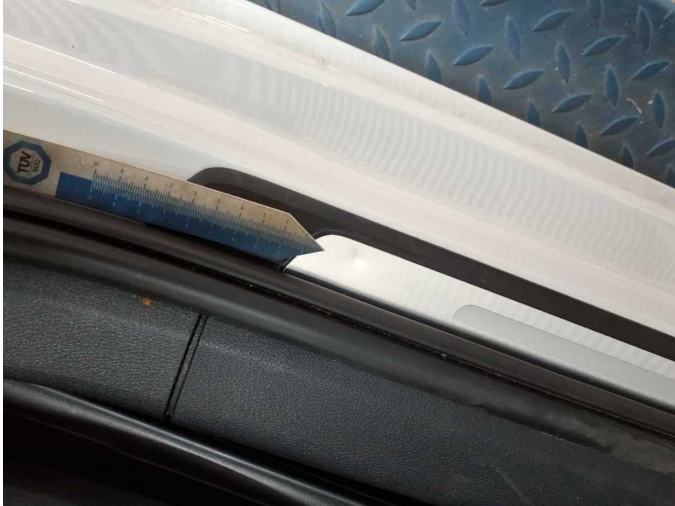
**Wear and tear 3:** Sill - left side: Sill (Zierleiste) - dent(s) - No deduction

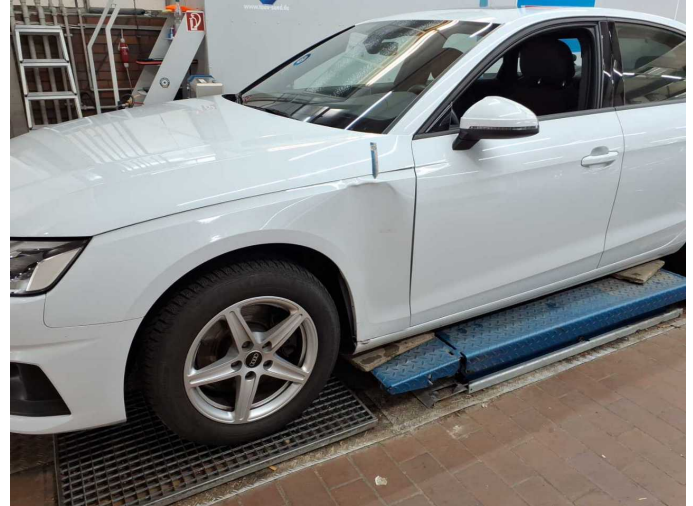
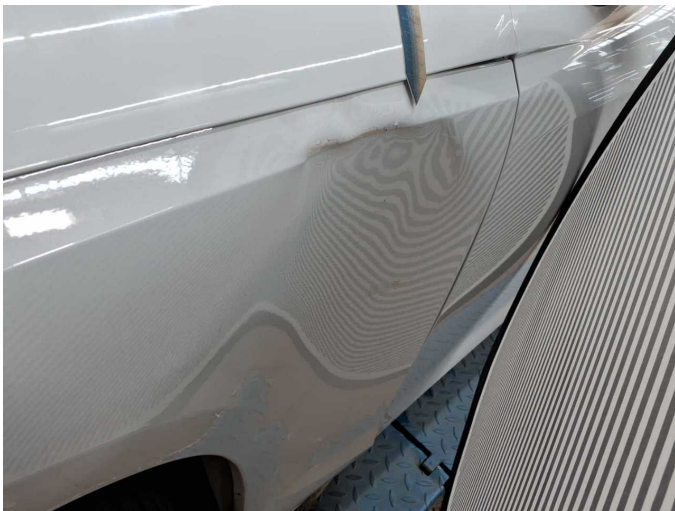
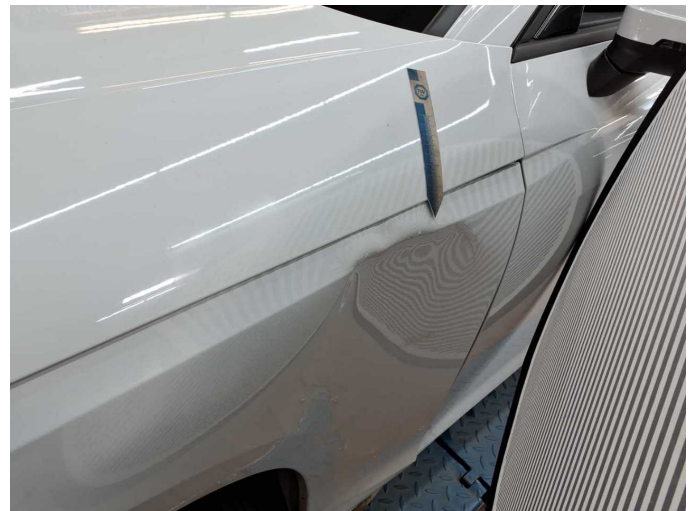
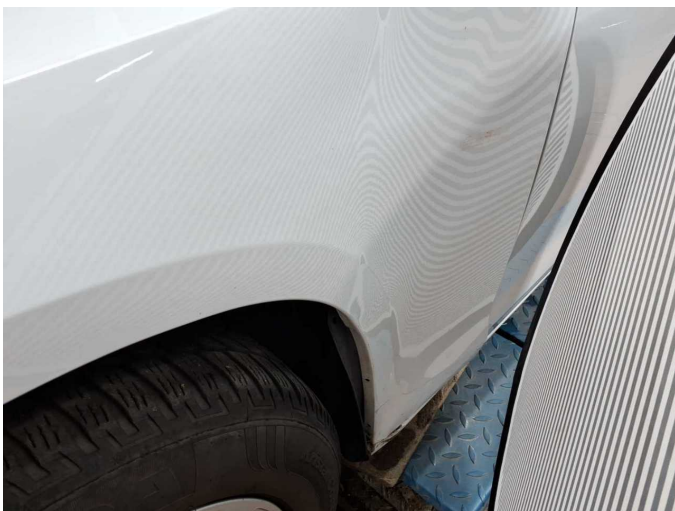
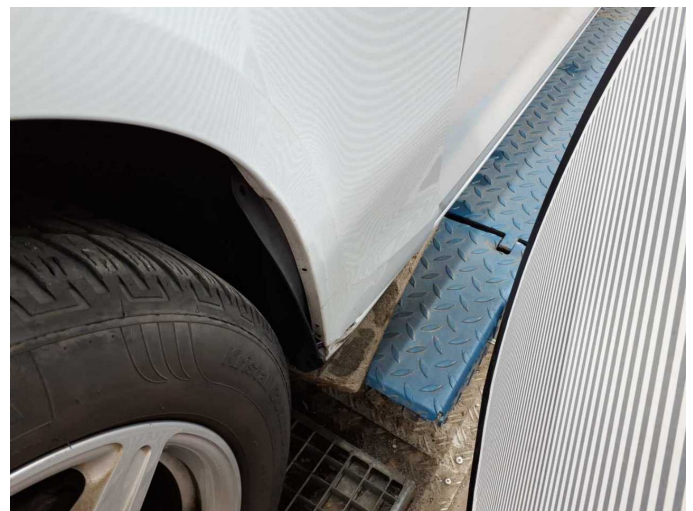
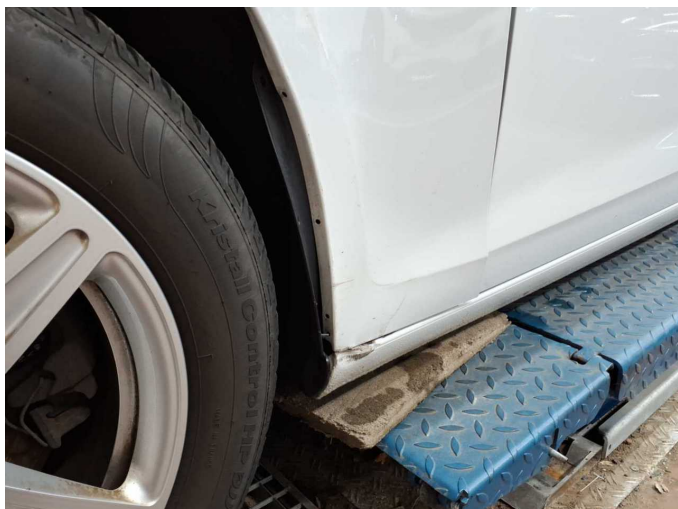
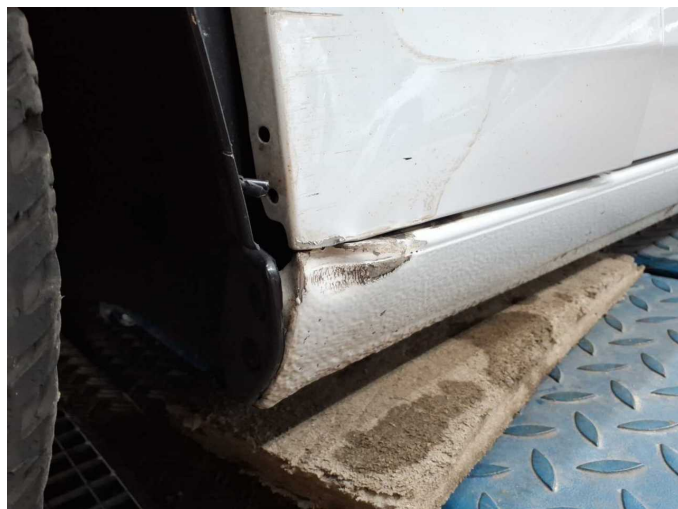
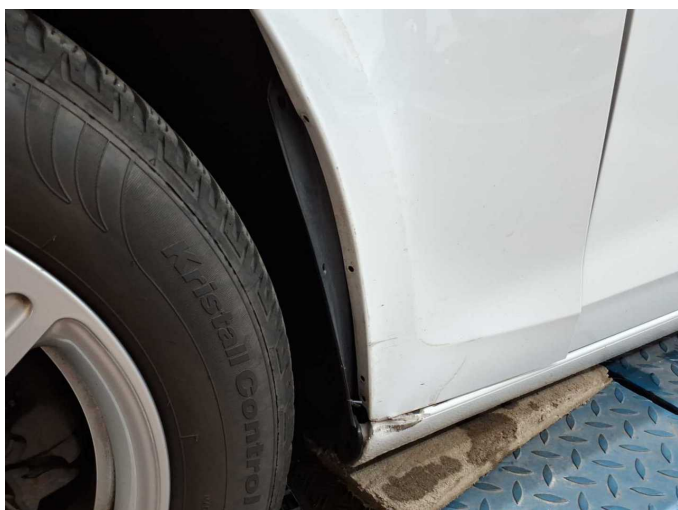
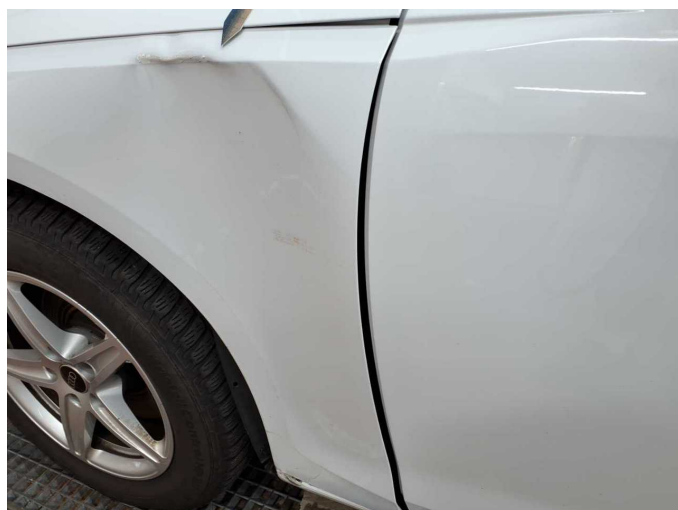
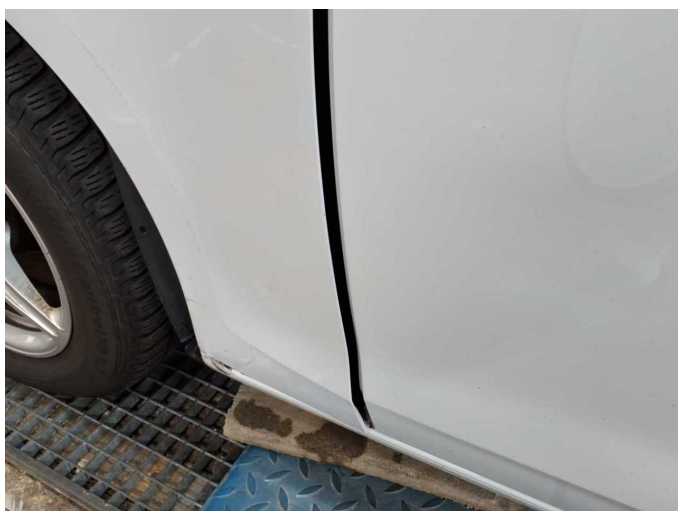
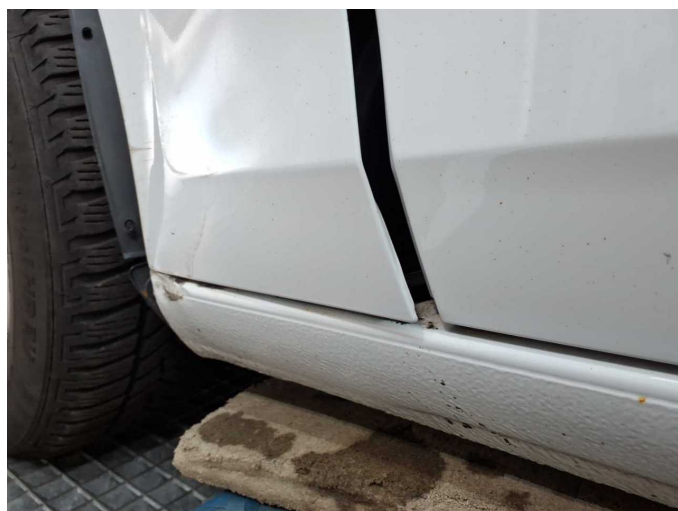
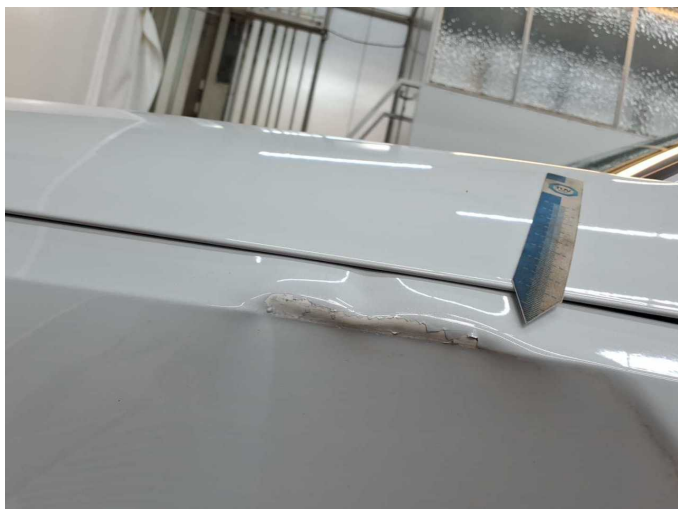
| No. | Accident |
|---|---|
| 1 | Side - left |

**Accident 1:** Side - left

**Accident 1: Side - left**

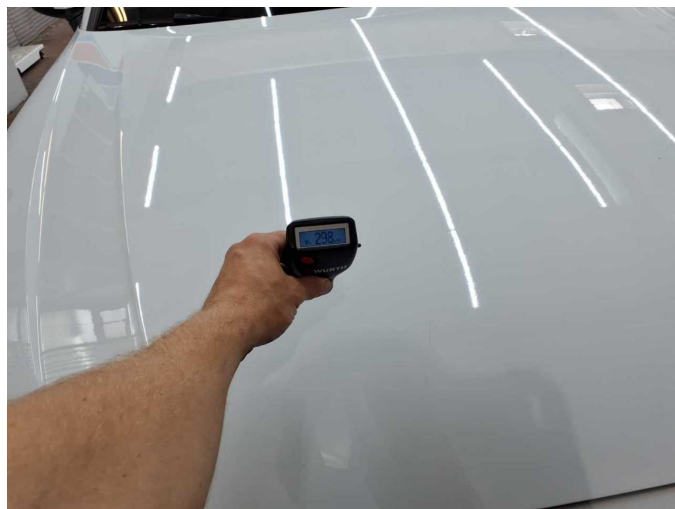
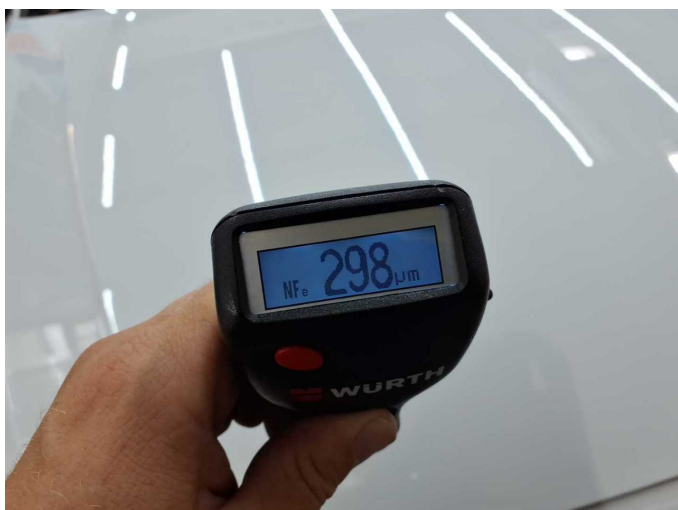
| No. | Repainting |
|---|---|
| 1 | Bonnet, Professionally carried out, Invoice of repair done Non-existent |

| Bonnet | 298 µm |

**Repainting 1: Bonnet**
