Expertise

Protocol number: 46375217  
Order No. / Reference: 26663191  
Inspection date: 6 Jul 2026

Manufacturer: Skoda  
VIN: TMBJR7NP8P7054575

Model: Superb Combi 2.0 TDI DSG Style

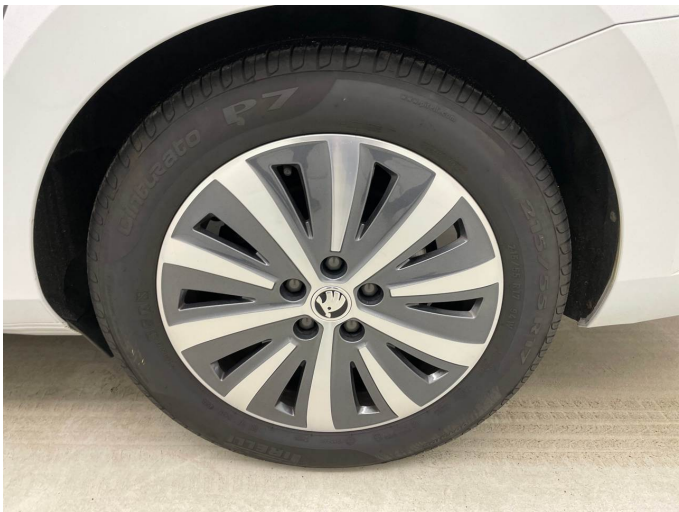
| # | Tyre size | Type of tyre | Manufacturer | Tread depth |
|---|---|---|---|---|
| 1) | 215/55 R17 94W | Summer tyres on Light alloy | Pirelli | 6mm / 6mm |
| 2) | 215/55 R17 94W | Summer tyres on Light alloy | Pirelli | 7mm / 7mm |

Figure 12: Mounted tyres

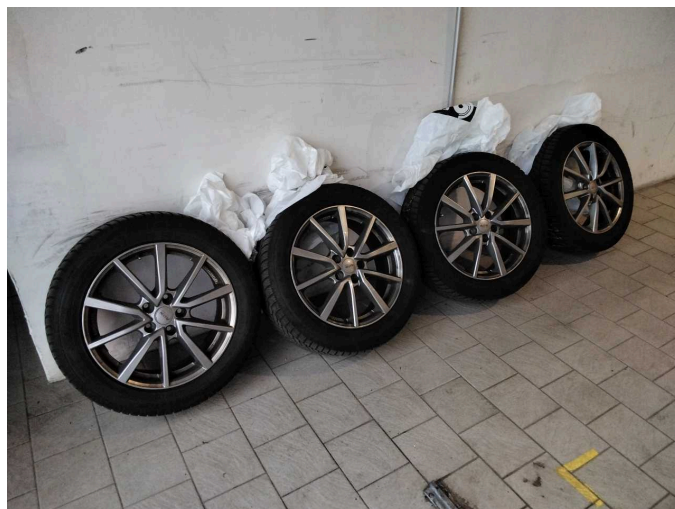
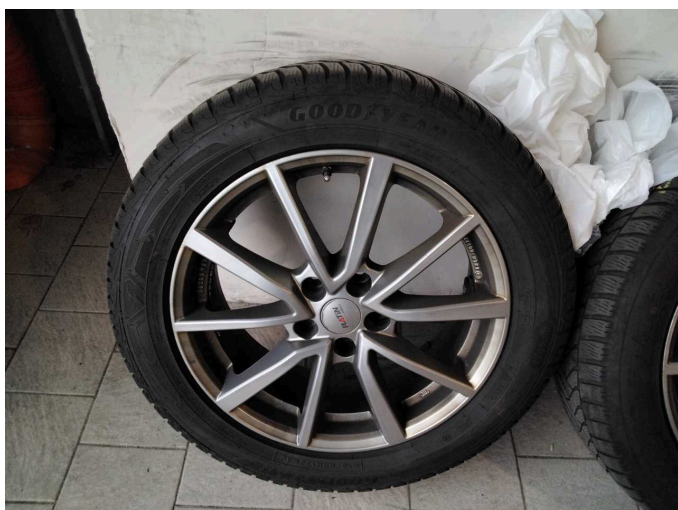
| # | Tyre size | Type of tyre | Manufacturer | Tread depth |
|---|---|---|---|---|
| 1) | 215/55 R17 98V | Winter tyres on Light alloy | Goodyear | 5mm / 5mm |
| 2) | 215/55 R17 98V | Winter tyres on Light alloy | Goodyear | 6mm / 6mm |

Figure 14: Additional tyres

Figure 15: Additional tyres

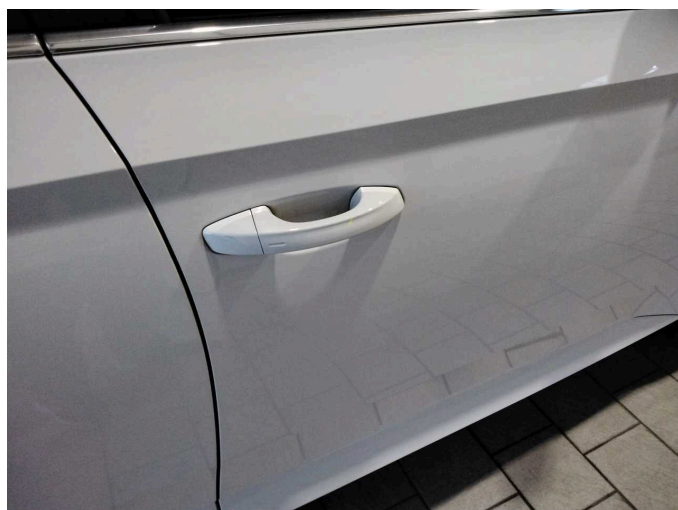
**Damage 2:** Door - front right side: Door handle - outside - Scratch(es) - Smart repair

| No. | Component group | Description |
|---|---|---|
| 2 | Door - front right side | Door handle - outside - Scratch(es) - Smart repair |

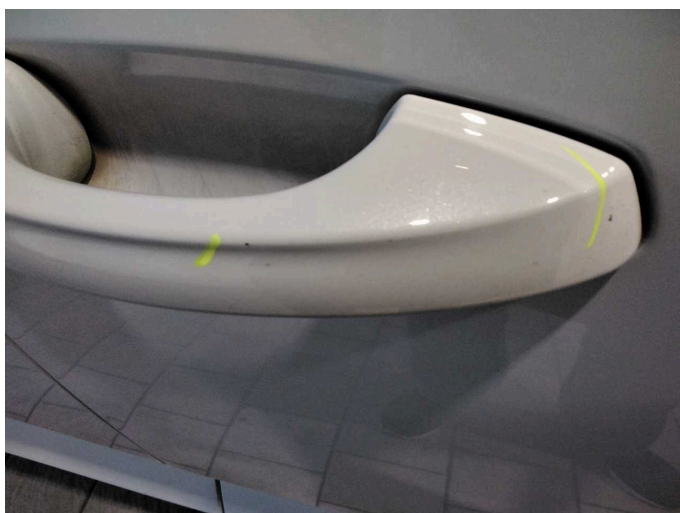
**Damage 2:** Door - front right side: Door handle - outside - Scratch(es) - Smart repair

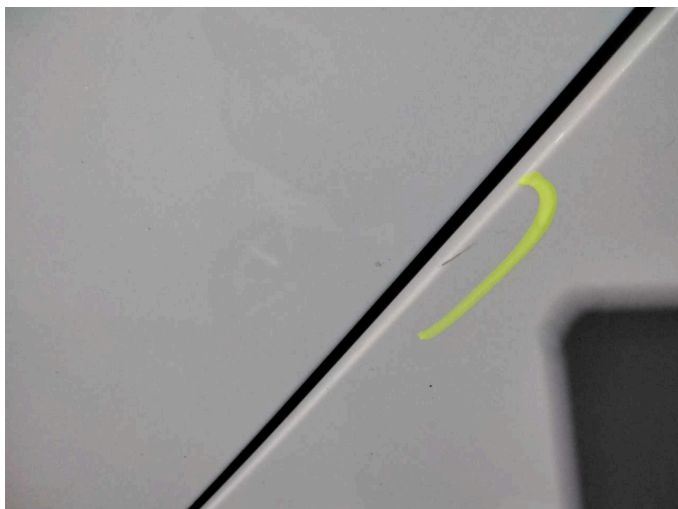
**Damage 3:** Side panel - rear left side: Side panel - Scratch(es) - Smart repair

| No. | Component group | Description |
|---|---|---|
| 3 | Side panel - rear left side | Side panel - Scratch(es) - Smart repair |

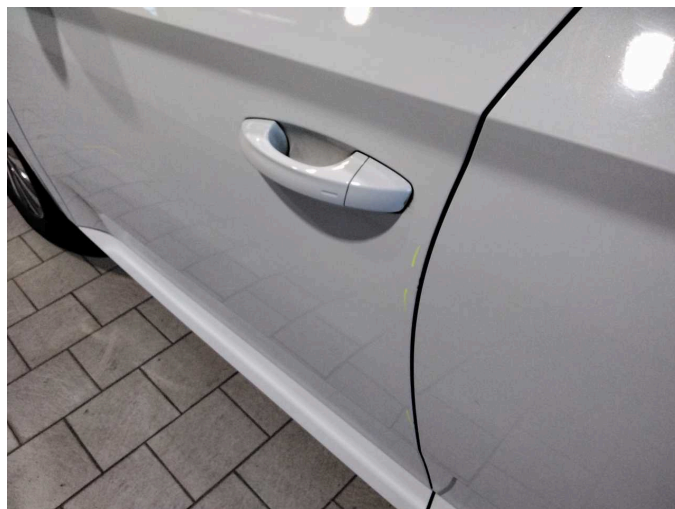
**Damage 4:** Door - front left side: Door edge - Scratch(es) - Smart repair

| No. | Component group | Description |
|---|---|---|
| 4 | Door - front left side | Door edge - Scratch(es) - Smart repair |

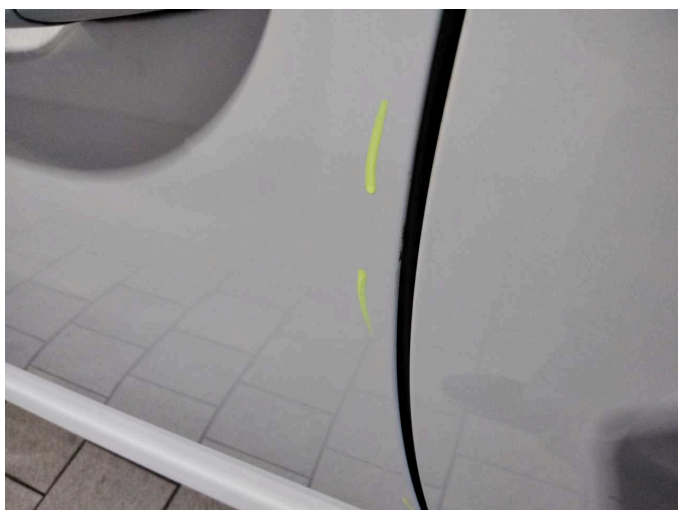
**Damage 4:** Door - front left side: Door edge - Scratch(es) - Smart repair

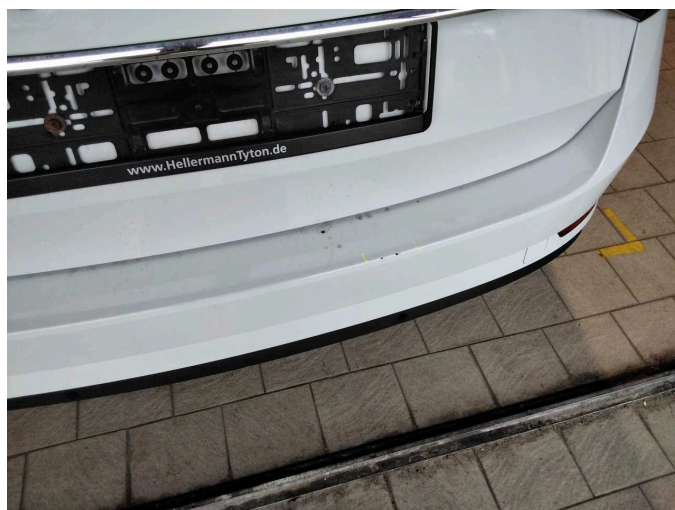
**Damage 5:** Rear bumper: Rear bumper - Scratch(es) - Smart repair

| No. | Component group | Description |
|---|---|---|
| 5 | Rear bumper | Rear bumper - Scratch(es) - Smart repair |

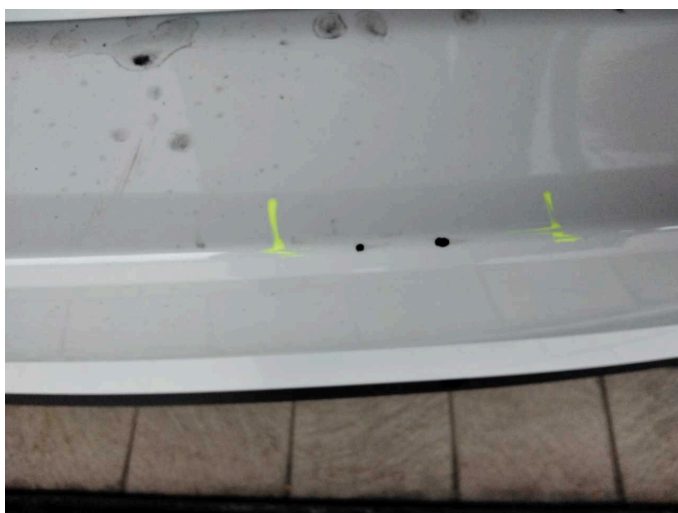
**Damage 5:** Rear bumper: Rear bumper - Scratch(es) - Smart repair

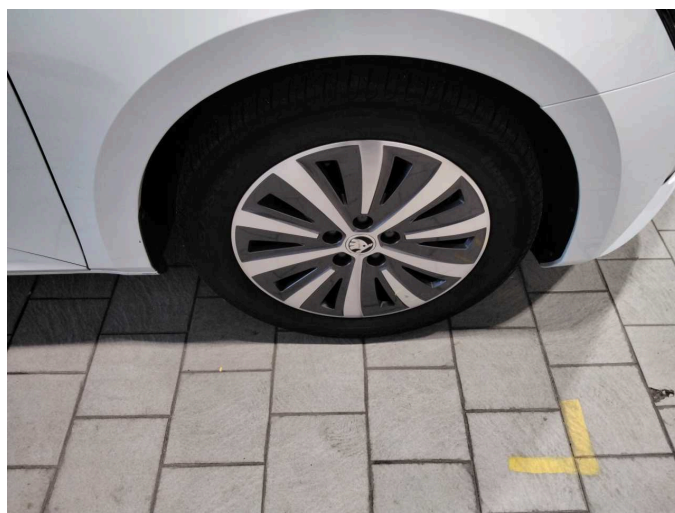
**Damage 6:** Wheel / tyres: Alloy rim - front right side - Scratch(es) - Replace

| No. | Component group | Description |
|---|---|---|
| 6 | Wheel / tyres | Alloy rim - front right side - Scratch(es) - Replace |

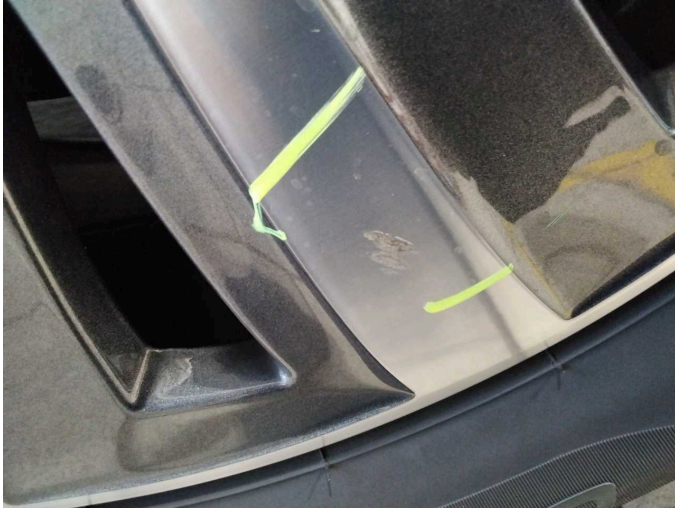
**Damage 6:** Wheel / tyres: Alloy rim - front right side - Scratch(es) - Replace

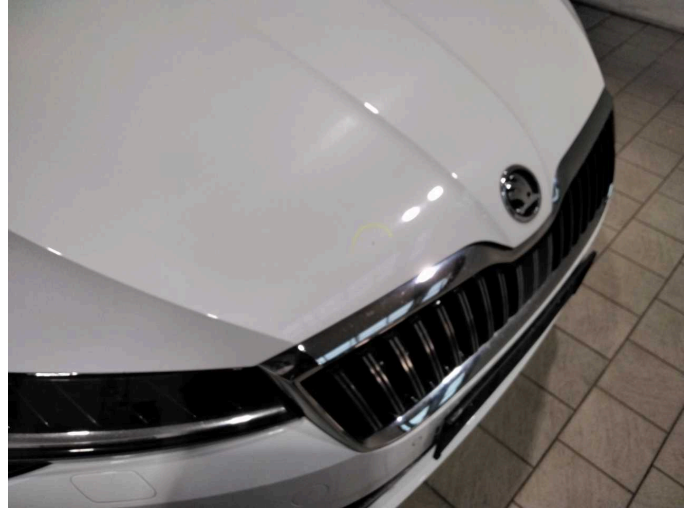
**Damage 7:** Bonnet: Bonnet - Dent / paintcoat damage - Repair and paint

| No. | Component group | Description |
|---|---|---|
| 7 | Bonnet | Bonnet - Dent / paintcoat damage - Repair and paint |

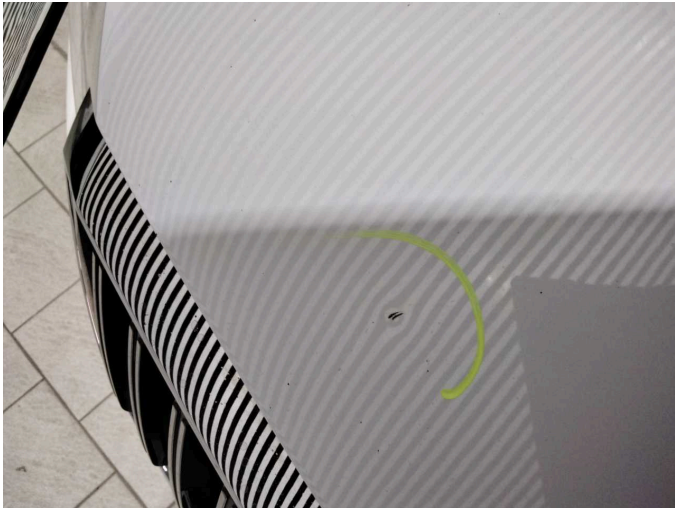
**Damage 7:** Bonnet: Bonnet - Dent / paintcoat damage - Repair and paint
