Expertise

Protocol number: 46508777  
Order No. / Reference: 26669285  
Inspection date: 13 Jul 2026

Manufacturer: Peugeot

Model: 208 Elektromotor 136 Allure

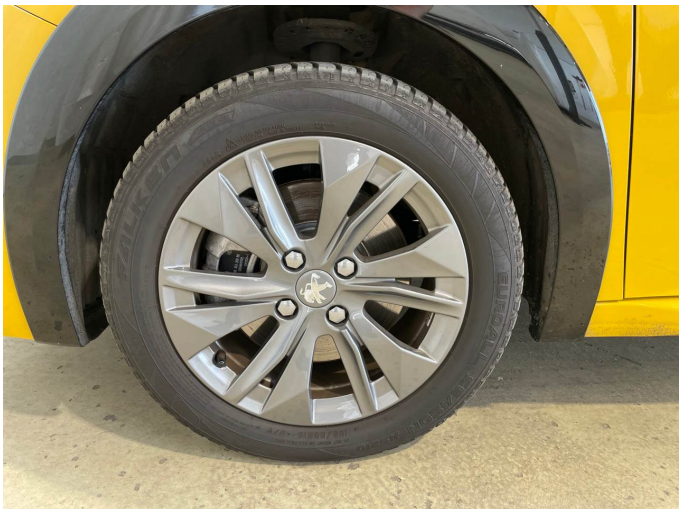
Figure 12: Mounted tyres

| # | Tyre size | Type of tyre | Manufacturer | Tread depth |
|---|---|---|---|---|
| 1) | 195/55 R16 87V | All-season tyres on Light alloy | Falken | 5mm / 5mm |
| 2) | 195/55 R16 87V | All-season tyres on Light alloy | Falken | 6mm / 6mm |

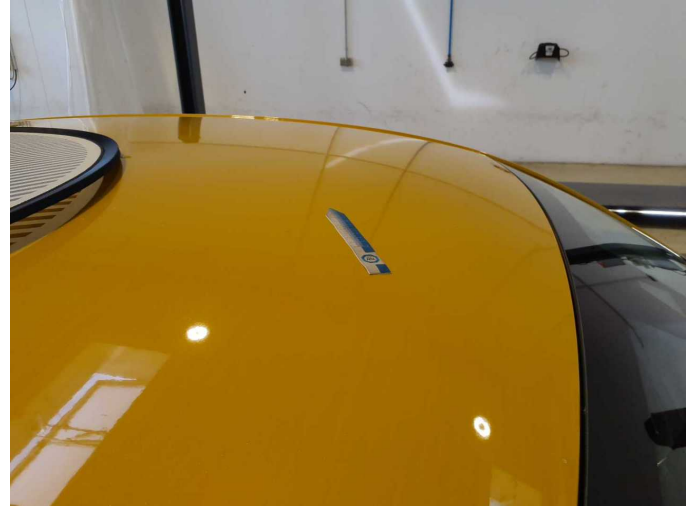
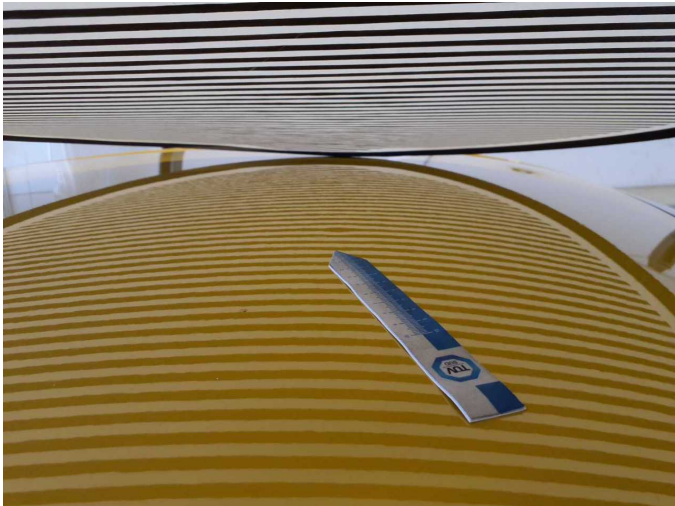
**Damage 1:** Roof: Roof - dent(s) - Smooth repair work

| No. | Component group | Description |
|---|---|---|
| 1 | Roof | Roof - dent(s) - Smooth repair work |

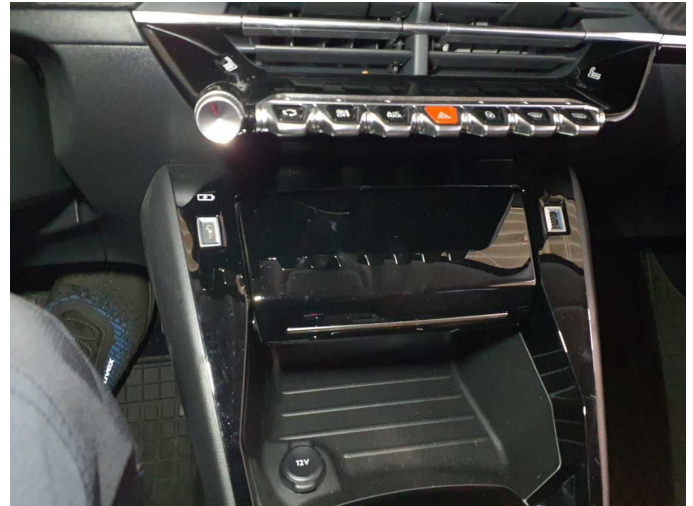
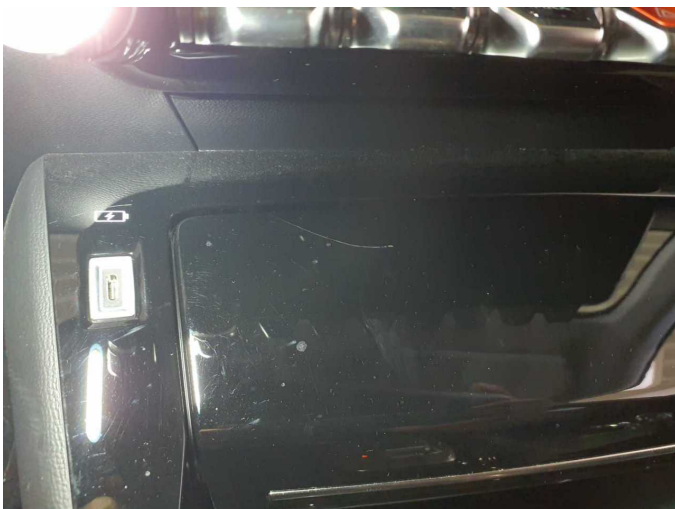
**Damage 2:** Instrument panel: Centre console - front - Scratch(es) - Smart repair

| No. | Component group | Description |
|---|---|---|
| 2 | Instrument panel | Centre console - front - Scratch(es) - Smart repair |

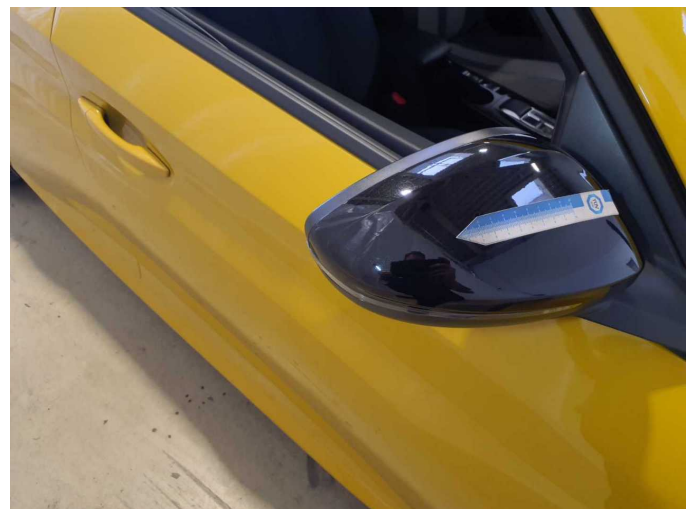
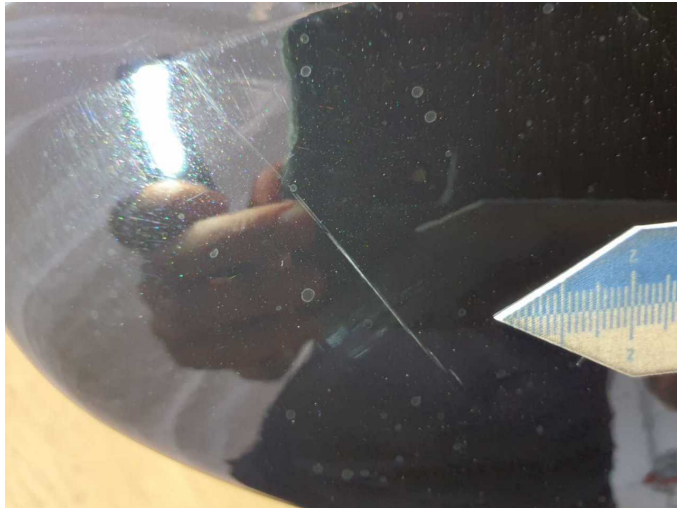
**Damage 3:** Wing mirror - right side: Cap - Scratch(es) - Smart repair

| No. | Component group | Description |
|---|---|---|
| 3 | Wing mirror - right side | Cap - Scratch(es) - Smart repair |

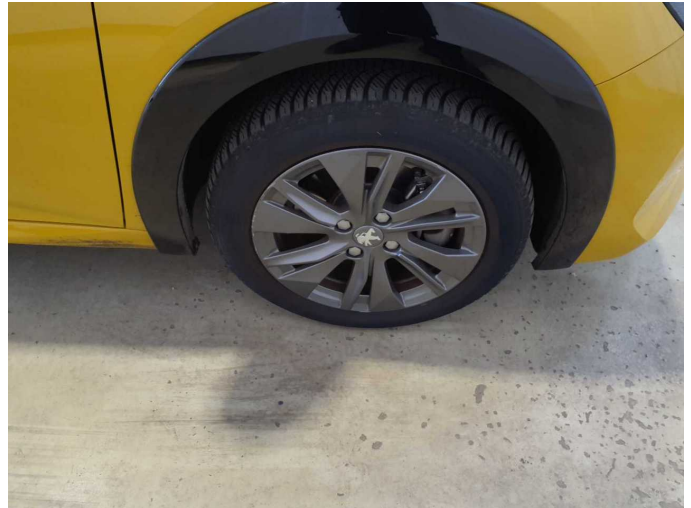
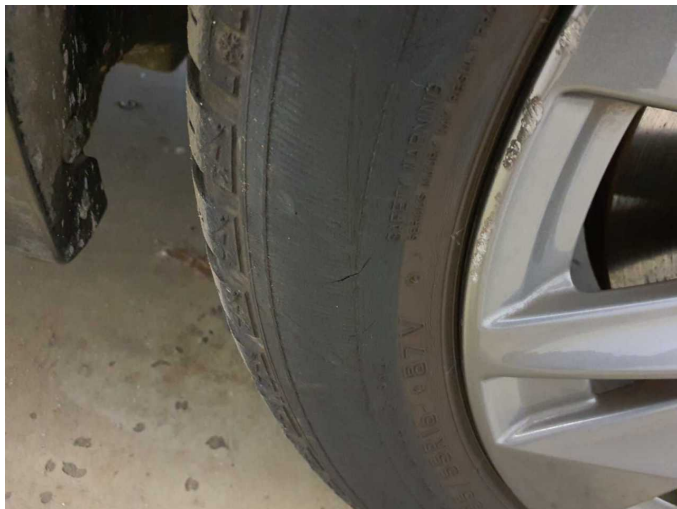
**Damage 4:** Wheel / tyres: Tyre - front right side - Broken / torn - Replace

| No. | Component group | Description |
|---|---|---|
| 4 | Wheel / tyres | Tyre - front right side - Broken / torn - Replace |

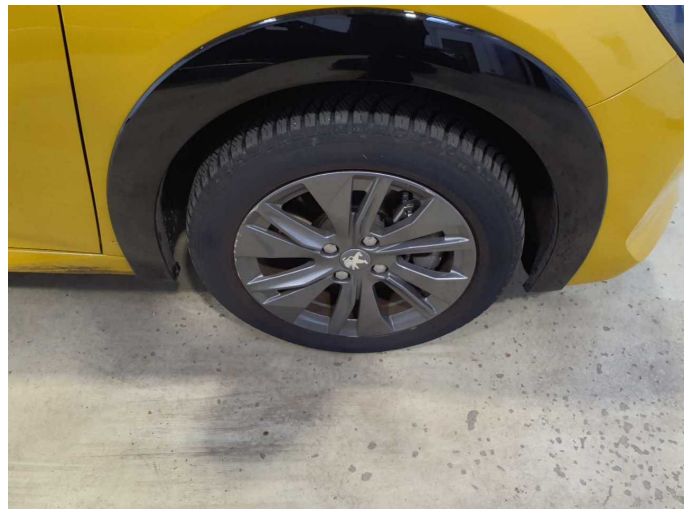
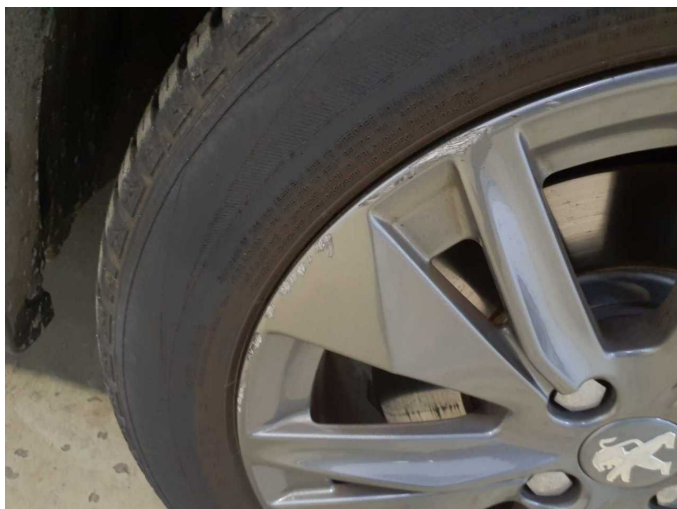
**Damage 5:** Wheel / tyres: Alloy rim - front right side - Scratch(es) - Replace

| No. | Component group | Description |
|---|---|---|
| 5 | Wheel / tyres | Alloy rim - front right side - Scratch(es) - Replace |
