Expertise

Protocol number: 45820335
Order No. / Reference: 26354001
Inspection date: 5 Jun 2026

Model: Octavia Combi 2.0 TDI DSG Style

VIN: TMBJJ8NX0PY101704

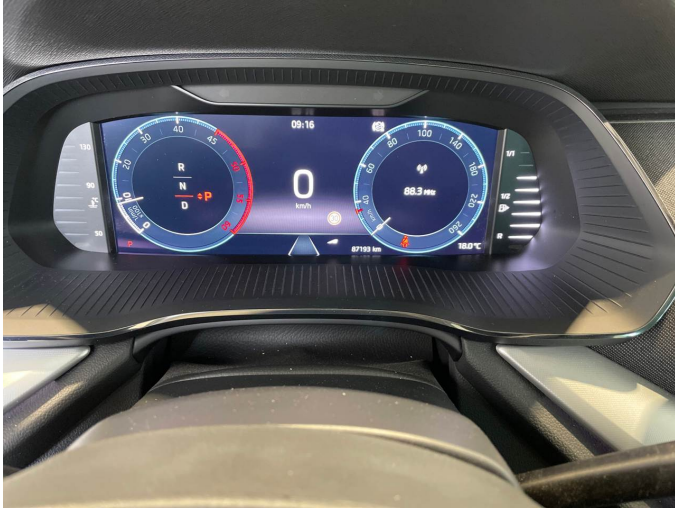
Figure 7: Instrument cluster

Mileage (Read) 87,193 km

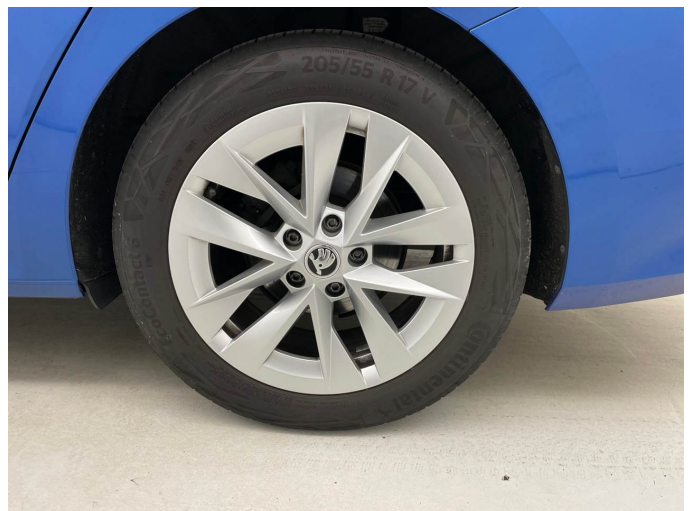
Figure 12: Mounted tyres

#	Tyre size	Type of tyre	Manufacturer	Tread depth
1)	205/55 R17 91V	Summer tyres on Light alloy	Continental	5mm / 5mm
2)	205/55 R17 91V	Summer tyres on Light alloy	Continental	6mm / 6mm

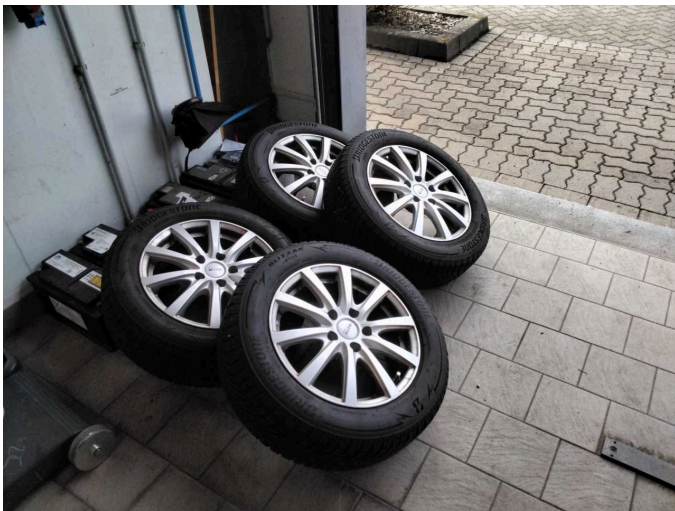
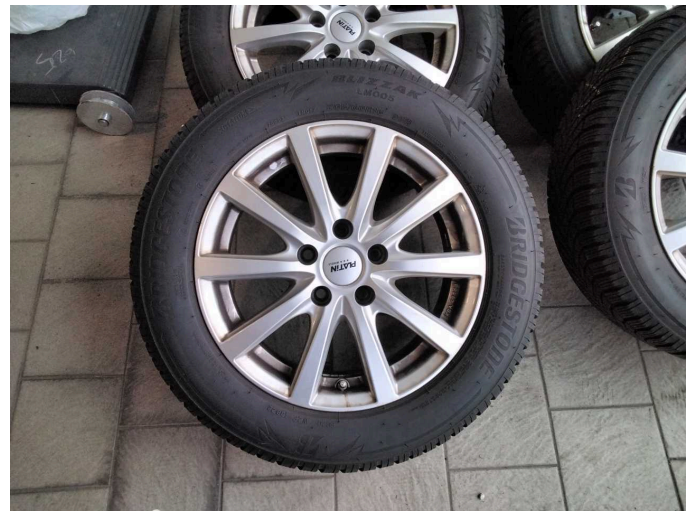
Figure 15: Additional tyres

#	Tyre size	Type of tyre	Manufacturer	Tread depth
1)	205/60 R16 96H	Winter tyres on Light alloy	Bridgestone	5mm / 5mm
2)	205/60 R16 96H	Winter tyres on Light alloy	Bridgestone	6mm / 6mm

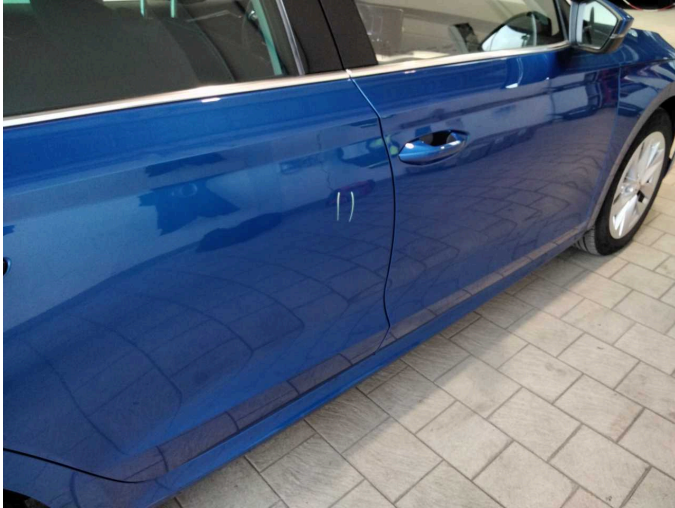
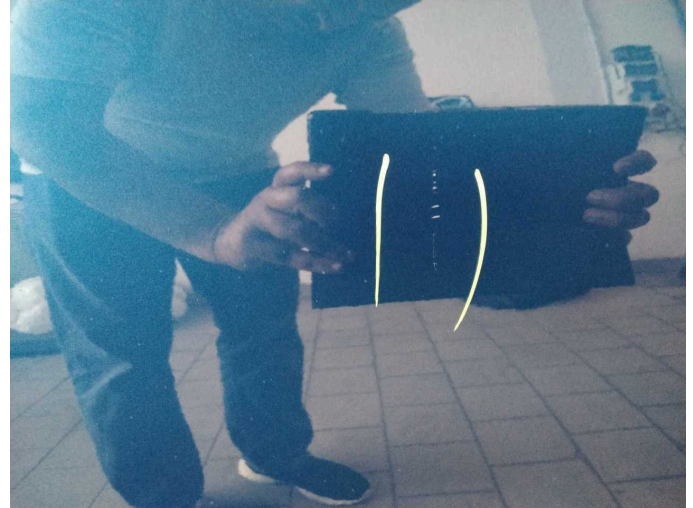
No.	Component group	Description
1	Door - rear right side	Door - Scratch(es) - Paint

Damage 1: Door - rear right side: Door - Scratch(es) - Paint

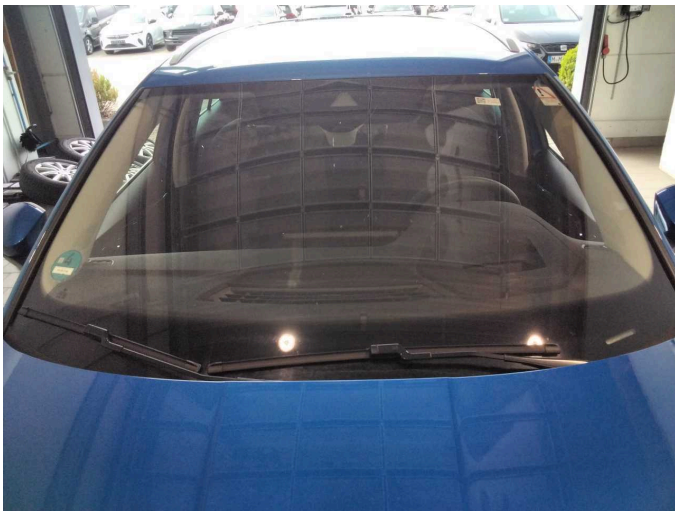
No.	Component group	Description
1	Vehicle glazing	Windscreen - Stone chips - No deduction
2	Bonnet	Bonnet - Stone chips - No deduction
3	Front bumper	Front bumper - Stone chips - No deduction
4	Rear bumper	Rear bumper - Scratch(es) - No deduction

Wear and tear 1: Vehicle glazing: Windscreen - Stone chips - No deduction
