Expertise

Protocol number: 46653676  
Order No. / Reference: 26663232  
Inspection date: 21 Jul 2026

Manufacturer: Skoda  
VIN: TMBJJ9NX9MY059549

Model: Octavia Combi 2.0 TDI DSG First Edition

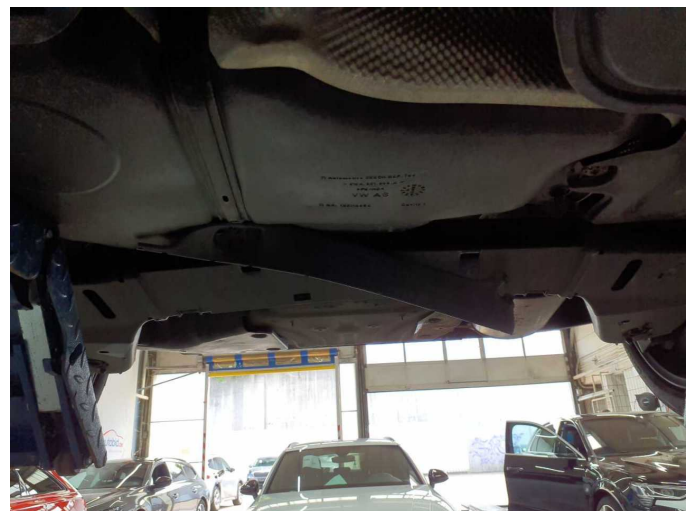
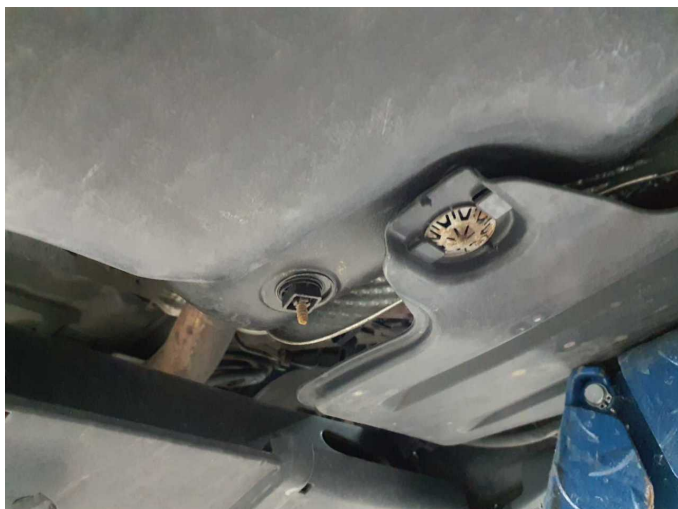
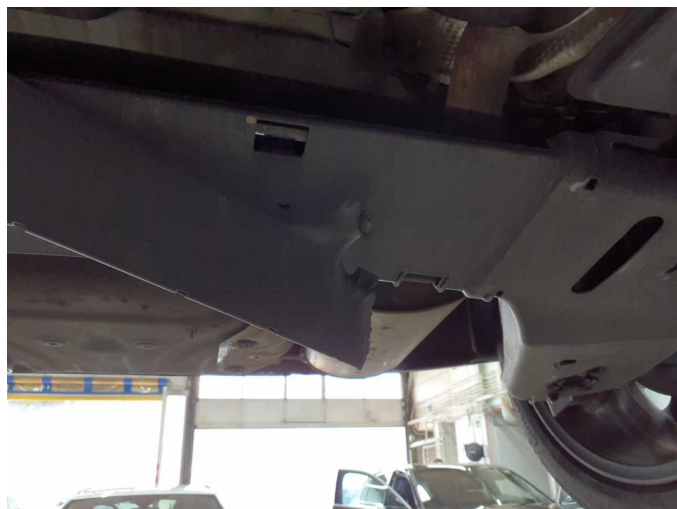
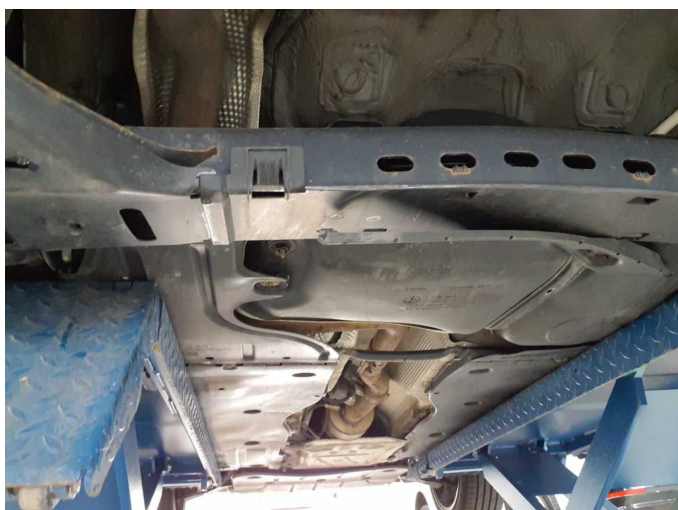
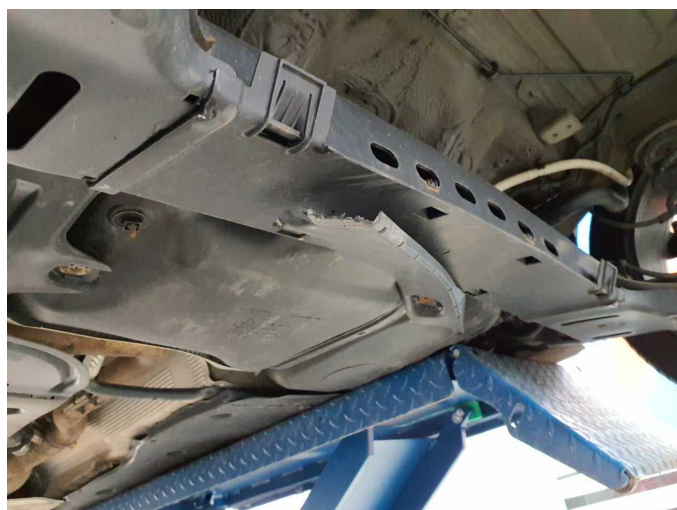
| No. | Component group | Description |
|---|---|---|
| 1 | Body | Underbody panelling (hinten mitte) - Broken / torn - Replace |

**Damage 1:** Body: Underbody panelling (hinten mitte) - Broken / torn - Replace

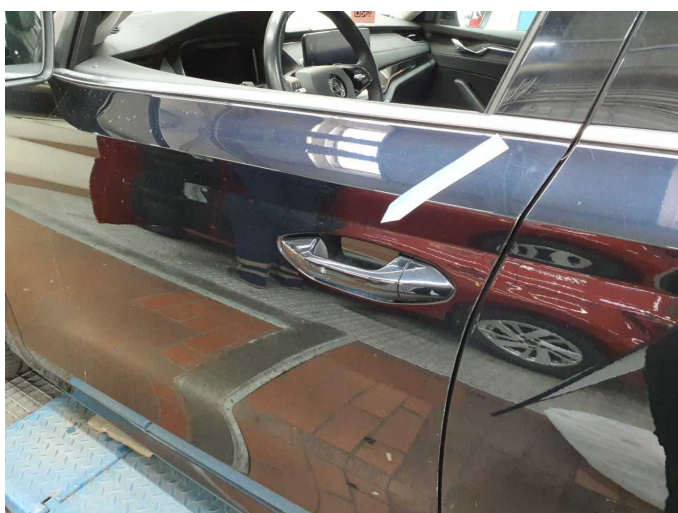
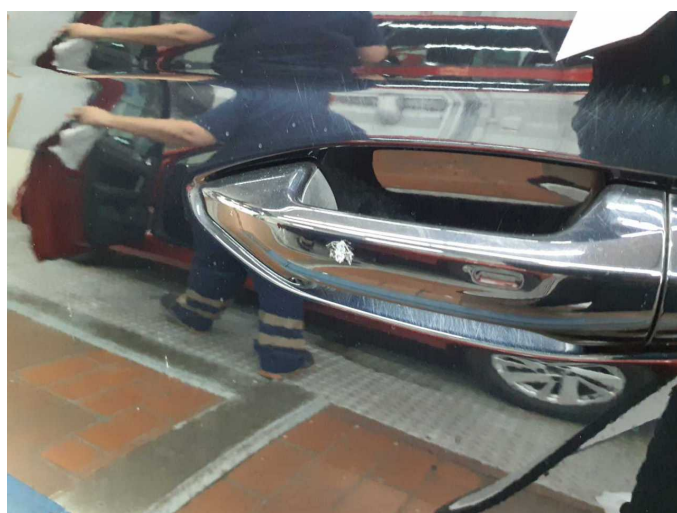
| No. | Component group | Description |
|---|---|---|
| 2 | Door - front left side | Door handle - outside - Scratch(es) - Smart repair |

**Damage 2:** Door - front left side: Door handle - outside - Scratch(es) - Smart repair

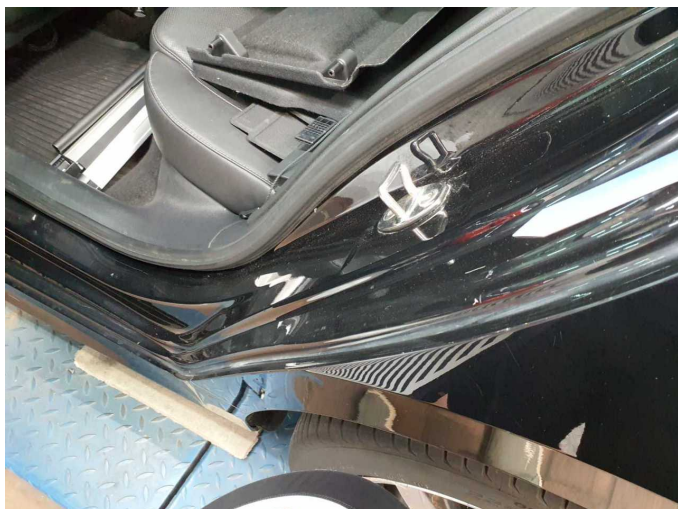
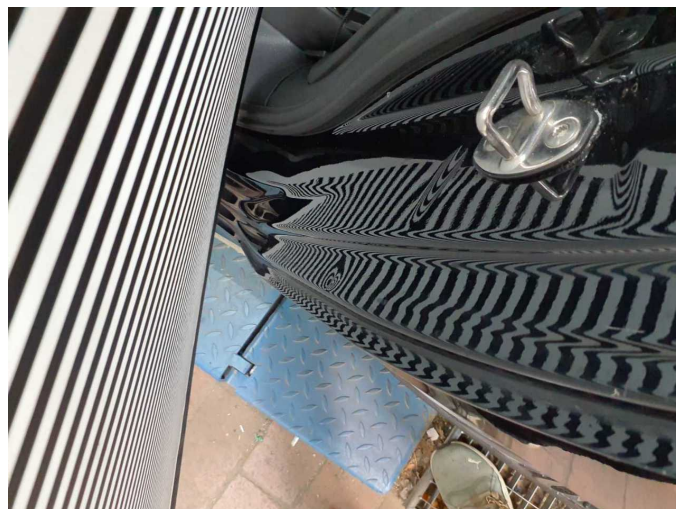
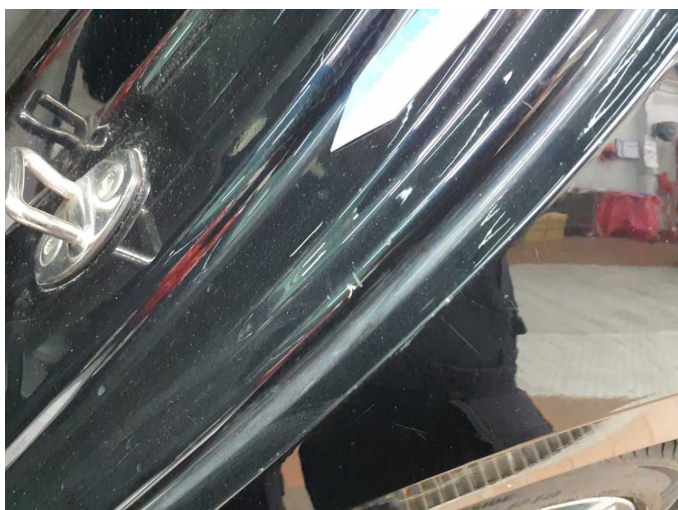
| No. | Component group | Description |
|---|---|---|
| 3 | Side panel - rear left side | Sill - Dent / paintcoat damage - Smart repair |

**Damage 3:** Side panel - rear left side: Sill - Dent / paintcoat damage - Smart repair

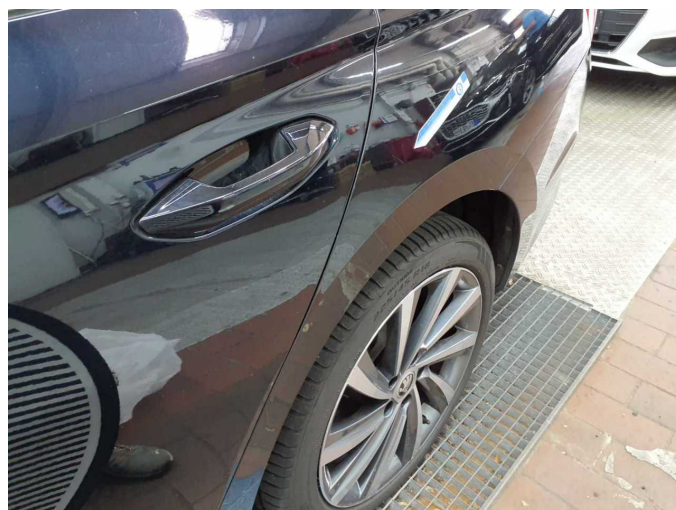
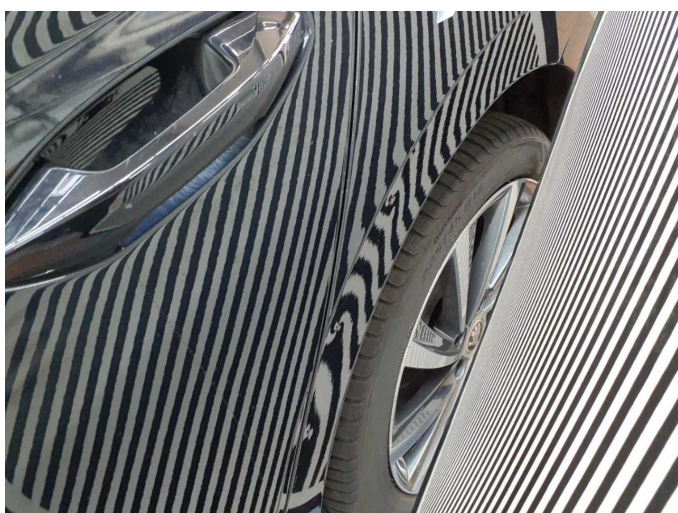
| No. | Component group | Description |
|---|---|---|
| 4 | Side panel - rear left side | Side panel - dent(s) - Smart repair |

**Damage 4:** Side panel - rear left side: Side panel - dent(s) - Smart repair

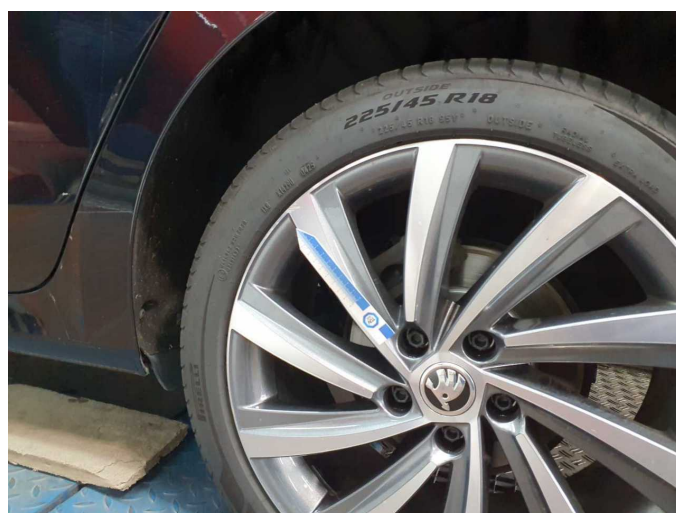
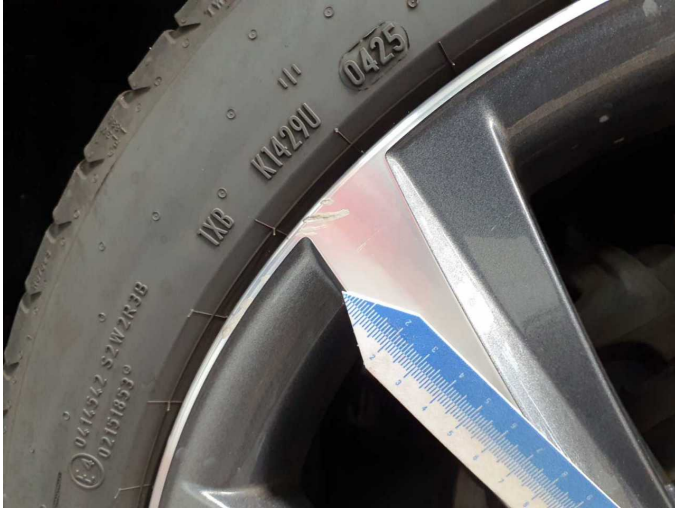
| No. | Component group | Description |
|---|---|---|
| 5 | Wheel / tyres | Alloy rim - rear left side - Scratch(es) - Loss in value |

**Damage 5:** Wheel / tyres: Alloy rim - rear left side - Scratch(es) - Loss in value

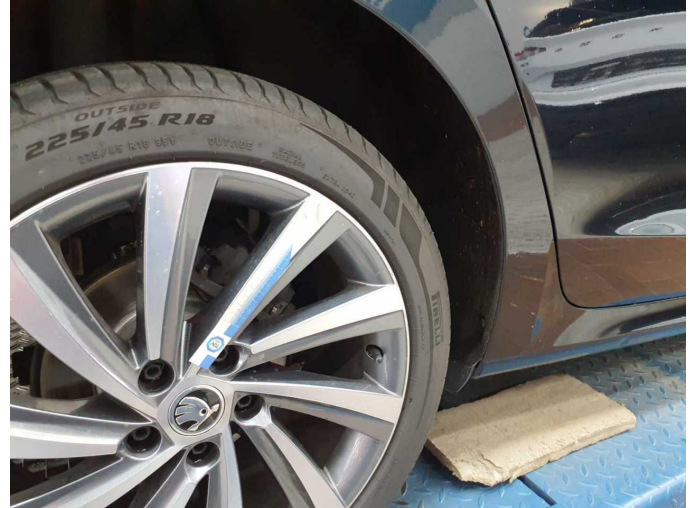
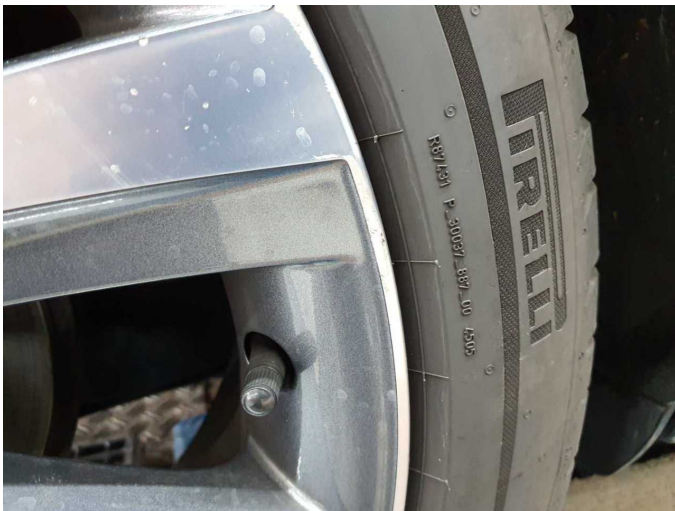
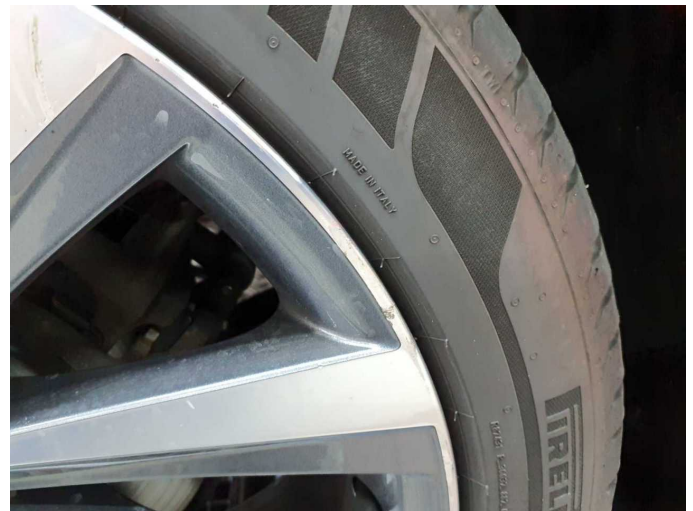
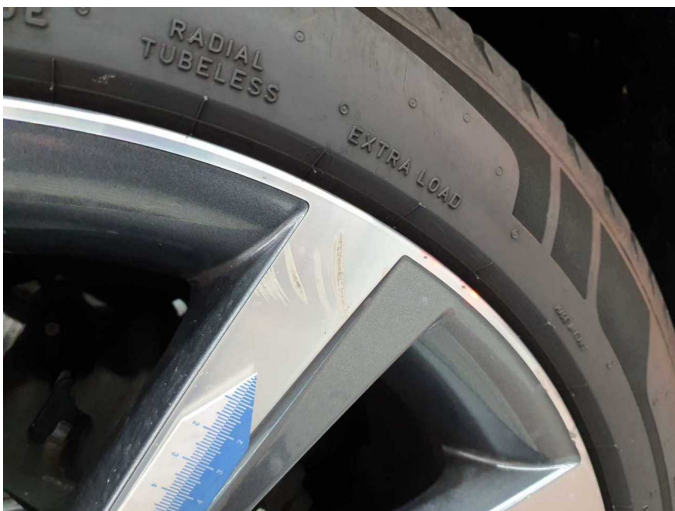
| No. | Component group | Description |
|---|---|---|
| 6 | Wheel / tyres | Alloy rim - rear right side - Scratch(es) - Loss in value |

**Damage 6:** Wheel / tyres: Alloy rim - rear right side - Scratch(es) - Loss in value

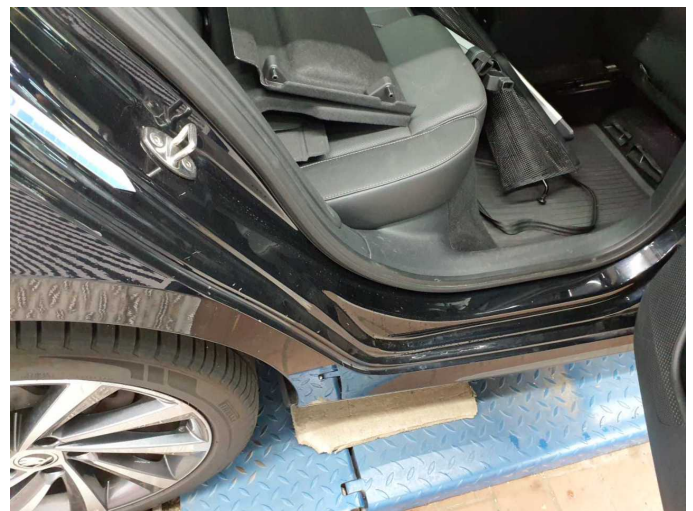
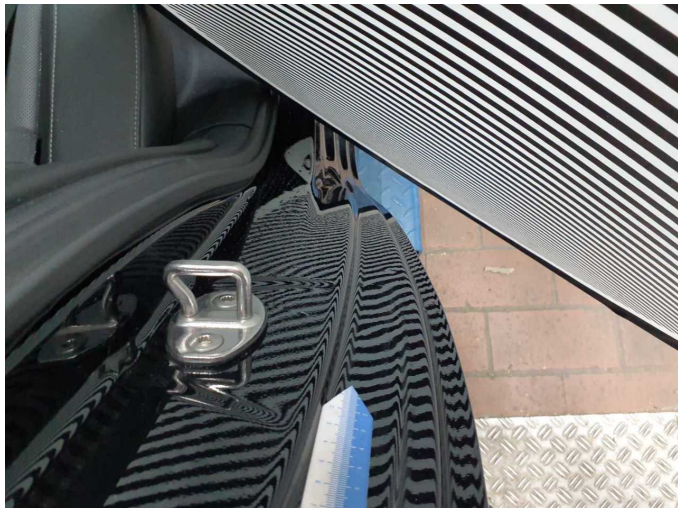
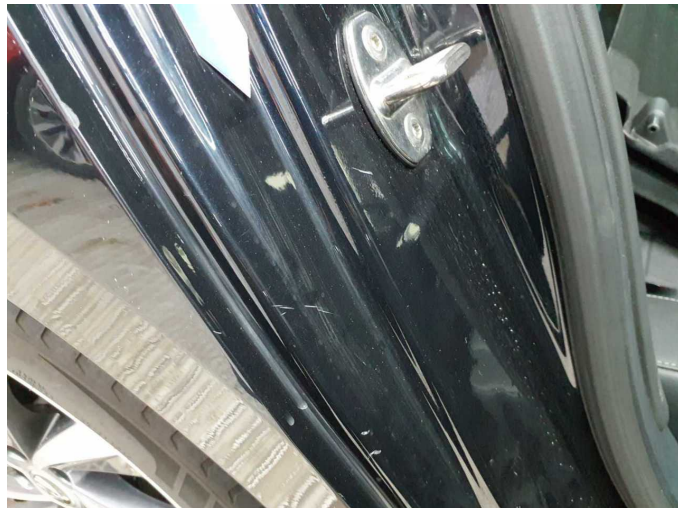
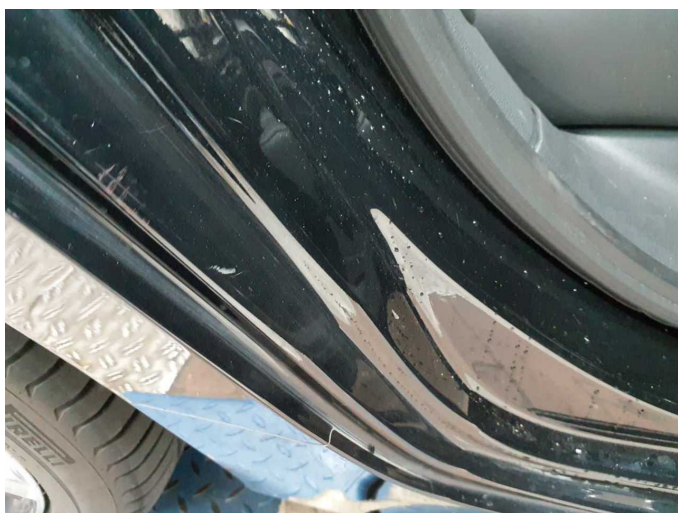
| No. | Component group | Description |
|---|---|---|
| 7 | Side panel - rear right side | Sill - Dent / paintcoat damage - Smart repair |

**Damage 7:** Side panel - rear right side: Sill - Dent / paintcoat damage - Smart repair

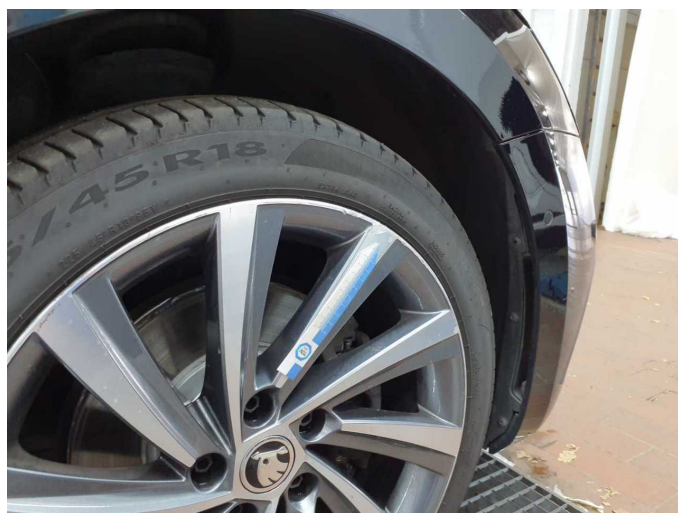
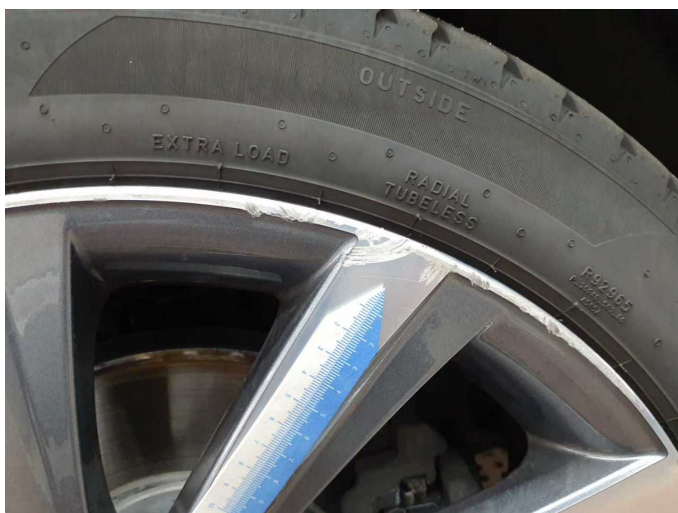
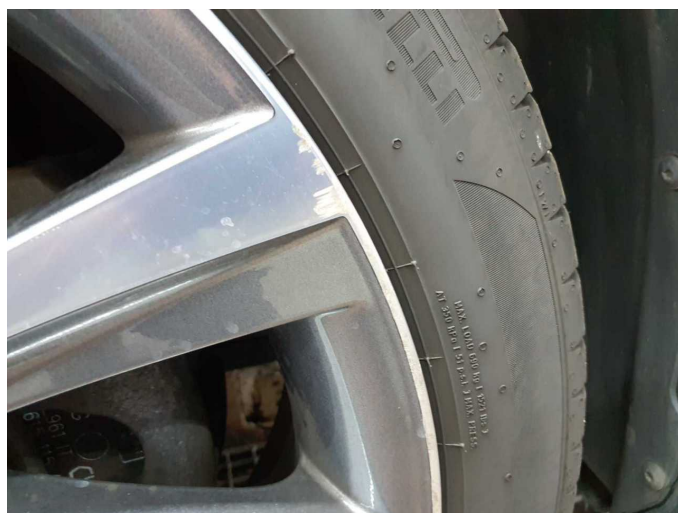
| No. | Component group | Description |
|---|---|---|
| 8 | Wheel / tyres | Alloy rim - front right side (Materialabtrag) - Functional / admissibility - Replace |

**Damage 8:** Wheel / tyres: Alloy rim - front right side (Materialabtrag) - Functional / admissibility - Replace

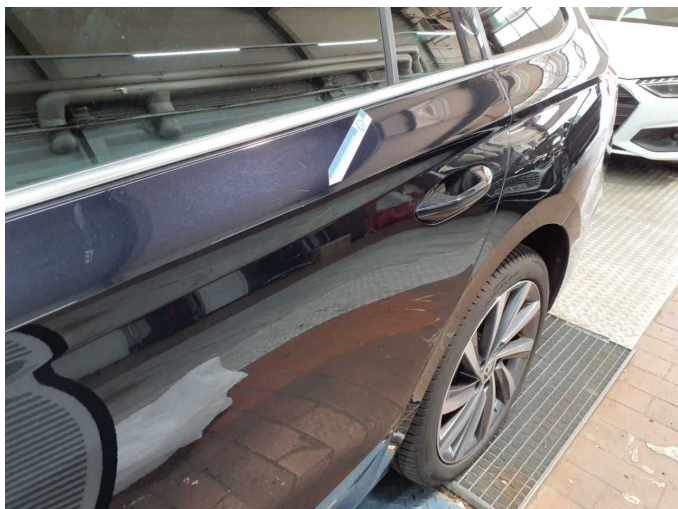
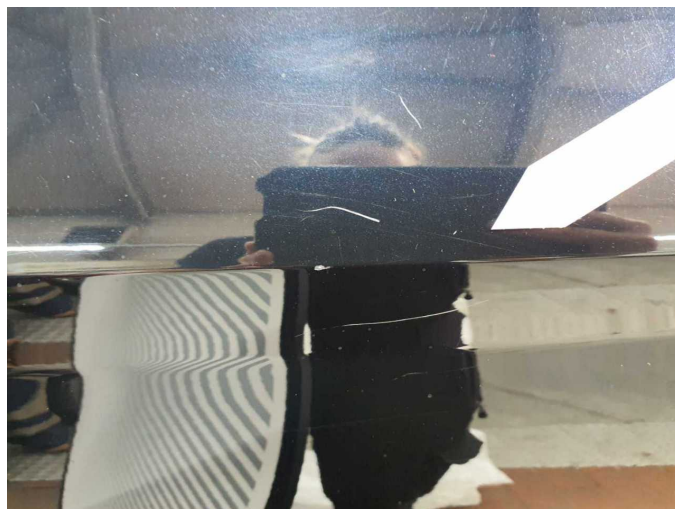
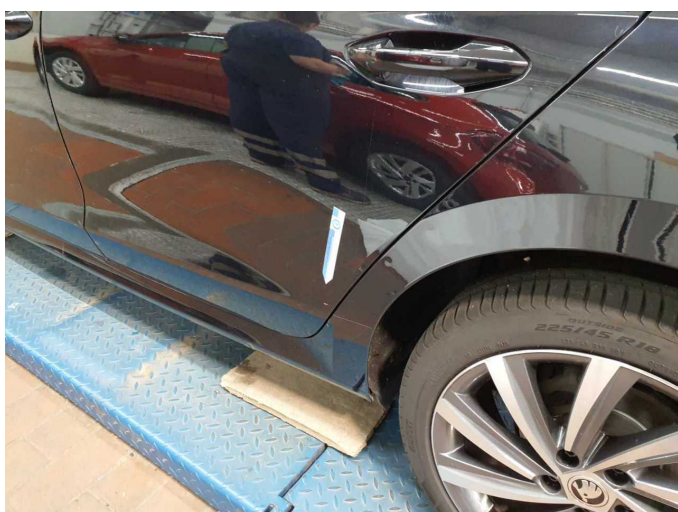
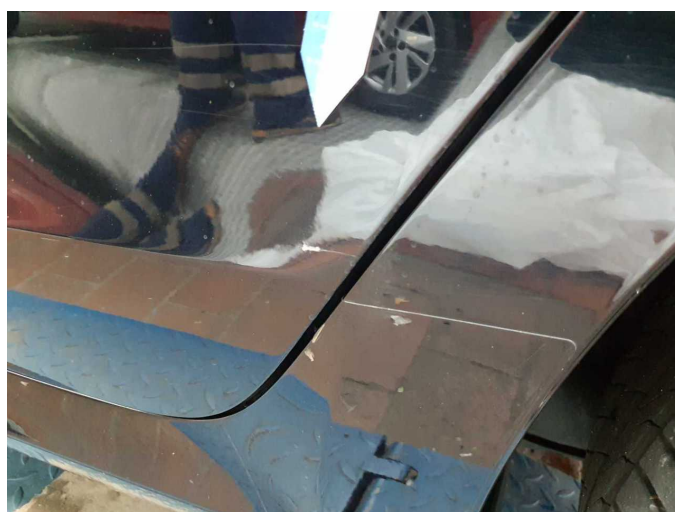
| No. | Component group | Description |
|---|---|---|
| 9 | Door - rear left side | Door - Scratched - Paint |

**Damage 9:** Door - rear left side: Door - Scratched - Paint

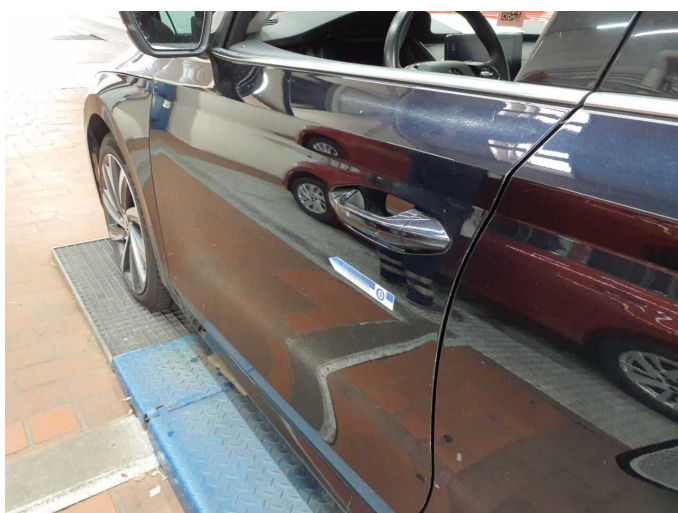
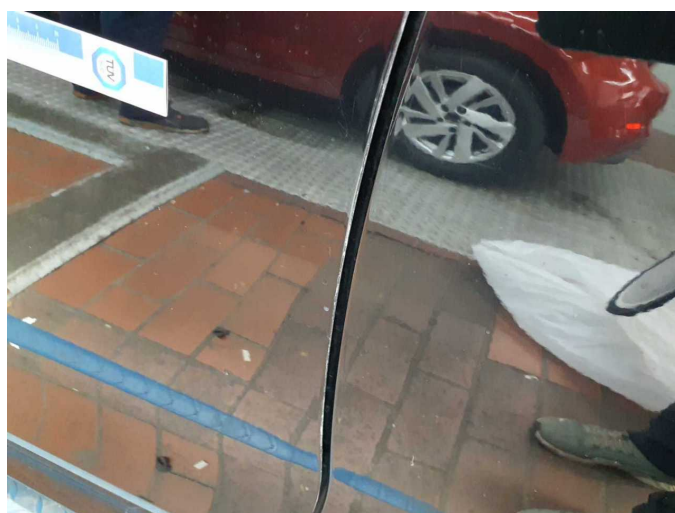
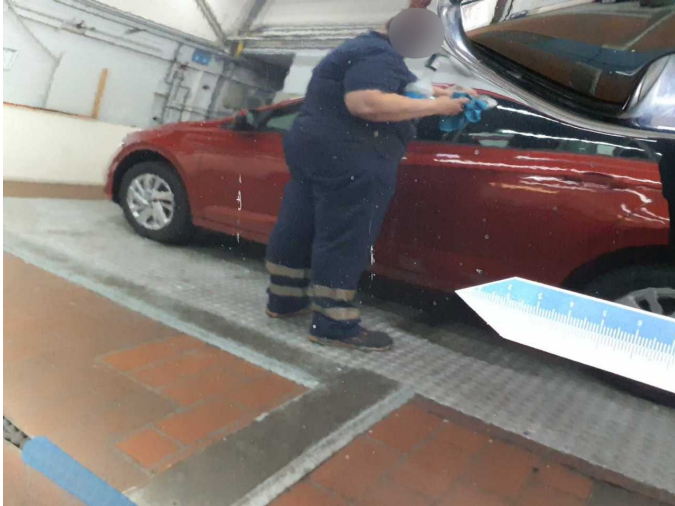
| No. | Component group | Description |
|---|---|---|
| 10 | Door - front left side | Door - Scratch(es) - Paint |

**Damage 10:** Door - front left side: Door - Scratch(es) - Paint

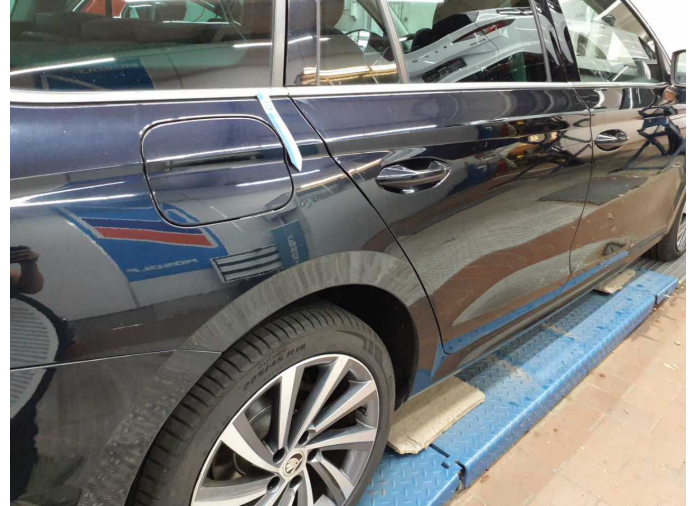
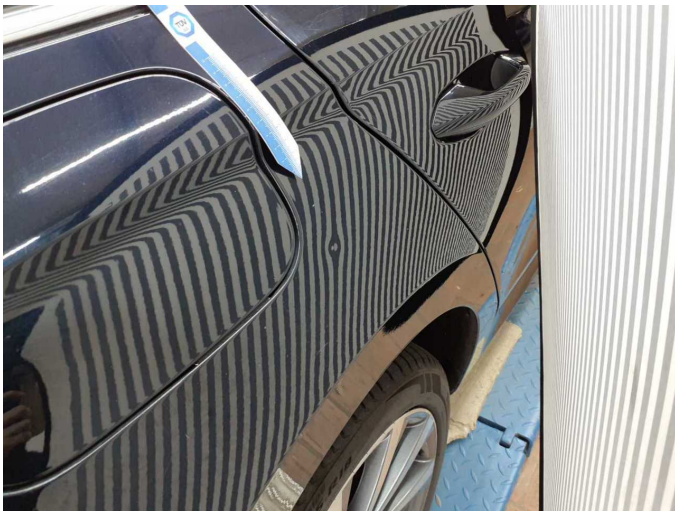
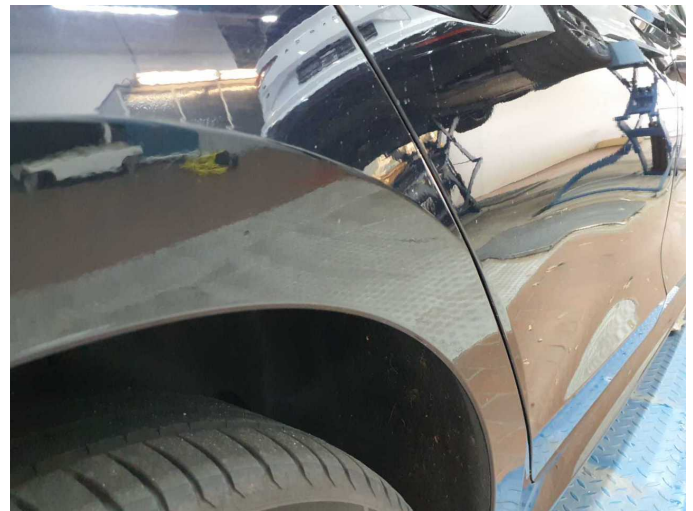
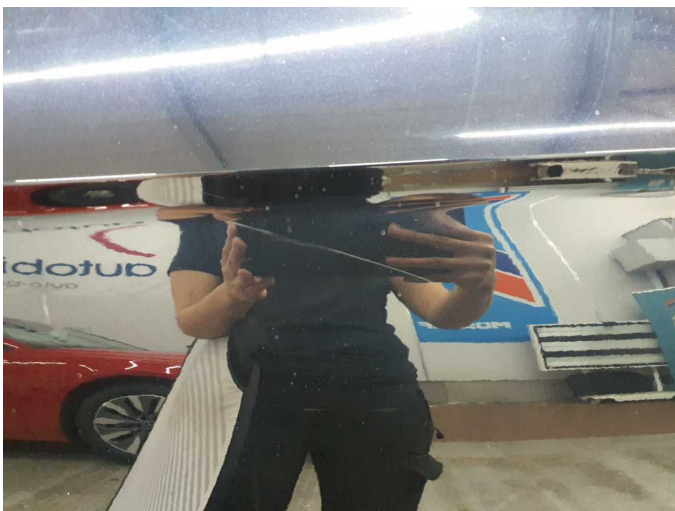
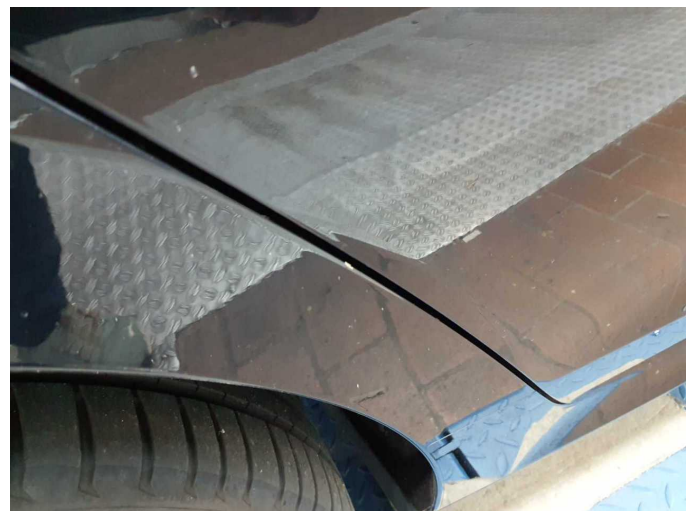
| No. | Component group | Description |
|---|---|---|
| 11 | Side panel - rear right side | Side panel (+ Kratzer) - Dent / paintcoat damage - Paint |

**Damage 11:** Side panel - rear right side: Side panel (+ Kratzer) - Dent / paintcoat damage - Paint

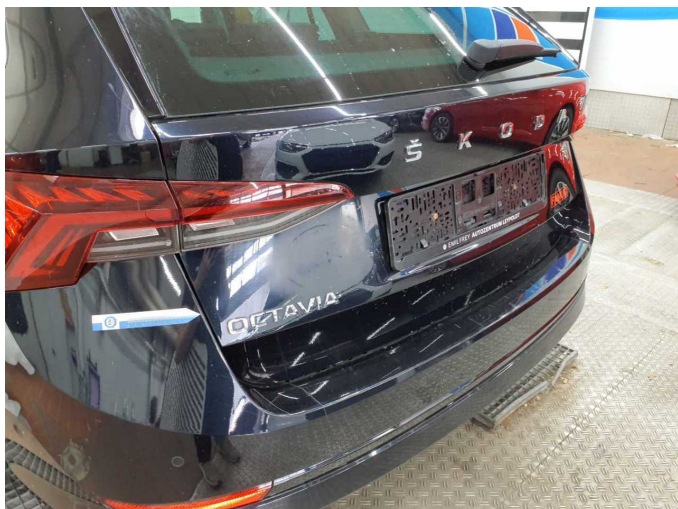
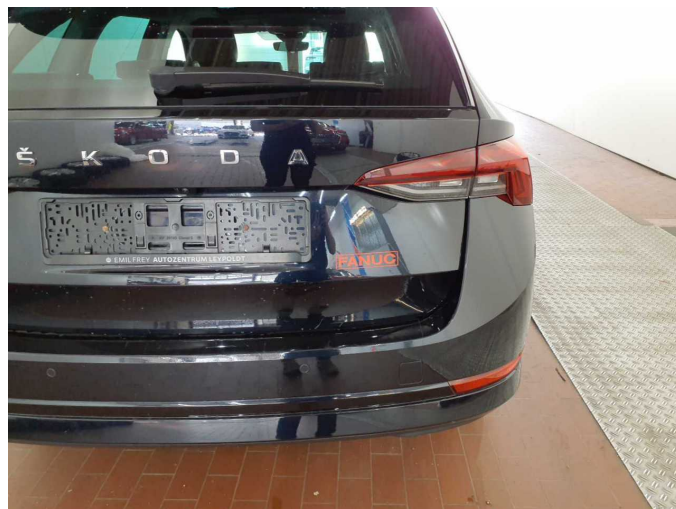
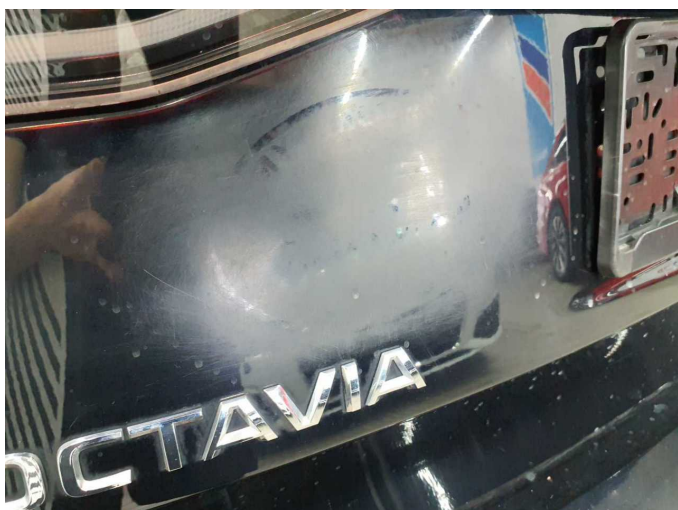
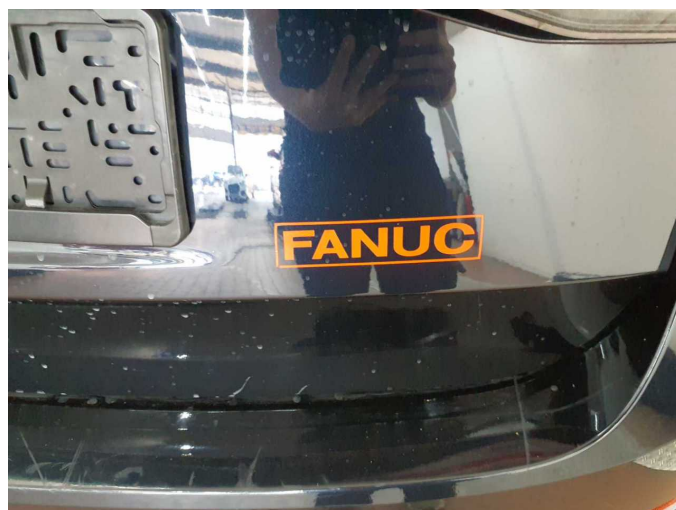
| No. | Component group | Description |
|---|---|---|
| 12 | Boot lid / rear door | Boot lid (mit Entkleben) - Scratched - Paint |

**Damage 12:** Boot lid / rear door: Boot lid (mit Entkleben) - Scratched - Paint

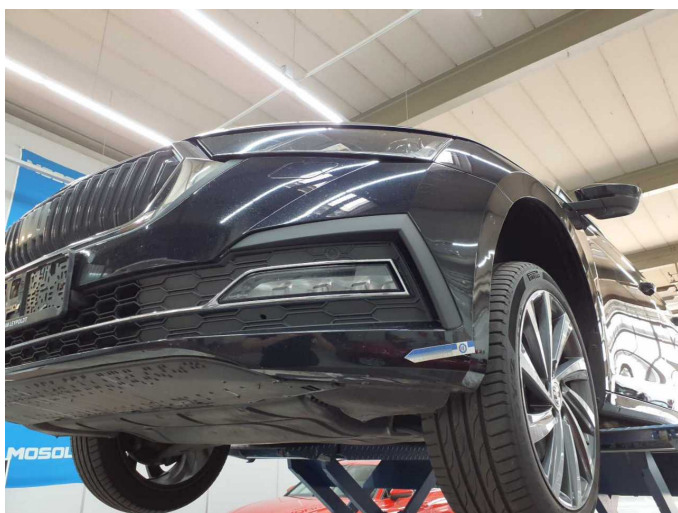
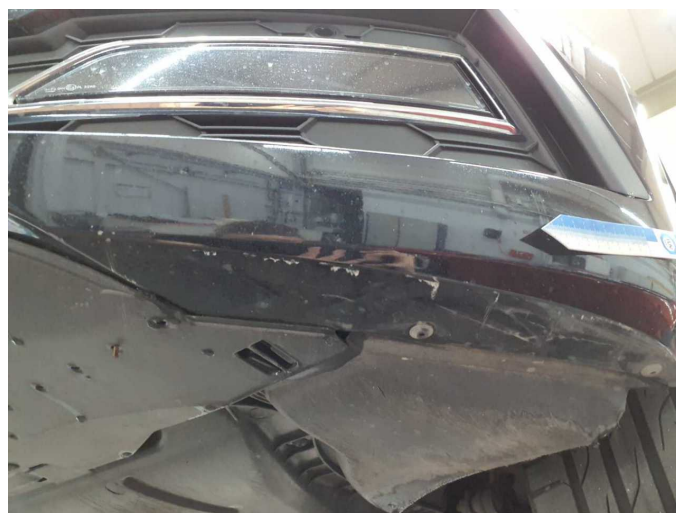
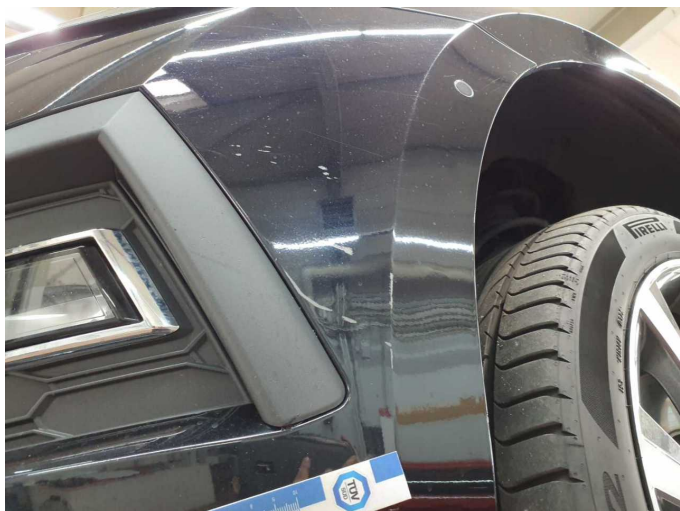
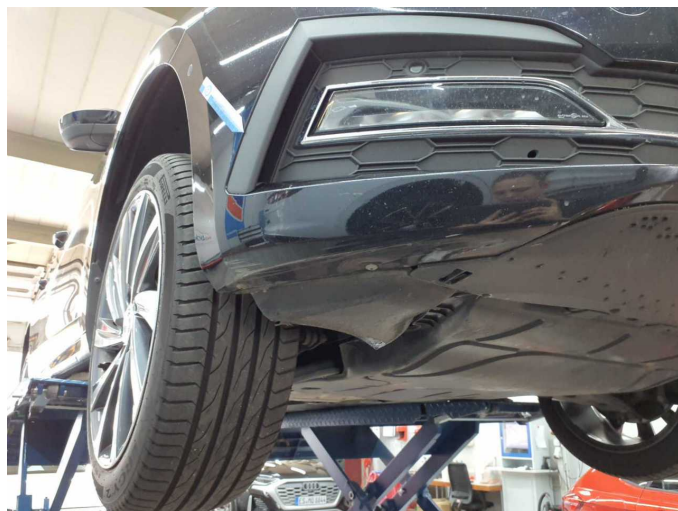
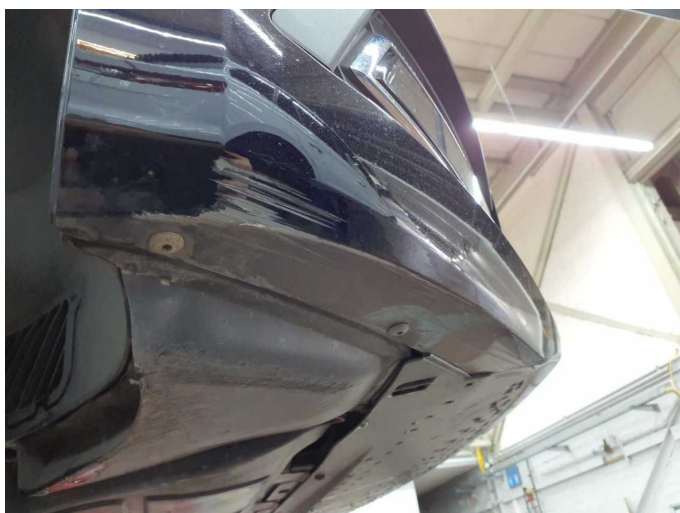
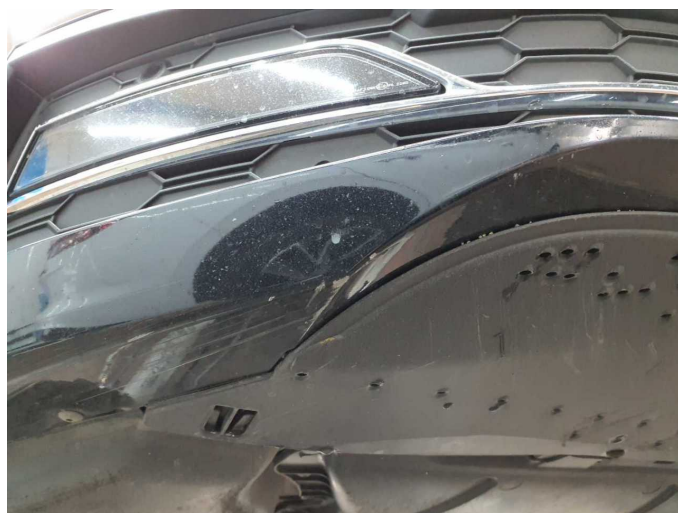
| No. | Component group | Description |
|---|---|---|
| 13 | Front bumper | Front bumper - Scratched - Paint |

**Damage 13:** Front bumper: Front bumper - Scratched - Paint

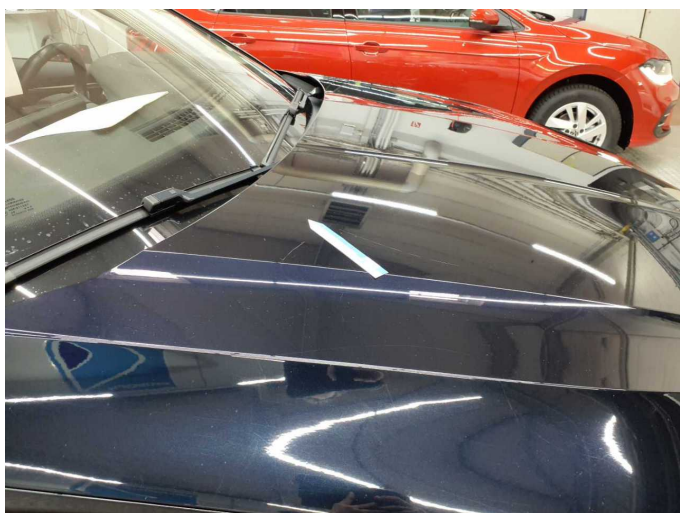
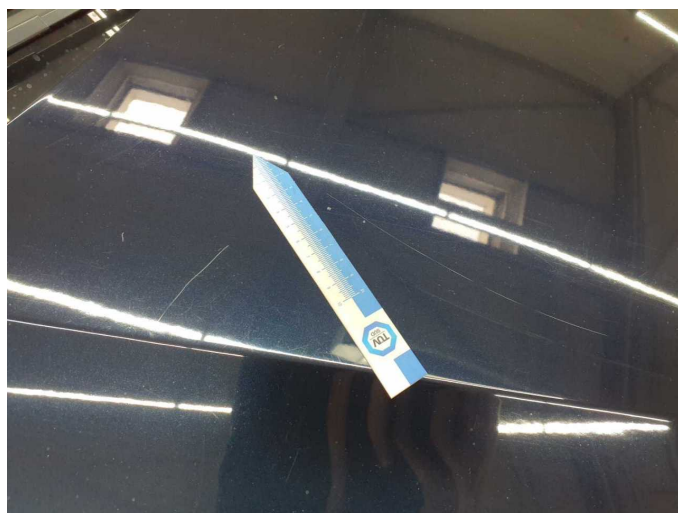
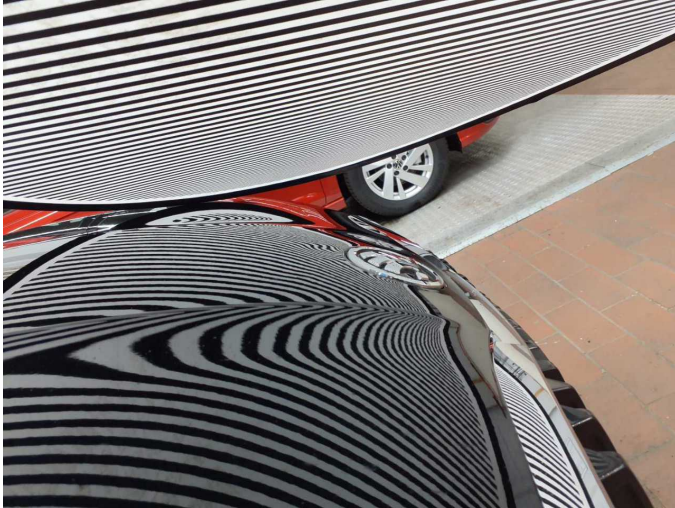
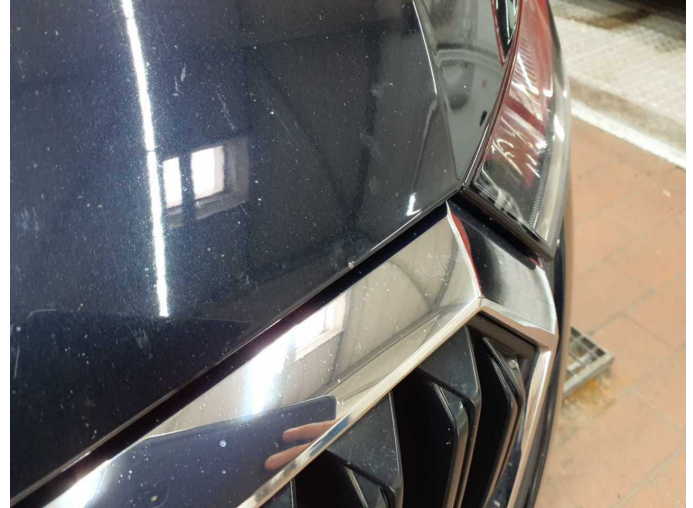
| No. | Component group | Description |
|---|---|---|
| 14 | Bonnet | Bonnet - Dent / paintcoat damage - Paint |

**Damage 14:** Bonnet: Bonnet - Dent / paintcoat damage - Paint
