Expertise

Protocol number: 46144442
Order No. / Reference: 26513078
Inspection date: 24 Jun 2026

Manufacturer: Volvo

Model: XC40 B3 B DKG Core

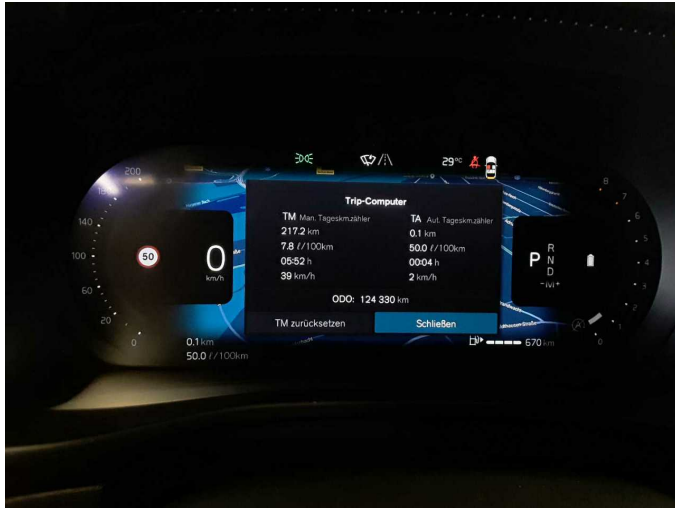
Figure 7: Instrument cluster

Mileage (Read) 124,330 km

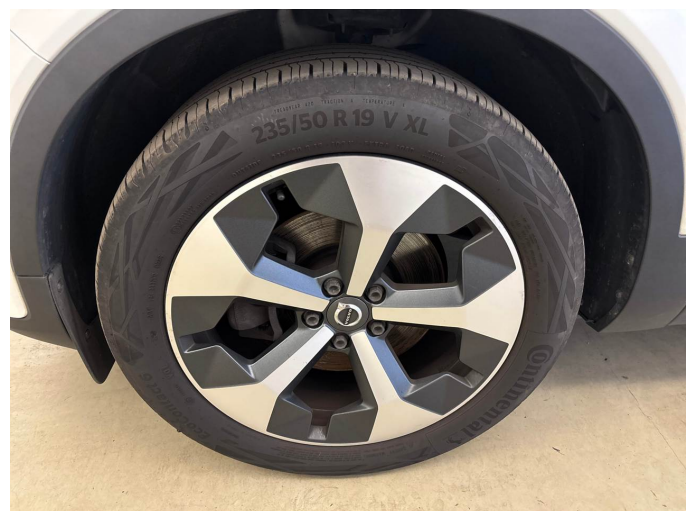
#	Tyre size	Type of tyre	Manufacturer	Tread depth
1)	235/50 R19 103V	Summer tyres on Light alloy	Continental	4mm / 4mm
2)	235/50 R19 103V	Summer tyres on Light alloy	Continental	4mm / 4mm

Figure 12: Mounted tyres

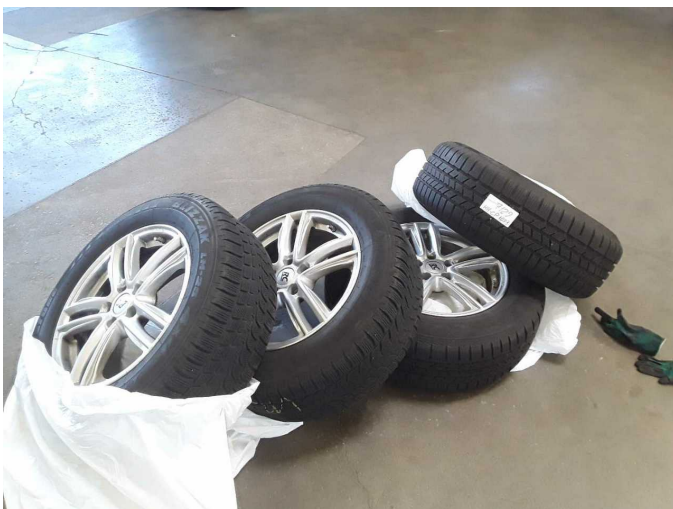
#	Tyre size	Type of tyre	Manufacturer	Tread depth
1)	235/60 R17 102H	Winter tyres on Light alloy	Bridgestone	5mm / 5mm
2)	235/60 R17 102H	Winter tyres on Light alloy	Continental	5mm / 5mm

Figure 17: Additional tyres

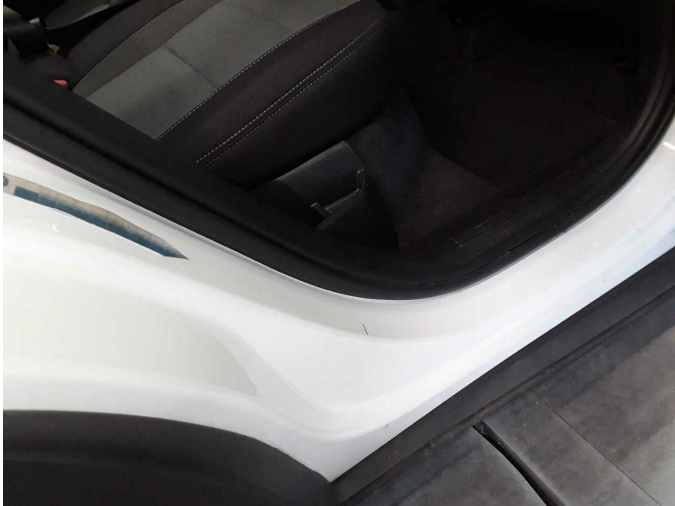
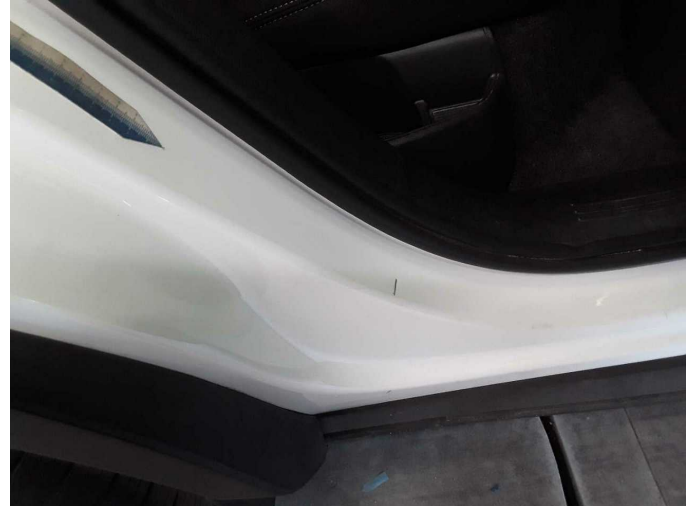
Damage 1: Side panel - rear right side: Sill - Scratch(es) - Smart repair

No.	Component group	Description
1	Side panel - rear right side	Sill - Scratch(es) - Smart repair
2	Rear bumper	Rear bumper - Scratch(es) - Smart repair
3	Bonnet	Insulation lining - Missing - Replace

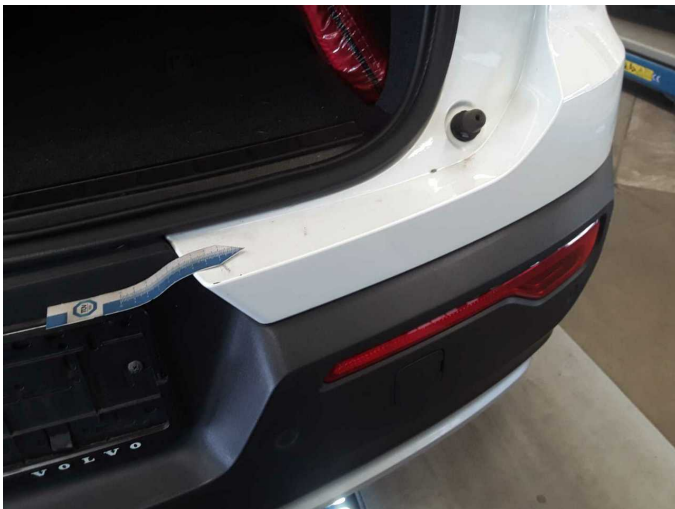
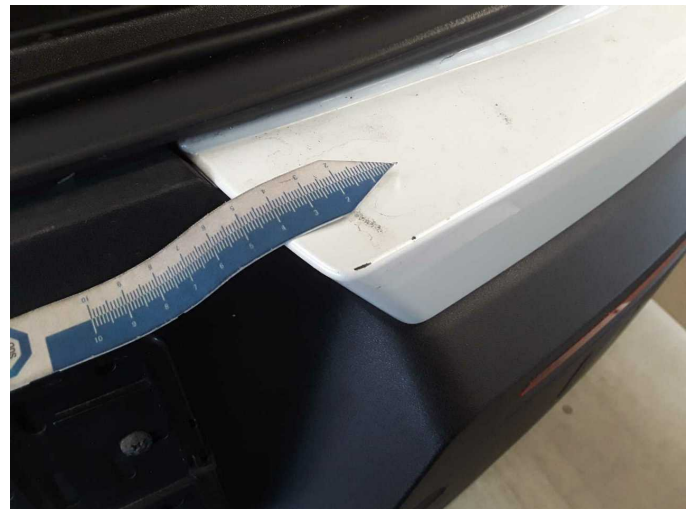
Damage 2: Rear bumper: Rear bumper - Scratch(es) - Smart repair

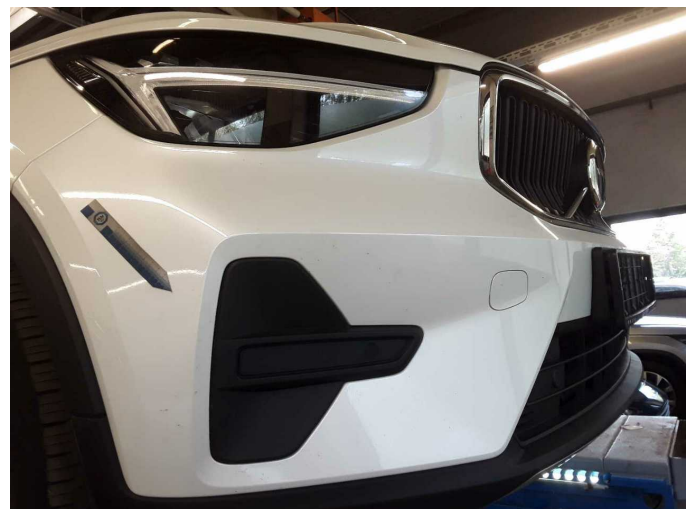
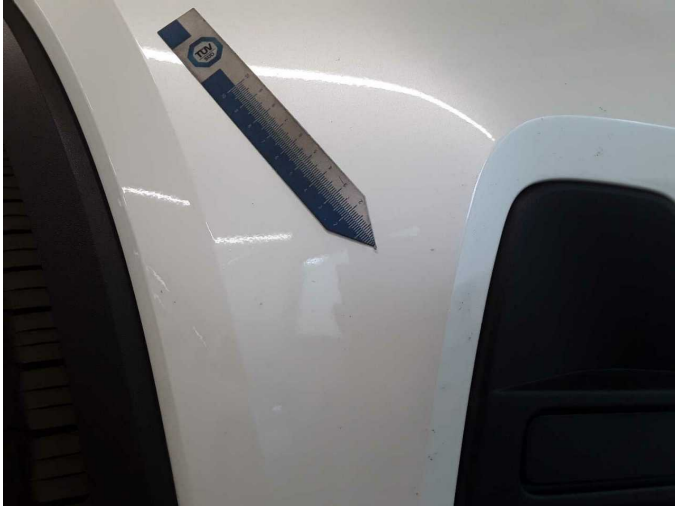
No.	Component group	Description
1	Front bumper	Front bumper - Stone chips - No deduction
2	Vehicle glazing	Windscreen - Stone chips - No deduction

Wear and tear 1: Front bumper: Front bumper - Stone chips - No deduction

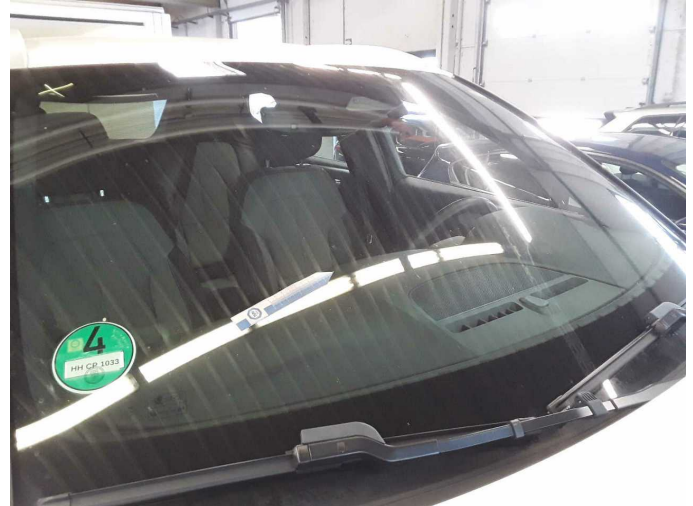
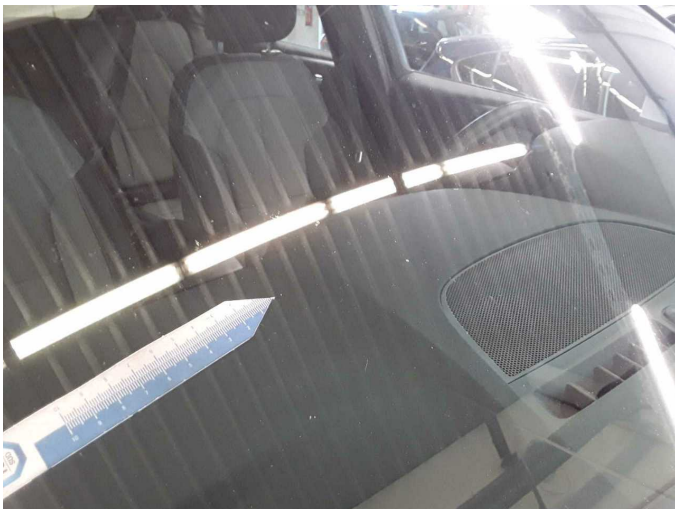
Wear and tear 2: Vehicle glazing: Windscreen - Stone chips - No deduction

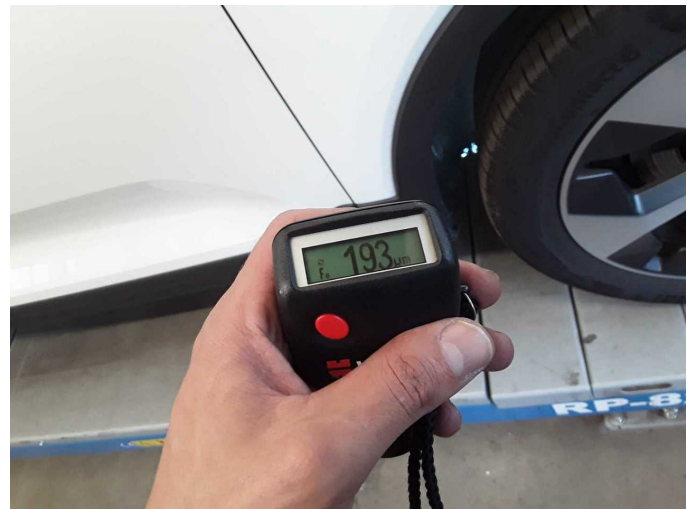
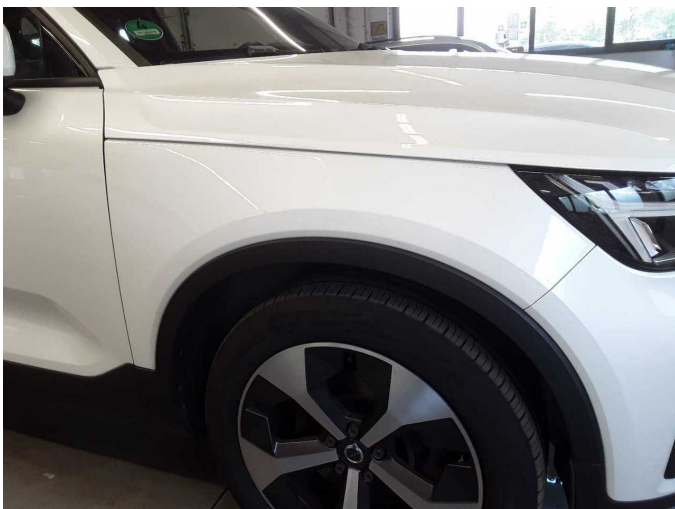
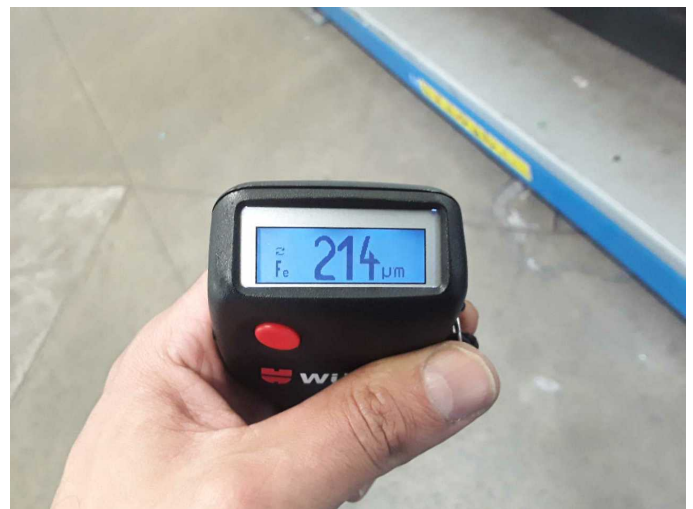
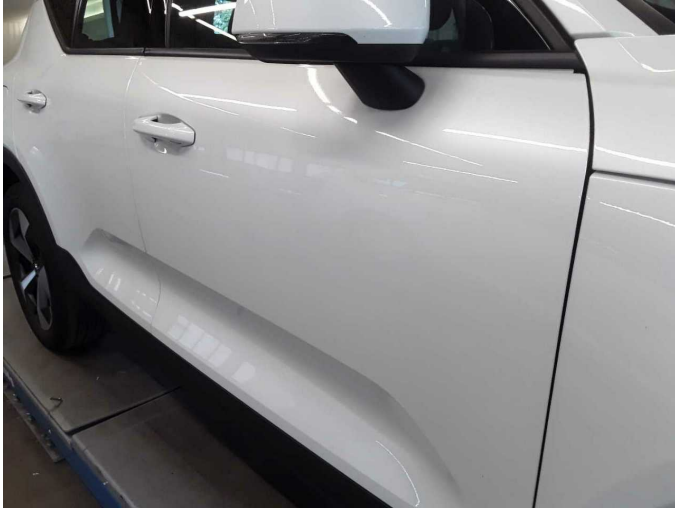
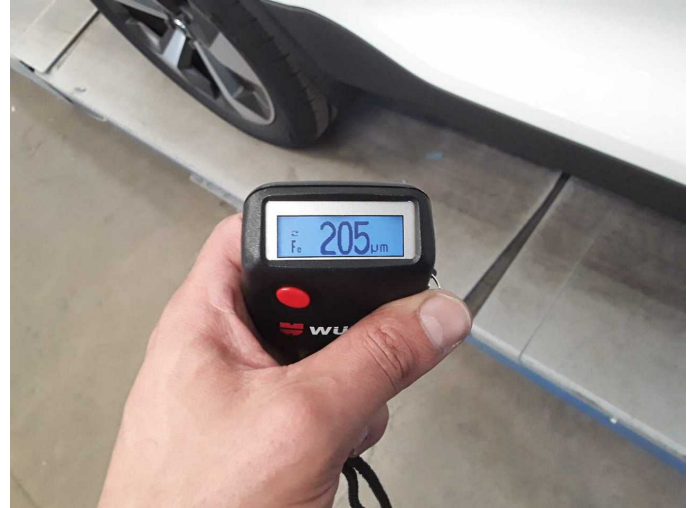
No.	Repainting
1	Mudguard - right side, Door - rear right side, Door - front right side, Professionally carried out, Invoice of repair done

Repainting 1: Mudguard - right side, Door - rear right side, Door - front right side
