## Expertise

Protocol number: 46117089  
Order No. / Reference: 26504959  
Inspection date: 18 Jun 2026

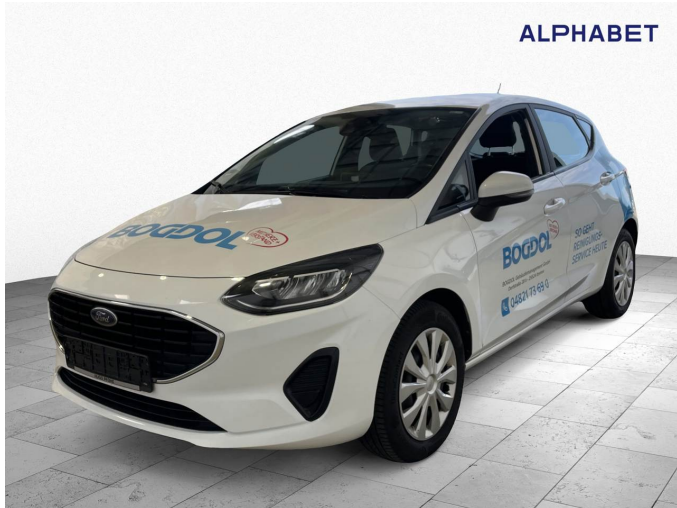
Figure 1: Diagonal front (left)

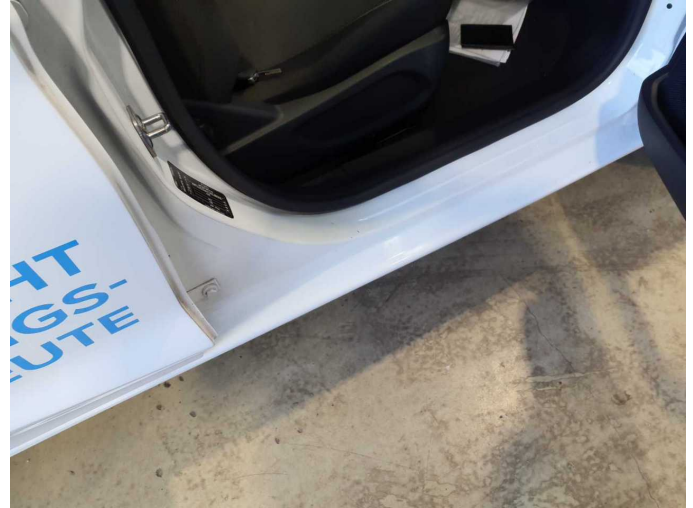
Damage 2: Sill - right side: Sill - Dent / paintcoat damage - Smart repair

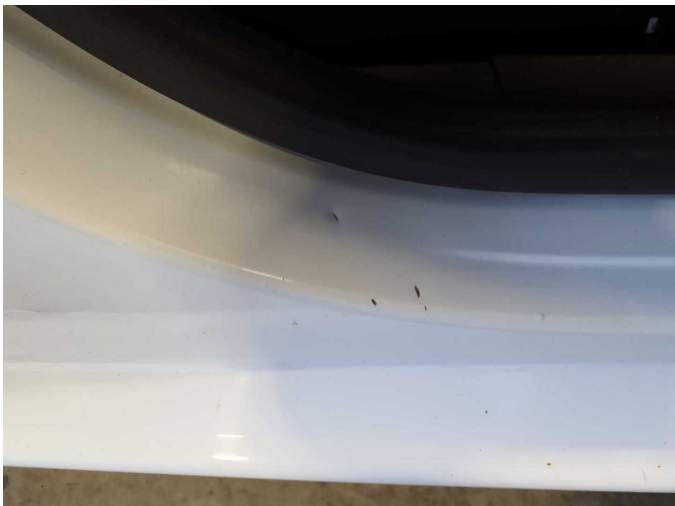
Damage 2: Sill - right side: Sill - Dent / paintcoat damage - Smart repair

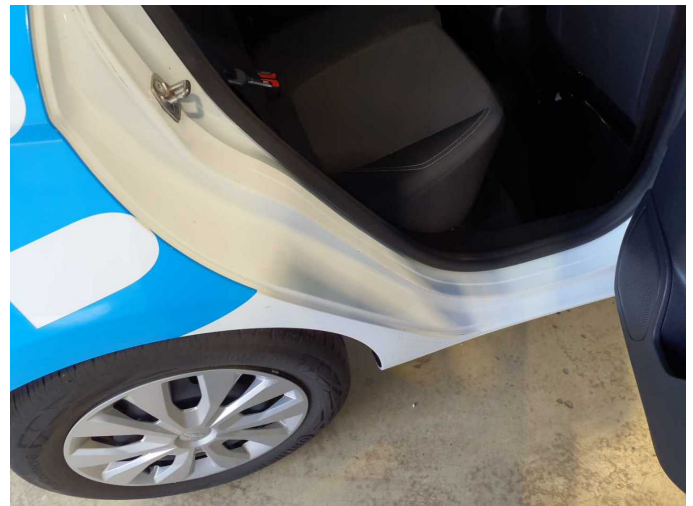
Damage 3: Side panel - rear right side: Sill - Scratch(es) - Smart repair

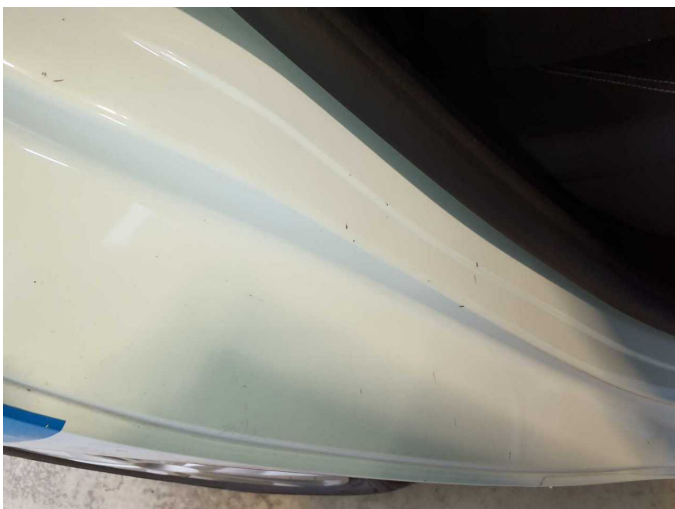
Damage 3: Side panel - rear right side: Sill - Scratch(es) - Smart repair

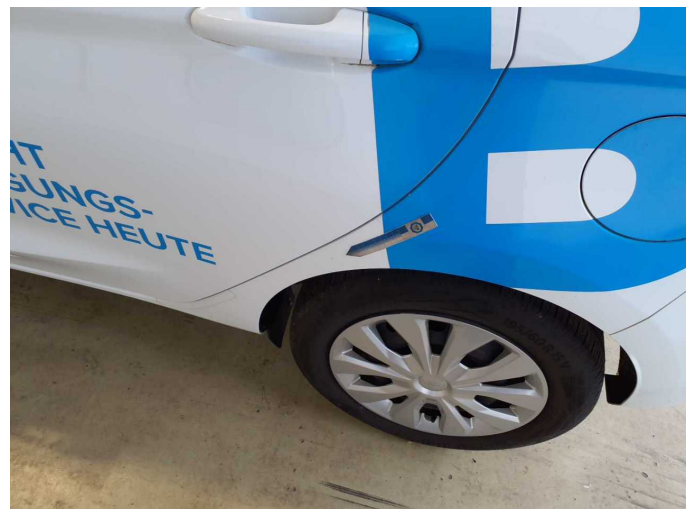
Damage 4: Side panel - rear left side: Side panel - Dent / paintcoat damage - Smart repair

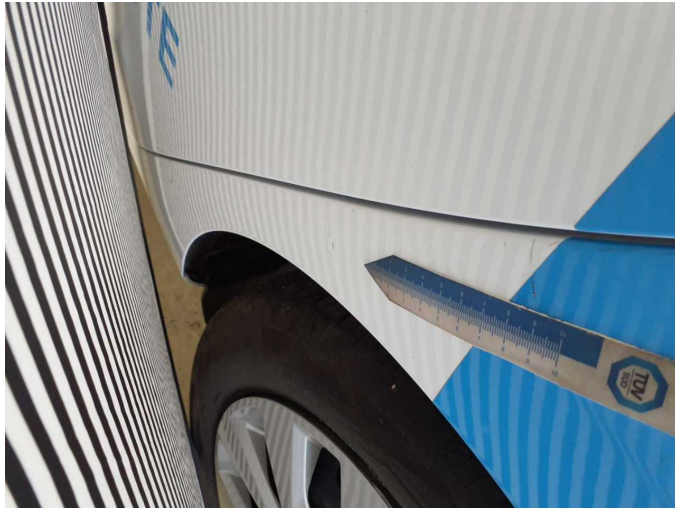
**Damage 4:** Side panel - rear left side: Side panel - Dent / paintcoat damage - Smart repair

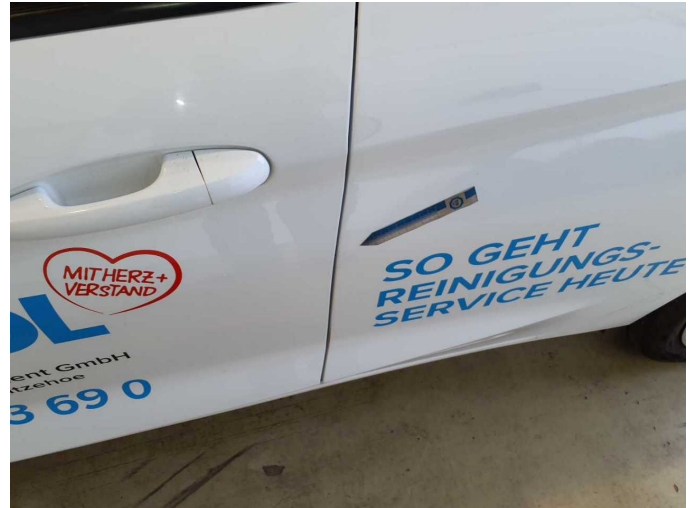
**Damage 5:** Door - rear left side: Door - Scratch(es) - Smart repair

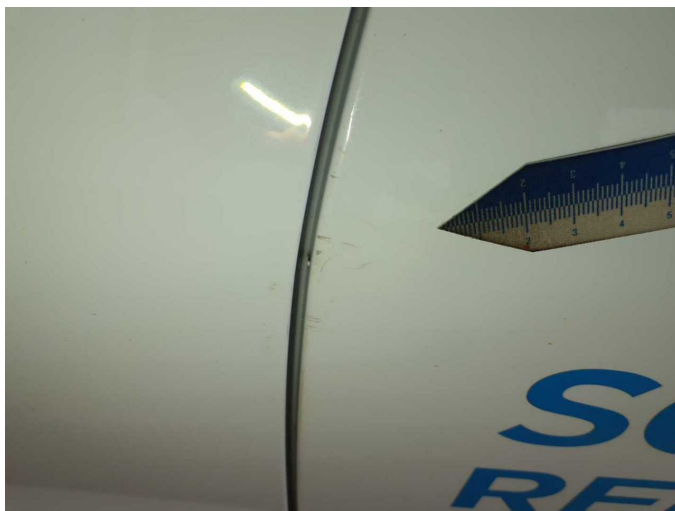
**Damage 5:** Door - rear left side: Door - Scratch(es) - Smart repair

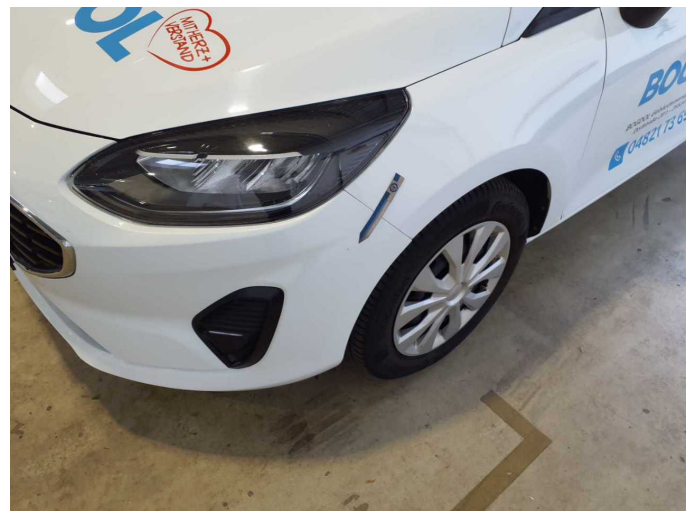
**Damage 6:** Front bumper: Front bumper - Stone chips - Smart repair

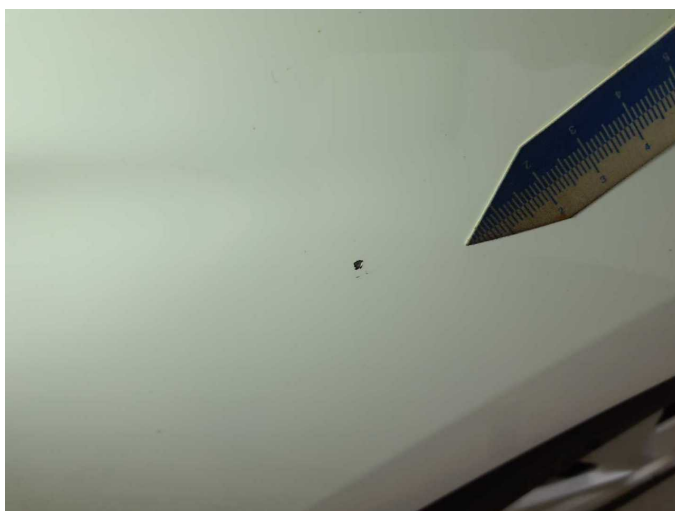
**Damage 6:** Front bumper: Front bumper - Stone chips - Smart repair

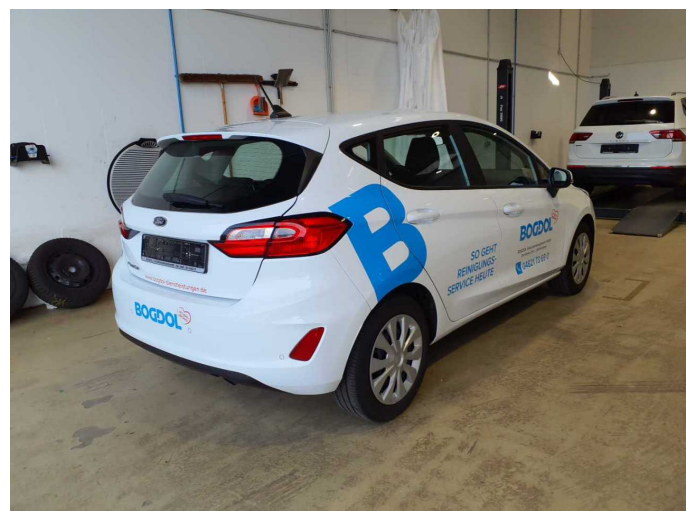
**Damage 7:** Body: Body - Glued / labelled - De-glude / neutralise

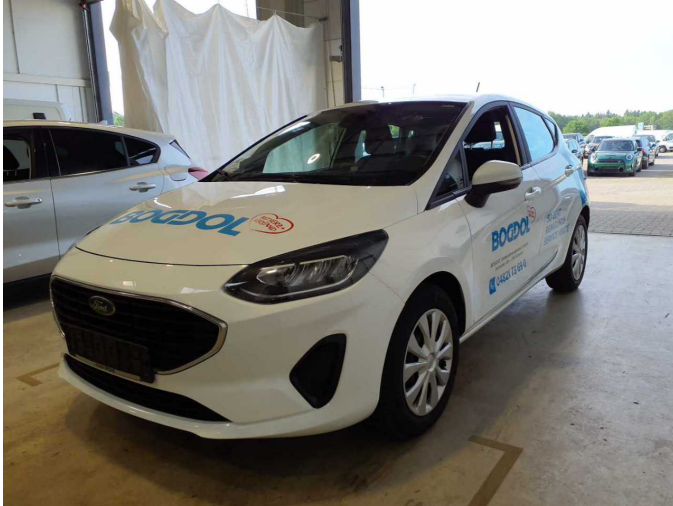
**Damage 7:** Body: Body - Glued / labelled - De-glue / neutralise

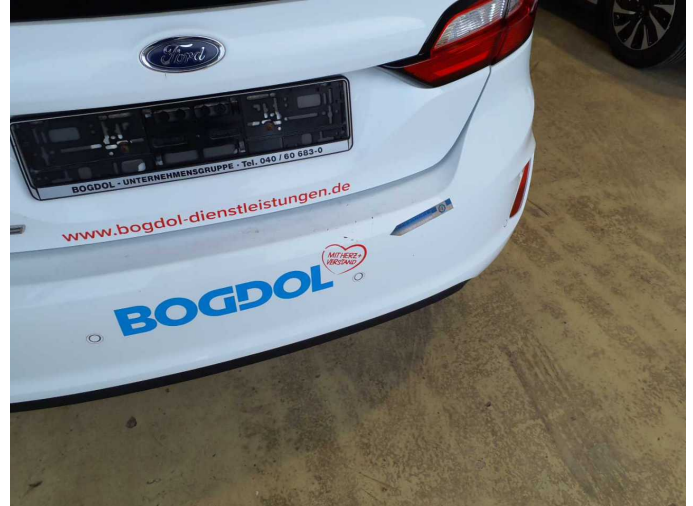
**Damage 8:** Rear bumper: Rear bumper - Scratch(es) - Paint

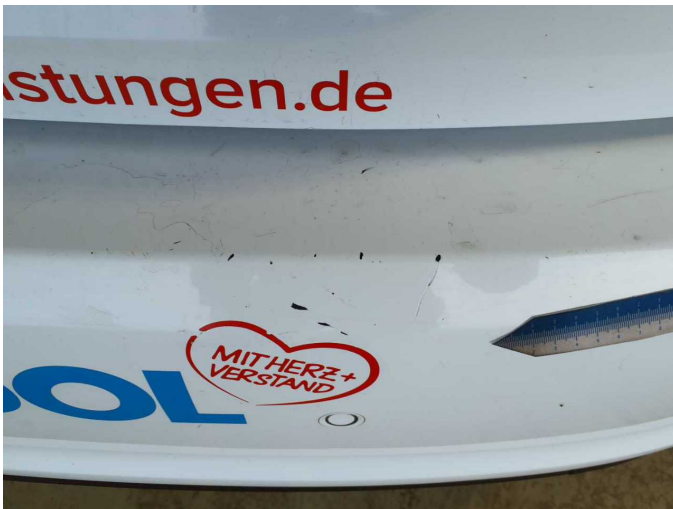
**Damage 8:** Rear bumper: Rear bumper - Scratch(es) - Paint

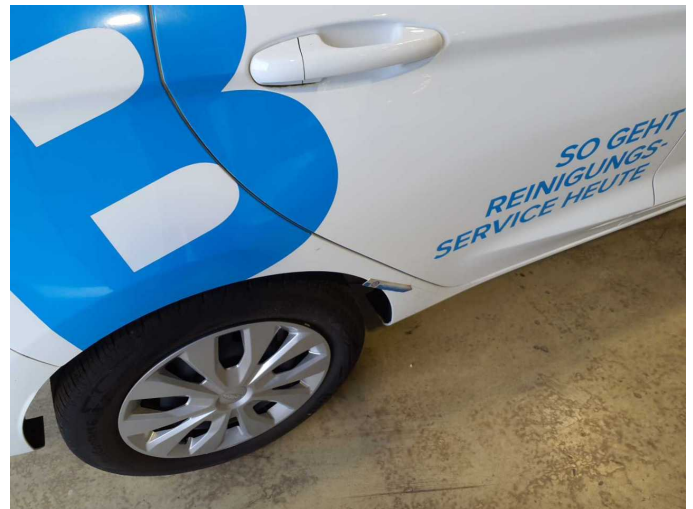
**Damage 9:** Side panel - rear right side: Side panel - Dent / paintcoat damage - Repair and paint

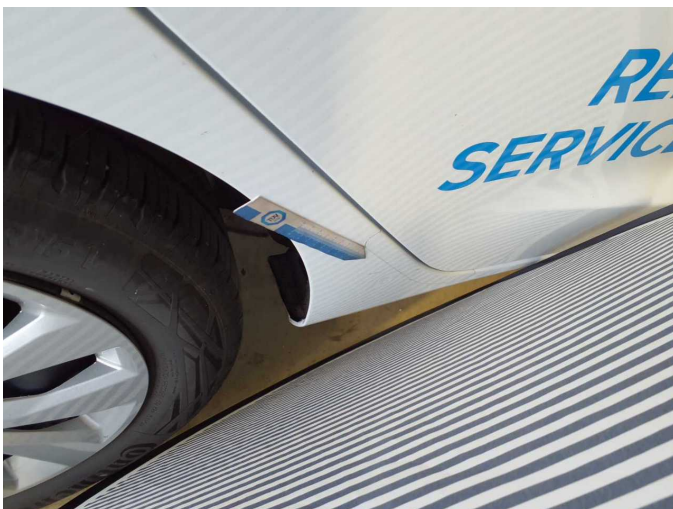
**Damage 9:** Side panel - rear right side: Side panel - Dent / paintcoat damage - Repair and paint

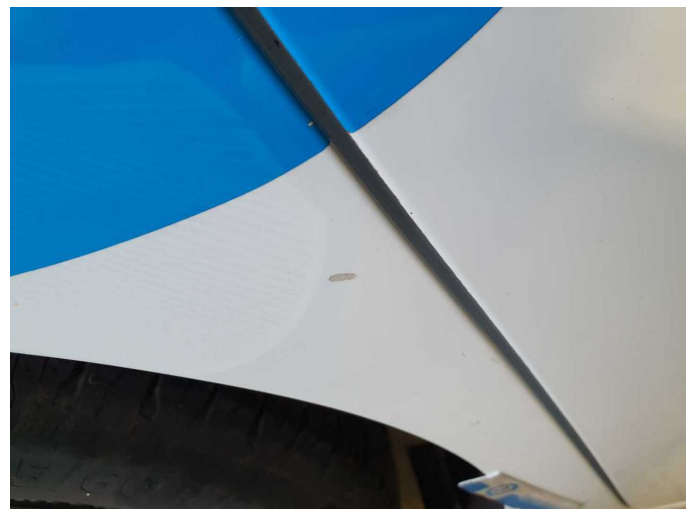
**Damage 9:** Side panel - rear right side: Side panel - Dent / paintcoat damage - Repair and paint

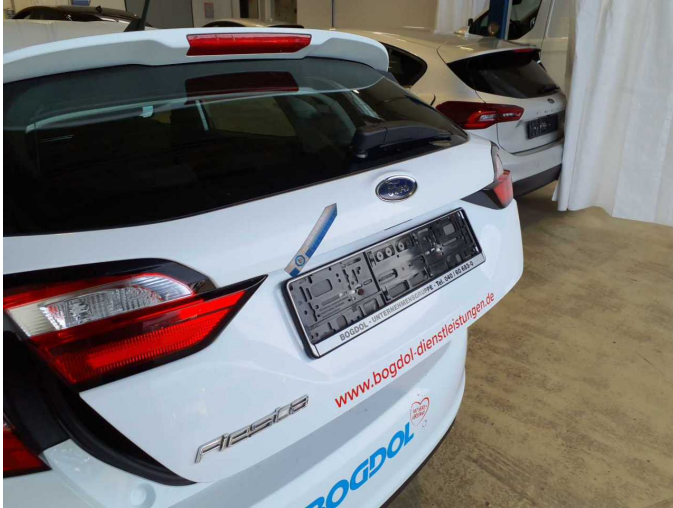
**Damage 10:** Boot lid / rear door: Boot lid - Dent / paintcoat damage - Repair and paint

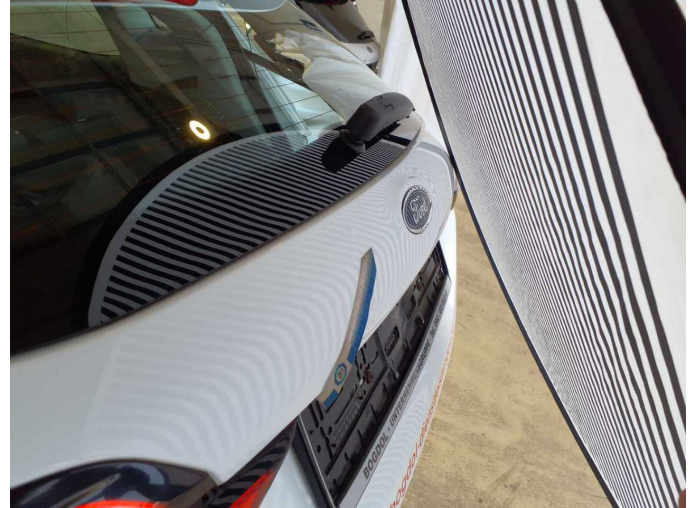
**Damage 10:** Boot lid / rear door: Boot lid - Dent / paintcoat damage - Repair and paint

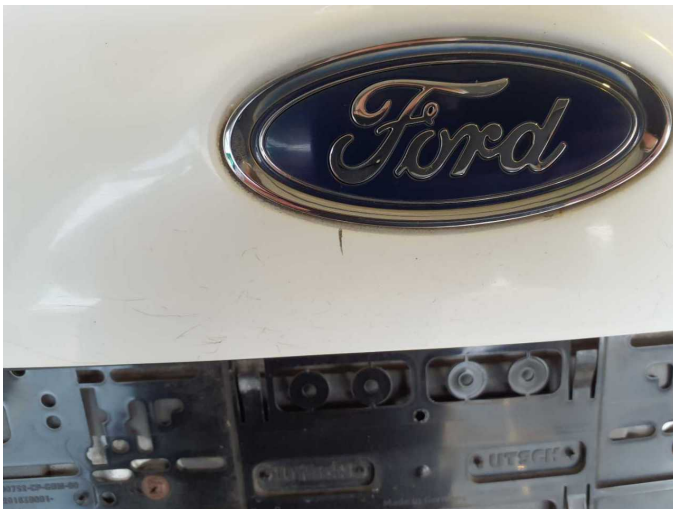
**Damage 10:** Boot lid / rear door: Boot lid - Dent / paintcoat damage - Repair and paint

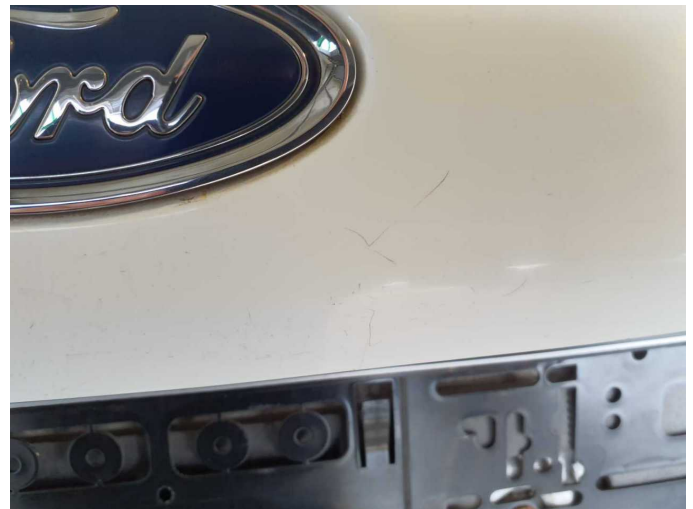
**Damage 10:** Boot lid / rear door: Boot lid - Dent / paintcoat damage - Repair and paint

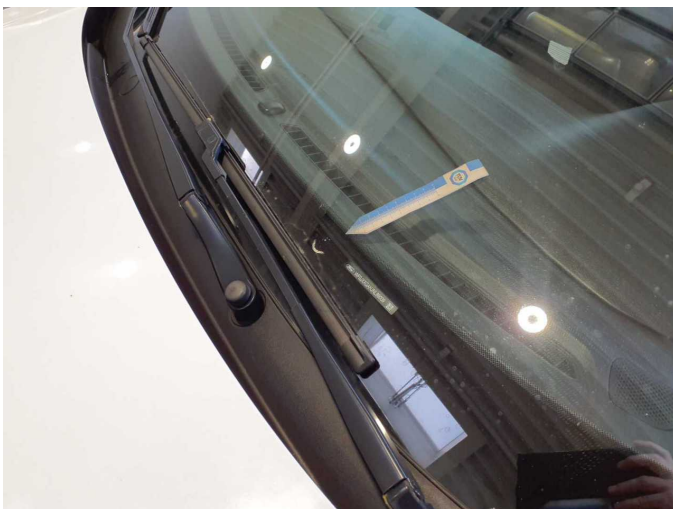
**Damage 11:** Vehicle glazing: Windscreen - Stone chips - repair according to calculation

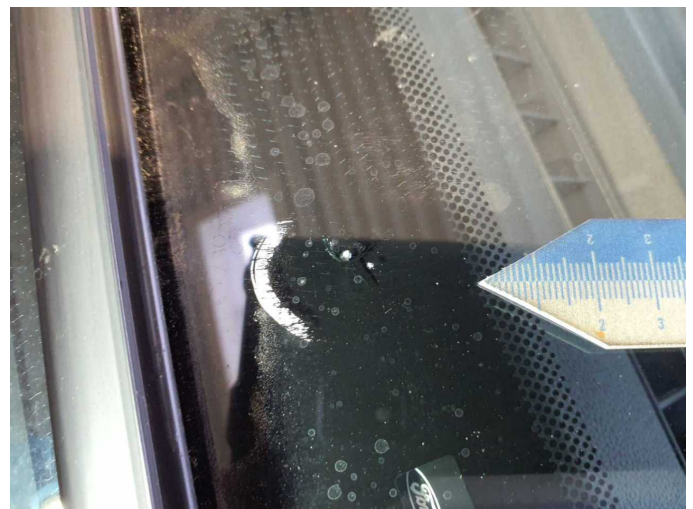
**Damage 11:** Vehicle glazing: Windscreen - Stone chips - repair according to calculation

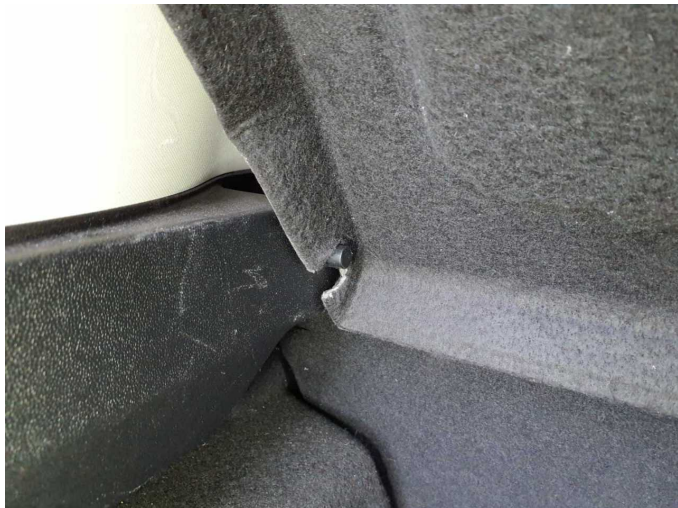
**Missing part 3:** Interior: Boot cover / roller cover (Halter fehlen) - Missing  
- Replace

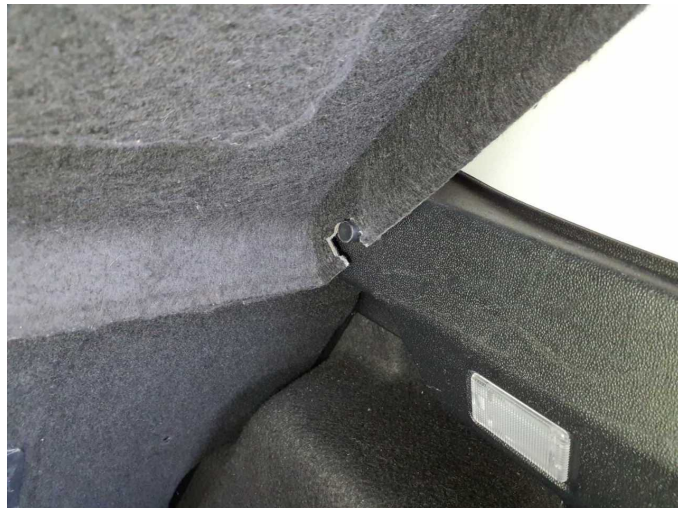
**Missing part 3:** Interior: Boot cover / roller cover (Halter fehlen) - Missing  
- Replace
