Expertise

Protocol number: 46538464  
Order No. / Reference: 26652694  
Inspection date: 15 Jul 2026

Manufacturer: Mercedes-Benz

Model: GLE 350 de 4Matic 9G-TRONIC AMG Line

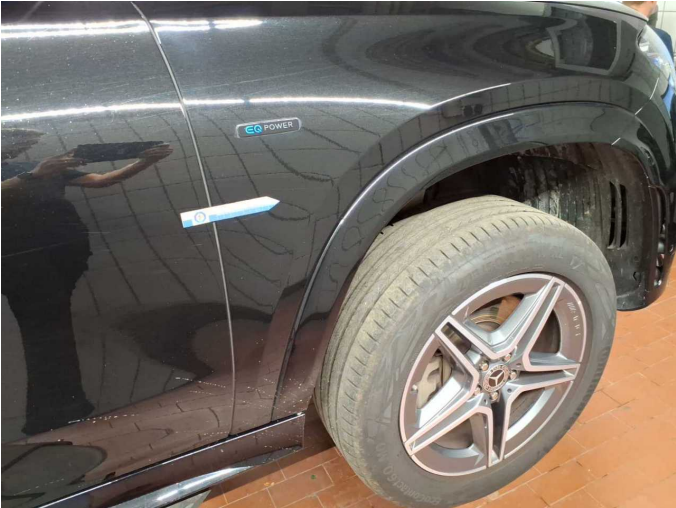
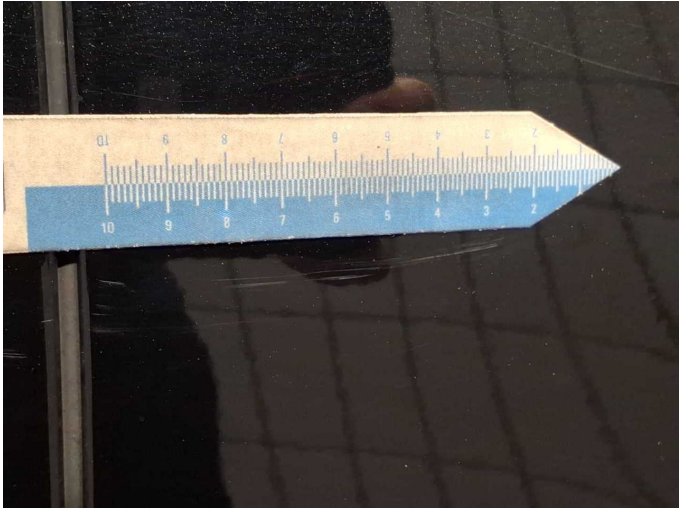
| No. | Component group | Description |
|---|---|---|
| 1 | Mudguard - right side | Mudguard - right side - Scratch(es) - Smart repair |

Damage 1: Mudguard - right side: Mudguard - right side - Scratch(es) - Smart repair

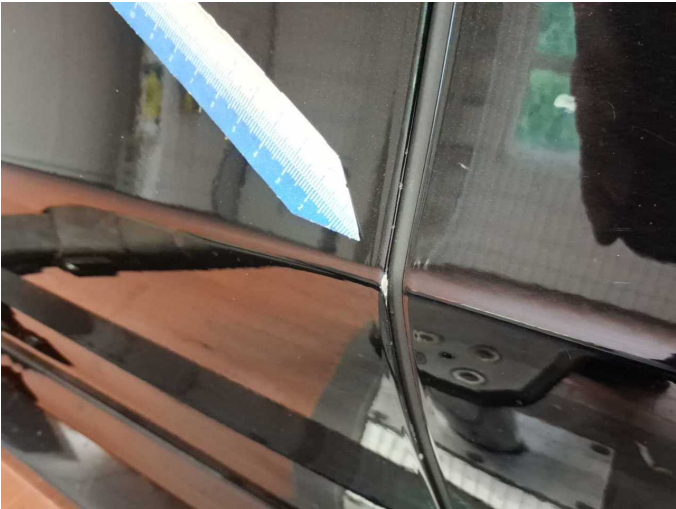
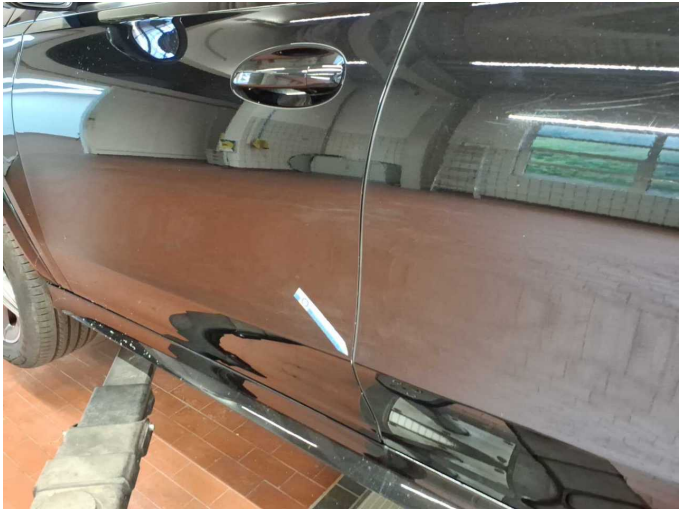
| No. | Component group | Description |
|---|---|---|
| 2 | Door - front left side | Door edge - Scratch(es) - Smart repair |

Damage 2: Door - front left side: Door edge - Scratch(es) - Smart repair

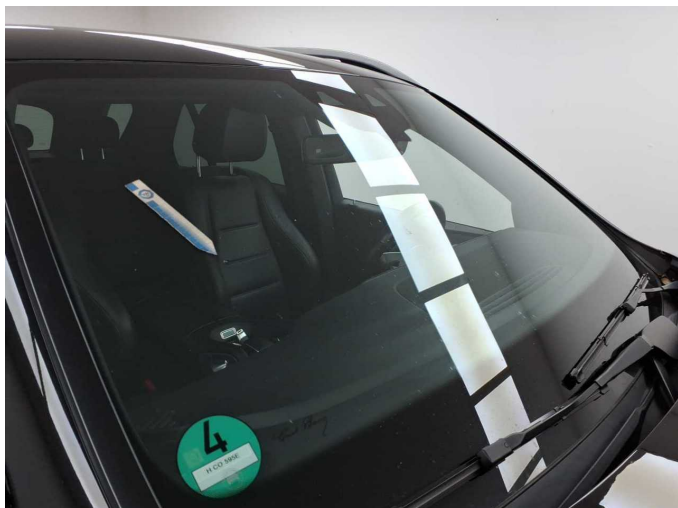
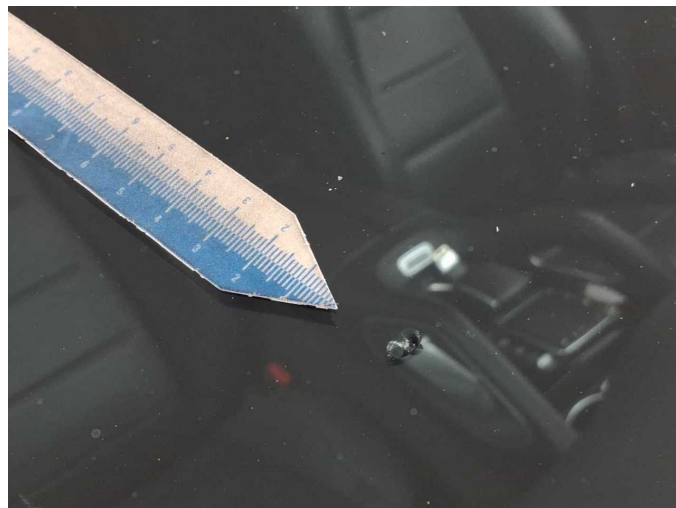
| No. | Component group | Description |
|---|---|---|
| 3 | Vehicle glazing | Windscreen - Stone chips - Smart repair |

**Damage 3:** Vehicle glazing: Windscreen - Stone chips - Smart repair

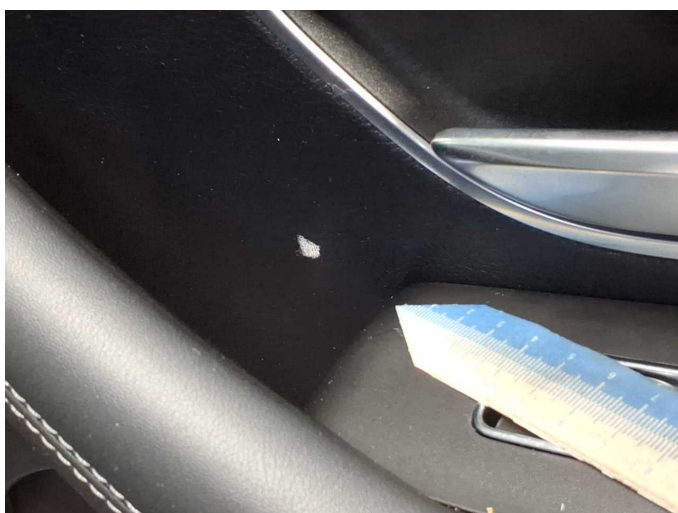
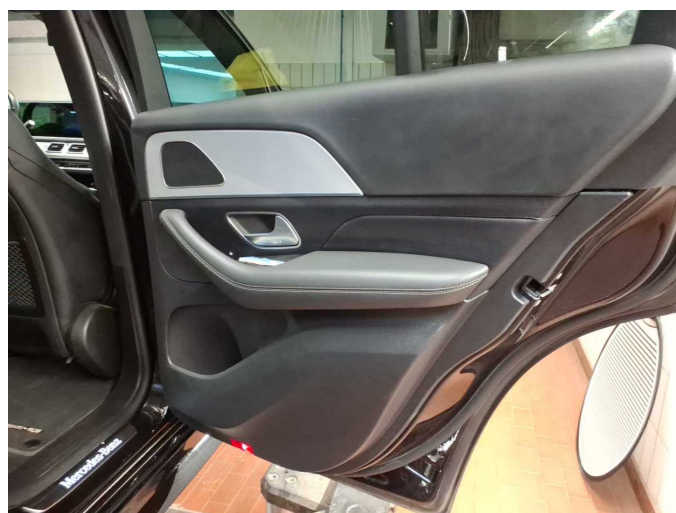
| No. | Component group | Description |
|---|---|---|
| 4 | Trim / covers | Door trim - rear right side - Broken / torn - Loss in value |

**Damage 4:** Trim / covers: Door trim - rear right side - Broken / torn - Loss in value

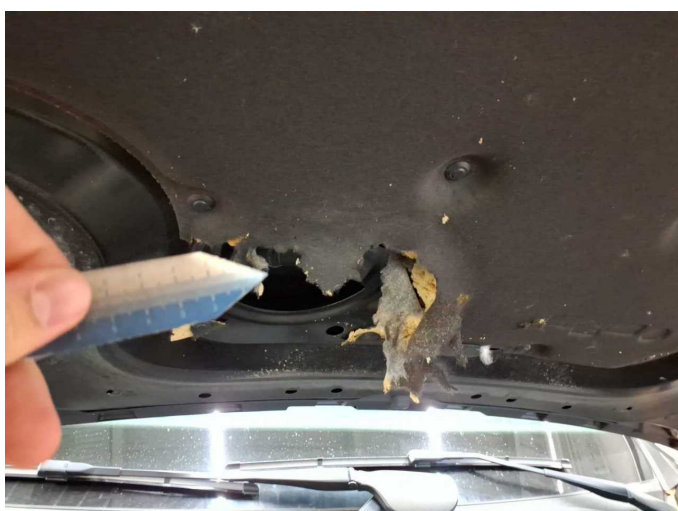
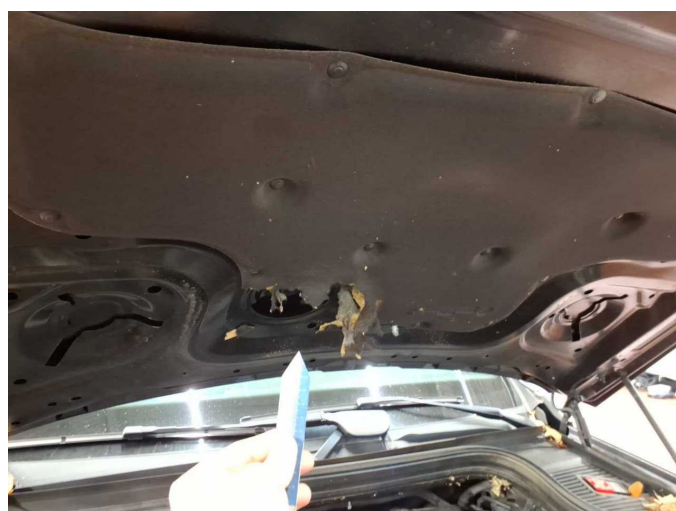
| No. | Component group | Description |
|---|---|---|
| 5 | Bonnet | Insulation lining - Damage caused by marten / rodent - Replace |

**Damage 5:** Bonnet: Insulation lining - Damage caused by marten / rodent - Replace

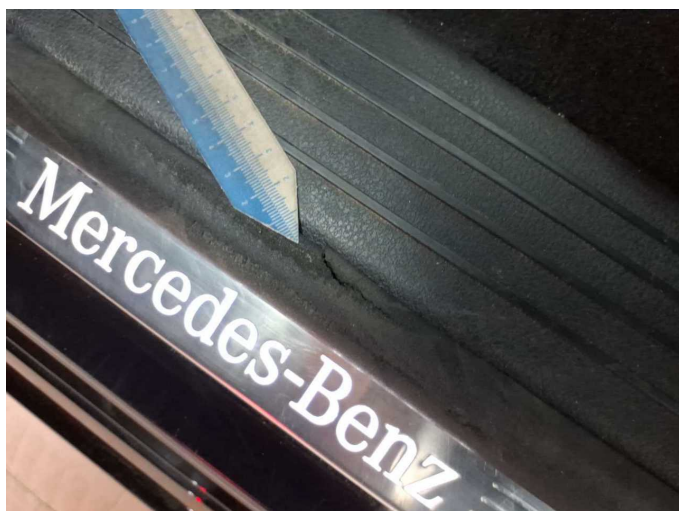
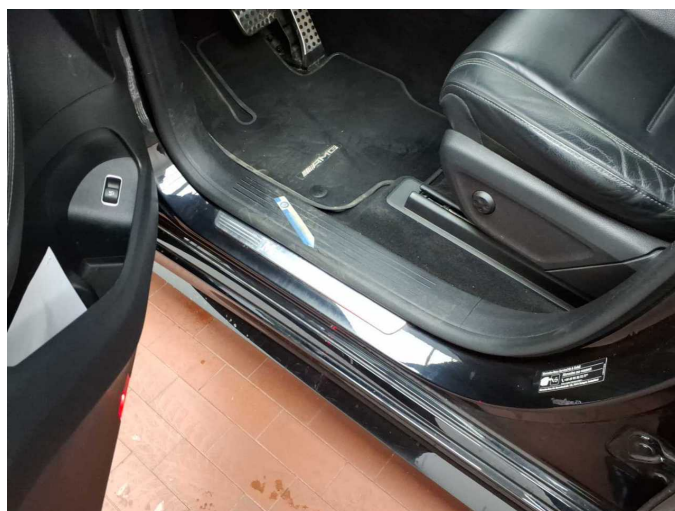
| No. | Component group | Description |
|---|---|---|
| 6 | Door - front left side | Door seal - Broken / torn - Replace |

**Damage 6:** Door - front left side: Door seal - Broken / torn - Replace

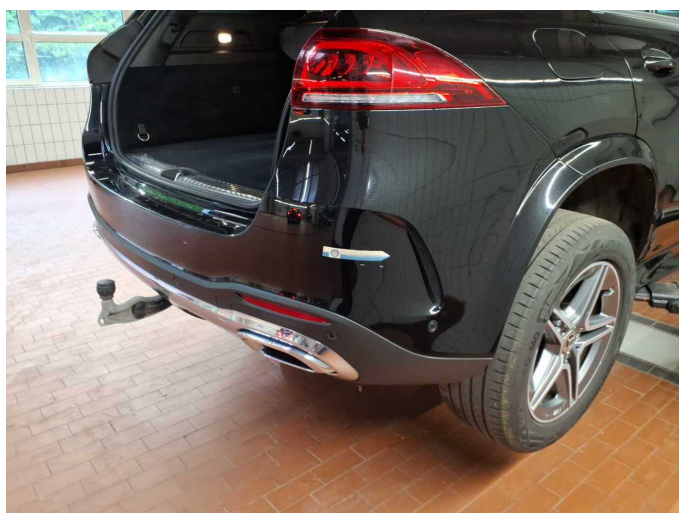
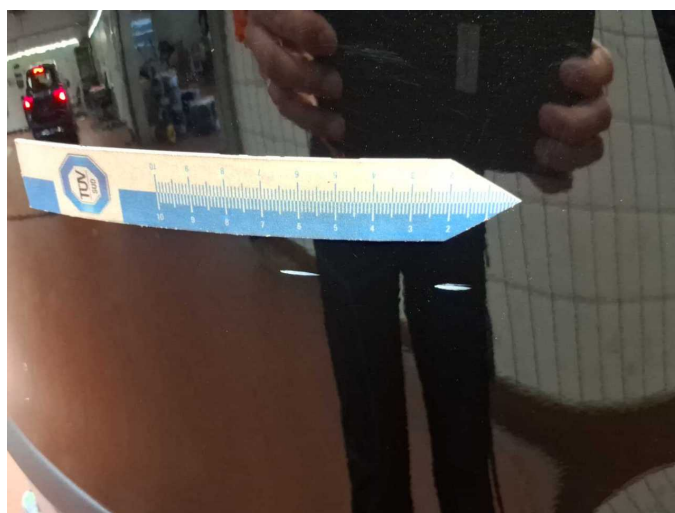
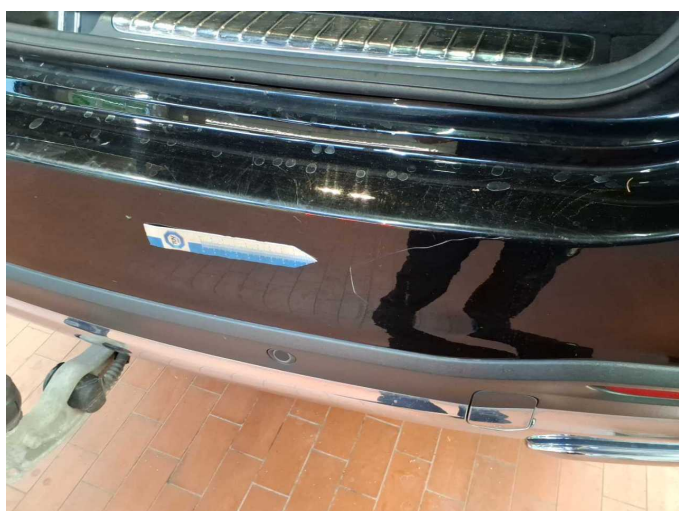
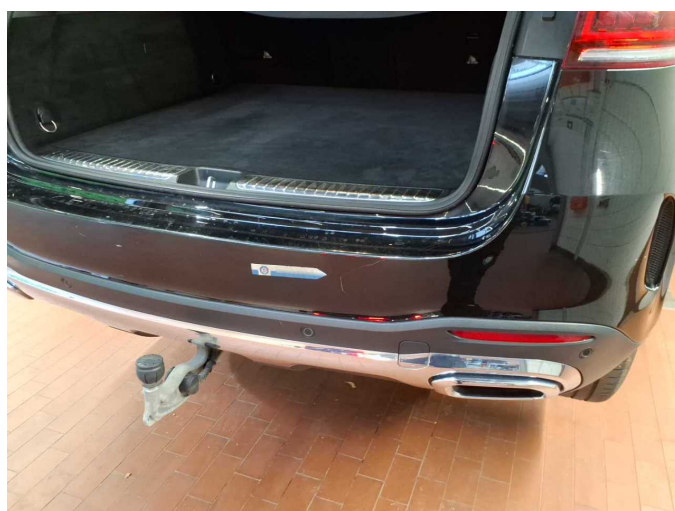
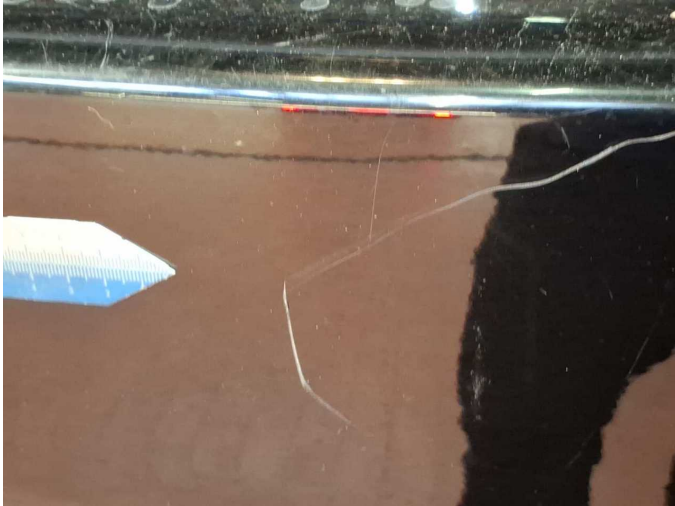
| No. | Component group | Description |
|---|---|---|
| 7 | Rear bumper | Rear bumper - Scratch(es) - Paint |

**Damage 7:** Rear bumper: Rear bumper - Scratch(es) - Paint

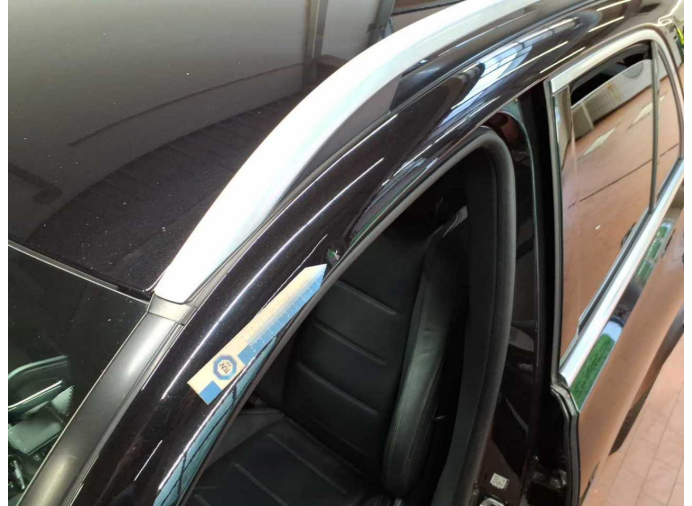
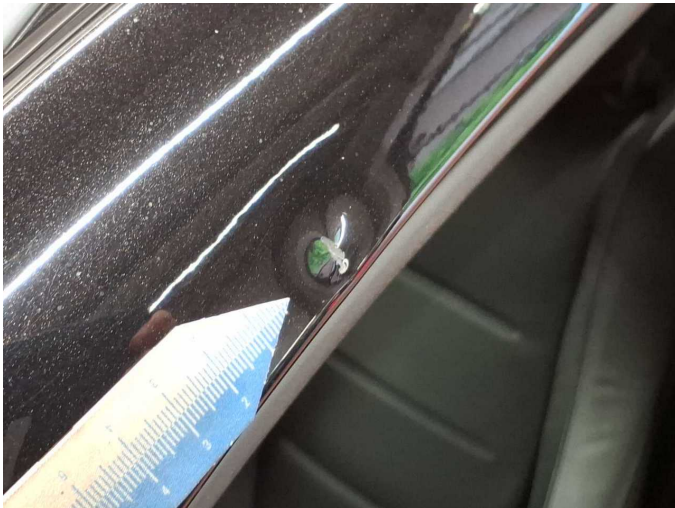
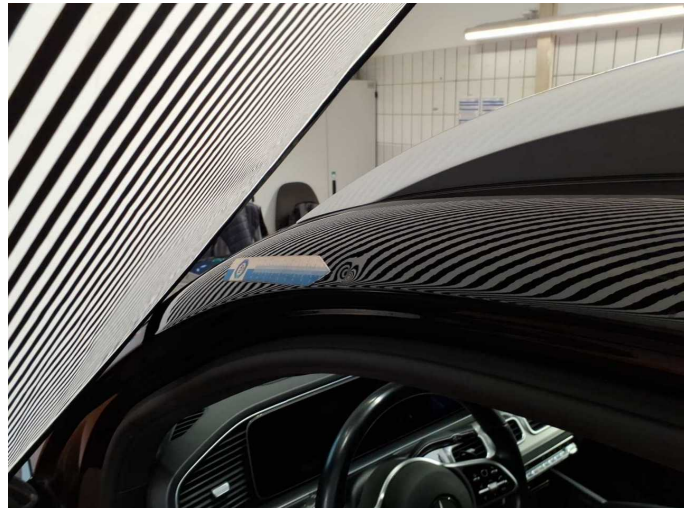
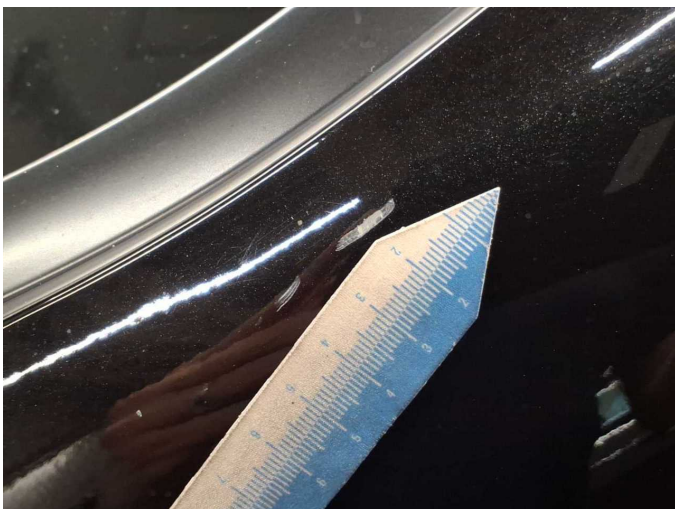
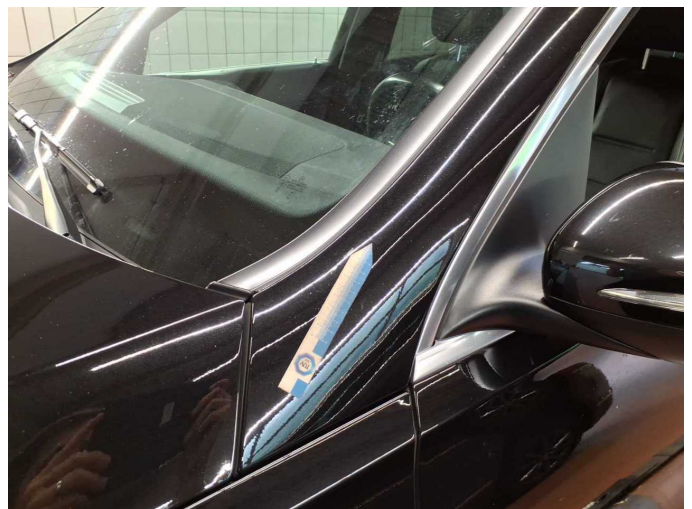
| No. | Component group | Description |
|---|---|---|
| 8 | Roof | Roof rail - left side - Dent / paintcoat damage - Repair and paint |

**Damage 8:** Roof: Roof rail - left side - Dent / paintcoat damage - Repair and paint

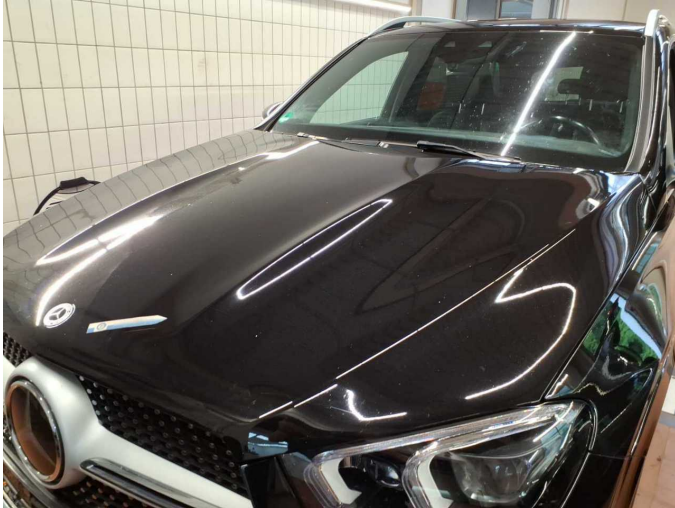
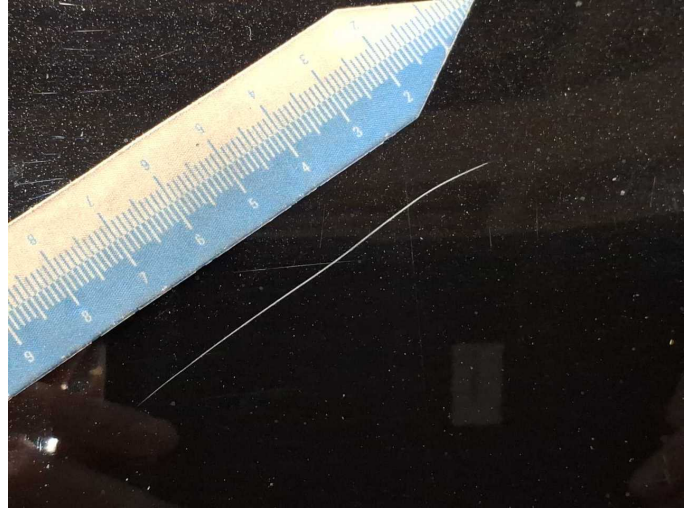
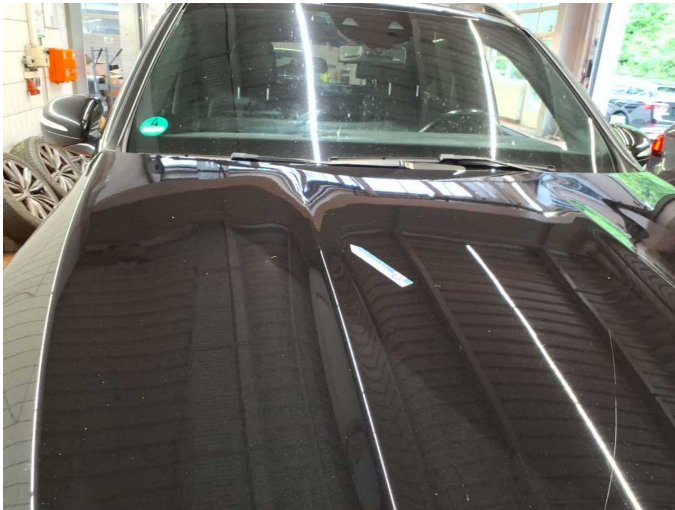
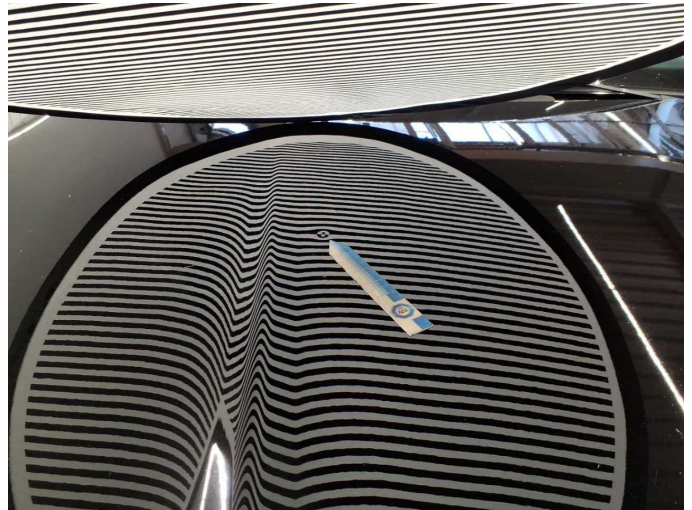
| No. | Component group | Description |
|---|---|---|
| 9 | Bonnet | Bonnet - Dent / paintcoat damage - Repair and paint |

**Damage 9:** Bonnet: Bonnet - Dent / paintcoat damage - Repair and paint

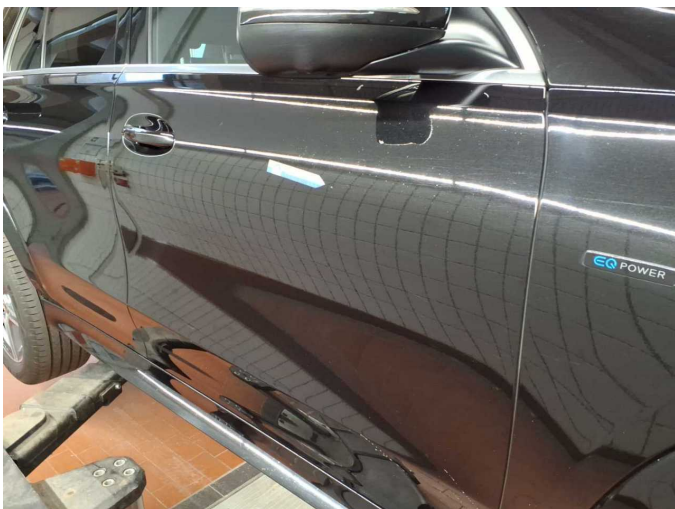
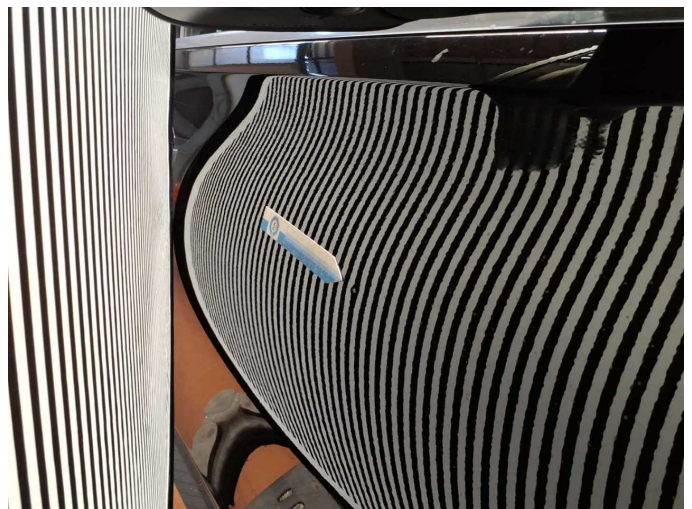
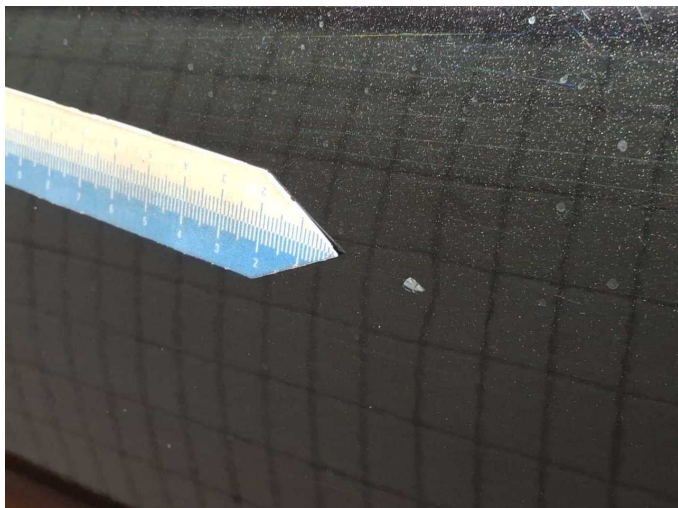
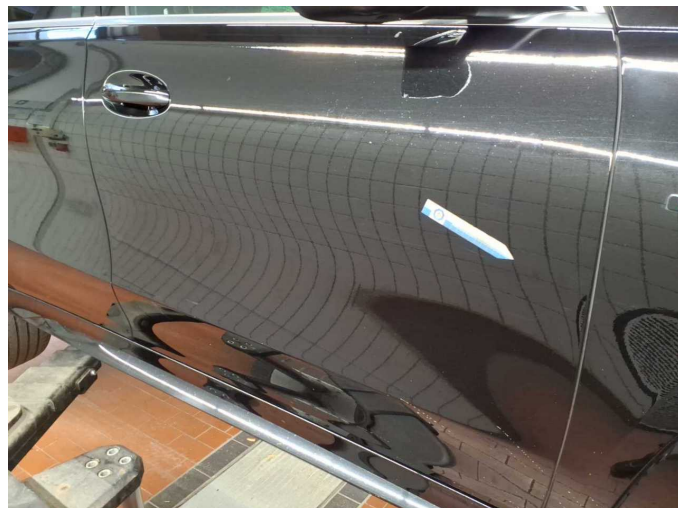
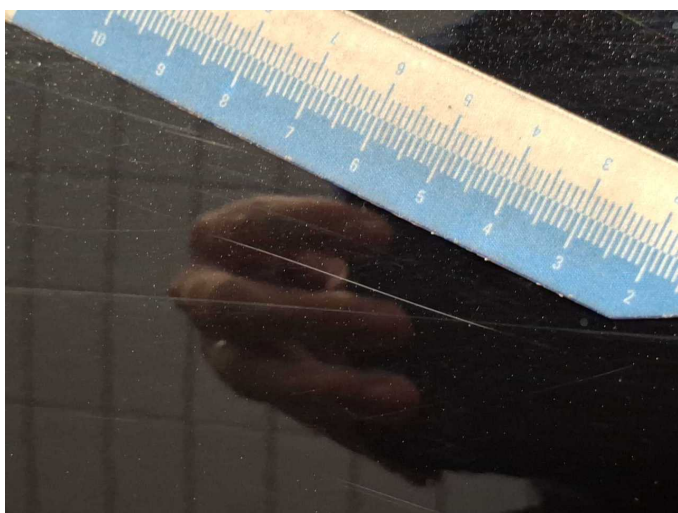
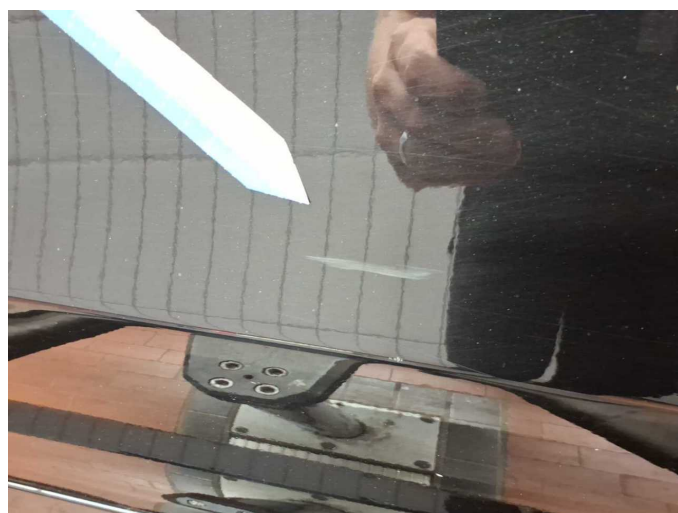
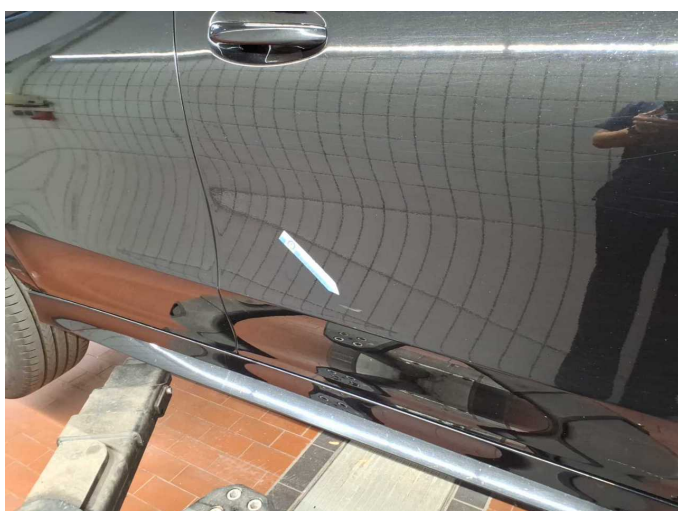
| No. | Component group | Description |
|---|---|---|
| 10 | Door - front right side | Door - Dent / paintcoat damage - Repair and paint |

**Damage 10:** Door - front right side: Door - Dent / paintcoat damage - Repair and paint

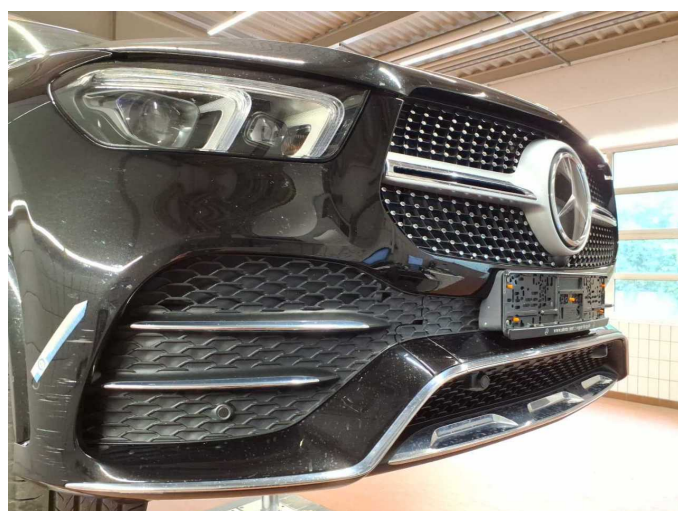
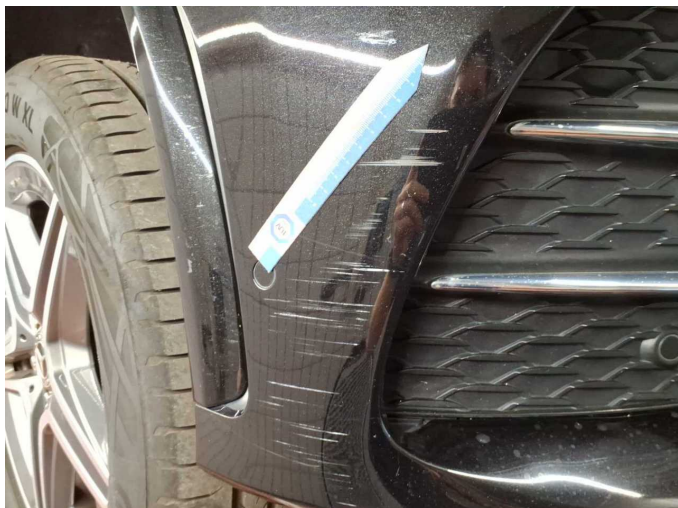
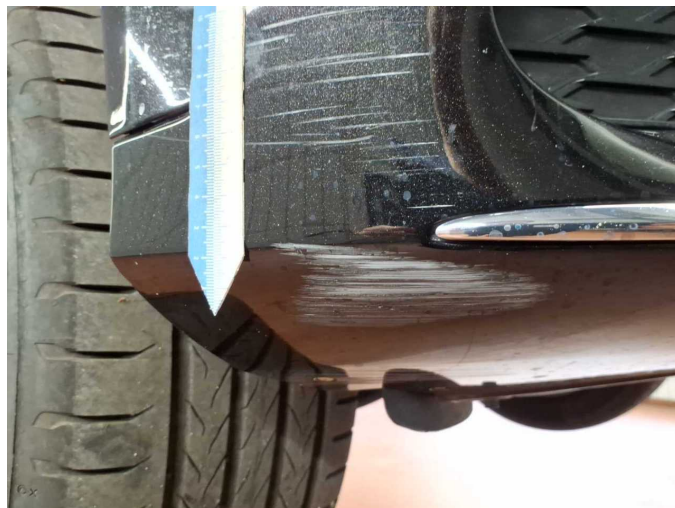
| No. | Component group | Description |
|---|---|---|
| 11 | Front bumper | Front bumper - Scratched - Paint |

**Damage 11:** Front bumper: Front bumper - Scratched - Paint

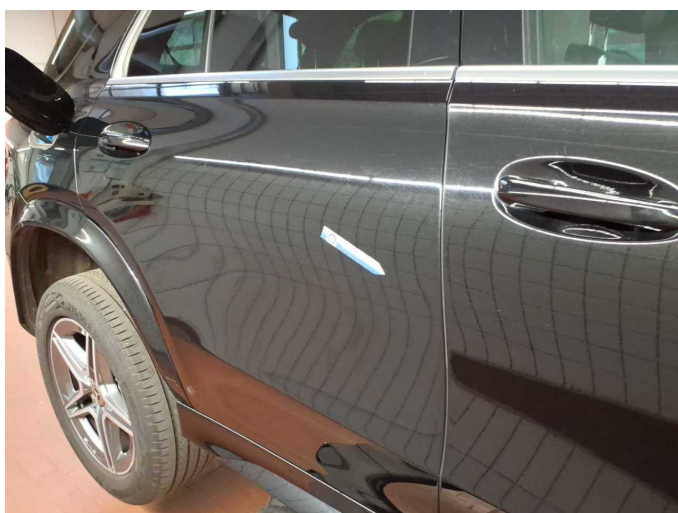
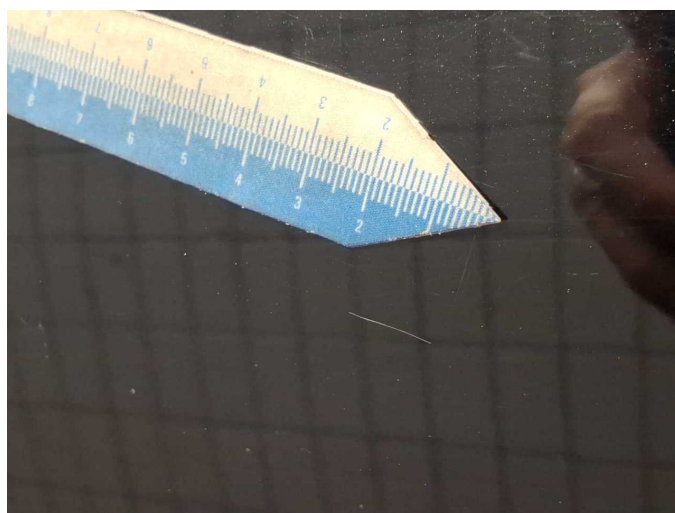
| No. | Component group | Description |
|---|---|---|
| 2 | Door - rear right side | Door - Scratch(es) - No deduction |

**Wear and tear 2:** Door - rear right side: Door - Scratch(es) - No deduction

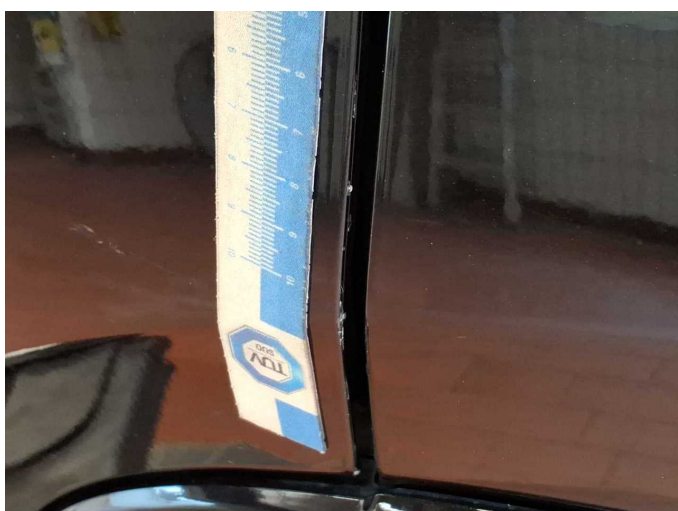
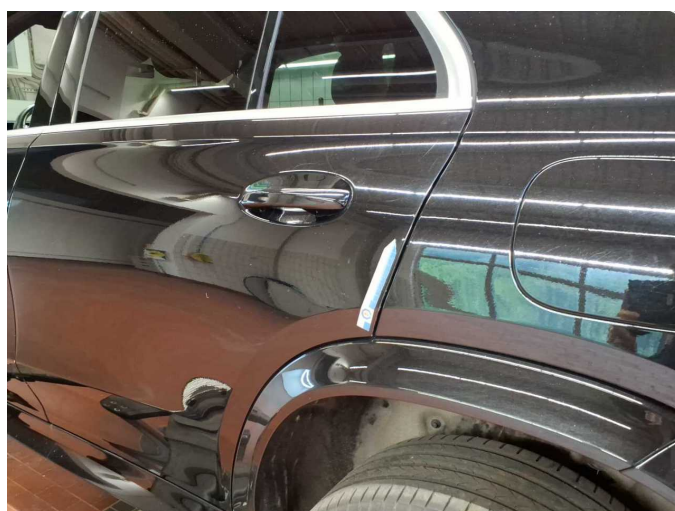
| No. | Component group | Description |
|---|---|---|
| 3 | Door - rear left side | Door edge - Scratch(es) - No deduction |

**Wear and tear 3:** Door - rear left side: Door edge - Scratch(es) - No deduction

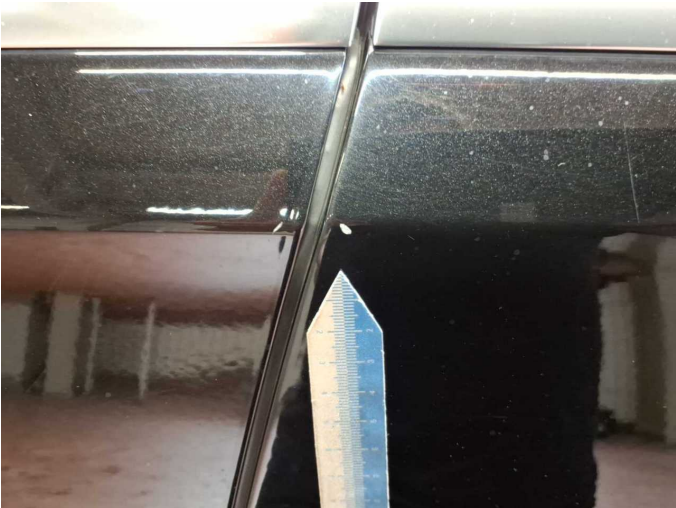
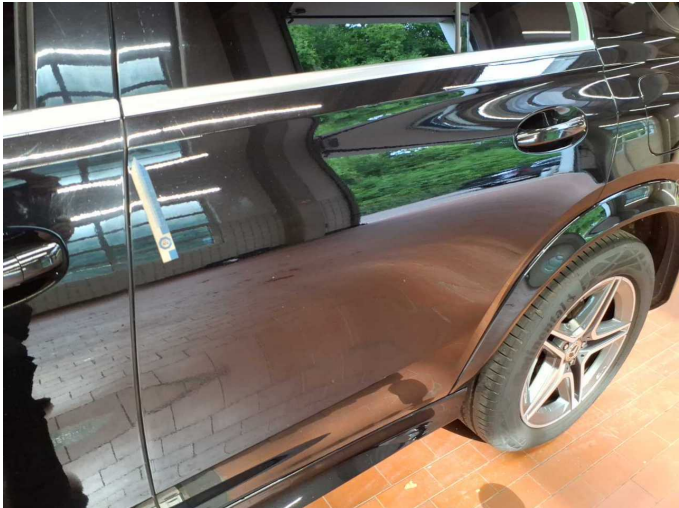
| No. | Component group | Description |
|---|---|---|
| 5 | Door - rear left side | Door - Scratch(es) - No deduction |

Wear and tear 5: Door - rear left side: Door - Scratch(es) - No deduction

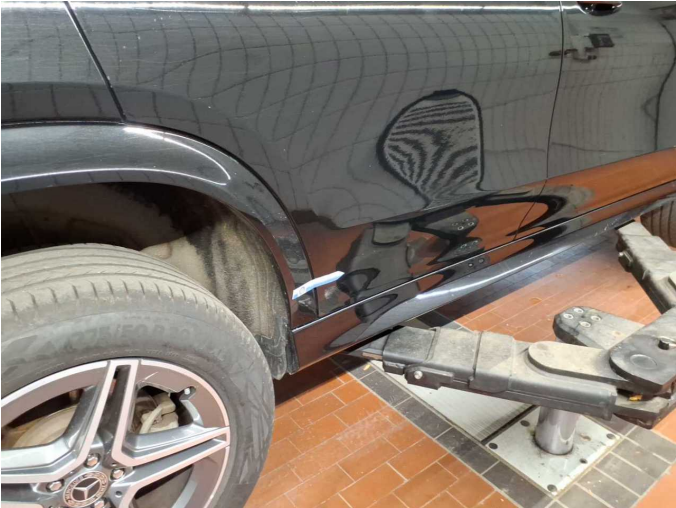
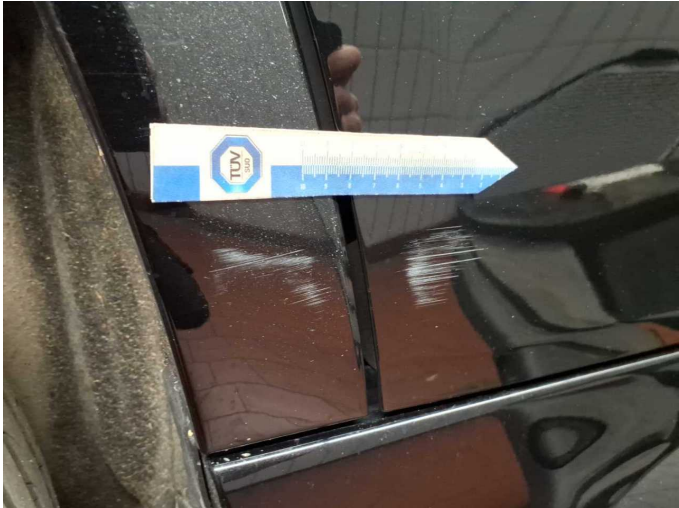
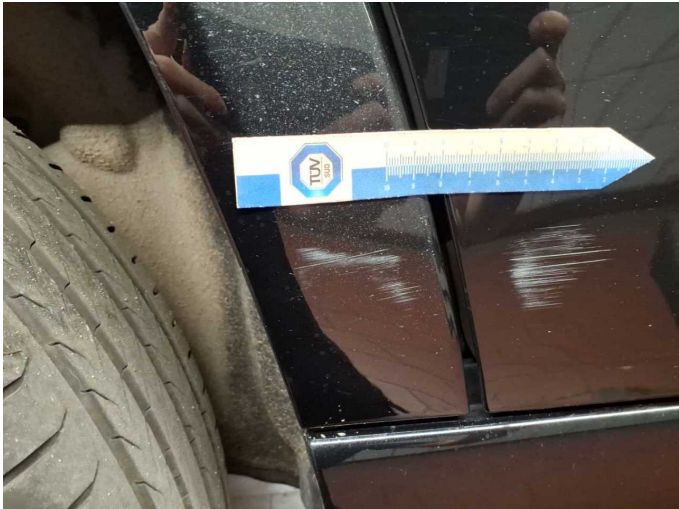
| No. | Accident |
|---|---|
| 1 | Side right |

Accident 1: Side right

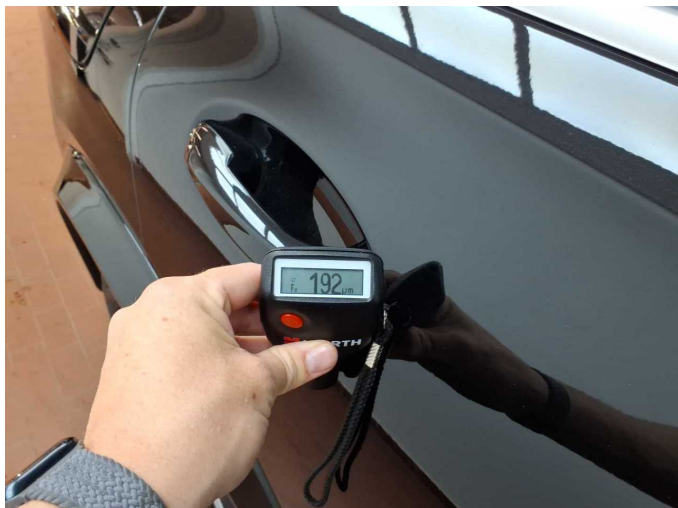
- 1 Door - rear right side, Professionally carried out, Invoice of repair done Non-existent

Door - rear right side

192 µm

**Repainting 1:** Door - rear right side
