## Expertise

Protocol number: 45857025  
Order No. / Reference: 26430467  
Inspection date: 9 Jun 2026

Model: Octavia Combi 2.0 TDI DSG Style

VIN: TMBJJ8NX4PY100541

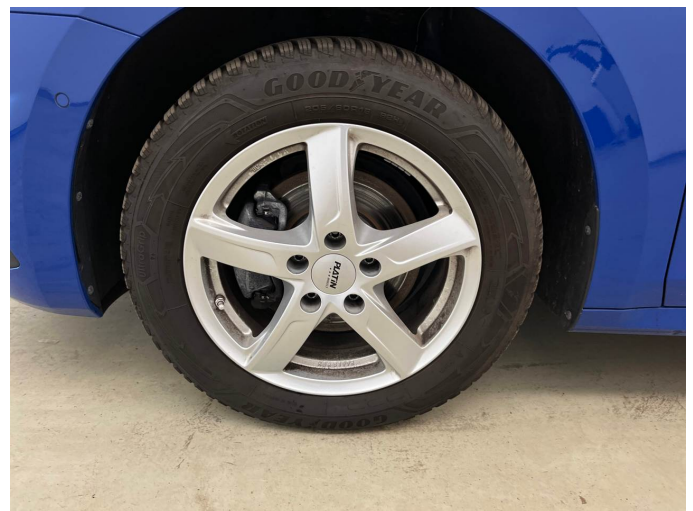
#	Tyre size	Type of tyre	Manufacturer	Tread depth
1)	205/60 R16 92H	Winter tyres on Light alloy	Goodyear	4mm / 4mm
2)	205/60 R16 92H	Winter tyres on Light alloy	Goodyear	5mm / 5mm

Figure 12: Mounted tyres

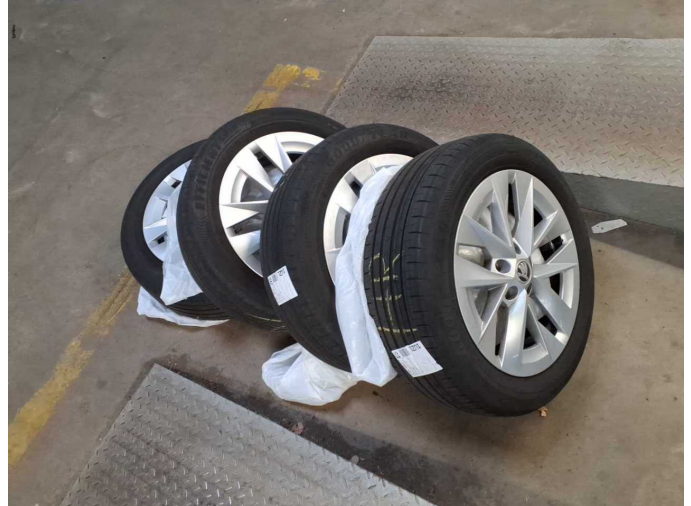
#	Tyre size	Type of tyre	Manufacturer	Tread depth
1)	205/55 R17 91V	Summer tyres on Light alloy	Goodyear	3mm / 3mm
2)	205/55 R17 91V	Summer tyres on Light alloy	Goodyear	4mm / 4mm

Figure 14: Additional tyres

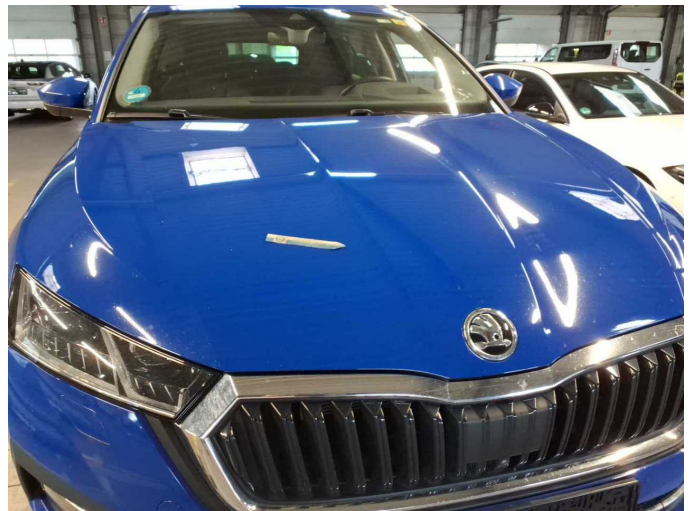
No.	Component group	Description
1	Equipment	Vehicle key (Batterie) - Empty - Replace
2	Bonnet	Bonnet - dent(s) - Smooth repair work
3	Equipment	Vehicle key with remote control - Damaged - Replace

Damage 2: Bonnet: Bonnet - dent(s) - Smooth repair work

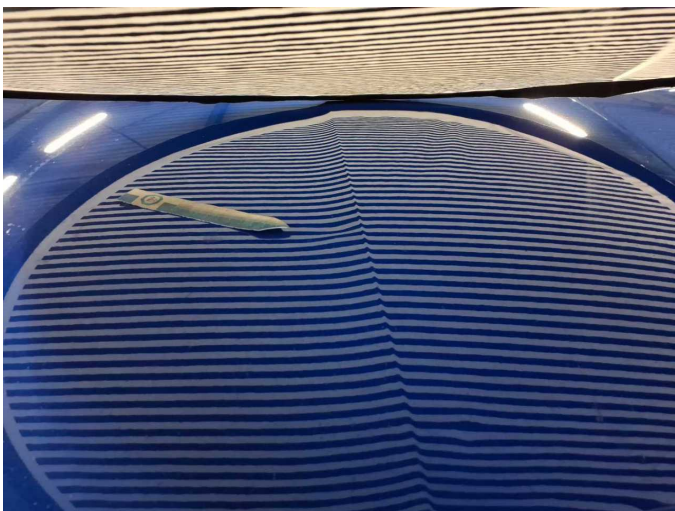
Damage 2: Bonnet: Bonnet - dent(s) - Smooth repair work

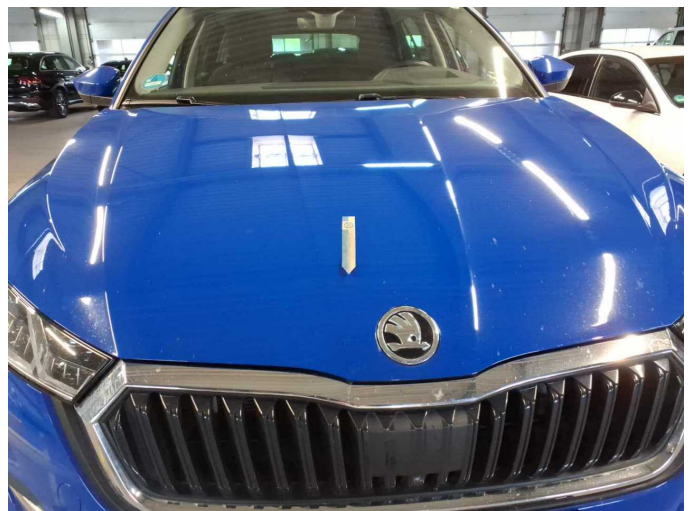
Damage 2: Bonnet: Bonnet - dent(s) - Smooth repair work

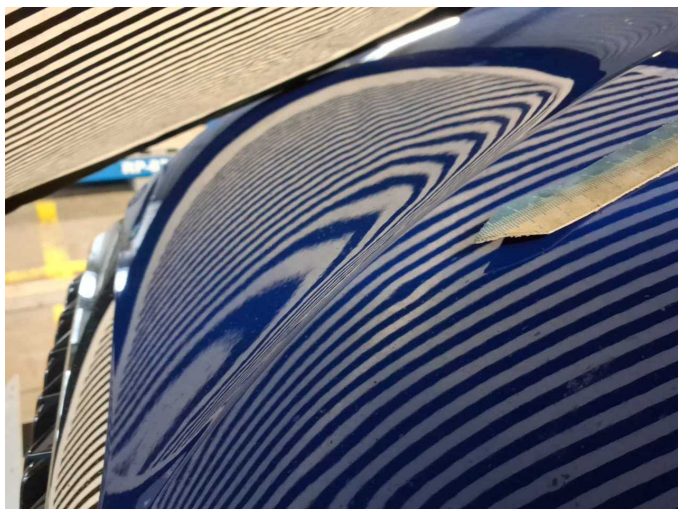
**Damage 2:** Bonnet: Bonnet - dent(s) - Smooth repair work

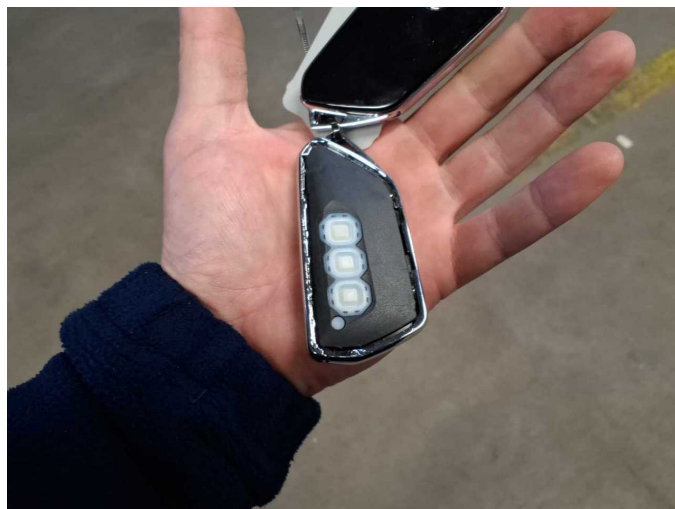
**Damage 3:** Equipment: Vehicle key with remote control - Damaged - Replace

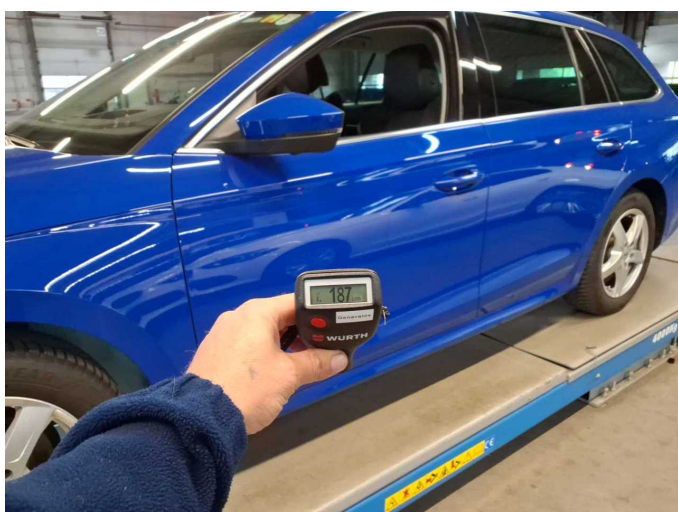
No.	Repainting
1	Door - front left side, Professionally carried out, Invoice of repair done Non-existent

Door - front left side 187 µm |

**Repainting 1:** Door - front left side
