Expertise

Protocol number: 45770214  
Order No. / Reference: 26438283  
Inspection date: 2 Jun 2026

Manufacturer: Mercedes-Benz  
VIN: W1N4M1CB6PW284680

Model: GLB 200 d 8G-DCT Progressive

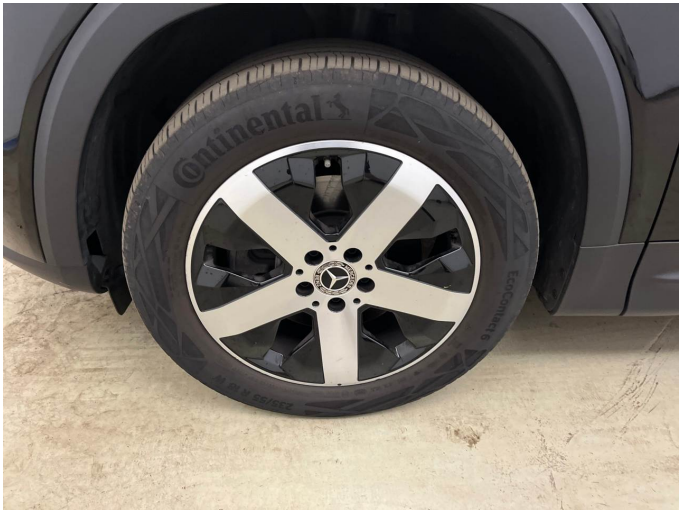
Figure 12: Mounted tyres

| # | Tyre size | Type of tyre | Manufacturer | Tread depth |
|---|---|---|---|---|
| 1) | 235/55 R18 100W | Summer tyres on Light alloy | Continental | 5mm / 5mm |
| 2) | 235/55 R18 100W | Summer tyres on Light alloy | Continental | 7mm / 7mm |

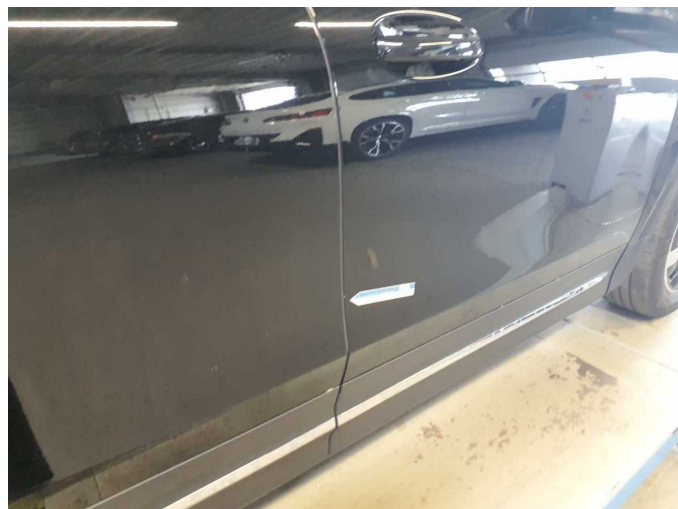
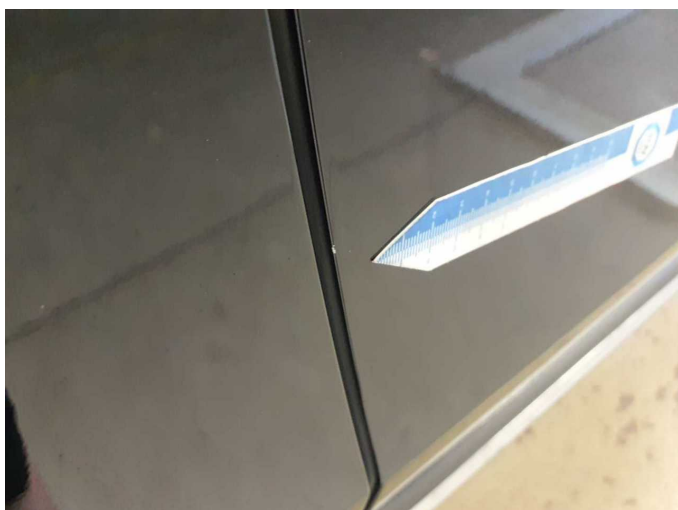
| No. | Component group | Description |
|---|---|---|
| 1 | Door - front right side | Door edge - Scratch(es) - Smart repair |

**Damage 1:** Door - front right side: Door edge - Scratch(es) - Smart repair

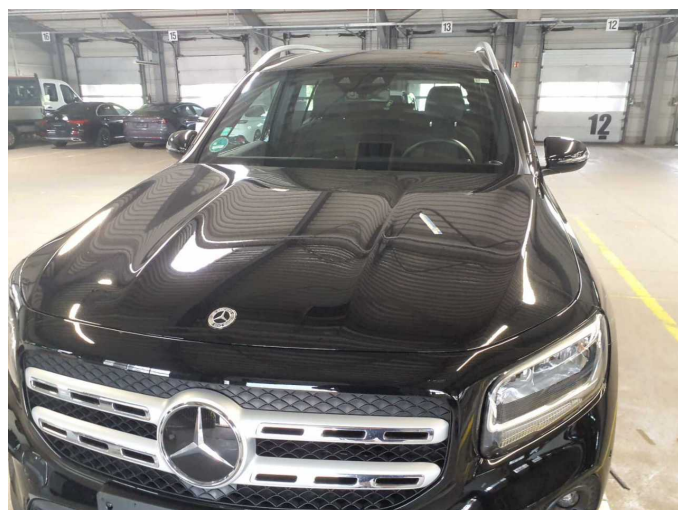
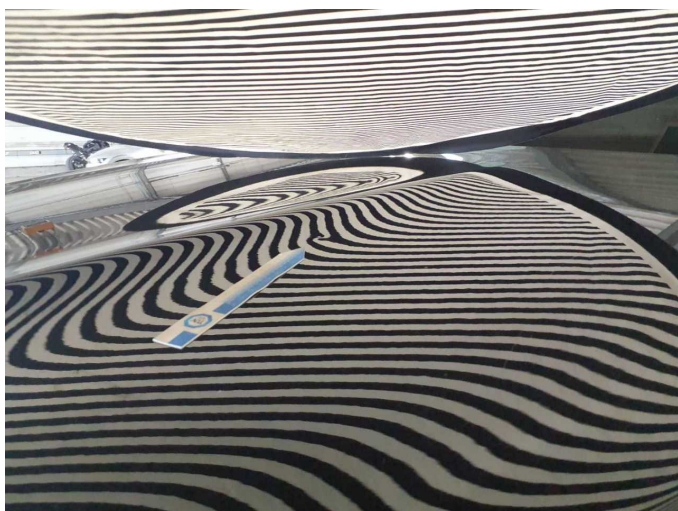
| No. | Component group | Description |
|---|---|---|
| 2 | Bonnet | Bonnet - dent(s) - Smooth repair work |

**Damage 2:** Bonnet: Bonnet - dent(s) - Smooth repair work

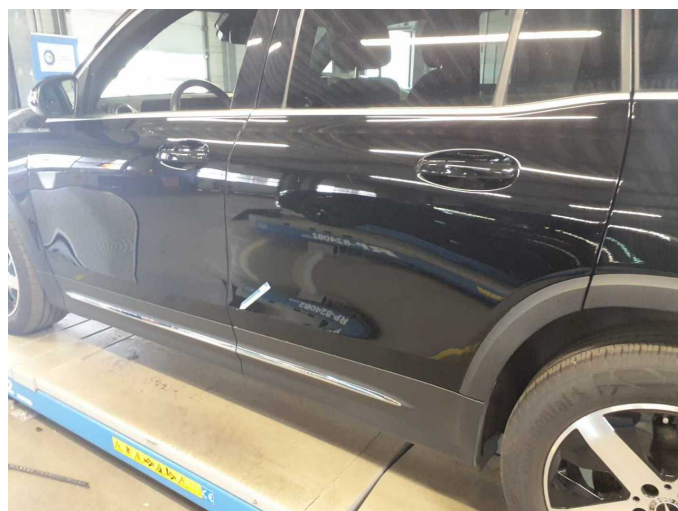
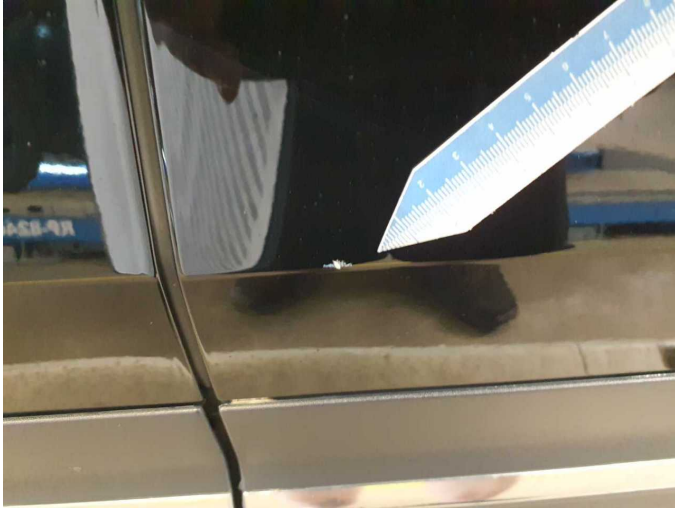
| No. | Component group | Description |
|---|---|---|
| 3 | Door - front left side | Door - Scratch(es) - Smart repair |

**Damage 3:** Door - front left side: Door - Scratch(es) - Smart repair

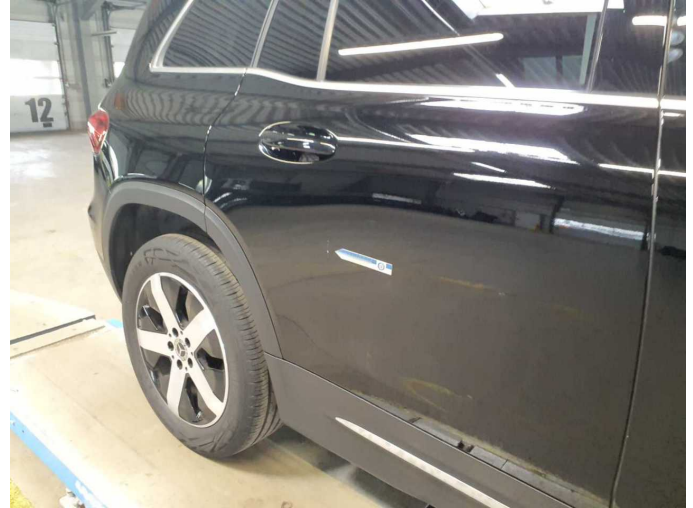
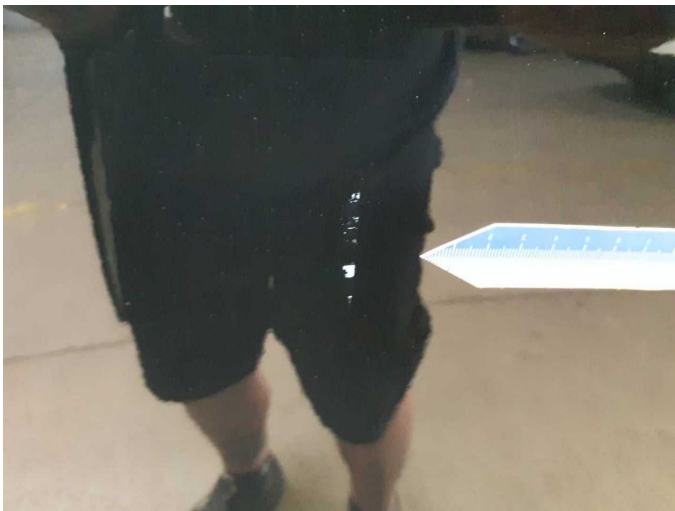
| No. | Component group | Description |
|---|---|---|
| 5 | Door - rear right side | Door - Scratch(es) - Smart repair |

**Damage 5:** Door - rear right side: Door - Scratch(es) - Smart repair

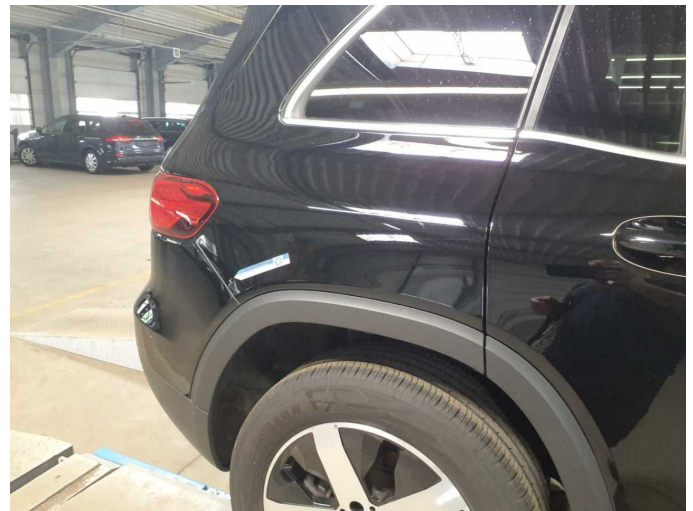
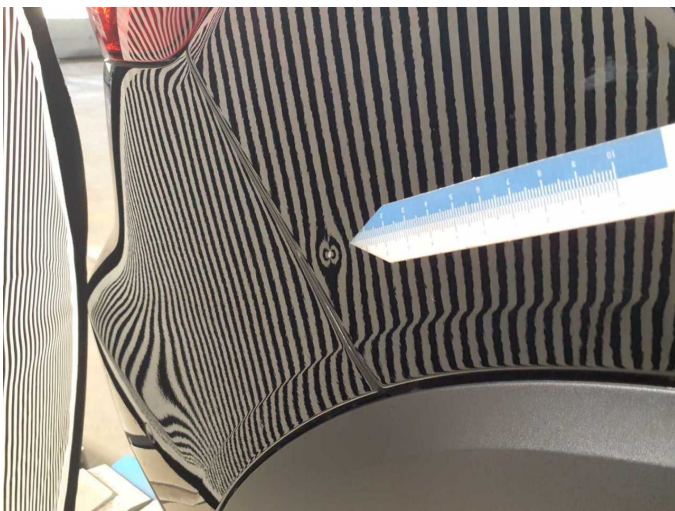
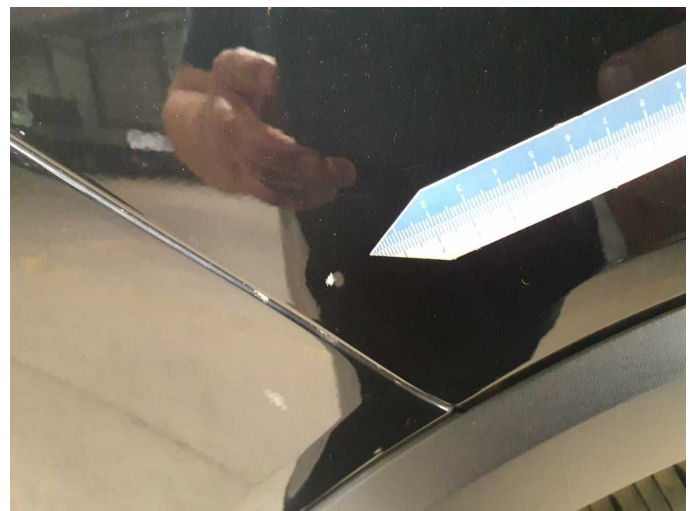
| No. | Component group | Description |
|---|---|---|
| 6 | Side panel - rear right side | Side panel - Dent / paintcoat damage - Smart repair |

**Damage 6:** Side panel - rear right side: Side panel - Dent / paintcoat damage - Smart repair

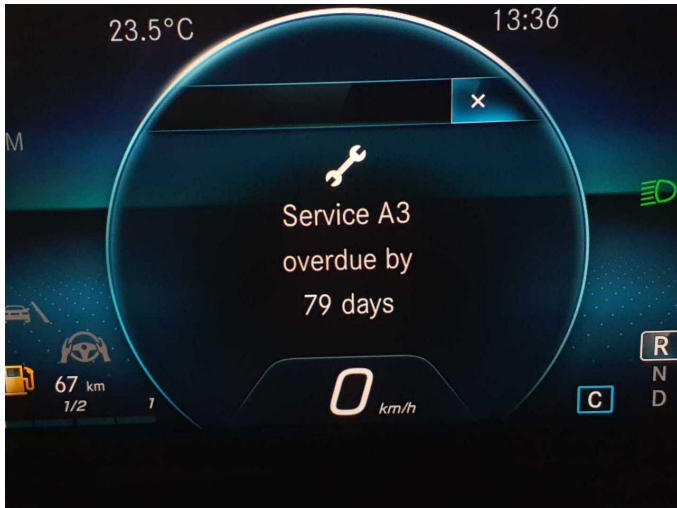
| No. | Component group | Description |
|---|---|---|
| 7 | Misc. | Inspection / maintenance - Due - Perform |

**Damage 7:** Misc.: Inspection / maintenance - Due - Perform

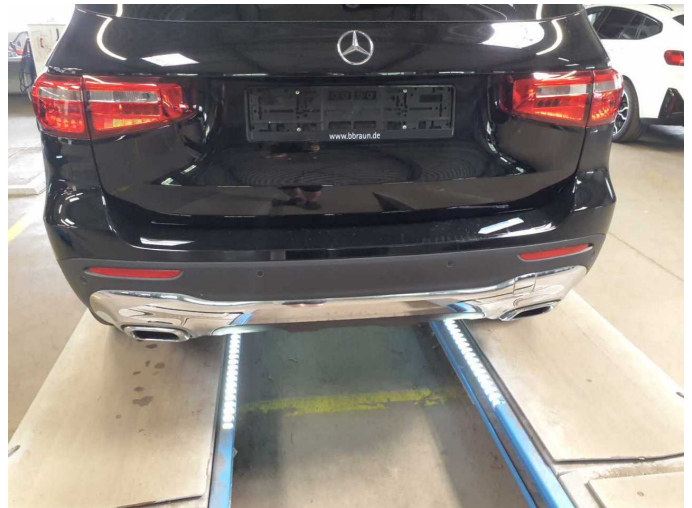
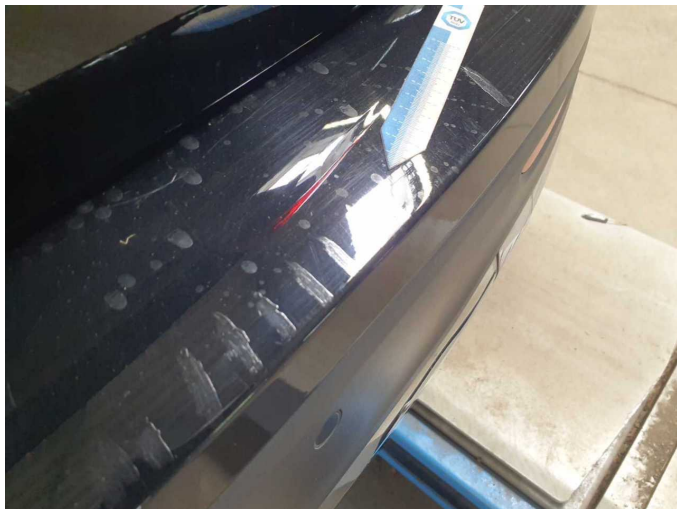
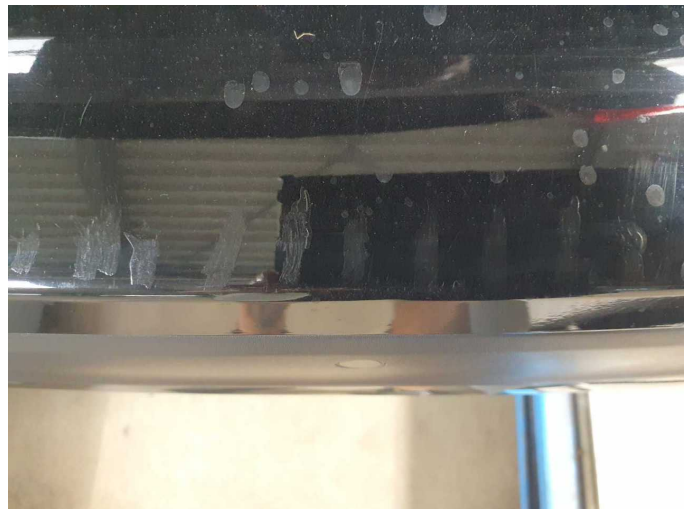
| No. | Component group | Description |
|---|---|---|
| 8 | Rear bumper | Rear bumper - Paint defect - Repair and paint |

**Damage 8:** Rear bumper: Rear bumper - Paint defect - Repair and paint
