LPSVSEGEKNL067393

Zustandsbericht

Inspection date: 11 May 2026
Protocol number: 45687905

Manufacturer	Polestar	Inspection condition	sufficient
Type / Model	2	Mileage (Read)	128,616 km
Vehicle Identification number	LPSVSEGEKNL067393	First registration	18 Mar 2022

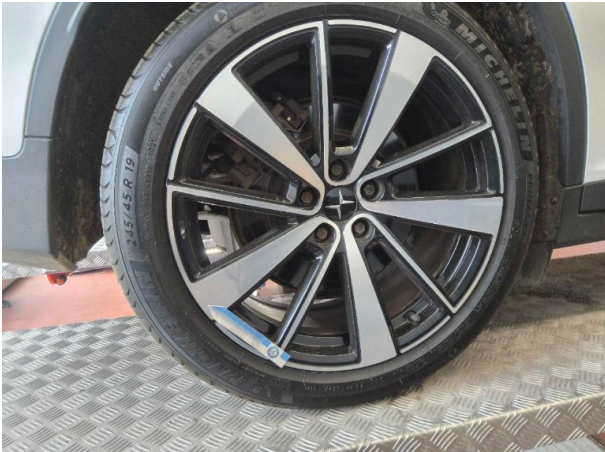
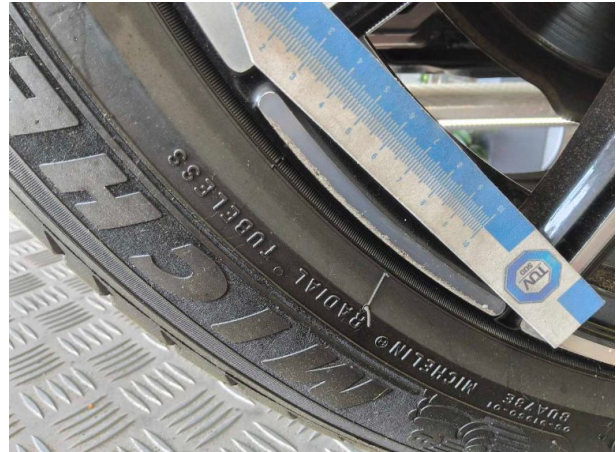
No.	Component group	Description
1	Wheel / tyres	Alloy rim - rear right side - Scratched - Loss in value
2	Rear bumper	Rear bumper - Scratch(es) - Smart repair
3	Misc.	Inspection / maintenance - Due - Replace

Damage #1: Wheel / tyres: Alloy rim - rear right side - Scratched - Loss in value

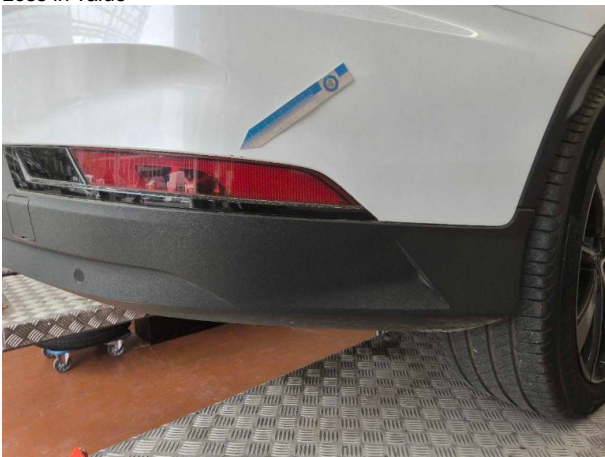
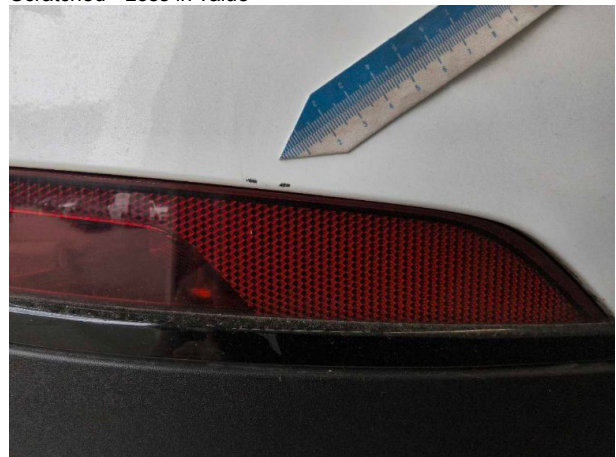
Damage #2: Rear bumper: Rear bumper - Scratch(es) - Smart repair

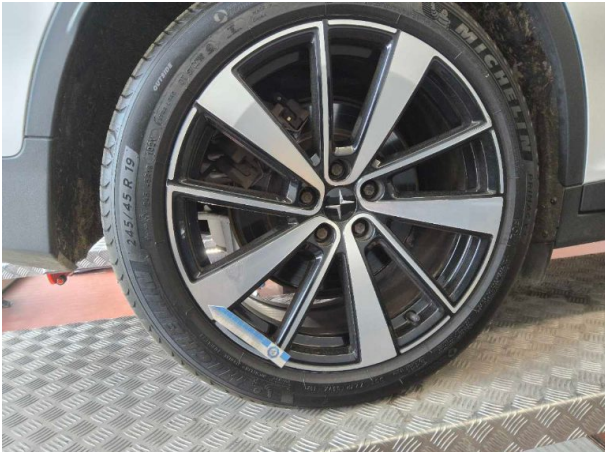
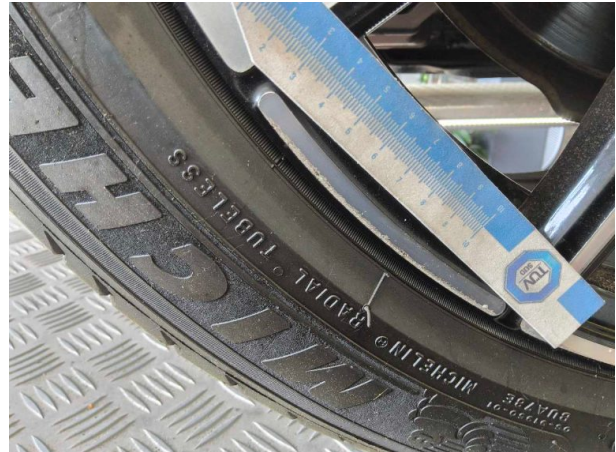
Nr.	Bauteilgruppe	Beschreibung
1	Rad/Reifen	Leichtmetallfelge hinten rechts - verkratzt / verschürft - Wertminderung
2	Stoßfänger hinten	Stoßfänger hinten - Kratzer - Smart Repair
3	Sonstiges	Inspektion/Wartung - fällig - erneuern

Beschädigung #1: Rad/Reifen: Leichtmetallfelge hinten rechts - verkratzt / verschürft - Wertminderung

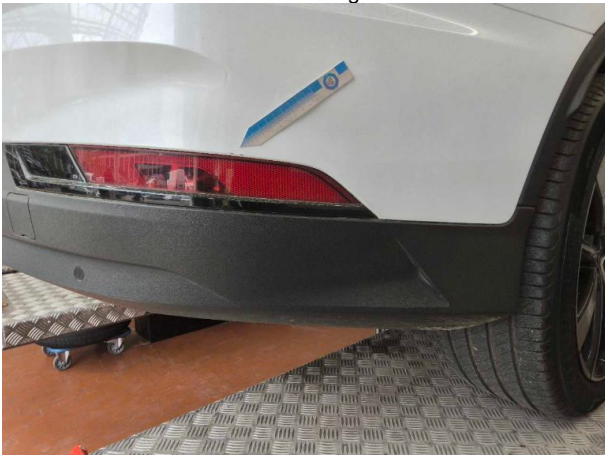
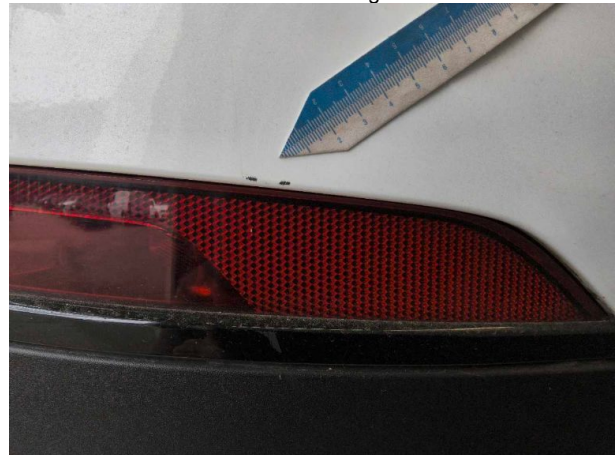
Beschädigung #2: Stossfänger hinten: Stossfänger hinten - Kratzer - Smart Repair
