Expertise

Protocol number: 46554945  
Order No. / Reference: 26469937  
Inspection date: 10 Jul 2026

Manufacturer: Volkswagen

Model: Tiguan Allspace 2.0 TDI SCR 4Motion DSG Life

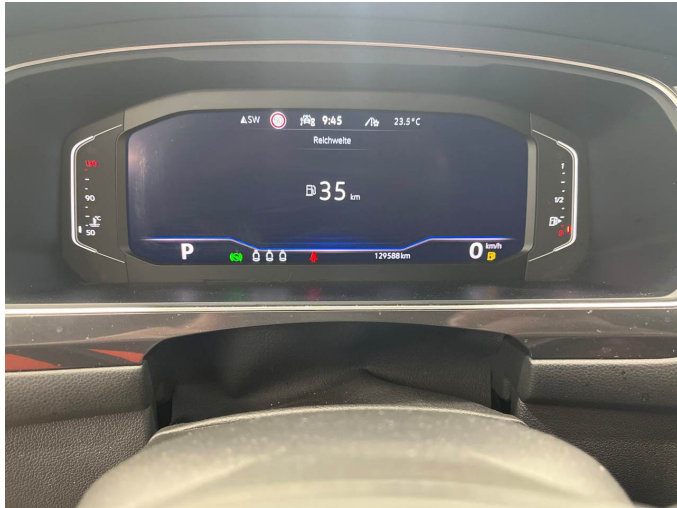
Figure 7: Instrument cluster

| Vehicle details | |
|---|---|
| Mileage (Read) | 129,588 km |

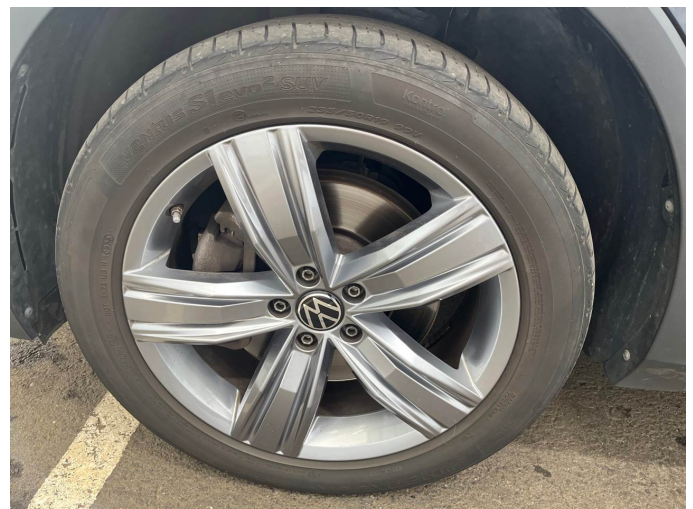
Figure 12: Mounted tyres

| # | Tyre size | Type of tyre | Manufacturer | Tread depth |
|---|---|---|---|---|
| 1) | 235/50 R19 99V | Summer tires (with run-flat tires) on Light alloy | Hankook | 4mm / 4mm |
| 2) | 235/50 R19 99V | Summer tires (with run-flat tires) on Light alloy | Hankook | 5mm / 5mm |

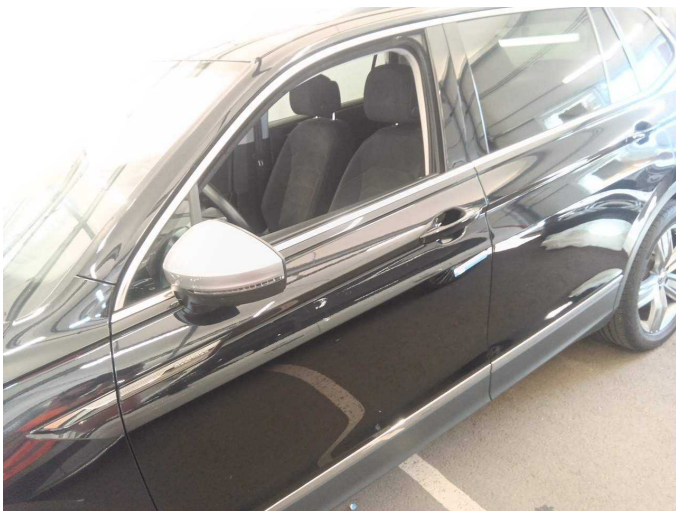
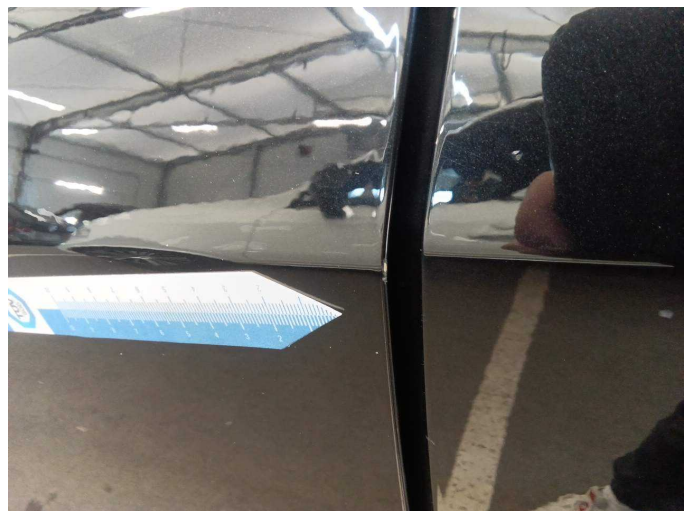
**Damage 1:** Door - front left side: Door edge - Scratch(es) - Smart repair

| No. | Component group | Description |
|---|---|---|
| 1 | Door - front left side | Door edge - Scratch(es) - Smart repair |

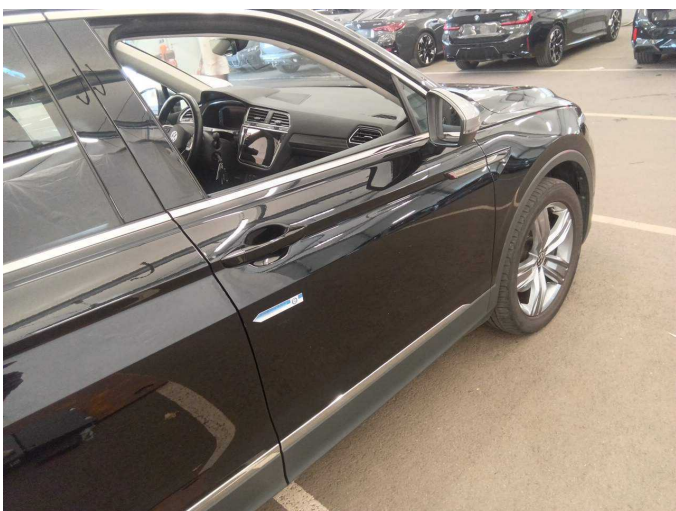
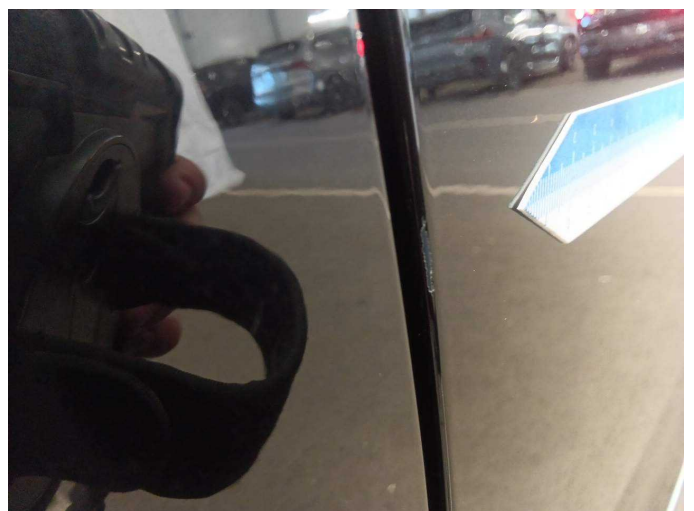
**Damage 2:** Door - front right side: Door edge - Scratch(es) - Smart repair

| No. | Component group | Description |
|---|---|---|
| 2 | Door - front right side | Door edge - Scratch(es) - Smart repair |

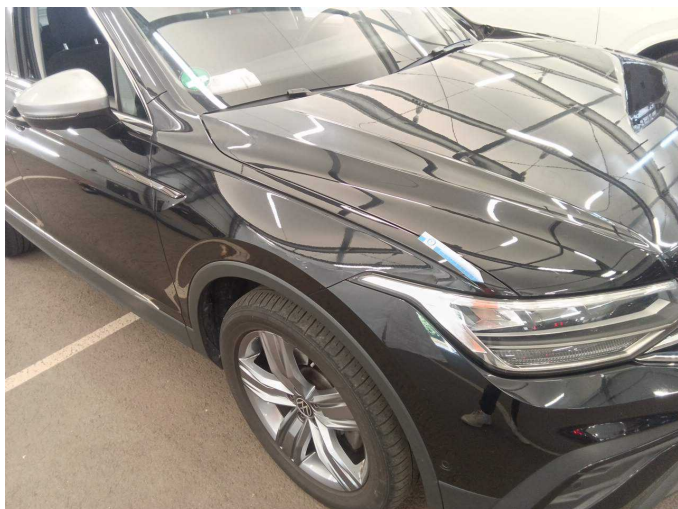
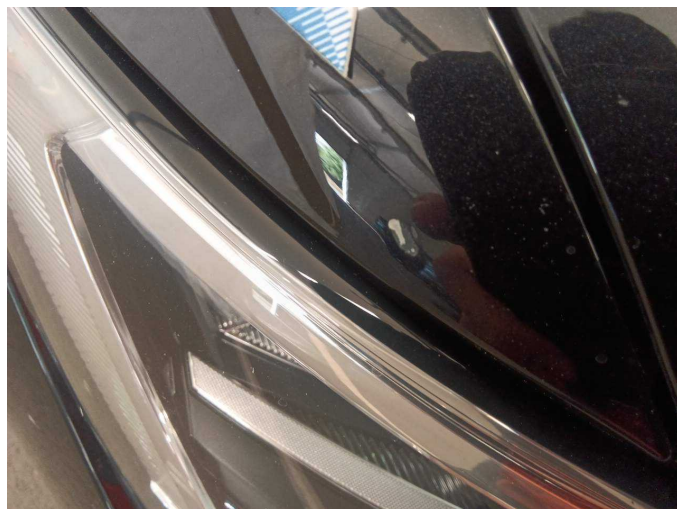
**Damage 3:** Mudguard - right side: Mudguard - right side - Stone chips - Smart repair

| No. | Component group | Description |
|---|---|---|
| 3 | Mudguard - right side | Mudguard - right side - Stone chips - Smart repair |

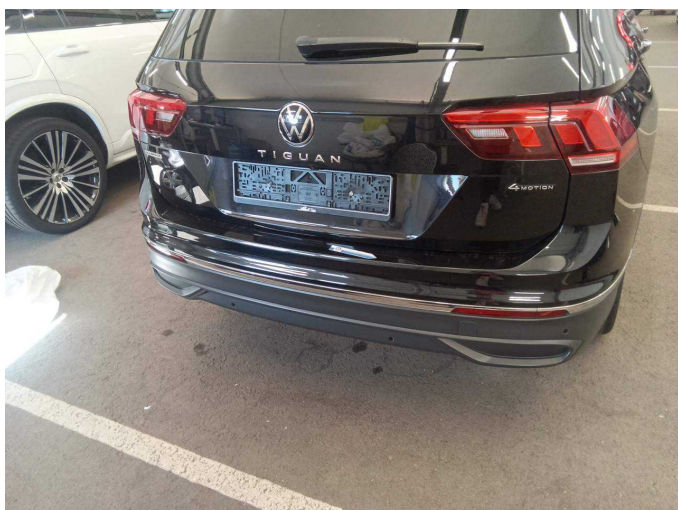
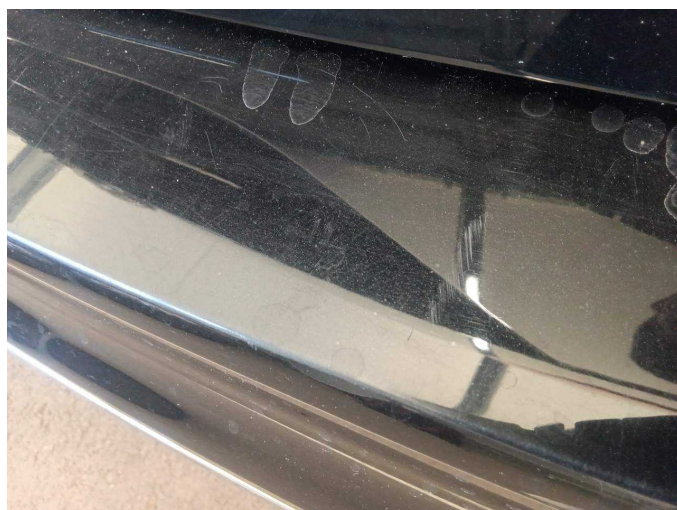
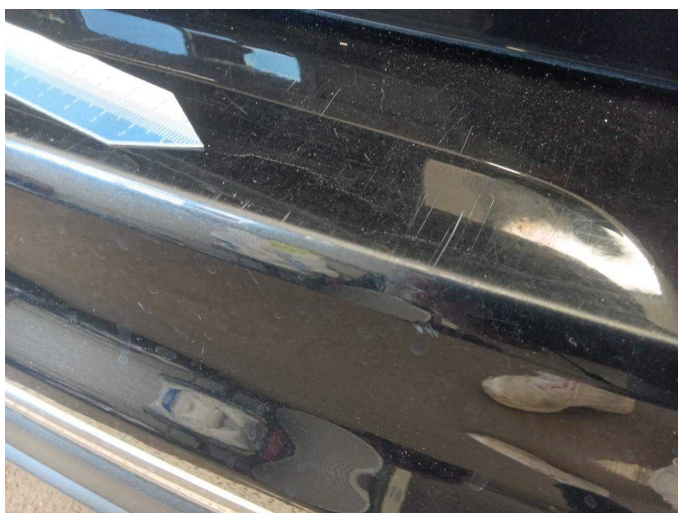
**Damage 5:** Rear bumper: Rear bumper - Scratch(es) - Paint

| No. | Component group | Description |
|---|---|---|
| 5 | Rear bumper | Rear bumper - Scratch(es) - Paint |

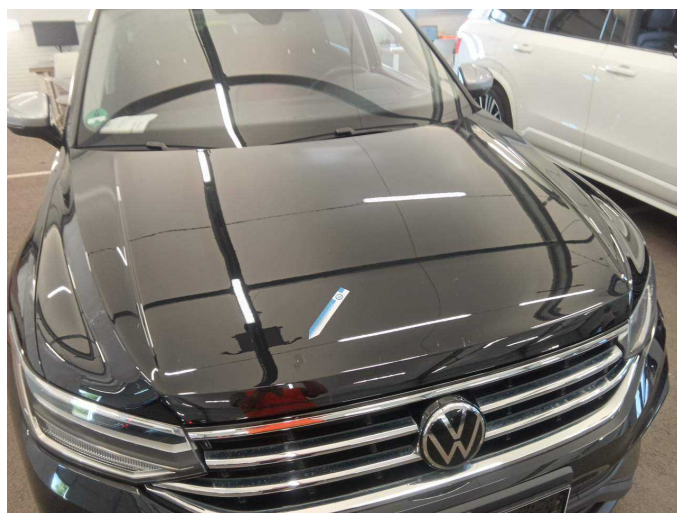
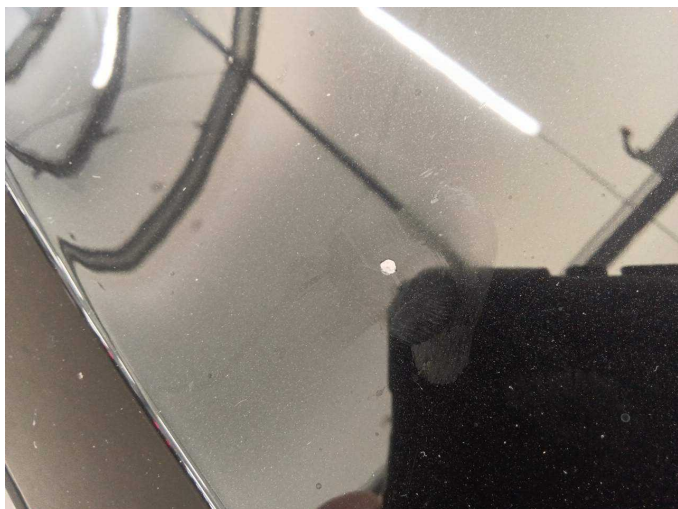
**Wear and tear 1:** Bonnet: Bonnet - Stone chips - No deduction

| No. | Component group | Description |
|---|---|---|
| 1 | Bonnet | Bonnet - Stone chips - No deduction |
