Expertise

Protocol number: 46548228  
Order No. / Reference: 26564950  
Inspection date: 15 Jul 2026

Manufacturer: Volkswagen

Model: Passat Variant 2.0 TDI SCR DSG Business

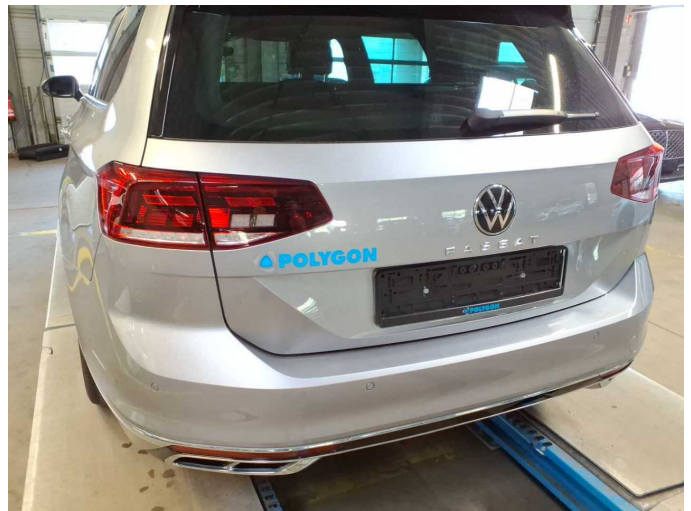
| No. | Component group | Description |
|---|---|---|
| 1 | Body | Body - Glued / labelled - De-glue / neutralise |

Damage 1: Body: Body - Glued / labelled - De-glue / neutralise

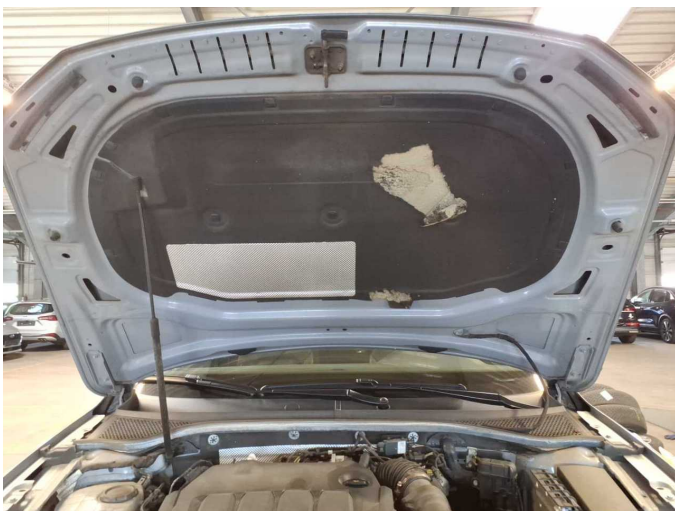
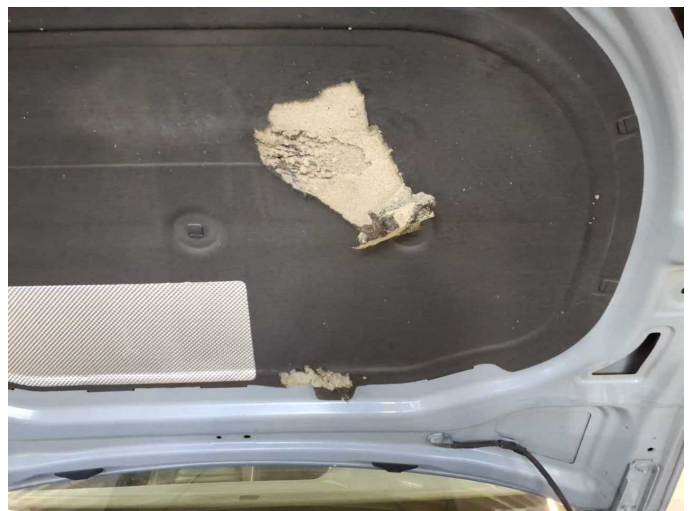
| No. | Component group | Description |
|---|---|---|
| 2 | Bonnet | Insulation lining - Damage caused by marten / rodent - Replace |

Damage 2: Bonnet: Insulation lining - Damage caused by marten / rodent  
- Replace

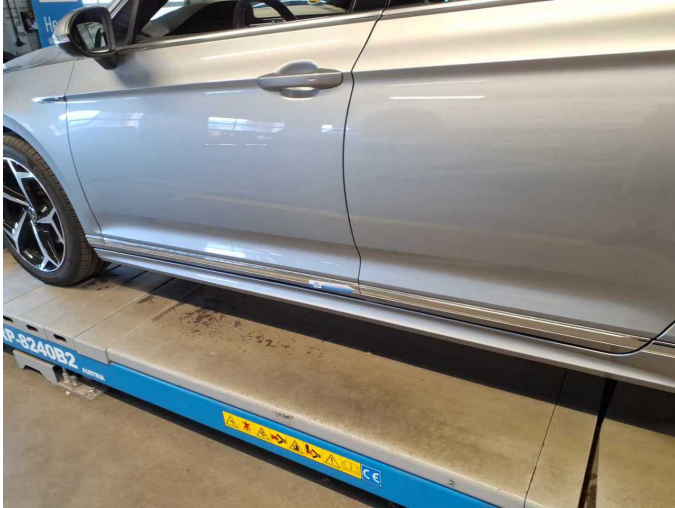
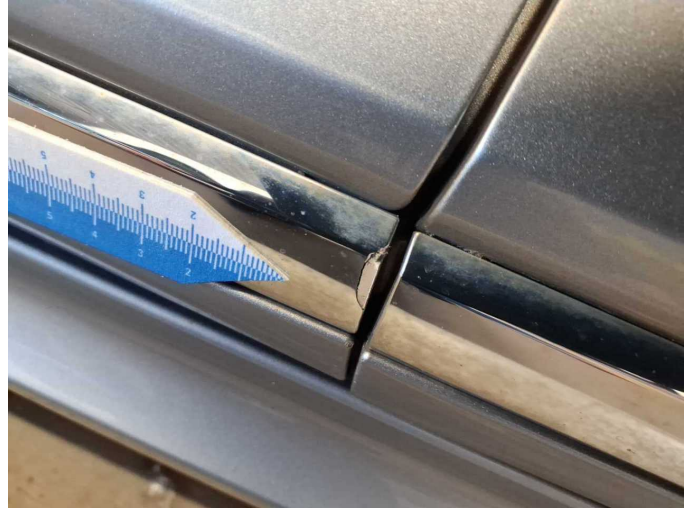
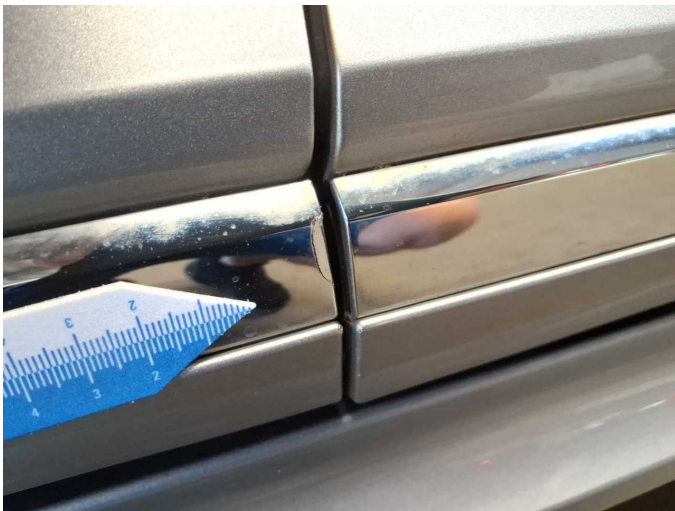
| No. | Component group | Description |
|---|---|---|
| 3 | Door - front left side | Brightware - lower - Broken / torn - Replace |

**Damage 3:** Door - front left side: Brightware - lower - Broken / torn - Replace

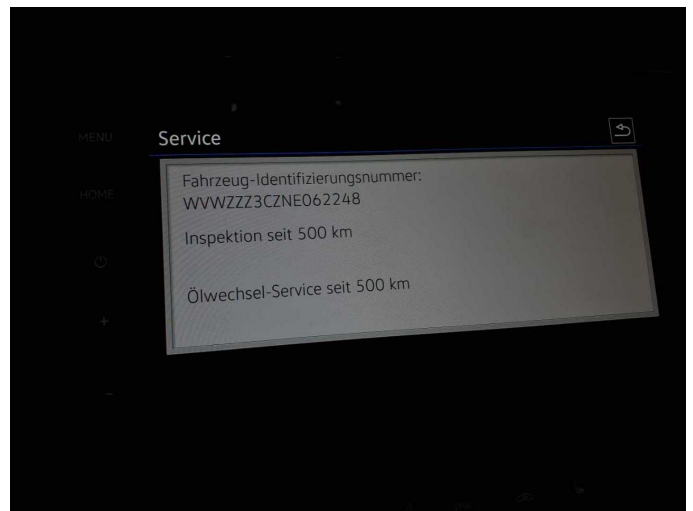
| No. | Component group | Description |
|---|---|---|
| 4 | Misc. | Inspection / maintenance - Due - Perform |

**Damage 4:** Misc.: Inspection / maintenance - Due - Perform

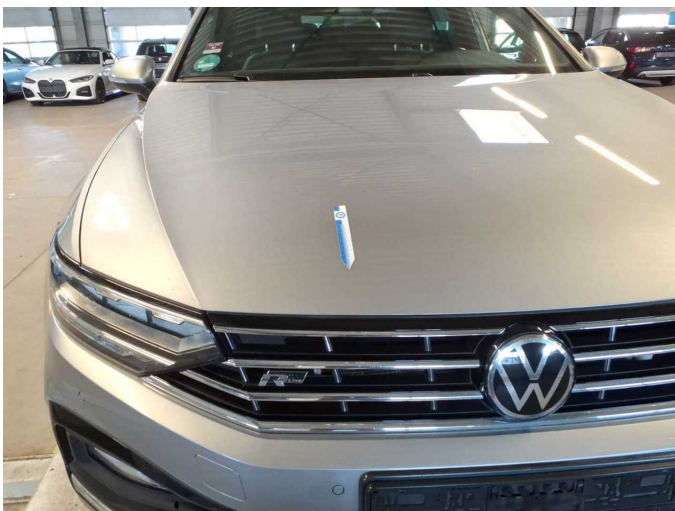
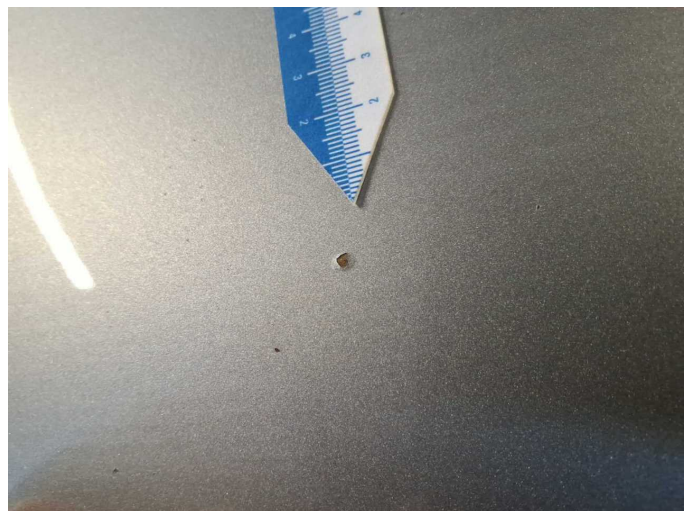
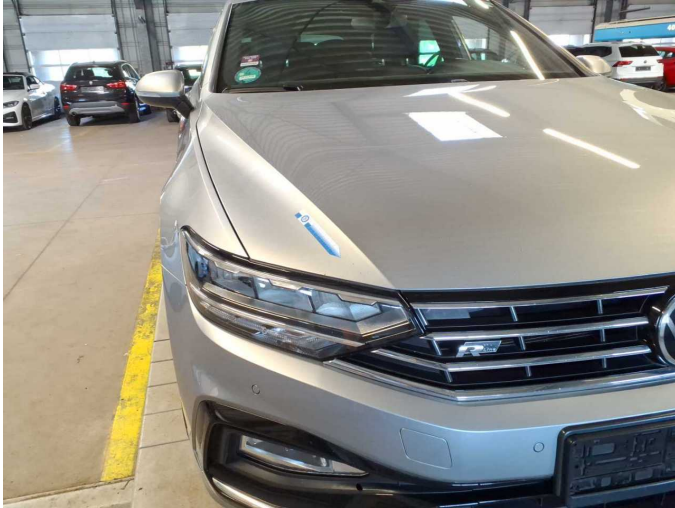
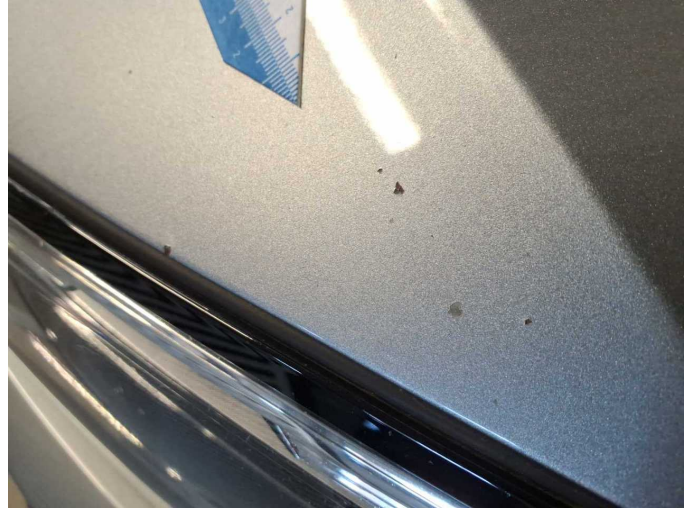
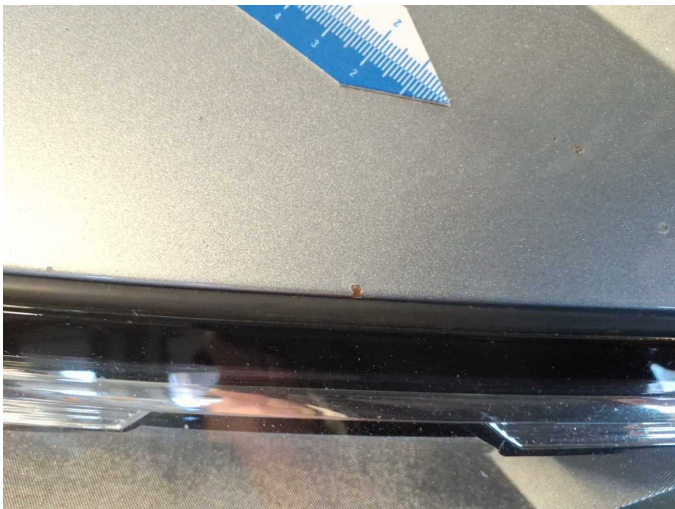
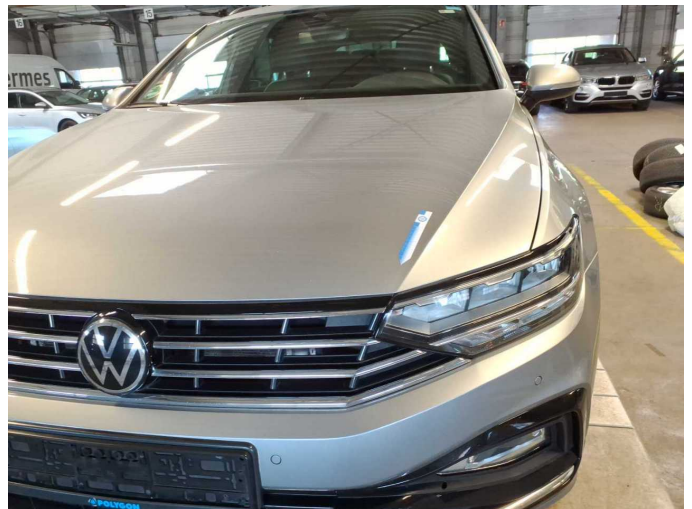
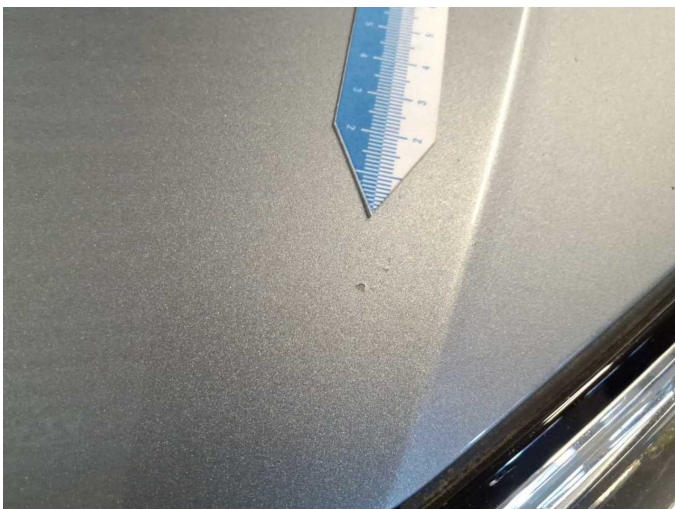
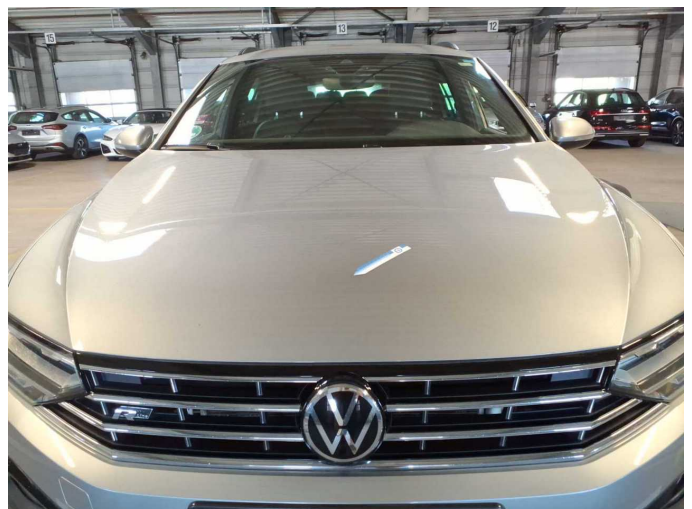
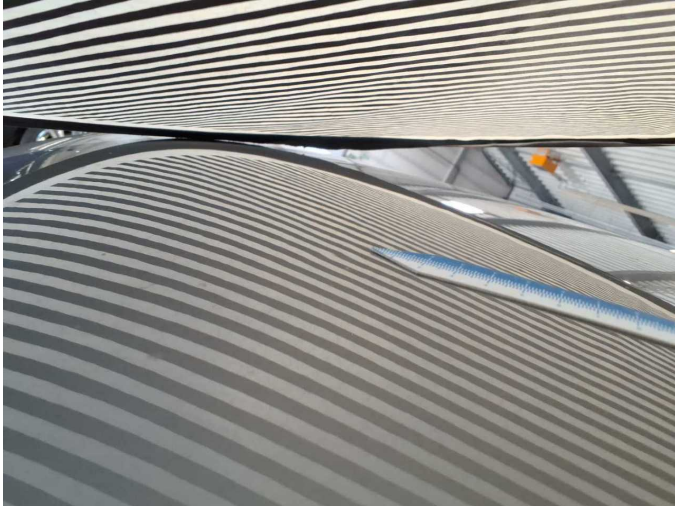
| No. | Component group | Description |
|---|---|---|
| 5 | Bonnet | Bonnet - Dent / paintcoat damage - Repair and paint |

**Damage 5:** Bonnet: Bonnet - Dent / paintcoat damage - Repair and paint

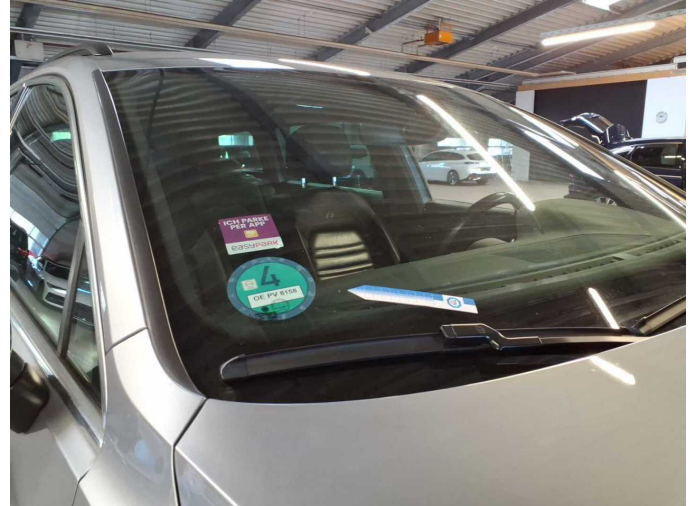
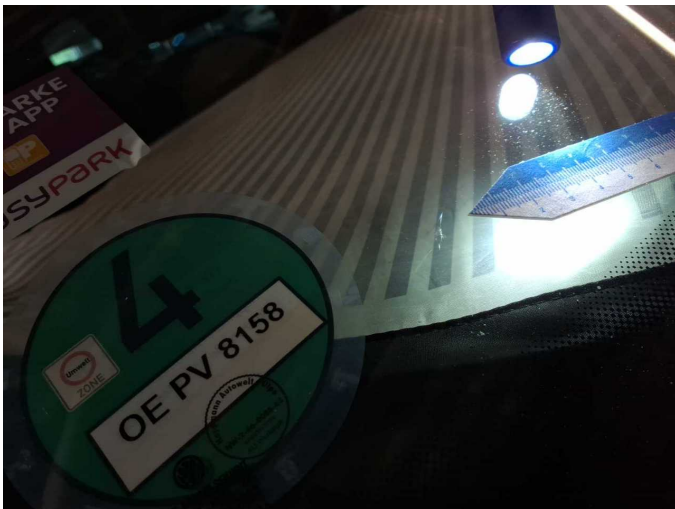
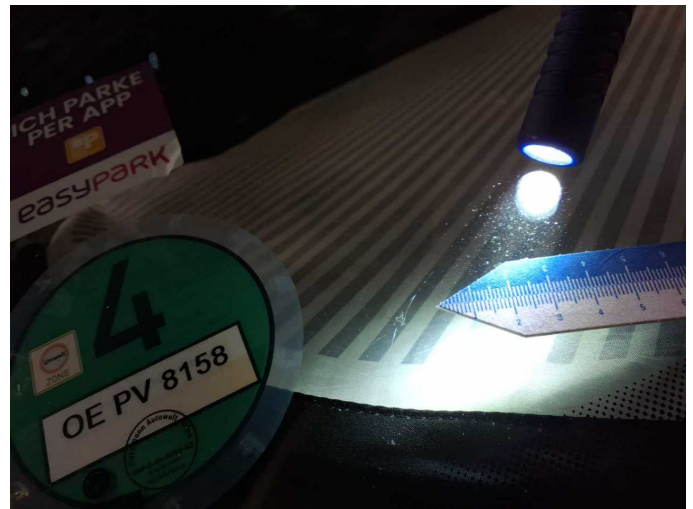
| No. | Component group | Description |
|---|---|---|
| 6 | Vehicle glazing | Windscreen (Rissbildung) - Stone chips - Replace |

**Damage 6:** Vehicle glazing: Windscreen (Rissbildung) - Stone chips - Replace

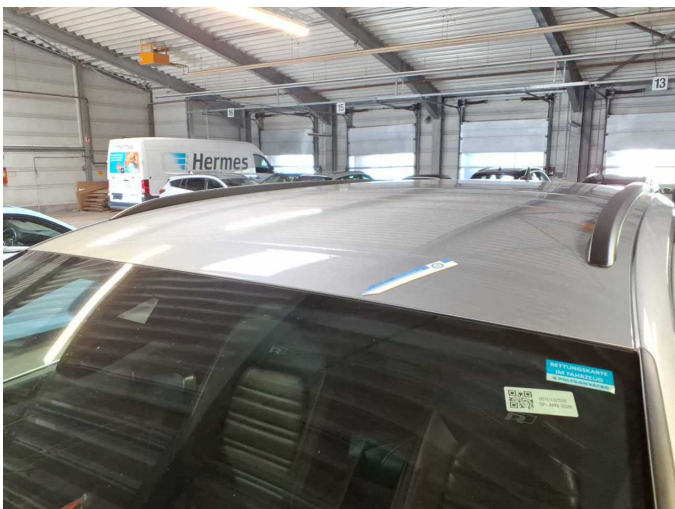
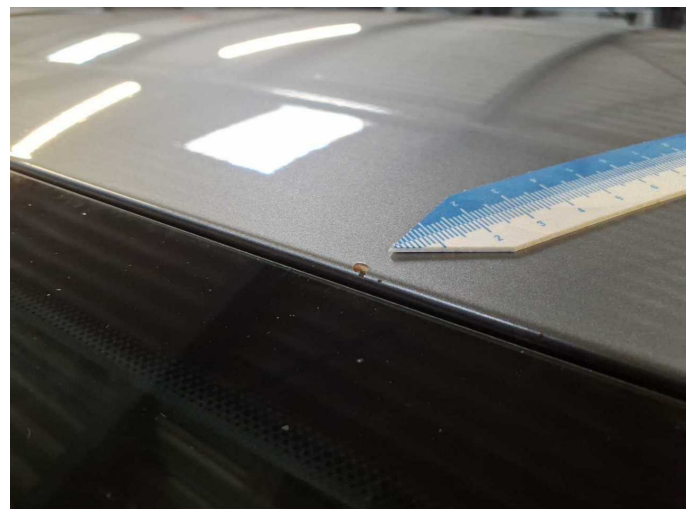
| No. | Component group | Description |
|---|---|---|
| 3 | Roof | Roof - Stone chips - No deduction |

**Wear and tear 3:** Roof: Roof - Stone chips - No deduction

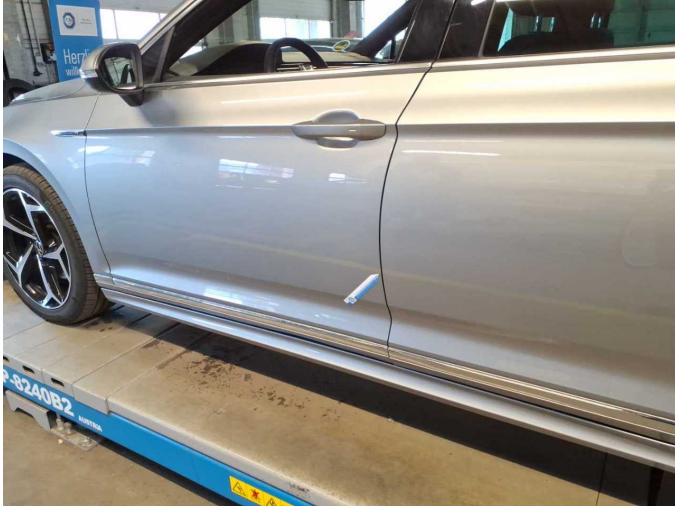
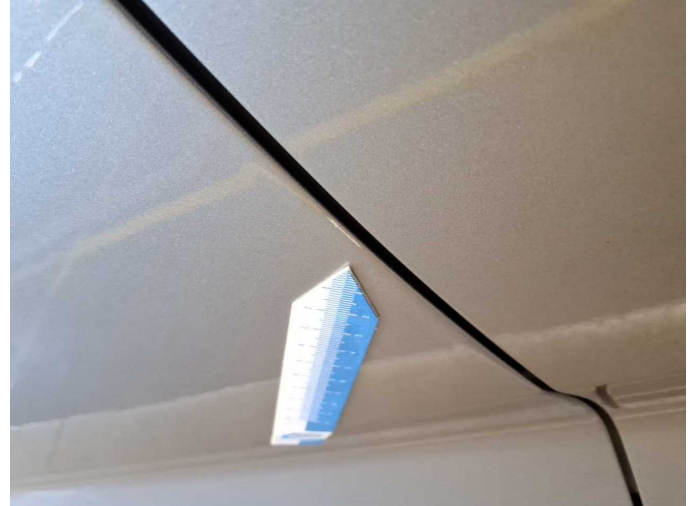
| No. | Component group | Description |
|---|---|---|
| 4 | Door - front left side | Door edge - Scratch(es) - No deduction |

**Wear and tear 4:** Door - front left side: Door edge - Scratch(es) - No deduction

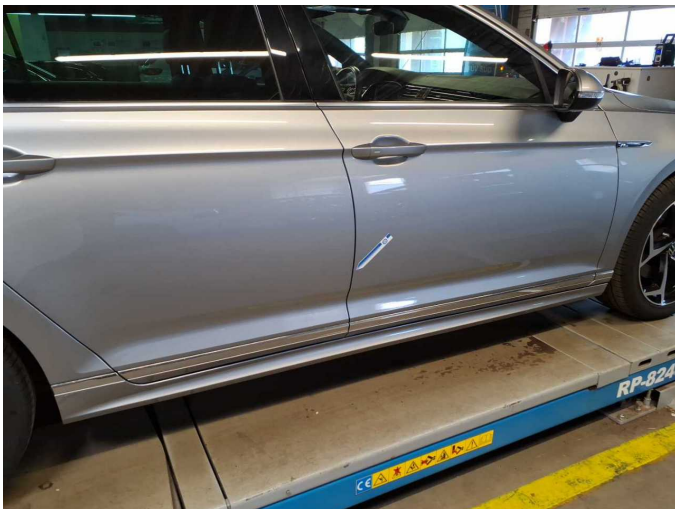
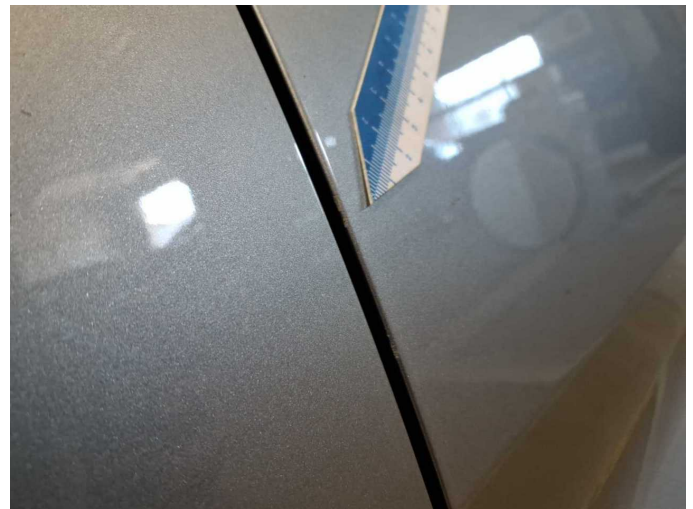
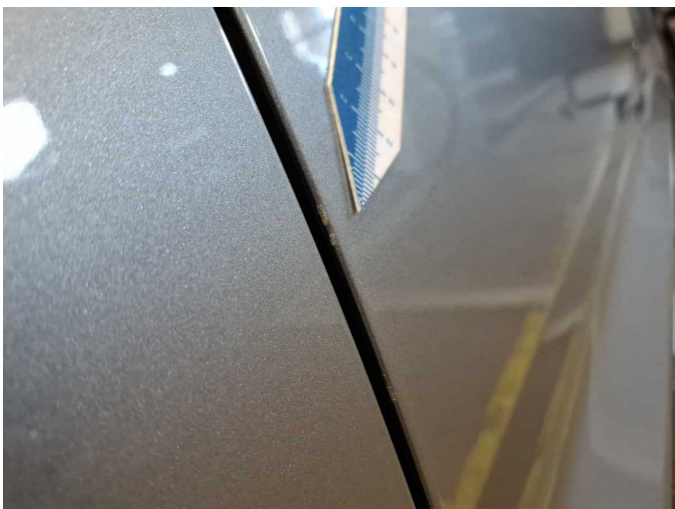
| No. | Component group | Description |
|---|---|---|
| 5 | Door - front right side | Door edge - Scratch(es) - No deduction |

**Wear and tear 5:** Door - front right side: Door edge - Scratch(es) - No deduction

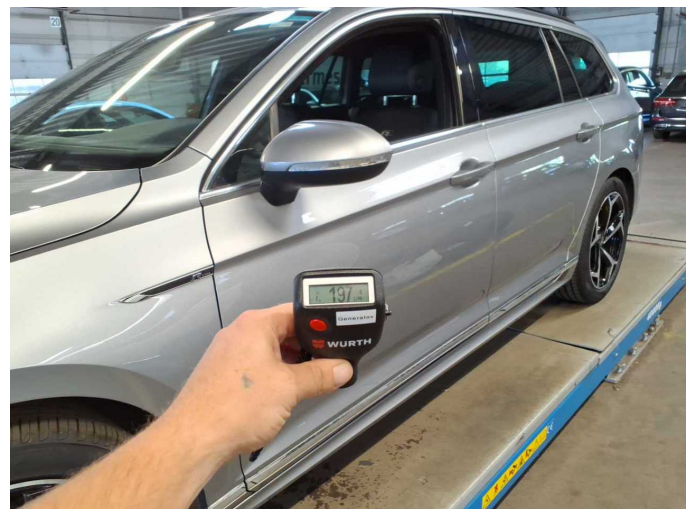
| No. | Repainting |
|---|---|
| 1 | Door - front left side, Professionally carried out, Invoice of repair done Non-existent |

| Door - front left side | 197 µm |

**Repainting 1:** Door - front left side
