Expertise

Protocol number: 46206771
Order No. / Reference: 26544912
Inspection date: 29 Jun 2026

Model: Focus Turnier 1.0 EcoBoost Hybrid Aut. TITANIUM

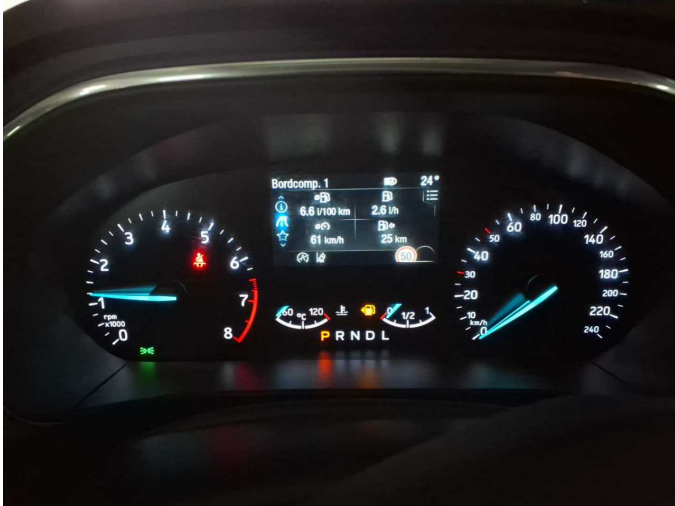
Figure 7: Instrument cluster

Mileage (Read) 59,421 km

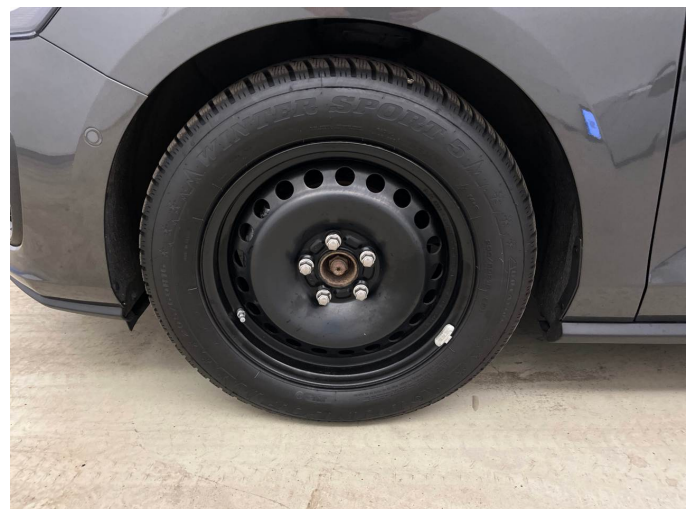
Figure 12: Mounted tyres

#	Tyre size	Type of tyre	Manufacturer	Tread depth
1)	205/60 R16 96H	Winter tyres on Steel	Dunlop	6mm / 6mm
2)	205/60 R16 96H	Winter tyres on Steel	Dunlop	6mm / 6mm

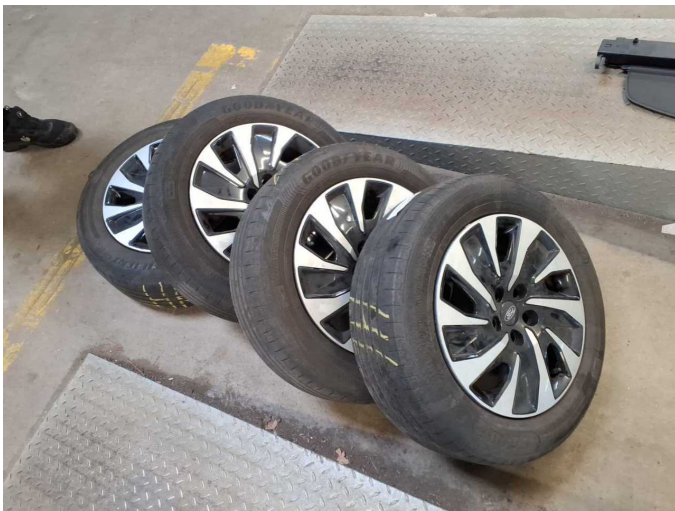
Figure 15: Additional tyres

#	Tyre size	Type of tyre	Manufacturer	Tread depth
1)	205/60 R16 92V	Summer tyres on Steel rim with wheel cover	Goodyear	3mm / 3mm
2)	205/60 R16 92V	Summer tyres on Steel rim with wheel cover	Goodyear	4mm / 4mm

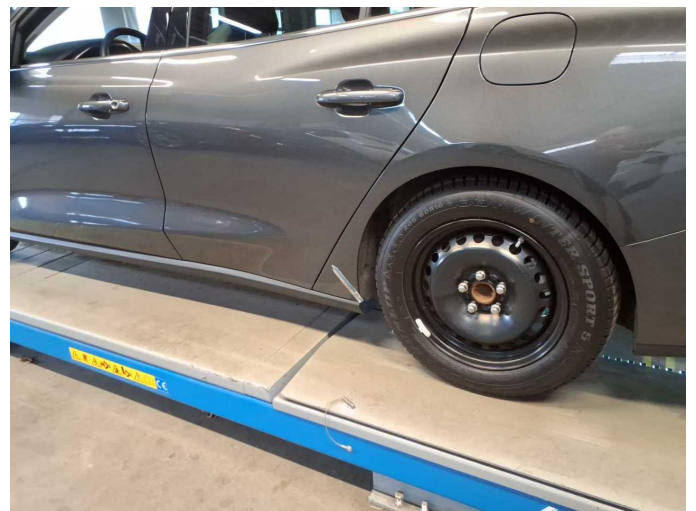
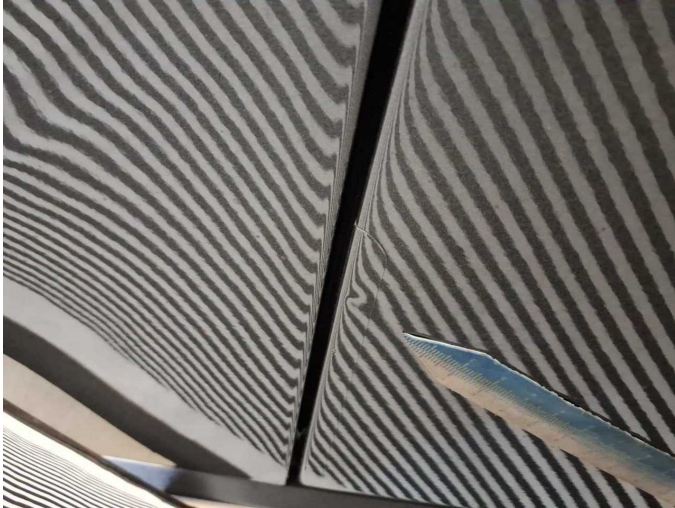
Damage 1: Side panel - rear left side: Side panel - dent(s) - Smooth repair work

No.	Component group	Description
1	Side panel - rear left side	Side panel - dent(s) - Smooth repair work
2	Front bumper	Spoiler - Scratch(es) - Smart repair
3	Misc.	Inspection / maintenance - Due - Perform

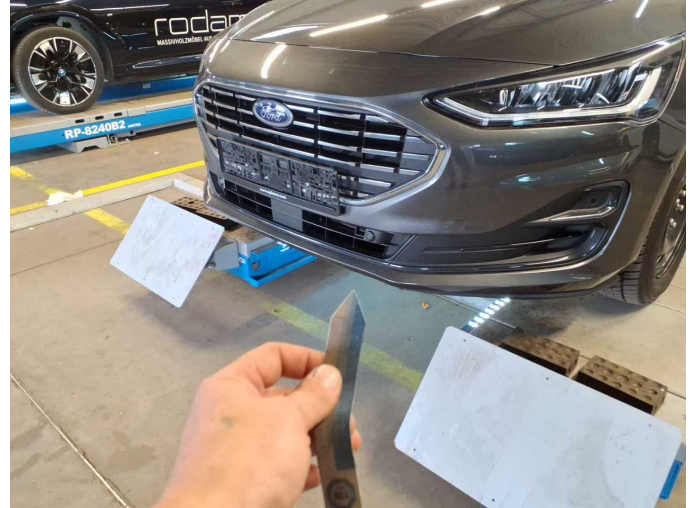
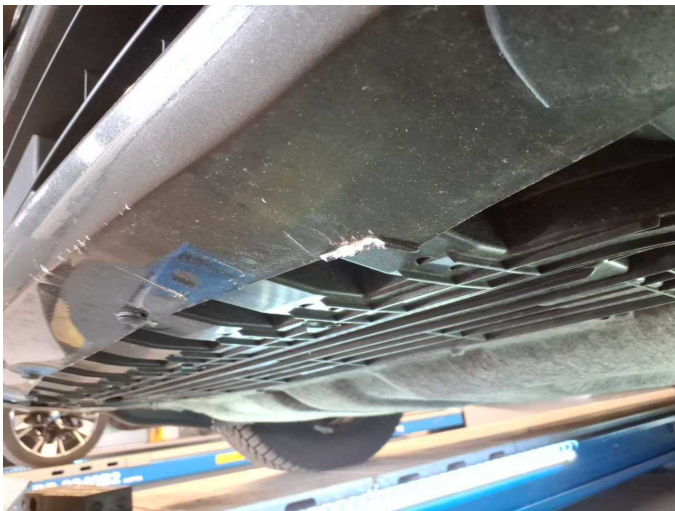
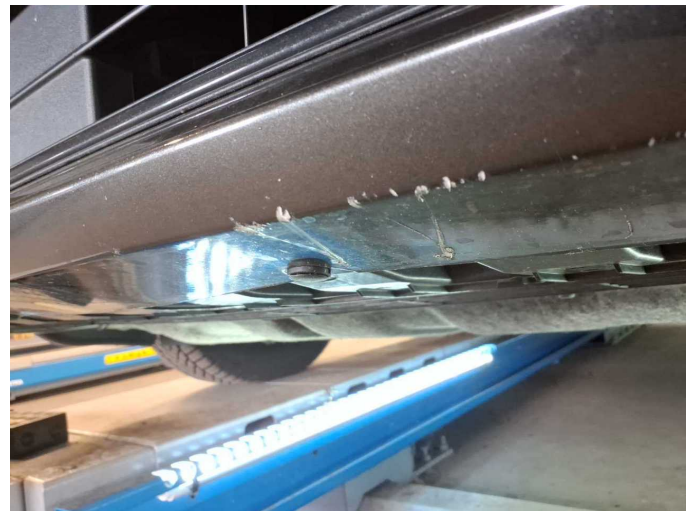
Damage 2: Front bumper: Spoiler - Scratch(es) - Smart repair

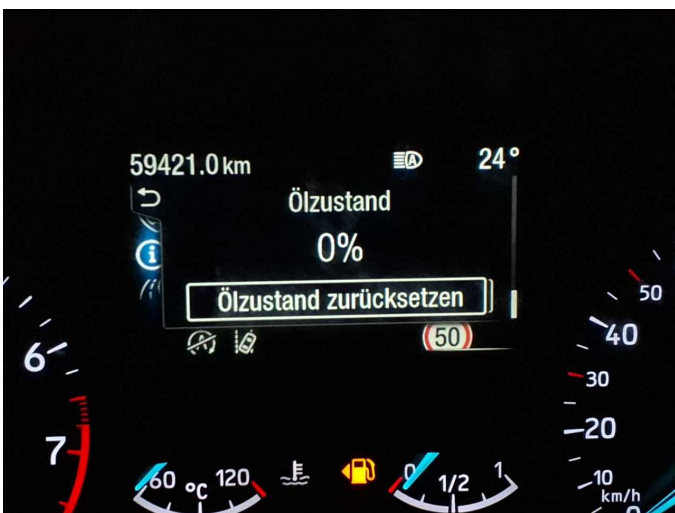
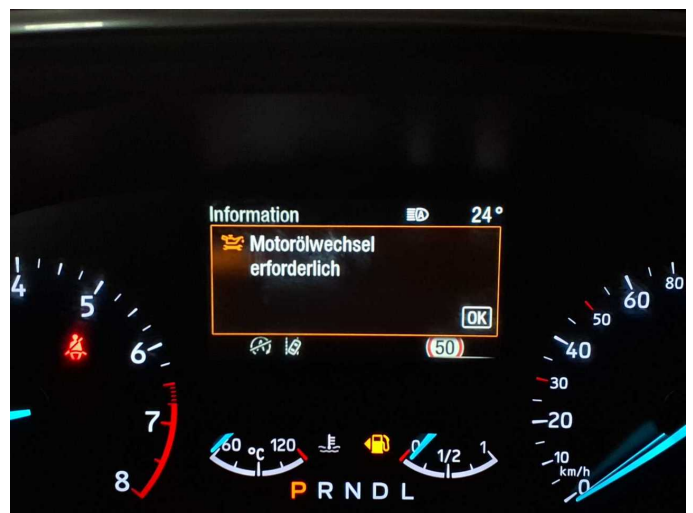
Damage 3: Misc.: Inspection / maintenance - Due - Perform

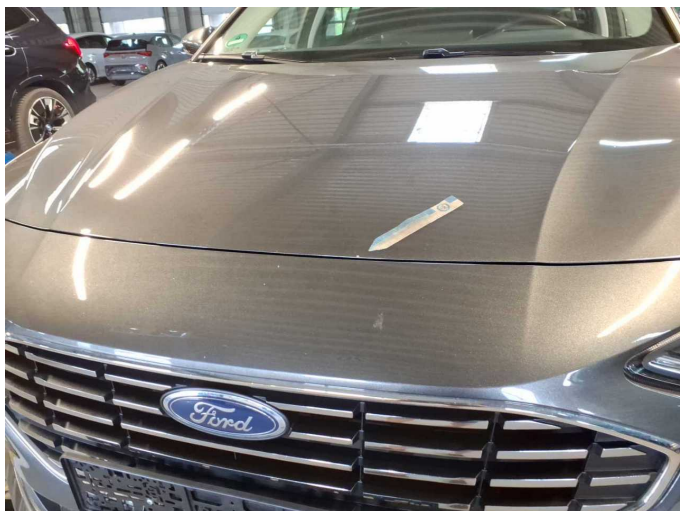
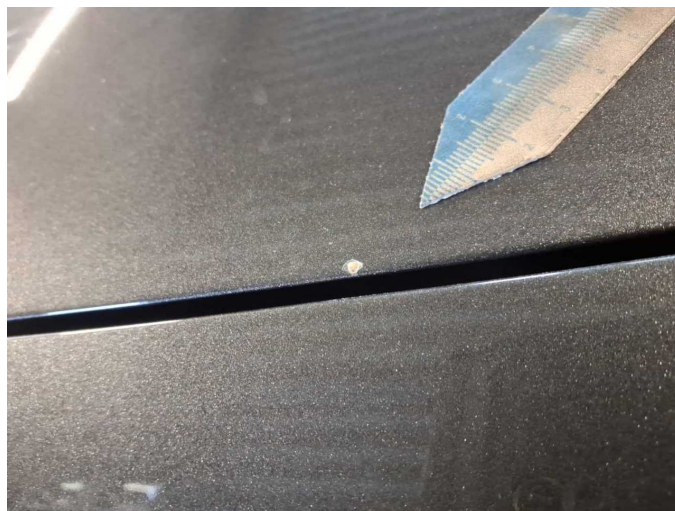
Wear and tear 2: Bonnet: Bonnet - Stone chips - No deduction
