Expertise

Protocol number: 46623289  
Order No. / Reference: 26727179-1  
Inspection date: 15 Jul 2026

| Manufacturer: Skoda | Model: Enyaq iV 80 |

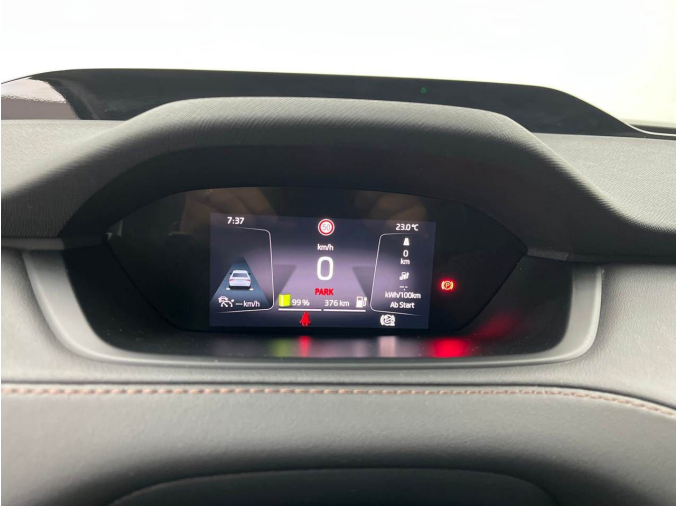
| Vehicle details | |
|---|---|
| Mileage (Read) | 136,280 km |

Figure 7: Instrument cluster

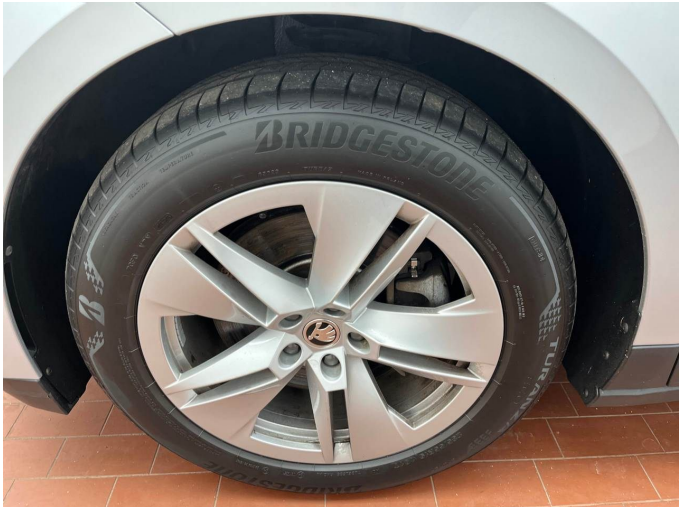
Figure 12: Mounted tyres

| # | Tyre size | Type of tyre | Manufacturer | Tread depth |
|---|---|---|---|---|
| 1) | 235/55 R19 101T | Summer tyres on Light alloy | Bridgestone | 6mm / 6mm |
| 2) | 255/50 R19 103T | Summer tyres on Light alloy | Bridgestone | 5mm / 5mm |

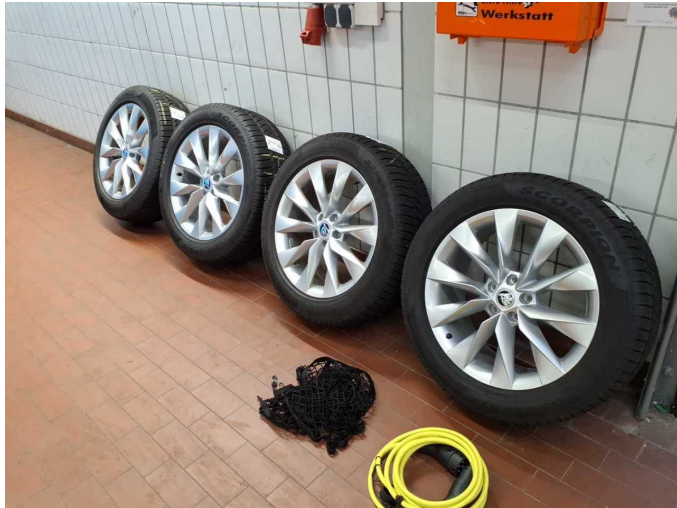
Figure 19: Additional tyres

| # | Tyre size | Type of tyre | Manufacturer | Tread depth |
|---|---|---|---|---|
| 1) | 235/55 R19 101H | Winter tyres on Light alloy | Pirelli | 7mm / 7mm |
| 2) | 255/50 R19 103H | Winter tyres on Light alloy | Pirelli | 5mm / 5mm |

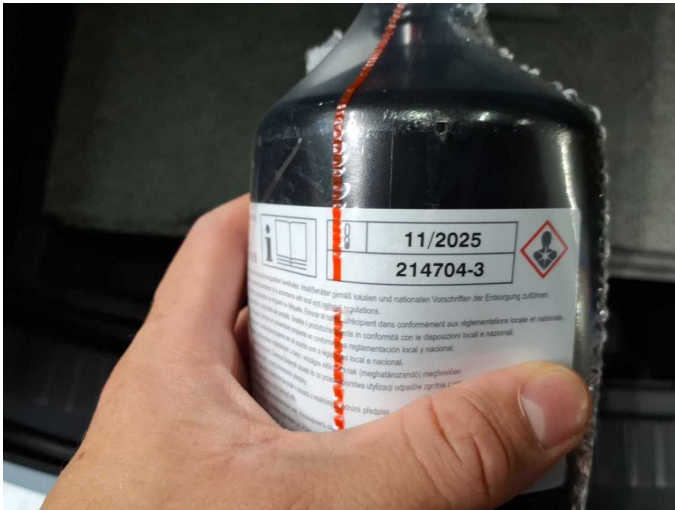
| No. | Component group | Description |
|---|---|---|
| 1 | Equipment | Tirefit filler - Due - Replace |

Damage 1: Equipment: Tirefit filler - Due - Replace

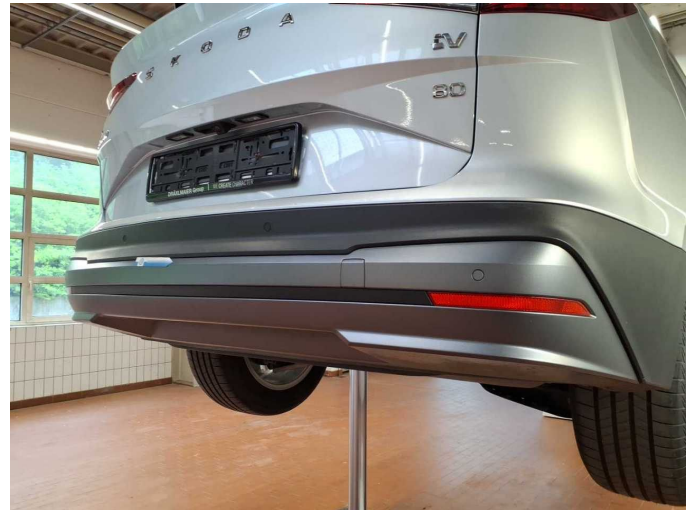
| No. | Component group | Description |
|---|---|---|
| 2 | Boot lid / rear door | Emblem - Damaged - Replace |

Damage 2: Boot lid / rear door: Emblem - Damaged - Replace

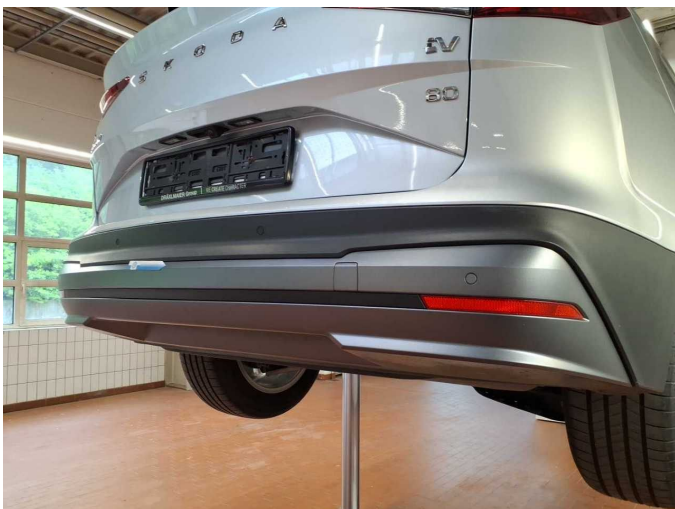
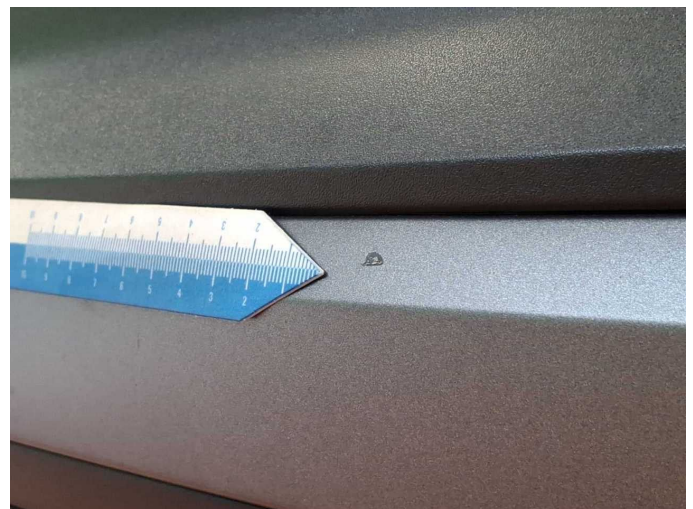
| No. | Component group | Description |
|---|---|---|
| 3 | Rear bumper | Spoiler - Scratch(es) - Smart repair |

Damage 3: Rear bumper: Spoiler - Scratch(es) - Smart repair

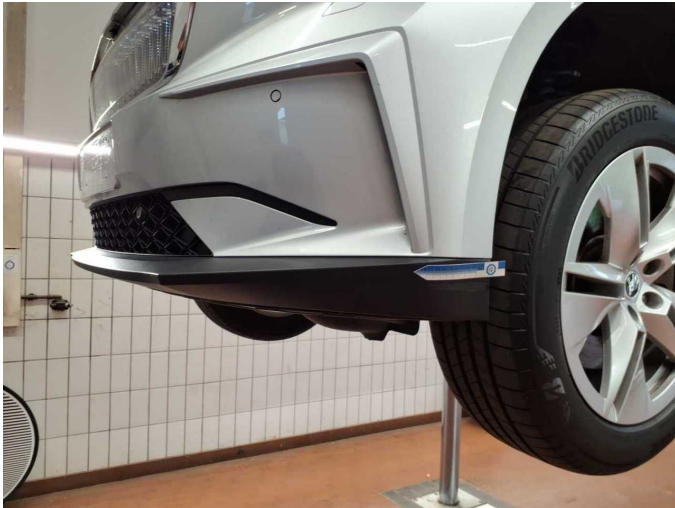
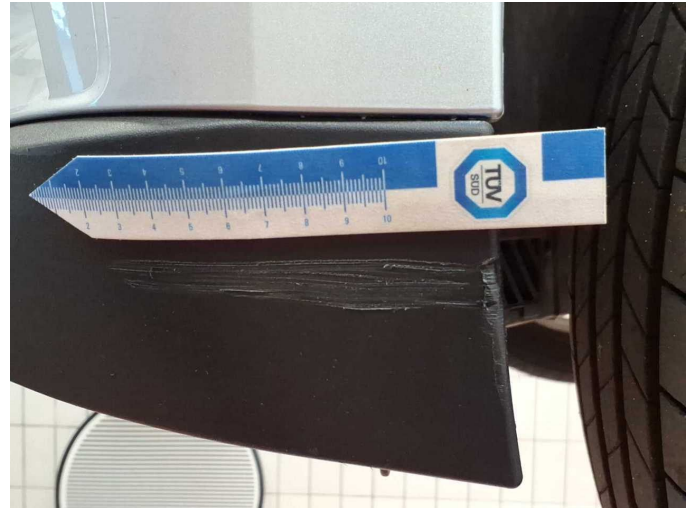
| No. | Component group | Description |
|---|---|---|
| 4 | Front bumper | Spoiler - Scratched - Replace |

**Damage 4:** Front bumper: Spoiler - Scratched - Replace

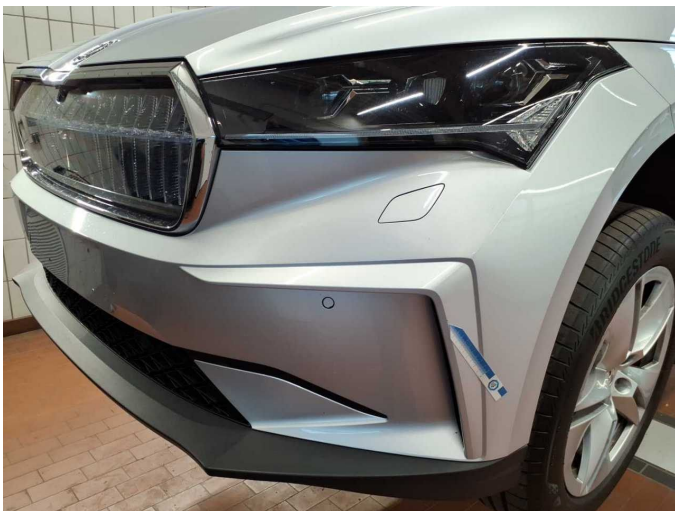
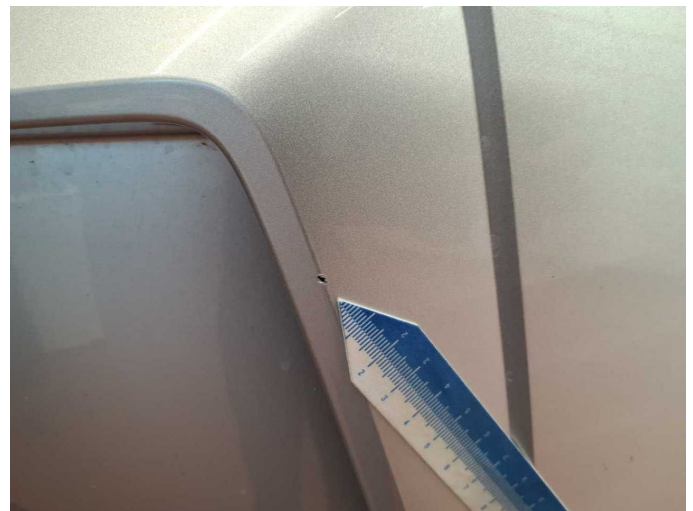
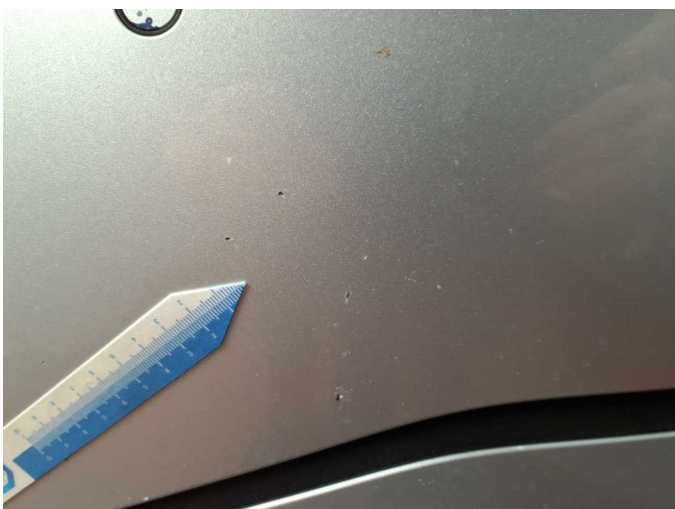
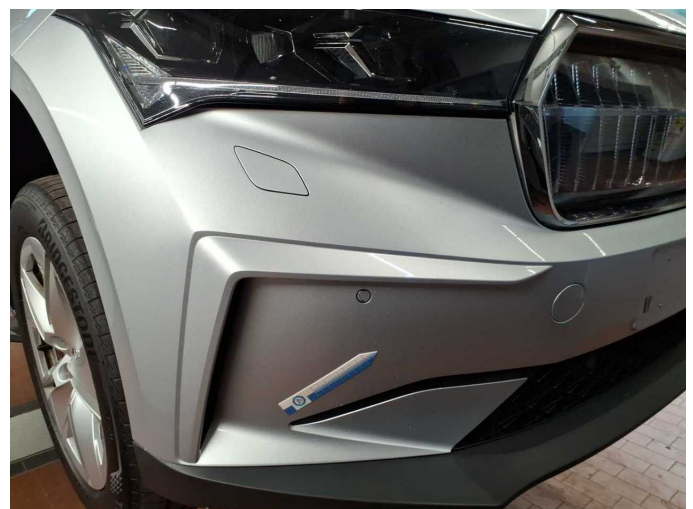
| No. | Component group | Description |
|---|---|---|
| 1 | Front bumper | Front bumper - Stone chips - No deduction |

**Wear and tear 1:** Front bumper: Front bumper - Stone chips - No deduction

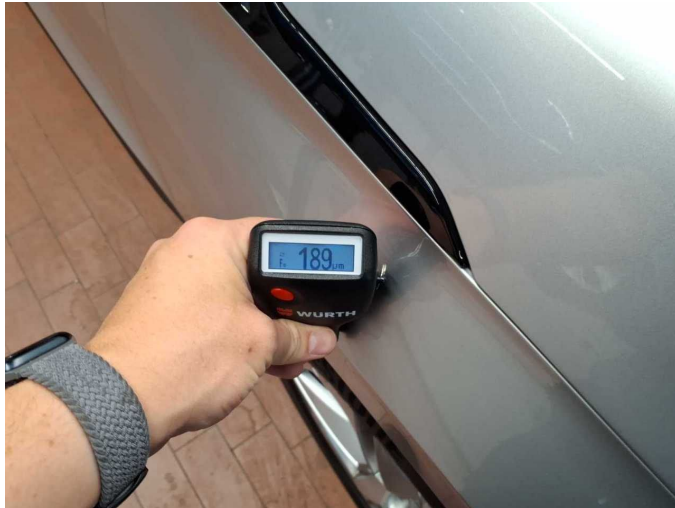
| No. | Repainting |
|---|---|
| 1 | Mudguard - right side, Professionally carried out, Invoice of repair done Non-existent |

| Mudguard - right side | 189 µm | Side panel - rear right side | 272 µm |

**Repainting 1:** Mudguard - right side

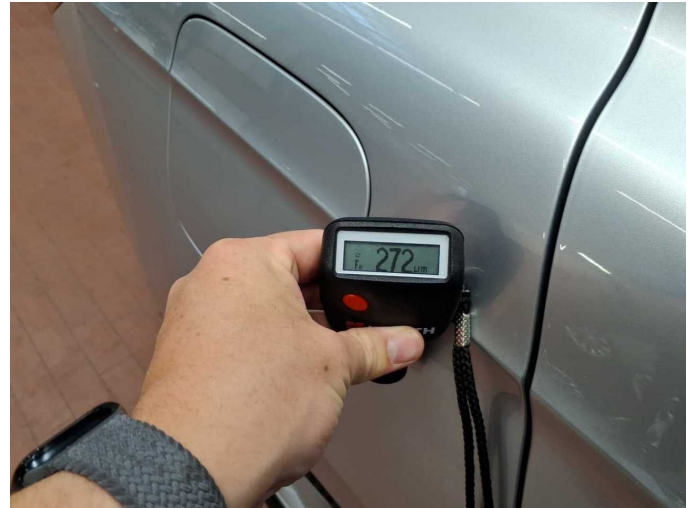
| No. | Repainting |
|---|---|
| 2 | Side panel - rear right side, Professionally carried out, Invoice of repair done Non-existent |

**Repainting 2:** Side panel - rear right side

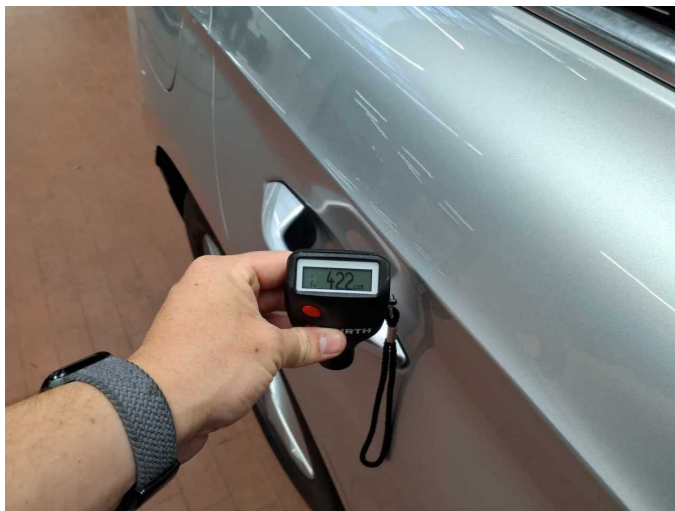
| No. | Repainting |
|---|---|
| 3 | Door - rear right side, Professionally carried out, Invoice of repair done Non-existent |

| Door - rear right side | 422 µm | Door - front right side | 204 µm |

**Repainting 3:** Door - rear right side

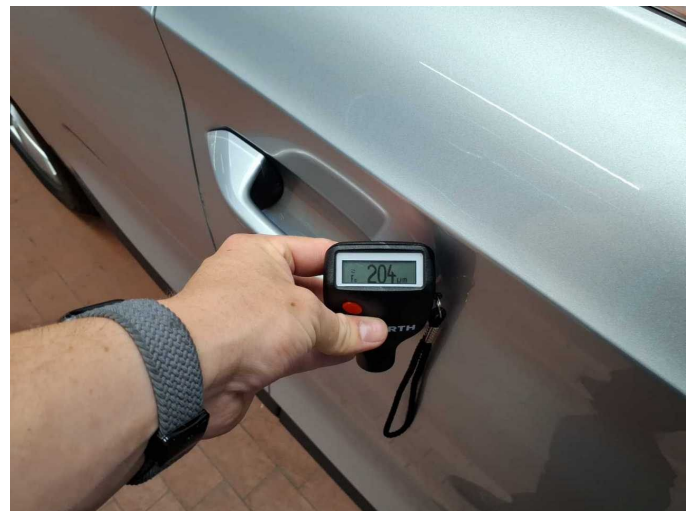
| No. | Repainting |
|---|---|
| 4 | Door - front right side, Professionally carried out, Invoice of repair done Non-existent |

**Repainting 4:** Door - front right side
