Expertise

Protocol number: 46833281  
Order No. / Reference: 26621731  
Inspection date: 3 Aug 2026

| Manufacturer: Opel | Model: Astra 1.5 D Automatik Business Elegance |

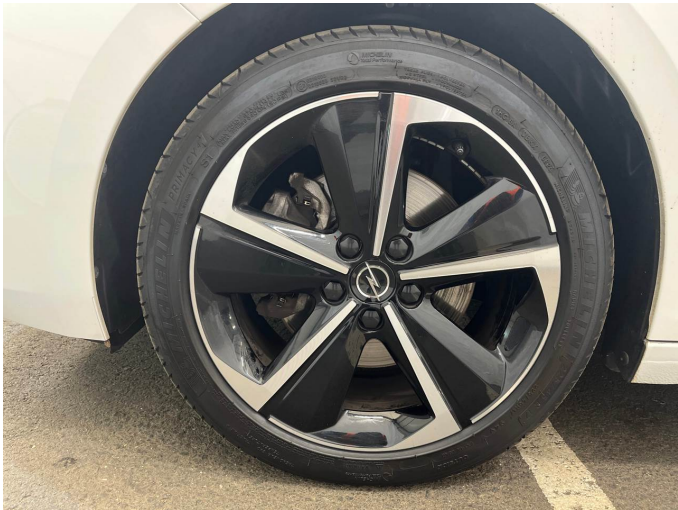
Figure 12: Mounted tyres

| Tyres | | | | |
|---|---|---|---|---|
| 1) | 225/45 R17 94V | Summer tyres on Light alloy | Michelin | 4mm / 4mm |
| 2) | 225/45 R17 94V | Summer tyres on Light alloy | Michelin | 5mm / 5mm |

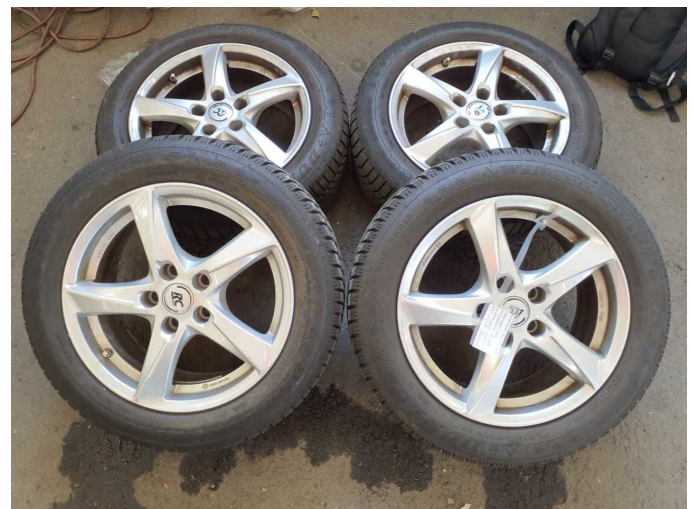
Figure 18: Additional tyres

| Tyres | | | | |
|---|---|---|---|---|
| 1) | 205/55 R16 91H | Winter tyres on Light alloy | Dunlop | 7mm / 7mm |
| 2) | 205/55 R16 91H | Winter tyres on Light alloy | Dunlop | 7mm / 7mm |

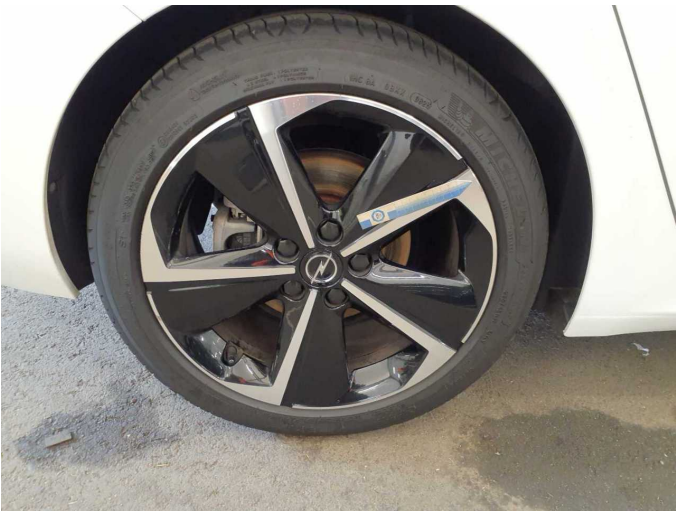
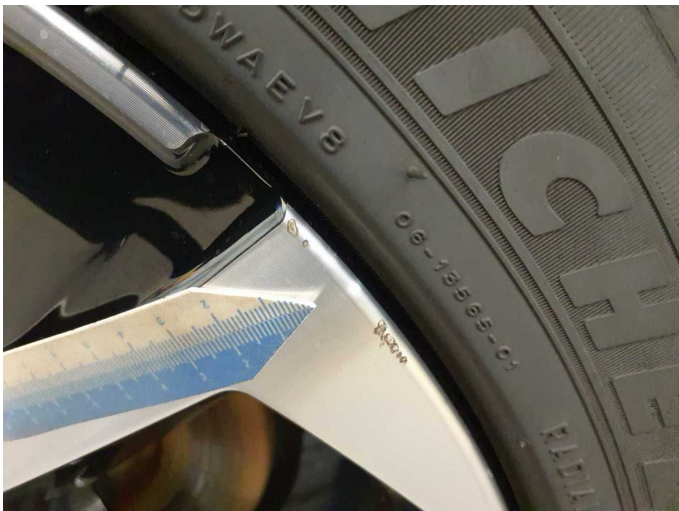
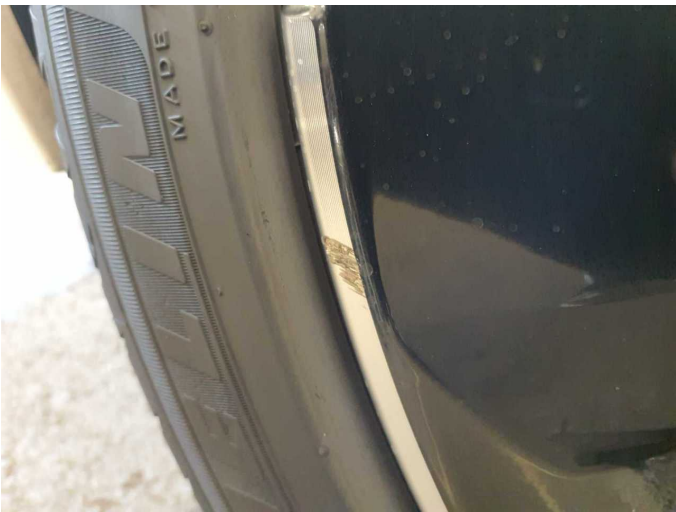
Damage 1: Wheel / tyres: Alloy rim - rear right side - Scratch(es) - Loss in value

| No. | Component group | Description |
|---|---|---|
| 1 | Wheel / tyres | Alloy rim - rear right side - Scratch(es) - Loss in value |

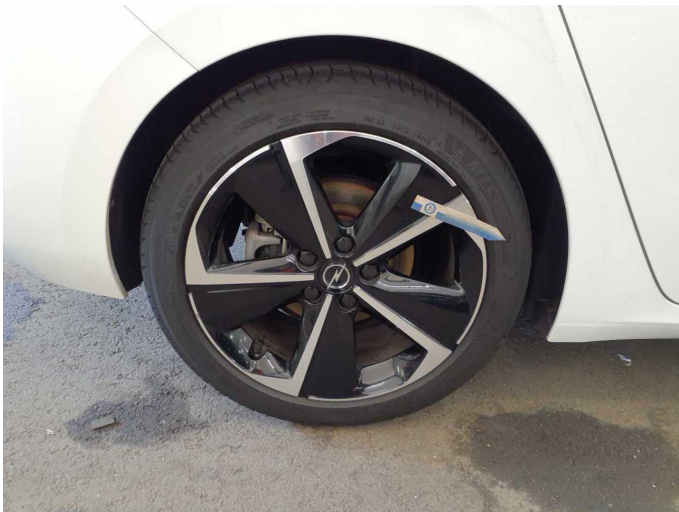
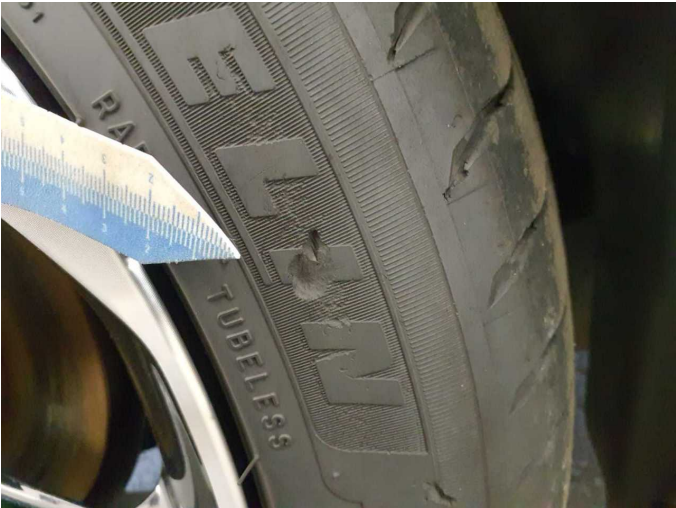
Damage 2: Wheel / tyres: Tyre - rear right side - Broken / torn - Replace value

Damage 2: Wheel / tyres: Tyre - rear right side - Broken / torn - Replace

| No. | Component group | Description |
|---|---|---|
| 2 | Wheel / tyres | Tyre - rear right side - Broken / torn - Replace |

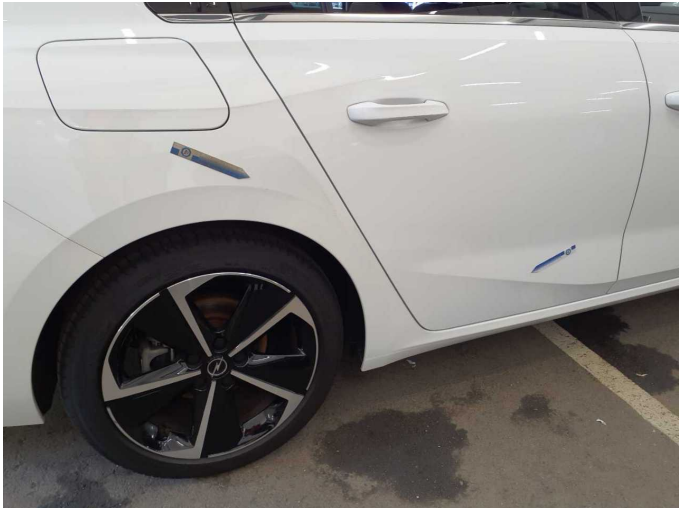
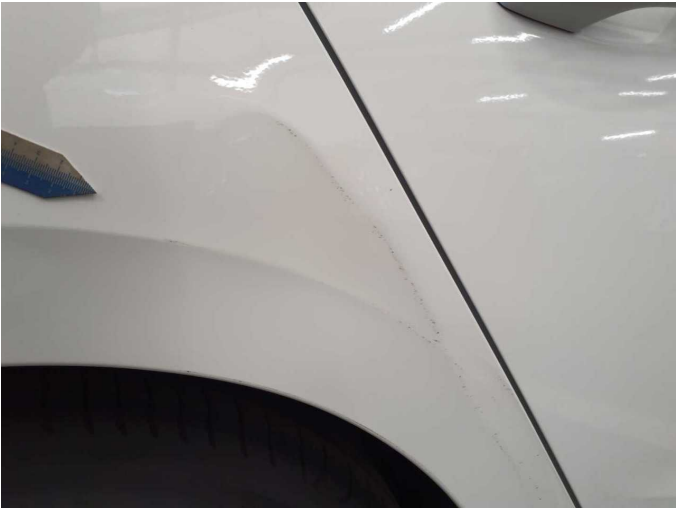
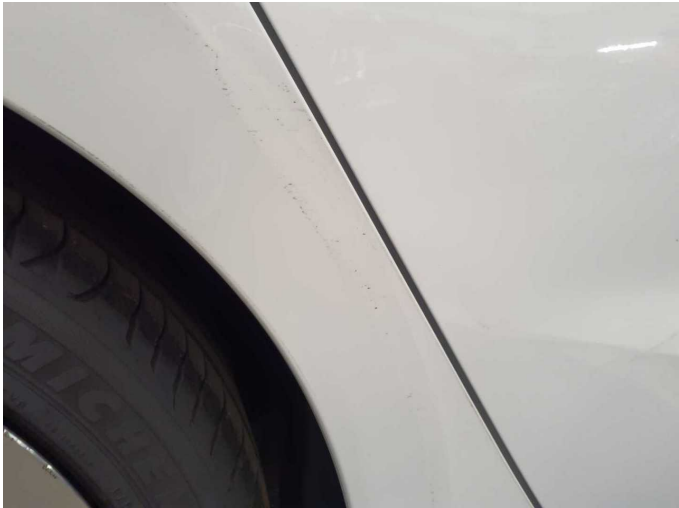
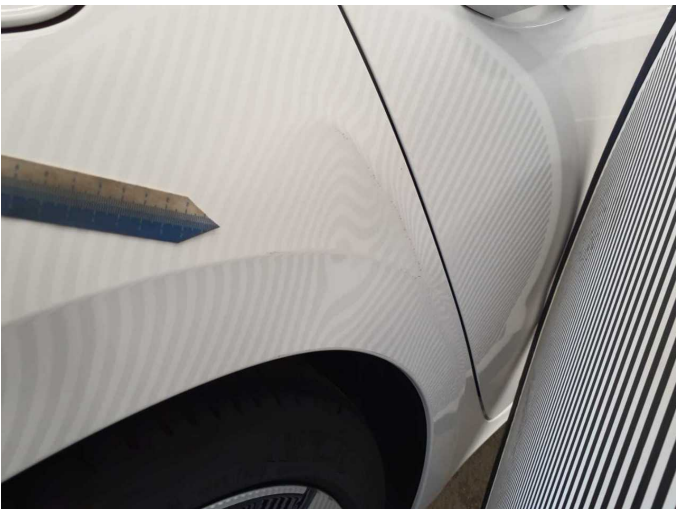
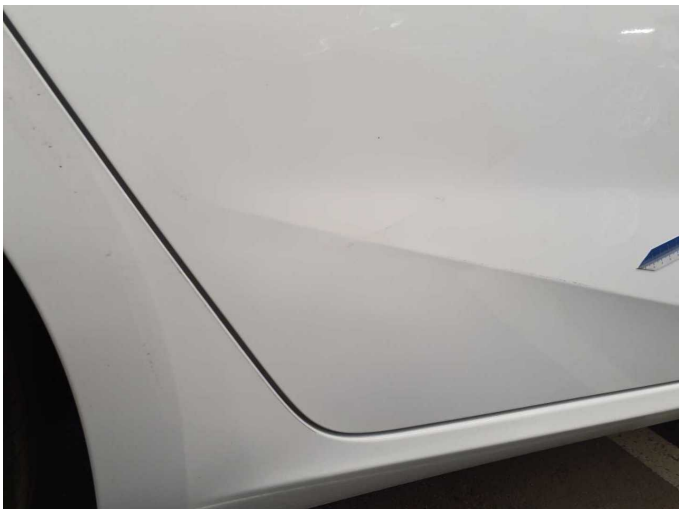
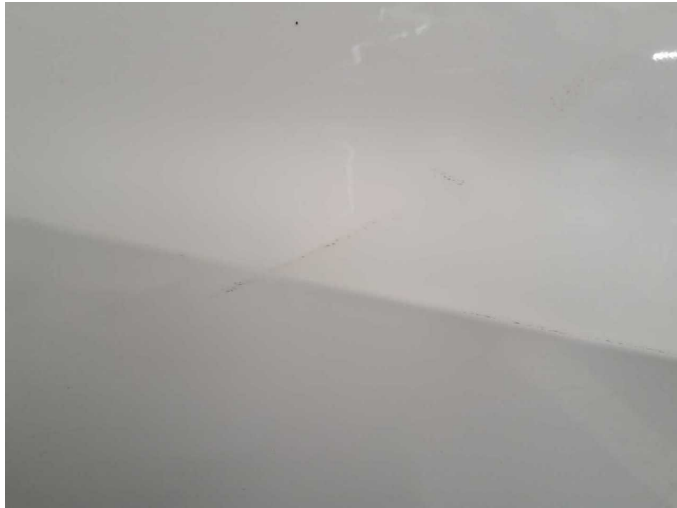
- 1 Side right

Accident 1: Side right

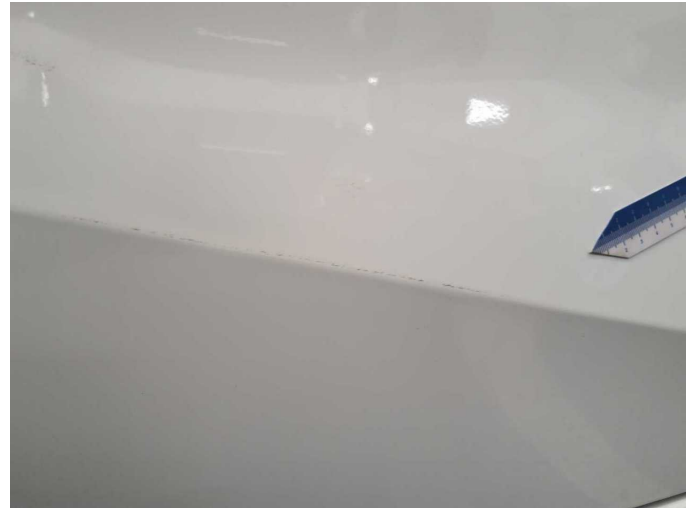
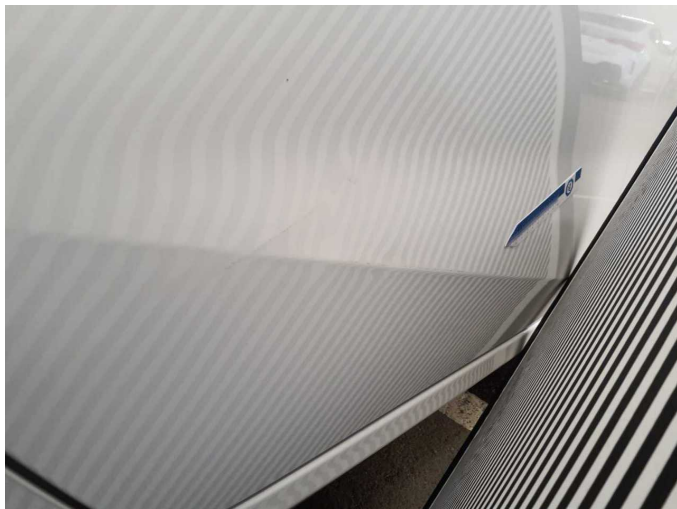
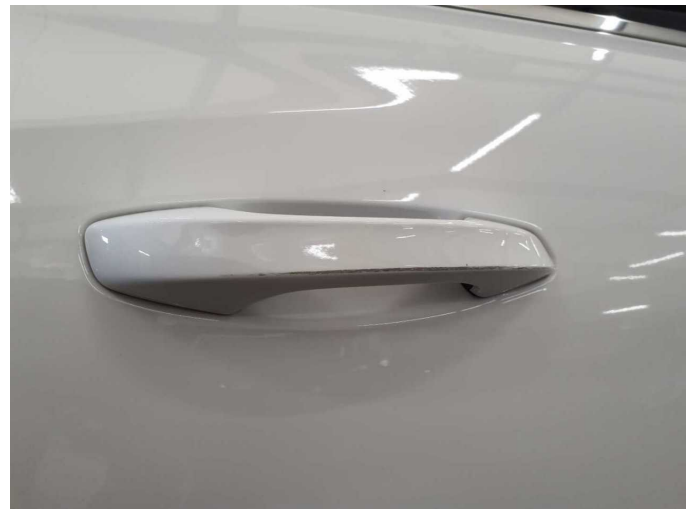
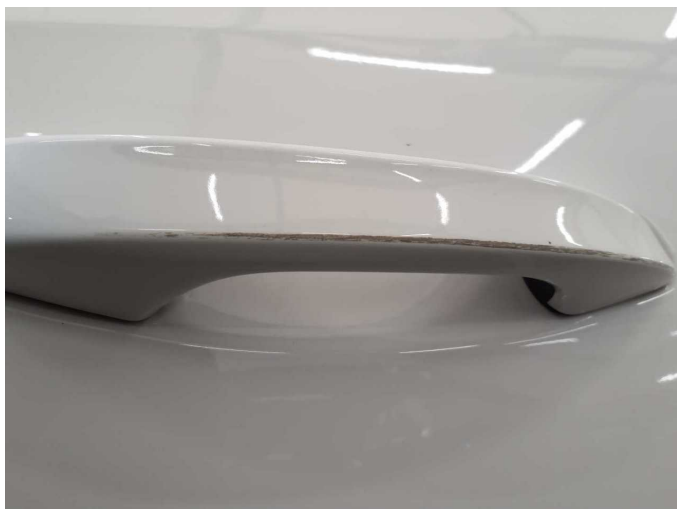
**Accident 1: Side right**

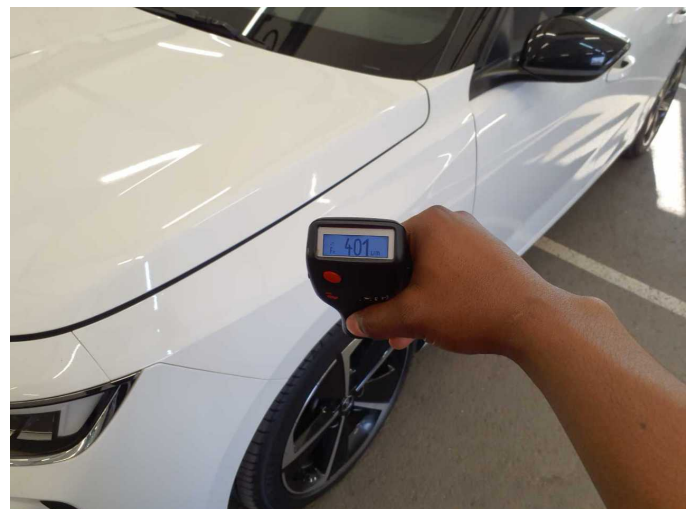
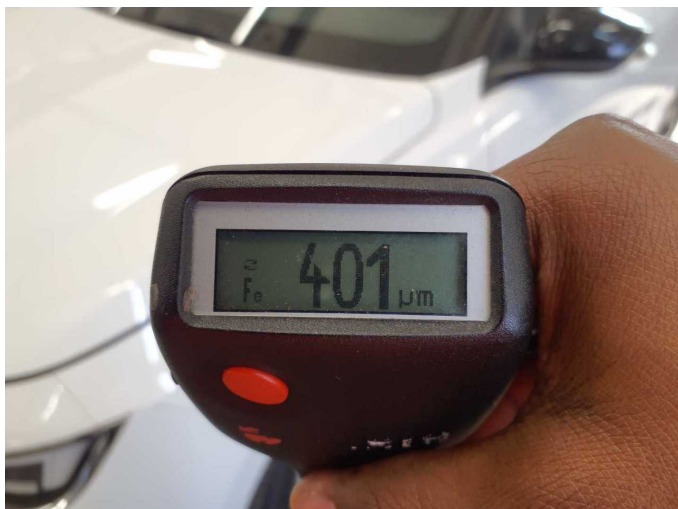
- 1 Mudguard - left side, Professionally carried out, Invoice of repair done Non-existent

Mudguard - left side 401  $\mu\text{m}$  |

**Repainting 1: Mudguard - left side**
