Expertise

Protocol number: 46688543  
Order No. / Reference: 26726490  
Inspection date: 24 Jul 2026

| Manufacturer: Opel | Model: Insignia Sports Tourer 2.0 Diesel Aut. Business |
| VIN: W0VZT8GP5N1001393 | |

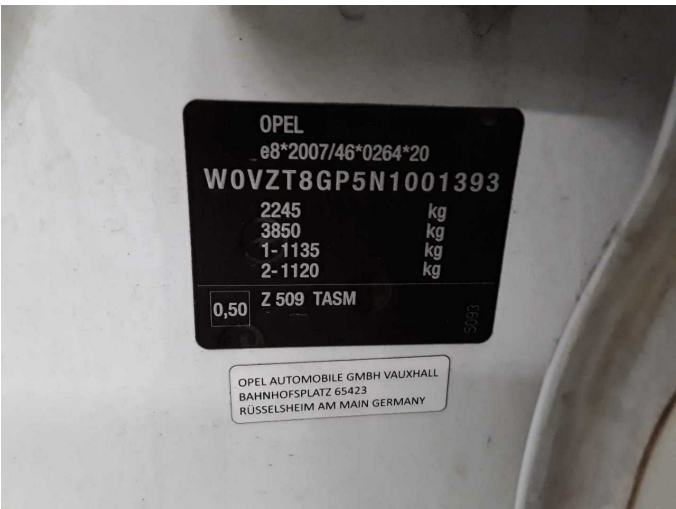
Figure 11: VIN

| VIN comparison | The vehicle identification number (VIN) was read from the vehicle and its conformity with the submitted documents was confirmed by the undersigned during the inspection. |

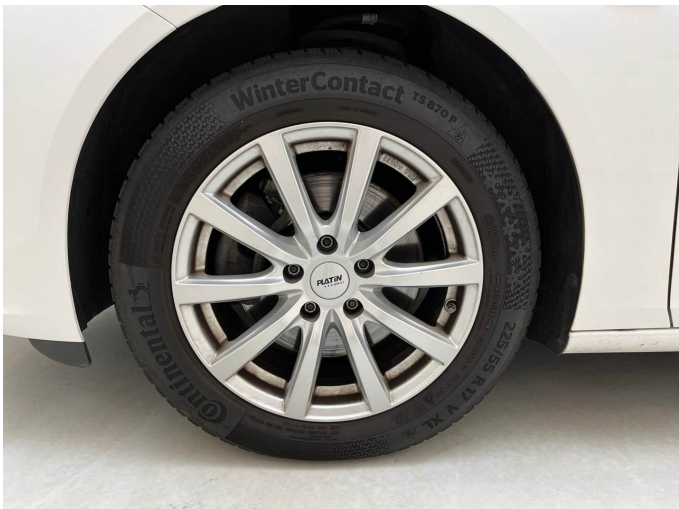
Figure 12: Mounted tyres

| # | Tyre size | Type of tyre | Manufacturer | Tread depth |
|---|---|---|---|---|
| 1) | 225/55 R17 101V | Winter tyres on Light alloy | Continental | 5mm / 5mm |
| 2) | 225/55 R17 101V | Winter tyres on Light alloy | Continental | 7mm / 7mm |

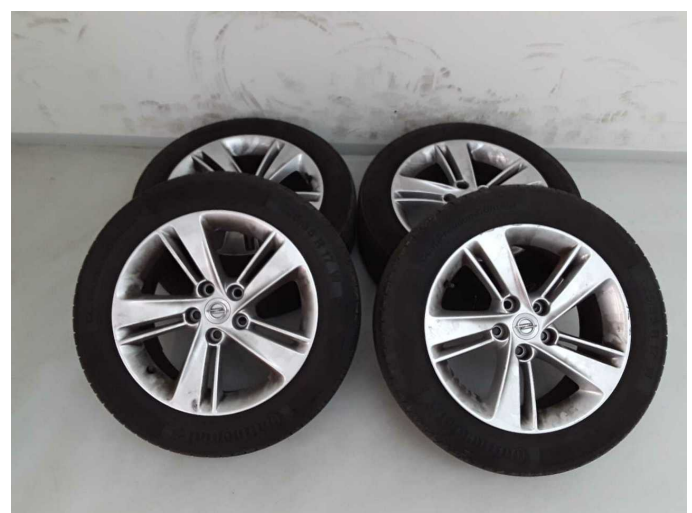
Figure 18: Additional tyres

| # | Tyre size | Type of tyre | Manufacturer | Tread depth |
|---|---|---|---|---|
| 1) | 225/55 R17 97W | Summer tyres on Light alloy | Continental | 5mm / 5mm |
| 2) | 225/55 R17 97W | Summer tyres on Light alloy | Continental | 7mm / 7mm |

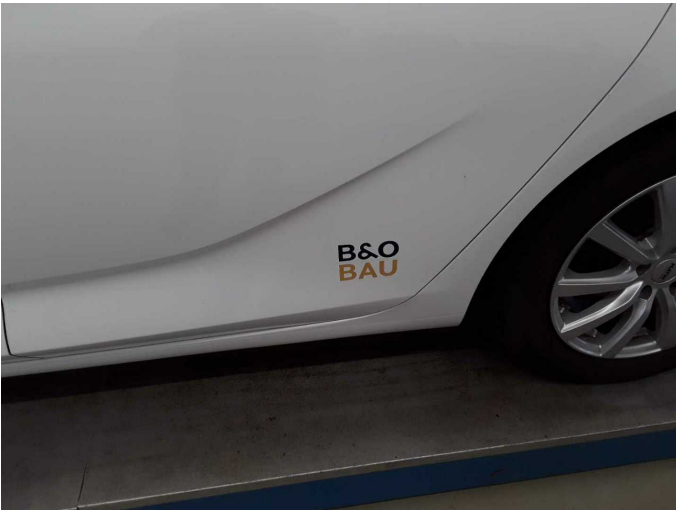
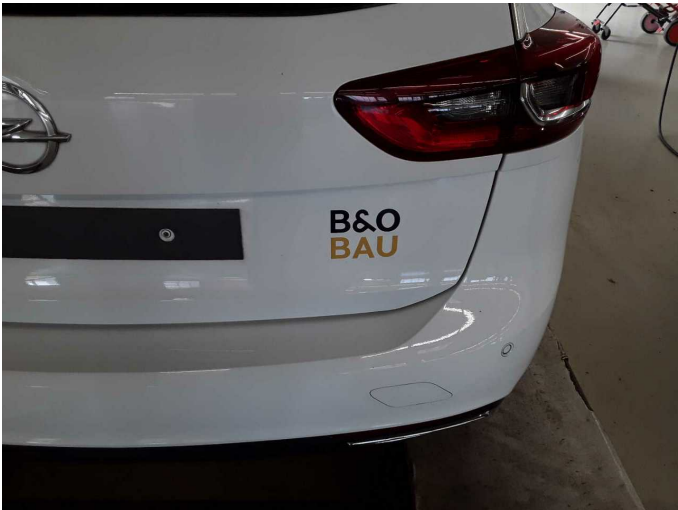
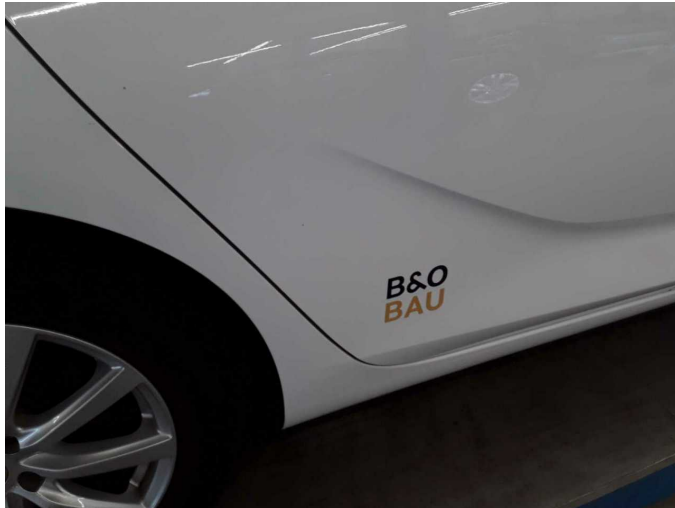
| No. | Component group | Description |
|---|---|---|
| 1 | Body | Body - Glued / labelled - De-glue / neutralise |

Damage 1: Body: Body - Glued / labelled - De-glue / neutralise

**Damage 1:** Body: Body - Glued / labelled - De-glue / neutralise

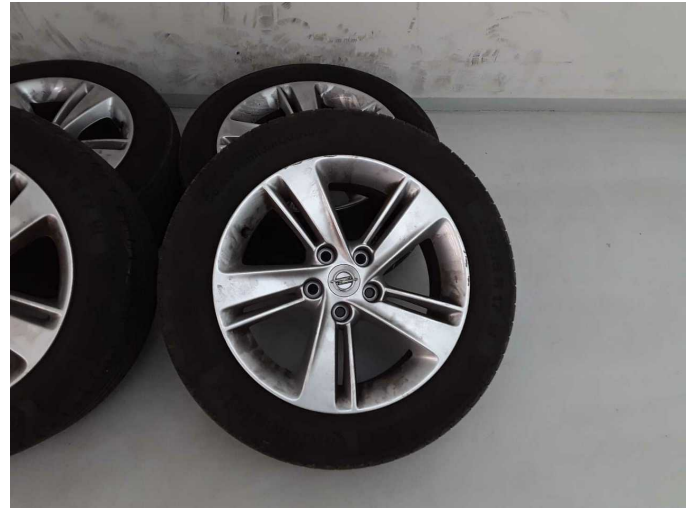
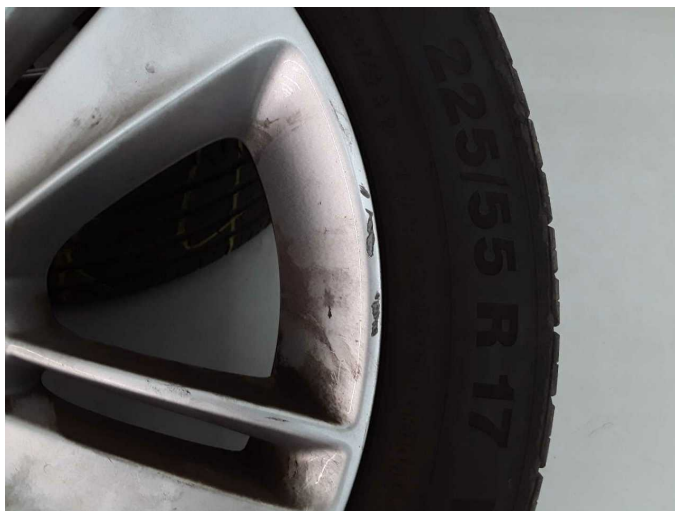
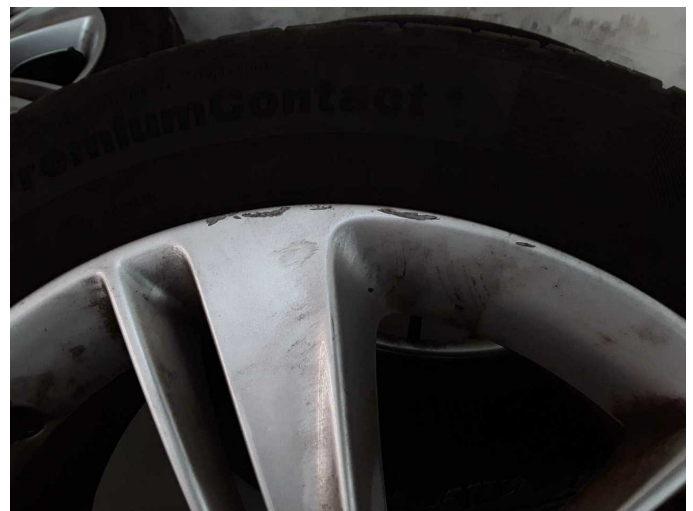
| No. | Component group | Description |
|---|---|---|
| 2 | 2nd wheel set | 1 alloy rim - Scratch(es) - Loss in value |

| No. | Component group | Description |
|---|---|---|
| 2 | 2nd wheel set | 1 alloy rim - Scratch(es) - No deduction |

**Damage 2:** 2nd wheel set: 1 alloy rim - Scratch(es) - Loss in value

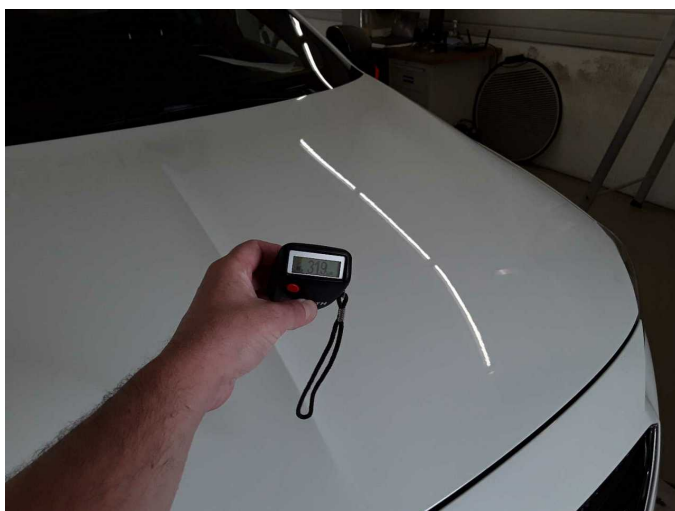
| No. | Repainting |
|---|---|
| 1 | Bonnet, Professionally carried out |

| Bonnet | 319 µm |

**Bonnet:** 319 µm
