## Condition Report / Loss of Value Assessment II

| | | Vehicle ident. no. | WAUZZZF12SD016095 |
| Type / sales designation | Q8 45 TDI | Kilometres read | 28,577 km |

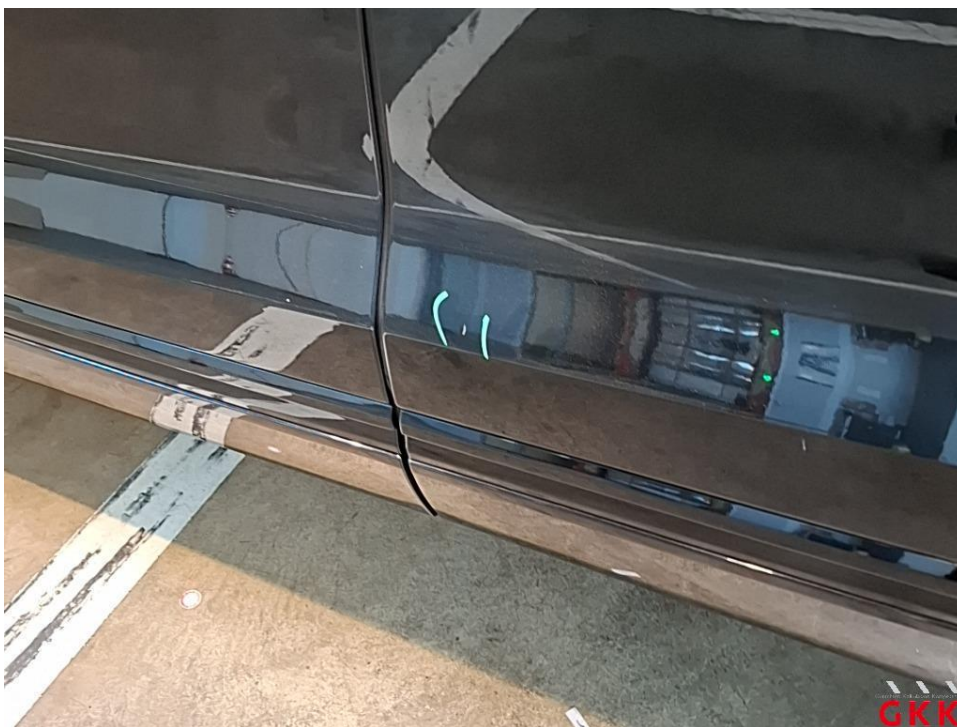
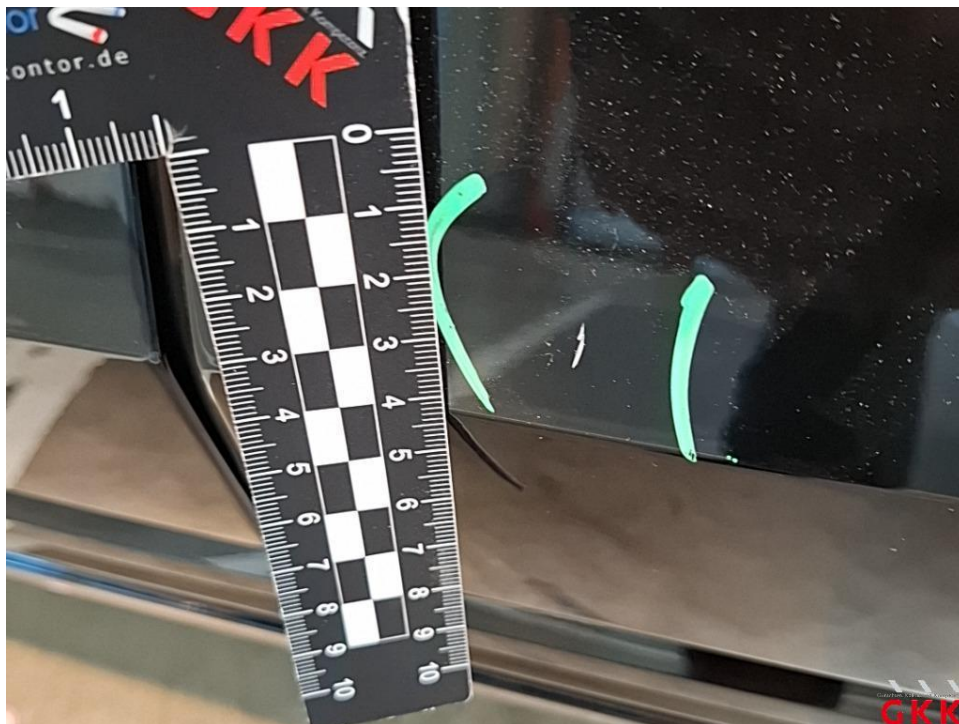
door rear left, scratched, disassemble, grind, polish (Image 19, Image 20)

Picture 19 door rear left, scratched, disassemble, grind, polish

Picture 20 door rear left, scratched, disassemble, grind, polish

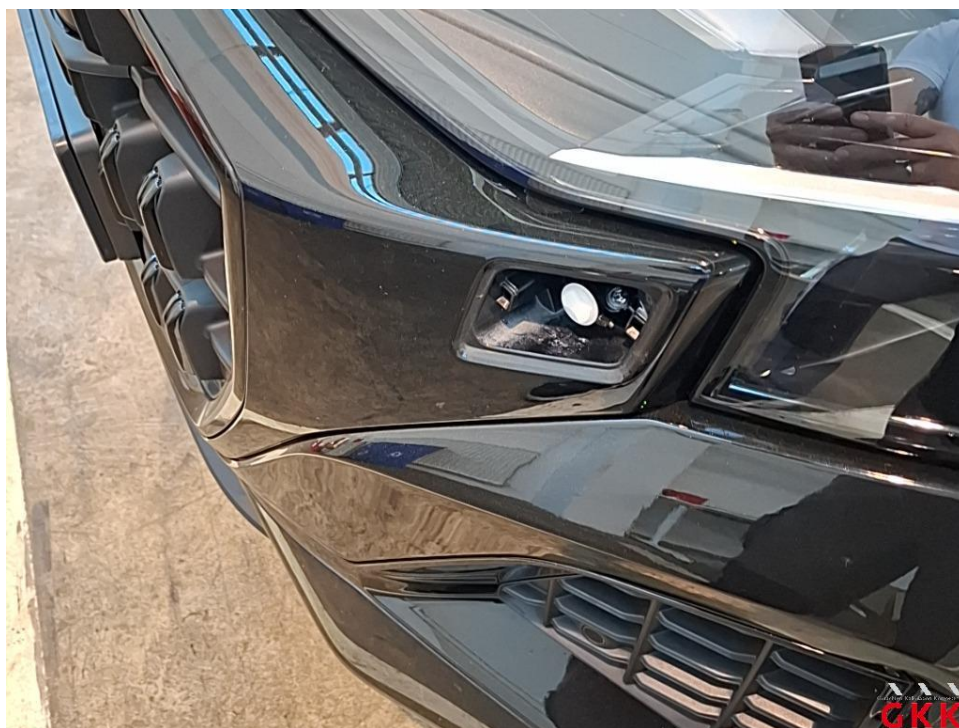
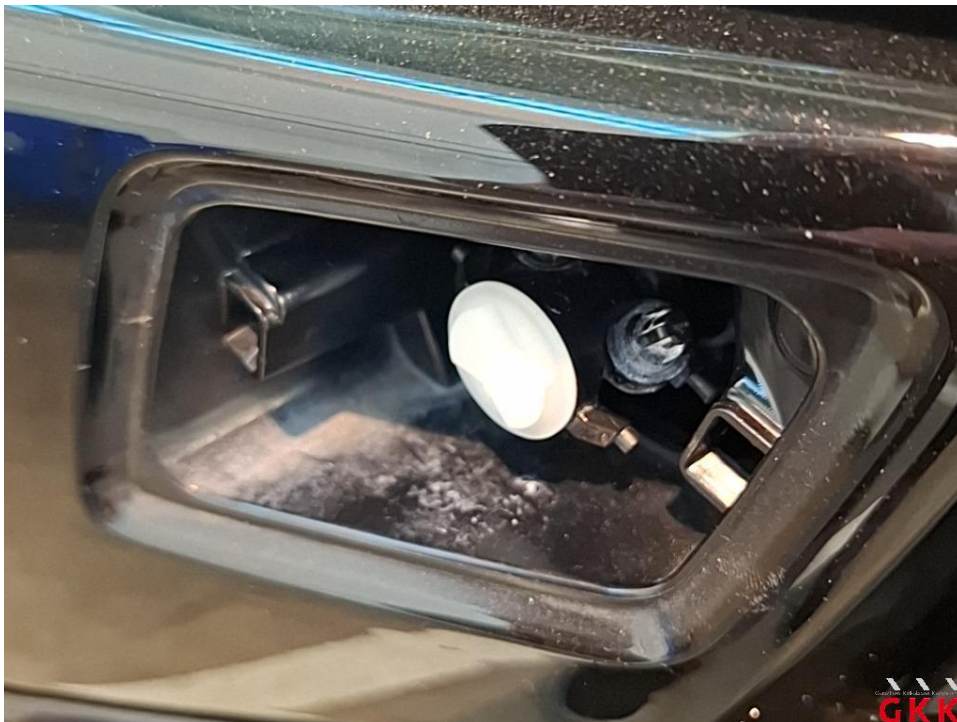
headlight cleaning system cover, missing, replace (Image 21, Image 22)

Picture 21 headlight cleaning system, cover, missing, replace

Picture 22 headlight cleaning system, cover, missing, replace

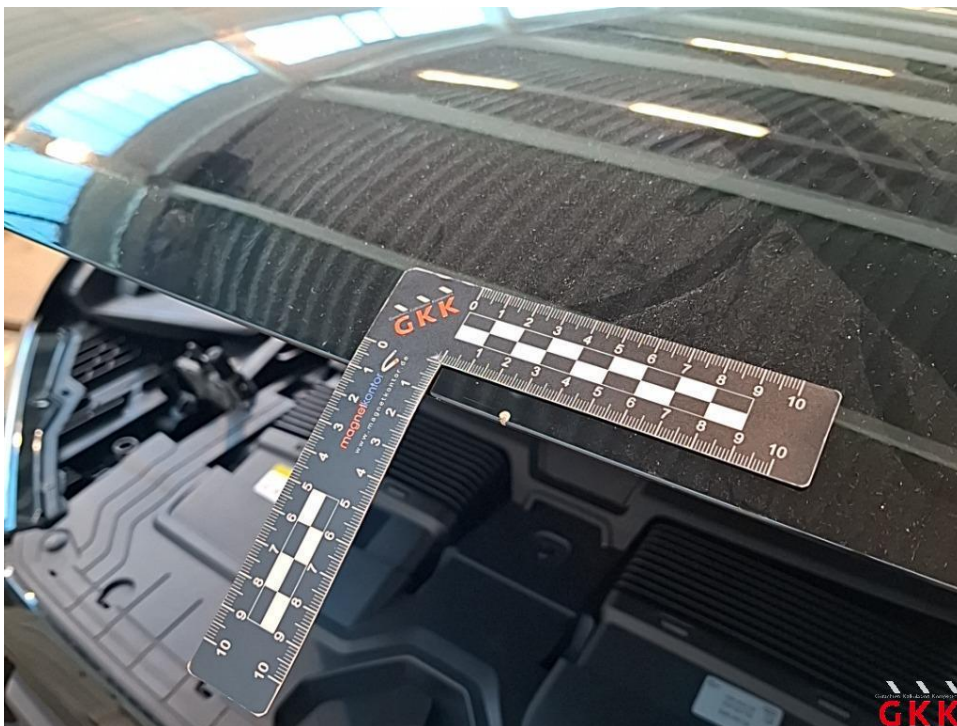
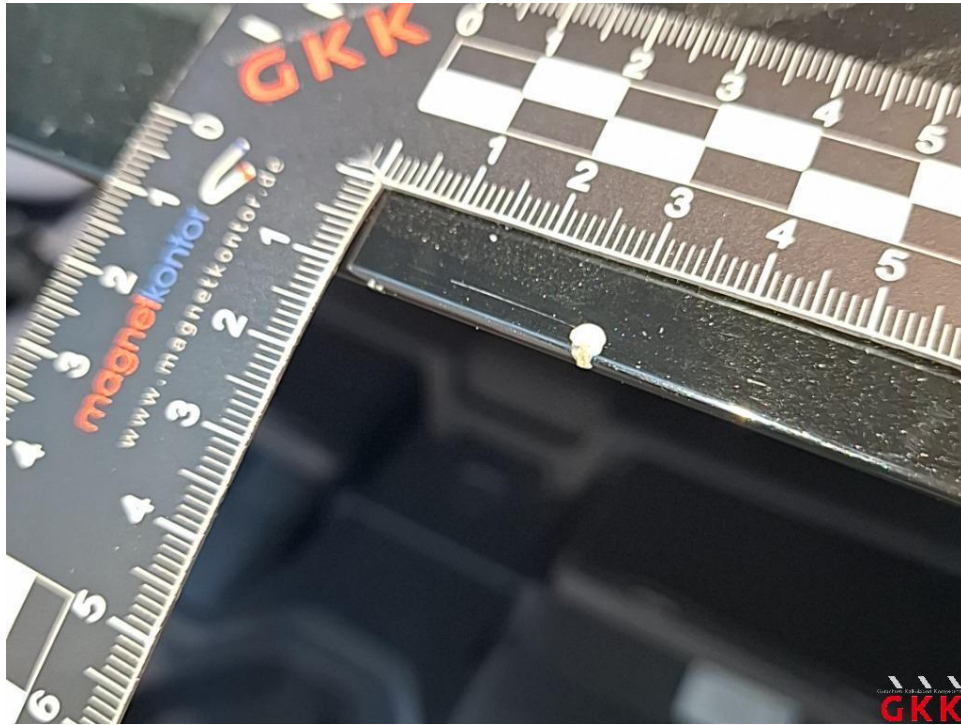
engine hood, paintwork flaked, smart repair (Image 23, Image 24)

Picture 23 engine hood, paintwork flaked, smart repair

Picture 24 engine hood, paintwork flaked, smart repair
