Expertise

Protocol number: 46444523  
Order No. / Reference: 26612461  
Inspection date: 10 Jul 2026

Model: Megane EV60 220hp optimum charge Evolution

VIN: VF1RCB00170614333

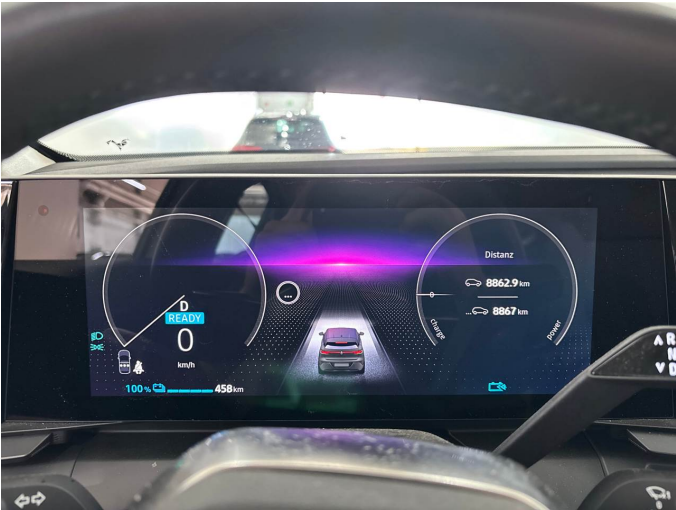
Figure 7: Instrument cluster

**Vehicle Identification number** VF1RCB00170614333  
**Mileage (Read)** 8,867 km  
**First registration** 9 Jun 2023  
**Number of holders** 1  
**Next periodical technical inspection** 06/2028  
(Report on hand)

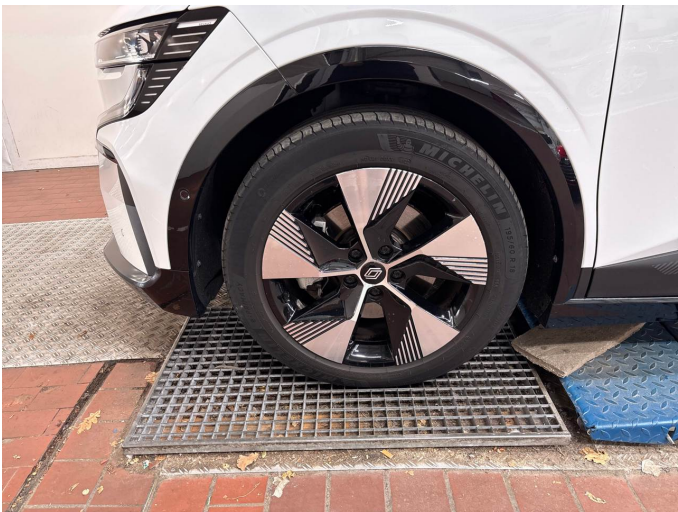
Figure 12: Mounted tyres

| # | Tyre size | Type of tyre | Manufacturer | Tread depth |
|---|---|---|---|---|
| 1) | 195/60 R18 96H | Summer tyres on Light alloy | Michelin | 6mm / 6mm |
| 2) | 195/60 R18 96H | Summer tyres on Light alloy | Michelin | 6mm / 6mm |

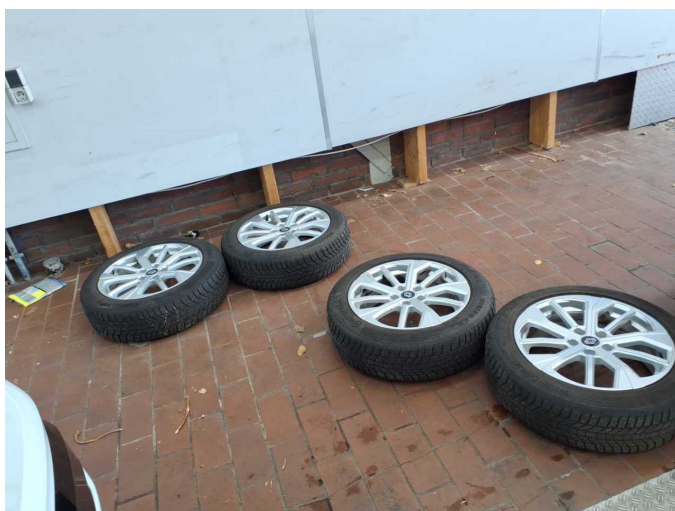
Figure 17: Additional tyres

| # | Tyre size | Type of tyre | Manufacturer | Tread depth |
|---|---|---|---|---|
| 1) | 195/60 R18 96H | Winter tyres on Light alloy | Continental | 6mm / 6mm |
| 2) | 195/60 R18 96H | Winter tyres on Light alloy | Continental | 7mm / 7mm |

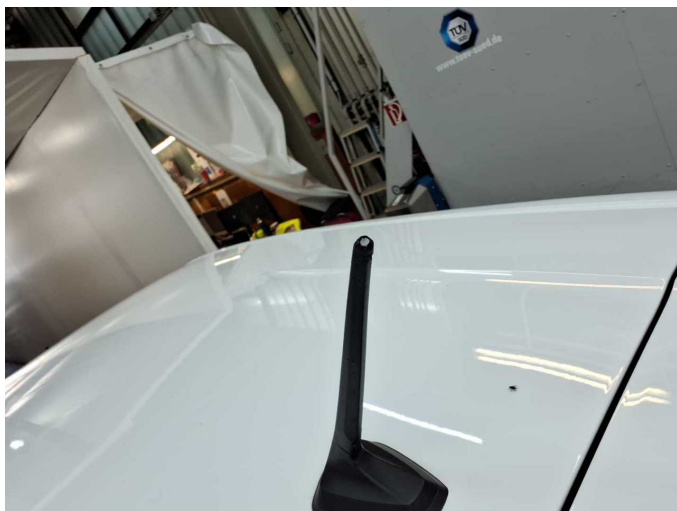
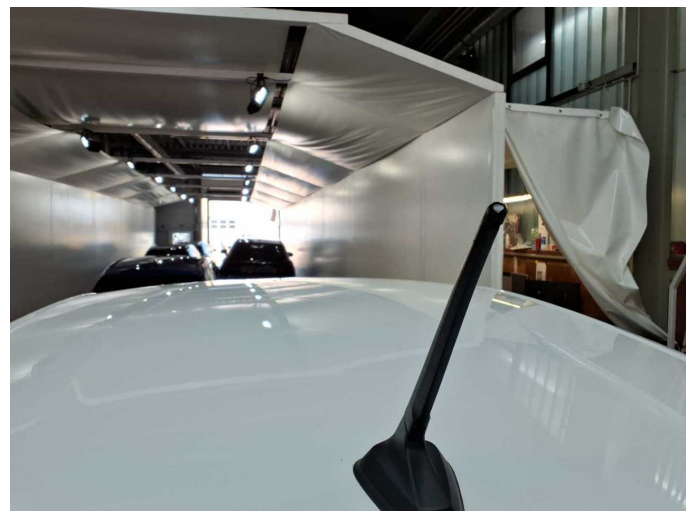
| No. | Component group | Description |
|---|---|---|
| 1 | Roof | Stub aerial - Damage caused by marten / rodent - Replace |

**Damage 1:** Roof: Stub aerial - Damage caused by marten / rodent - Replace

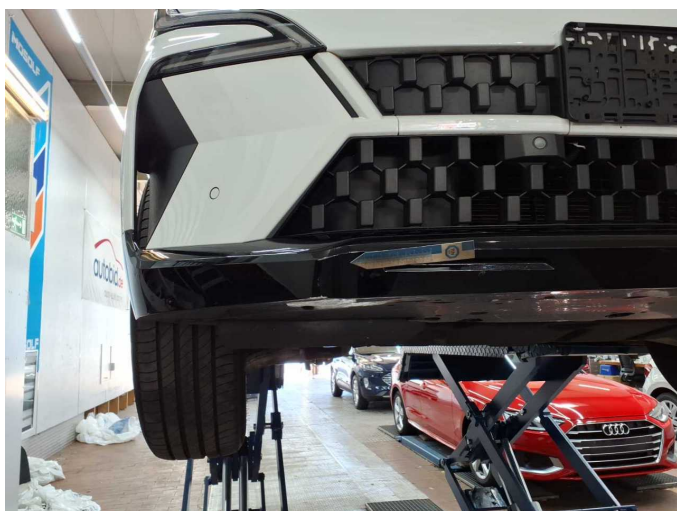
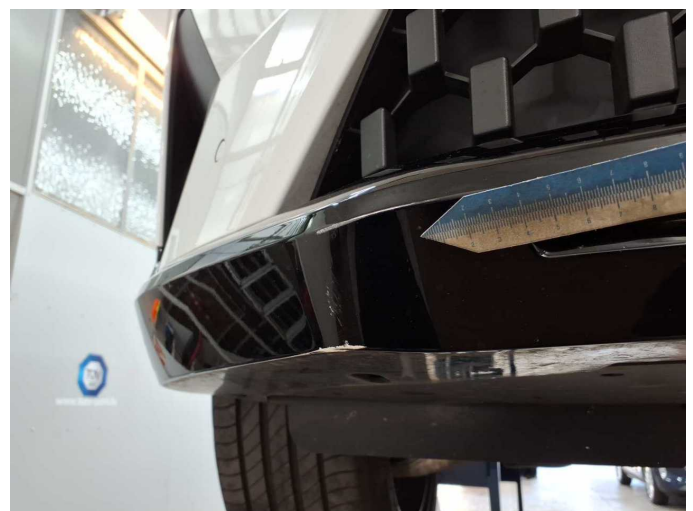
| No. | Component group | Description |
|---|---|---|
| 2 | Front bumper | Spoiler - Scratch(es) - Smart repair |

**Damage 2:** Front bumper: Spoiler - Scratch(es) - Smart repair

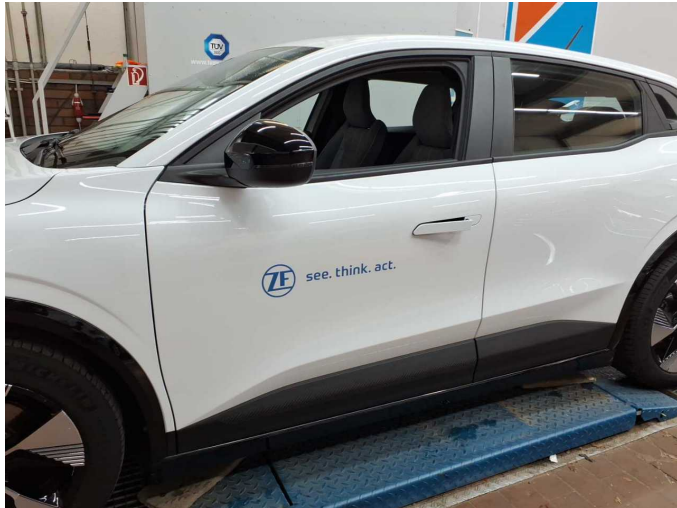
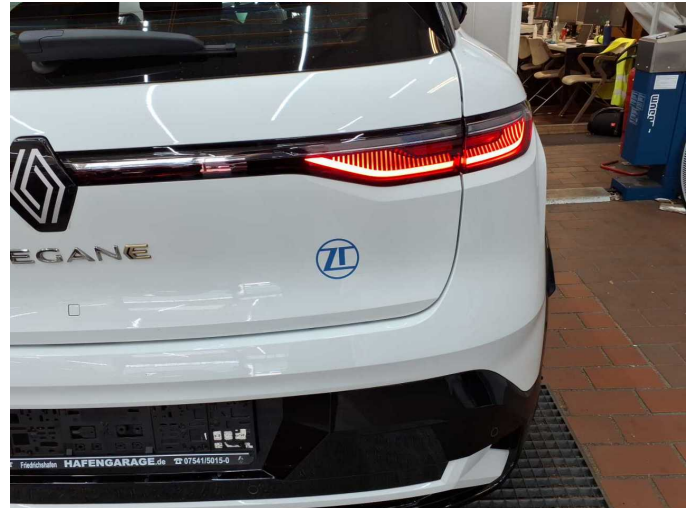
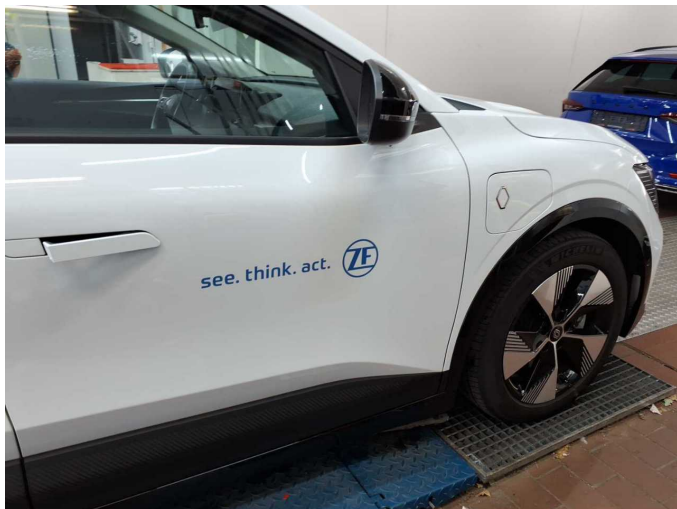
| No. | Component group | Description |
|---|---|---|
| 3 | Body | Body - Glued / labelled - De-glue / neutralise |

**Damage 3:** Body: Body - Glued / labelled - De-glue / neutralise
