Expertise

Protocol number: 46584484  
Order No. / Reference: 26678748  
Inspection date: 16 Jul 2026

| Manufacturer: Volkswagen | Model: Golf Variant 2.0 TDI SCR DSG Style |

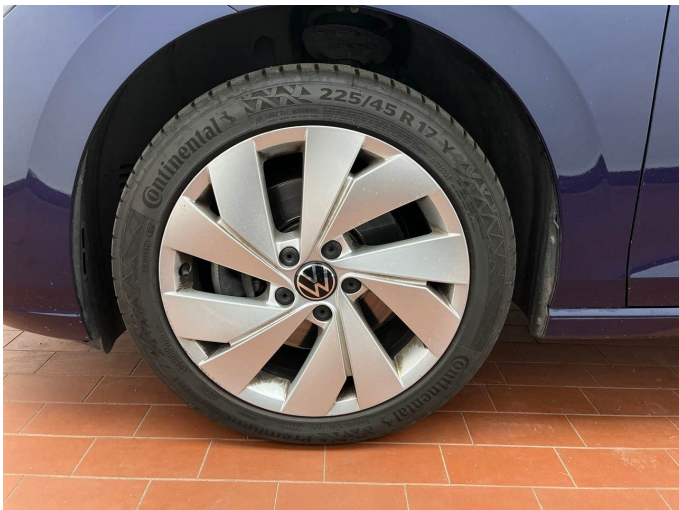
Figure 12: Mounted tyres

| # | Tyre size | Type of tyre | Manufacturer | Tread depth |
|---|---|---|---|---|
| 1) | 225/45 R17 91Y | Summer tyres on Light alloy | Continental | 4mm / 4mm |
| 2) | 225/45 R17 91W | Summer tyres on Light alloy | Nexen | 5mm / 5mm |

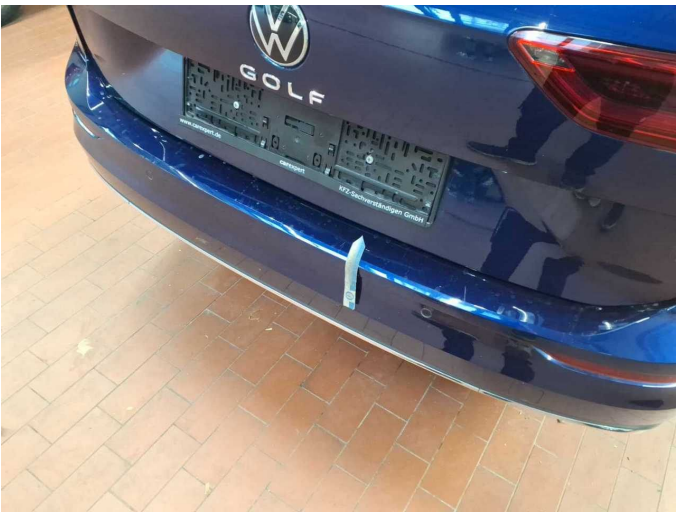
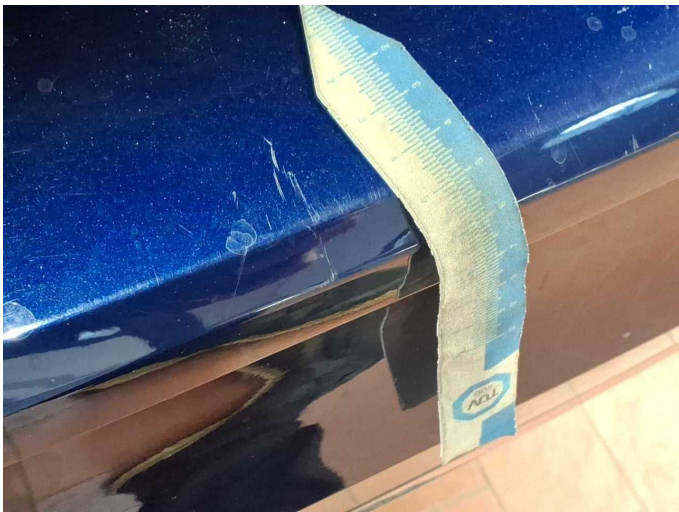
| No. | Component group | Description |
|---|---|---|
| 1 | Rear bumper | Rear bumper - Scratch(es) - Smart repair |

Damage 1: Rear bumper: Rear bumper - Scratch(es) - Smart repair

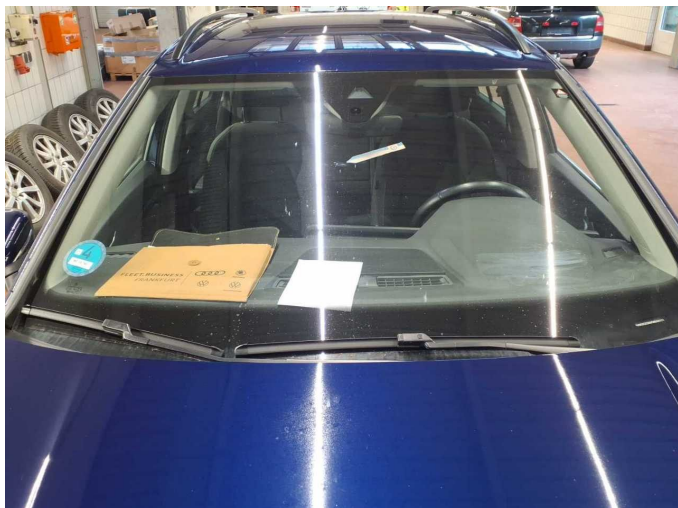
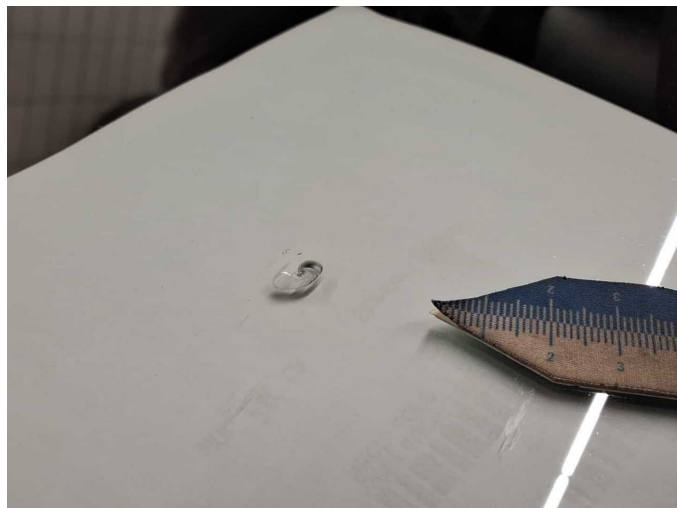
| No. | Component group | Description |
|---|---|---|
| 2 | Vehicle glazing | Windscreen - Stone chips - Smart repair |

**Damage 2:** Vehicle glazing: Windscreen - Stone chips - Smart repair

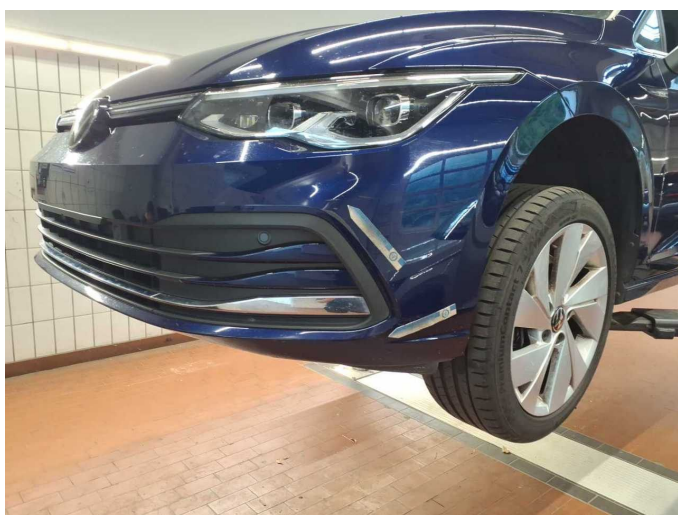
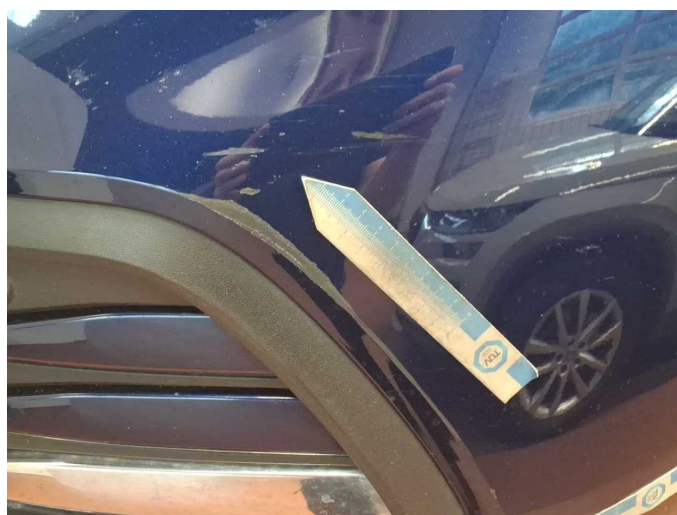
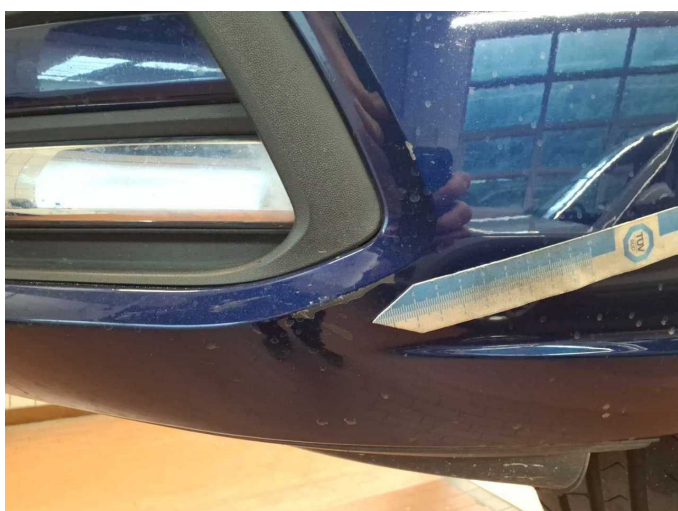
| No. | Component group | Description |
|---|---|---|
| 3 | Front bumper | Front bumper - Scratched - Paint |

**Damage 3:** Front bumper: Front bumper - Scratched - Paint

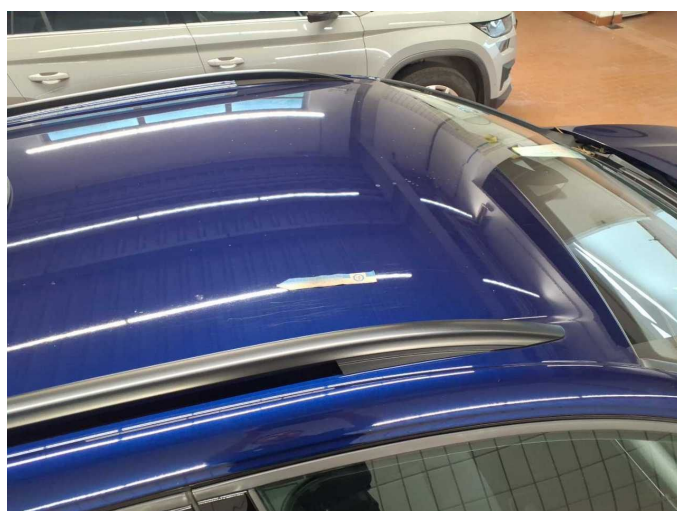
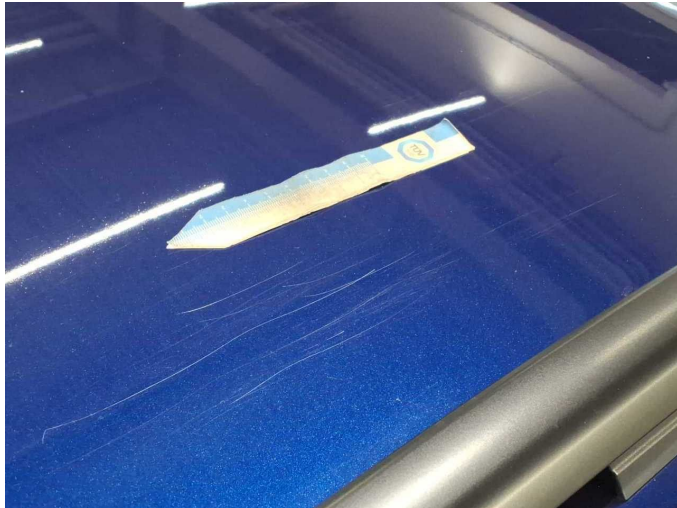
| No. | Component group | Description |
|---|---|---|
| 4 | Roof | Roof - Scratch(es) - Paint |

**Damage 4:** Roof: Roof - Scratch(es) - Paint

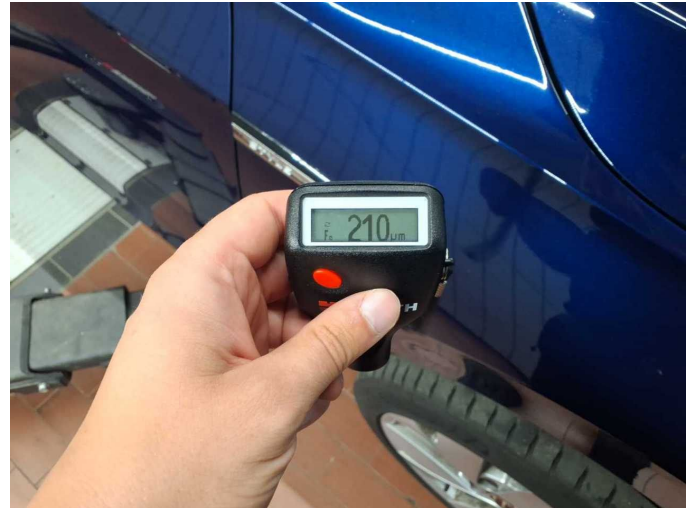
| No. | Repainting |
|---|---|
| 1 | Mudguard - right side, Professionally carried out, Invoice of repair done Available |

| Mudguard - right side | 210 µm | Side panel - rear right side | 188 µm |

**Repainting 1:** Mudguard - right side

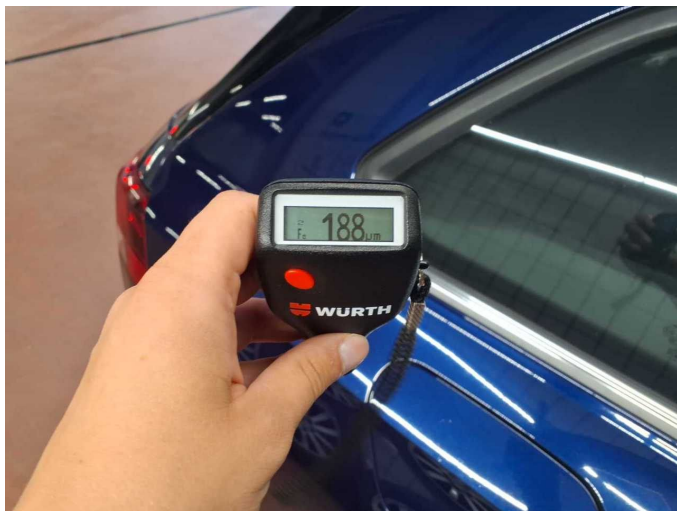
| No. | Repainting |
|---|---|
| 2 | Side panel - rear right side, Professionally carried out, Invoice of repair done Non-existent |

**Repainting 2:** Side panel - rear right side

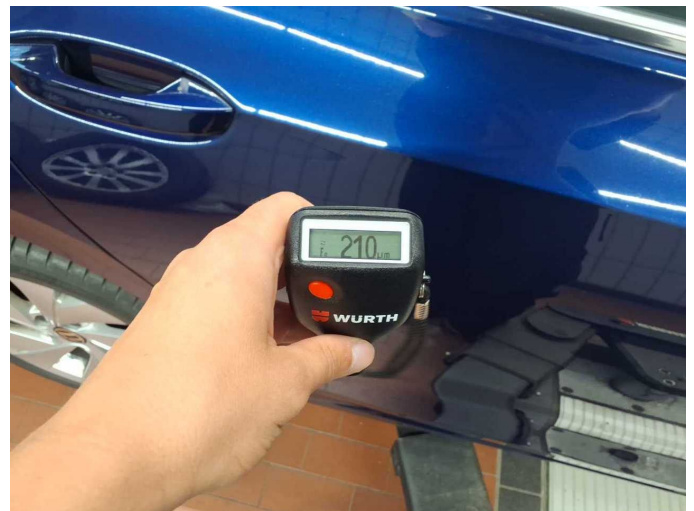
| No. | Repainting |
|---|---|
| 3 | Door - rear right side, Professionally carried out, Invoice of repair done Non-existent |

| Door - rear right side | 210 µm | Door - front right side | 205 µm |

**Repainting 3:** Door - rear right side

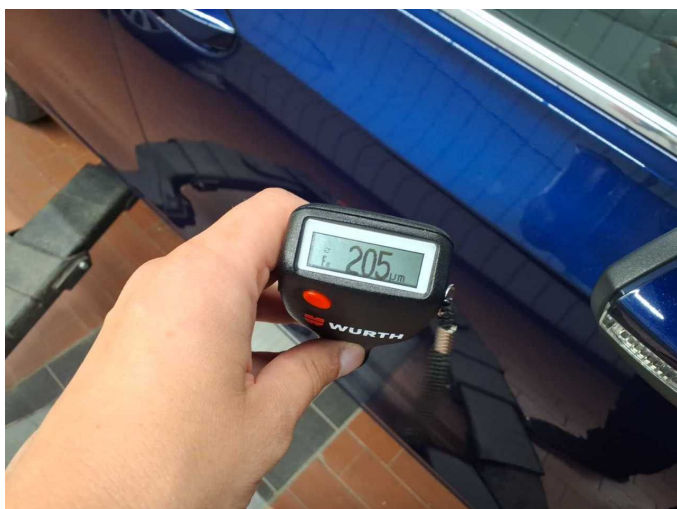
| No. | Repainting |
|---|---|
| 4 | Door - front right side, Professionally carried out, Invoice of repair done Non-existent |

**Repainting 4:** Door - front right side
