Expertise

Protocol number: 46270492  
Order No. / Reference: 26581433  
Inspection date: 29 Jun 2026

Manufacturer: Skoda  
VIN: TMBJH7NP6N7037192

Model: Superb Combi 2.0 TDI DSG Ambition

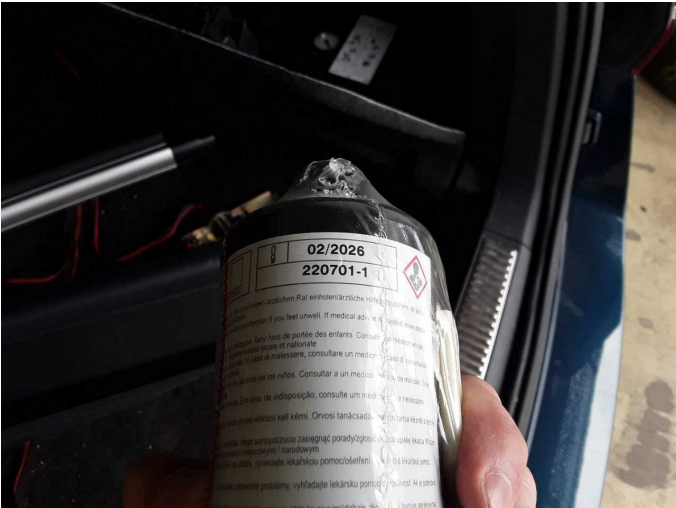
| No. | Component group | Description |
|---|---|---|
| 2 | Equipment | Tirefit filler - Expired - Replace |

Damage 2: Equipment: Tirefit filler - Expired - Replace

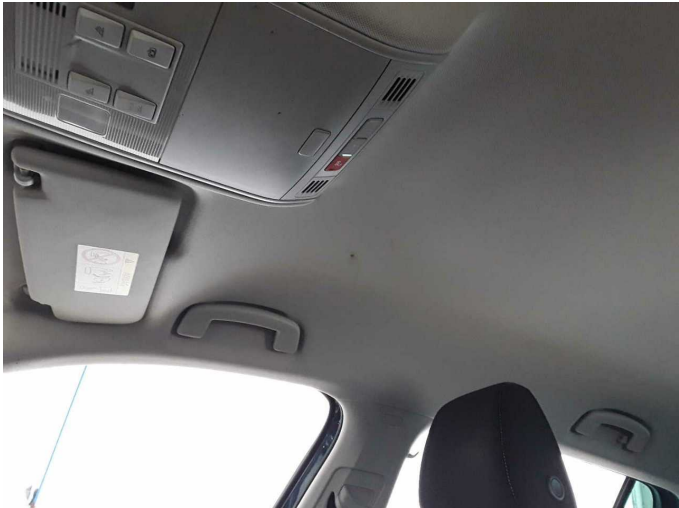
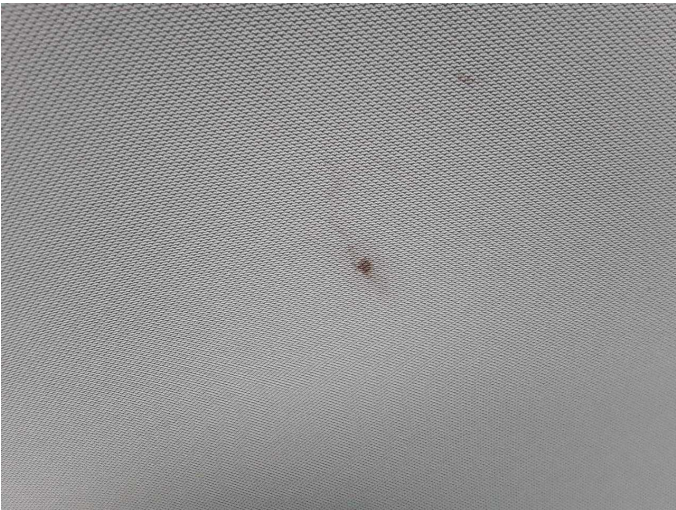
| No. | Component group | Description |
|---|---|---|
| 3 | Trim / covers | Roof lining - Soiled - Clean |

Damage 3: Trim / covers: Roof lining - Soiled - Clean

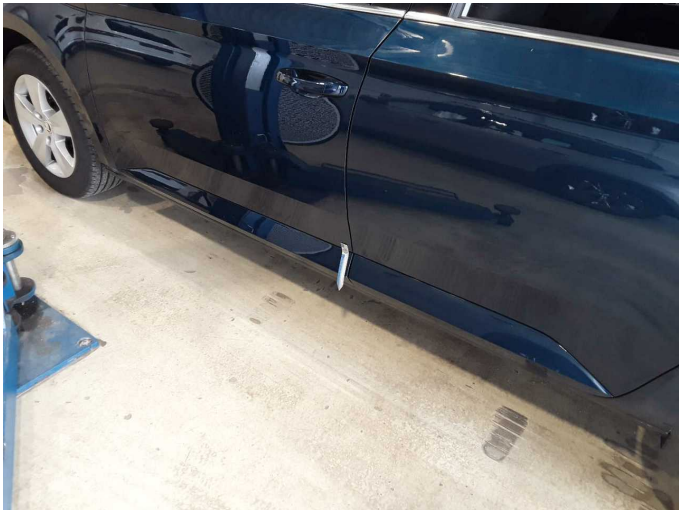
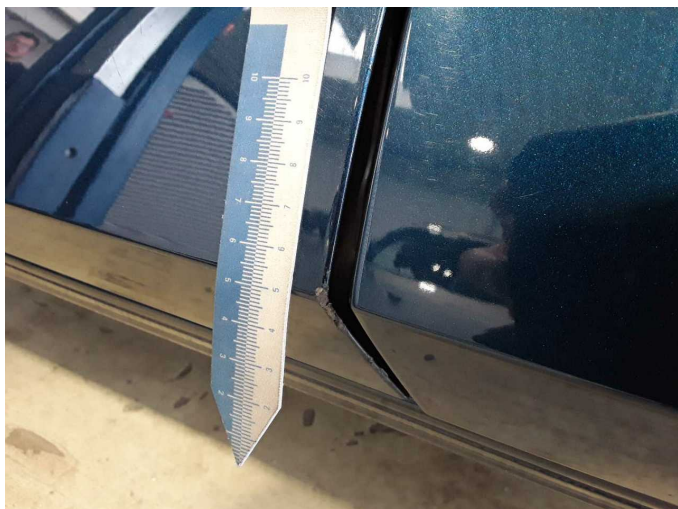
| No. | Component group | Description |
|---|---|---|
| 4 | Door - front left side | Brightware - lower - Scratch(es) - Smart repair |

Damage 4: Door - front left side: Brightware - lower - Scratch(es) - Smart repair

**Damage 4:** Door - front left side: Brightware - lower - Scratch(es) - Smart repair

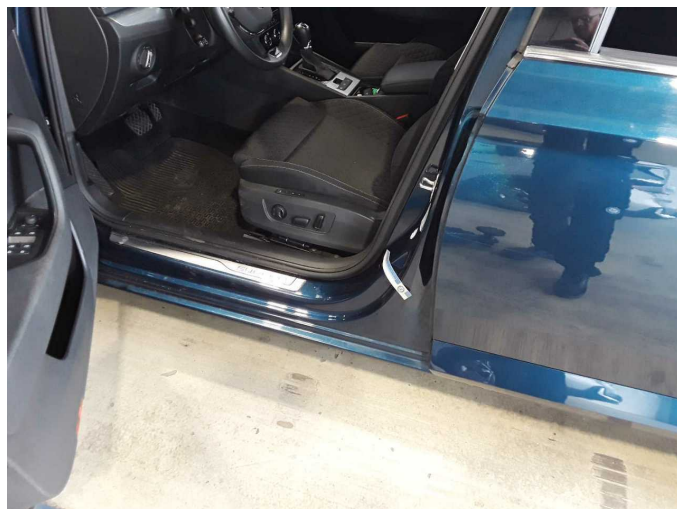
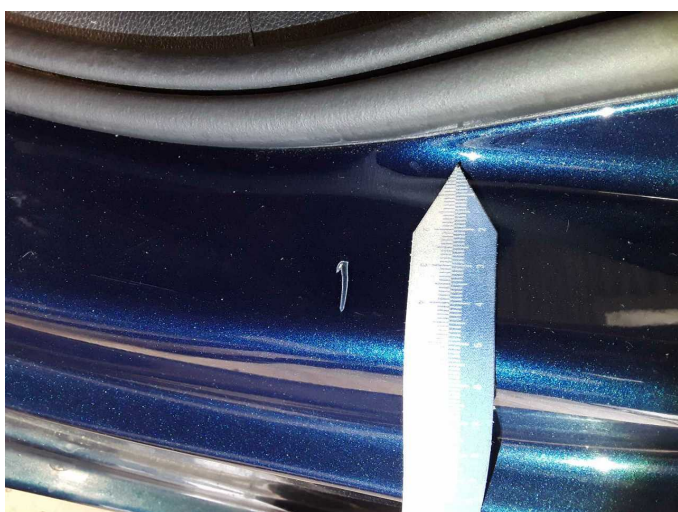
| No. | Component group | Description |
|---|---|---|
| 5 | Sill - left side | Sill - Dent / paintcoat damage - Smart repair |

**Damage 5:** Sill - left side: Sill - Dent / paintcoat damage - Smart repair

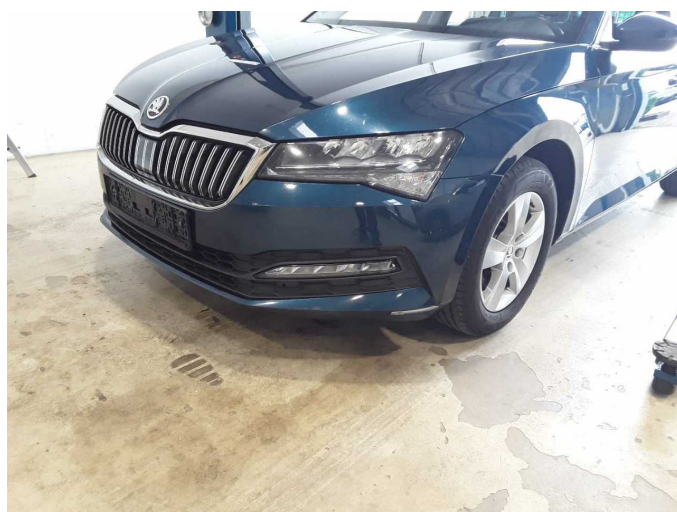
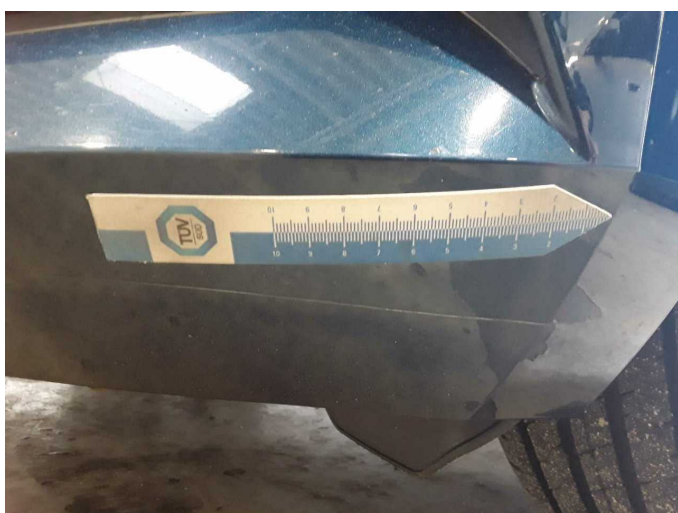
| No. | Component group | Description |
|---|---|---|
| 6 | Front bumper | Front bumper - Scratch(es) - Smart repair |

**Damage 6:** Front bumper: Front bumper - Scratch(es) - Smart repair

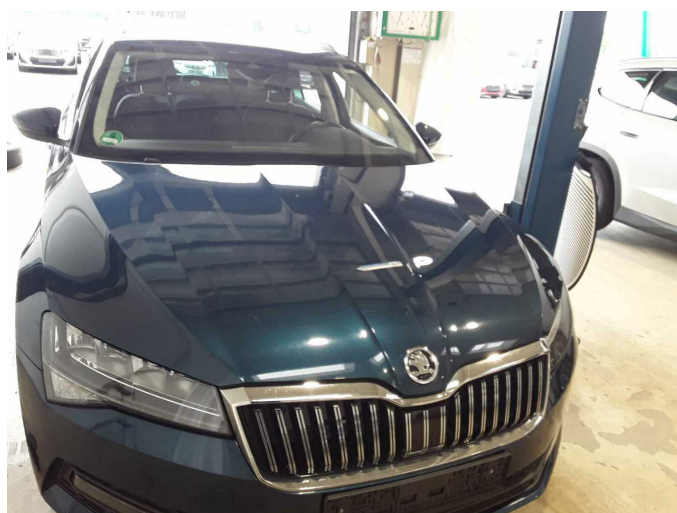
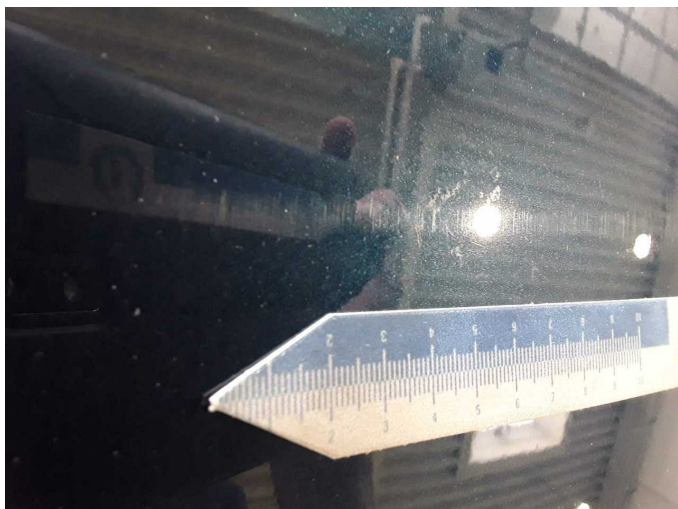
| No. | Component group | Description |
|---|---|---|
| 7 | Bonnet | Bonnet (Anätzung-Mehrkosten möglich) - Paint defect - Conditioning |

**Damage 7:** Bonnet: Bonnet (Anätzung-Mehrkosten möglich) - Paint defect - Conditioning

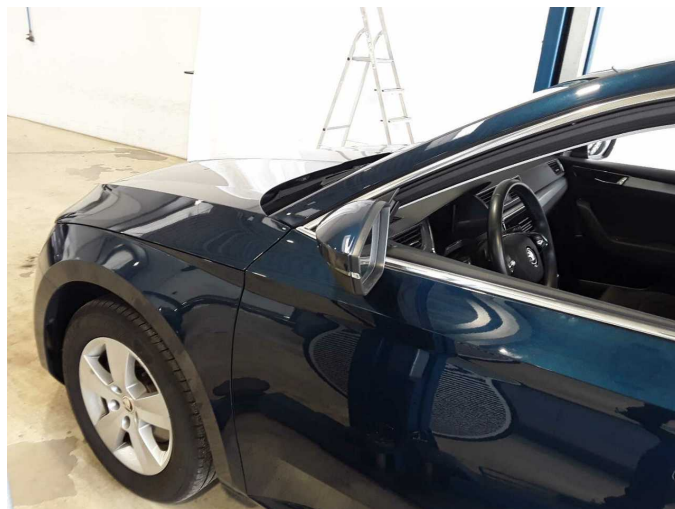
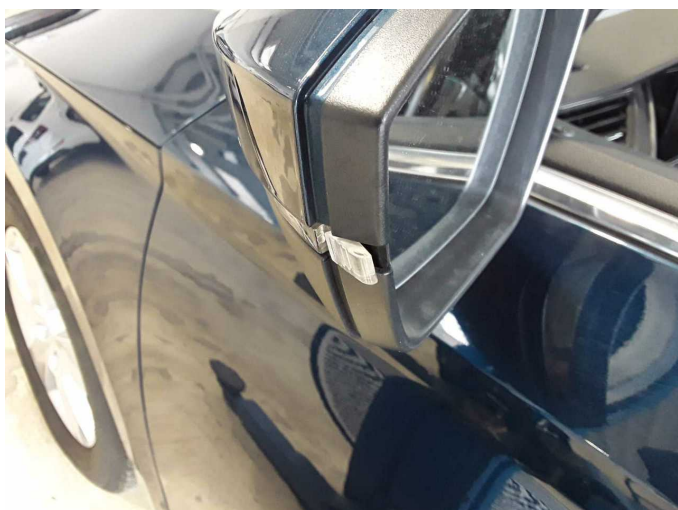
| No. | Component group | Description |
|---|---|---|
| 8 | Indicator - front | Mirror - left side - Broken / torn - Replace |

**Damage 8:** Indicator - front: Mirror - left side - Broken / torn - Replace

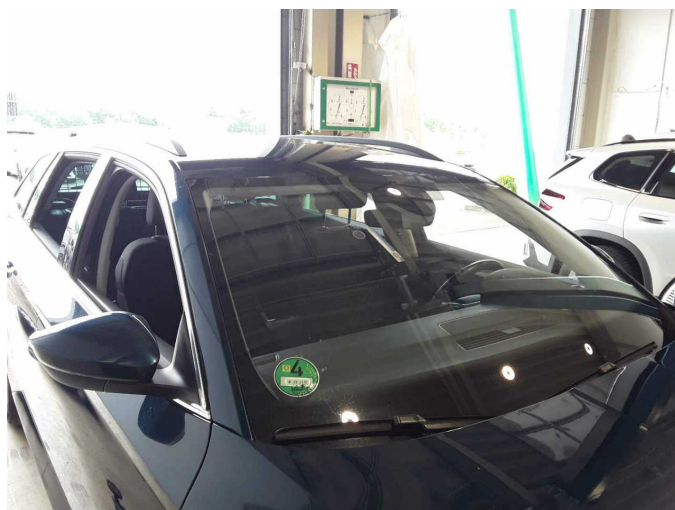
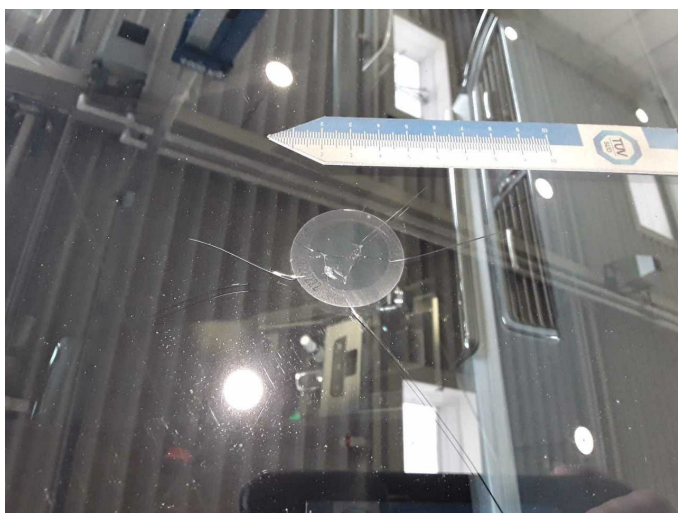
| No. | Component group | Description |
|---|---|---|
| 9 | Vehicle glazing | Windscreen - Broken / torn - repair according to calculation |

**Damage 9:** Vehicle glazing: Windscreen - Broken / torn - repair according to calculation

Die beigefügte Reparaturkostenkalkulation wurde nach bestem Wissen und Gewissen unter eingeschränkter Besichtigungsbedingung im demontagefreien Zustand erstellt. Es können aufgrund verdeckter Beschädigung erhebliche Mehrkosten und somit Abweichung der für den Unfall ausgewiesenen Reparaturkosten nicht ausgeschlossen werden.

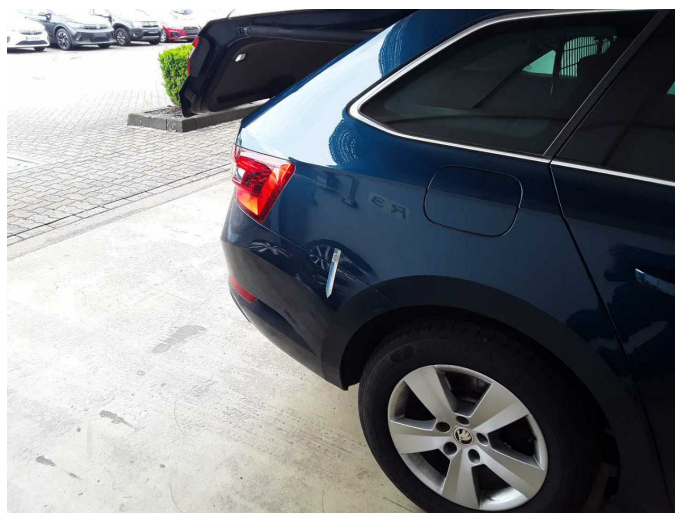
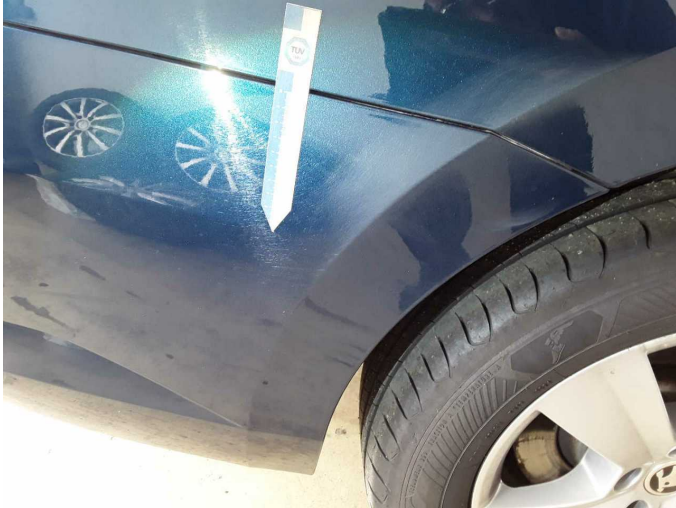
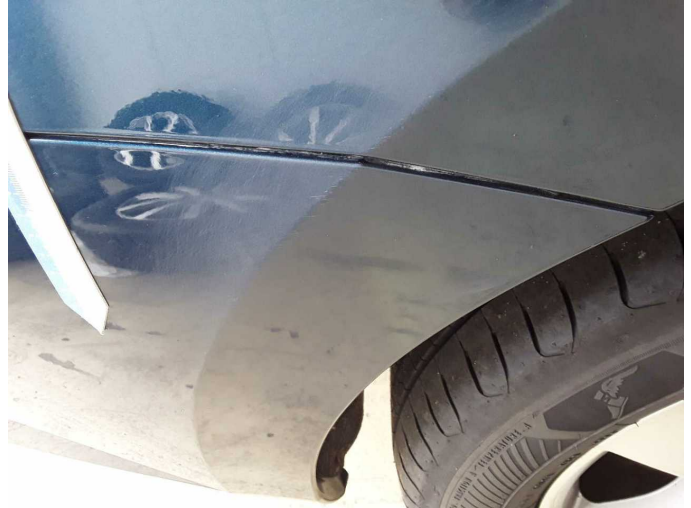
| No. | Component group | Description |
|---|---|---|
| 2 | Rear bumper | Rear bumper (im Unfall berücksichtigt) - Paint defect - No deduction |

**Wear and tear 2:** Rear bumper: Rear bumper (im Unfall berücksichtigt) - Paint defect - No deduction

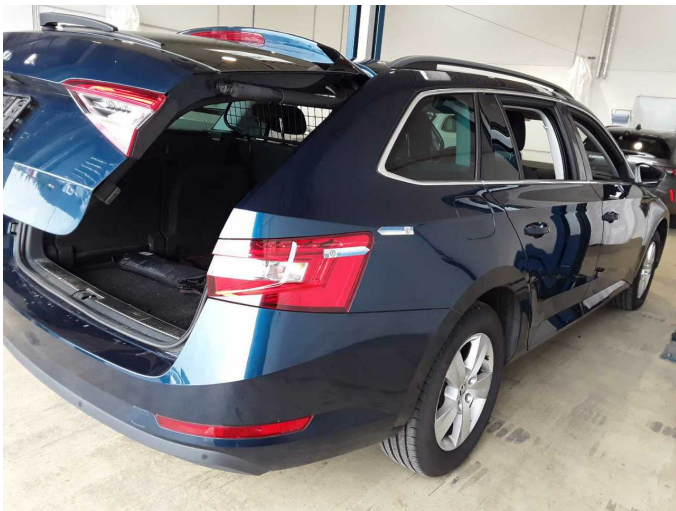
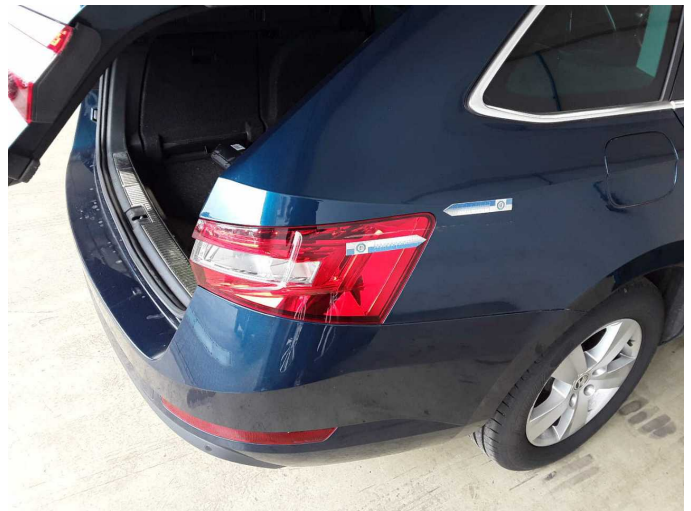
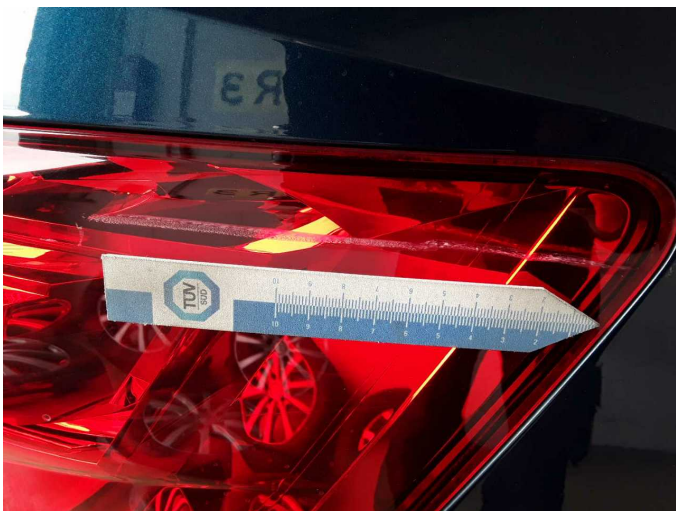
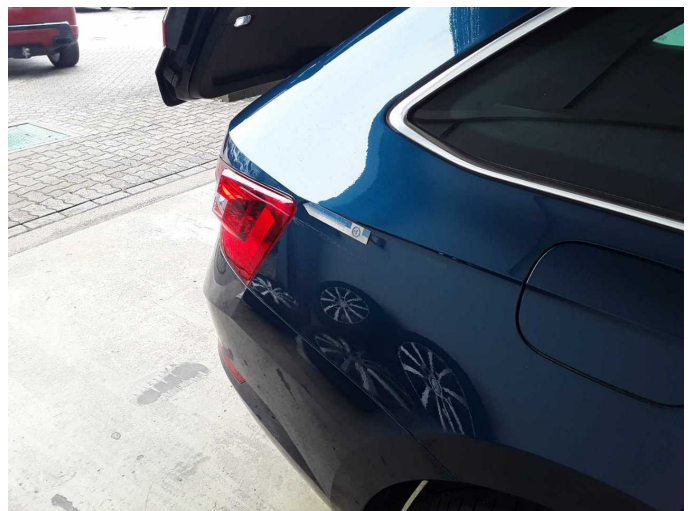
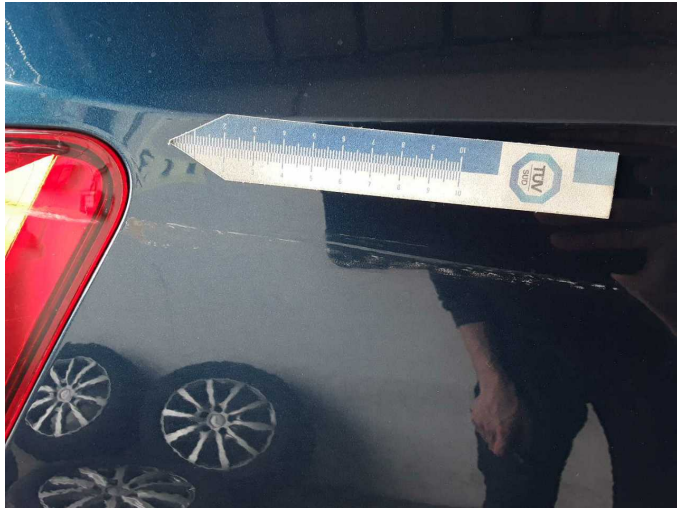
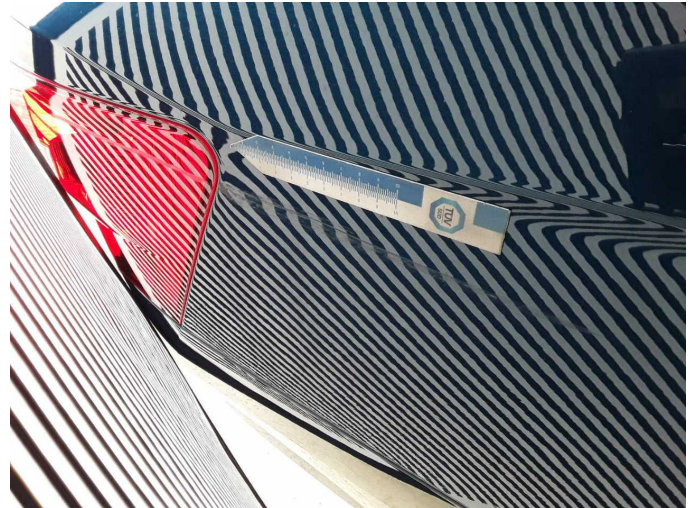
| No. | Accident |
|---|---|
| 1 | Side right |

**Accident 1:** Side right

**Accident 1: Side right**

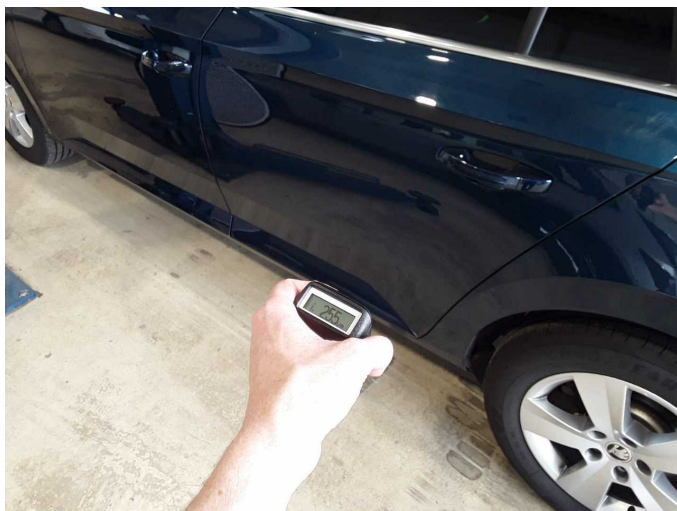
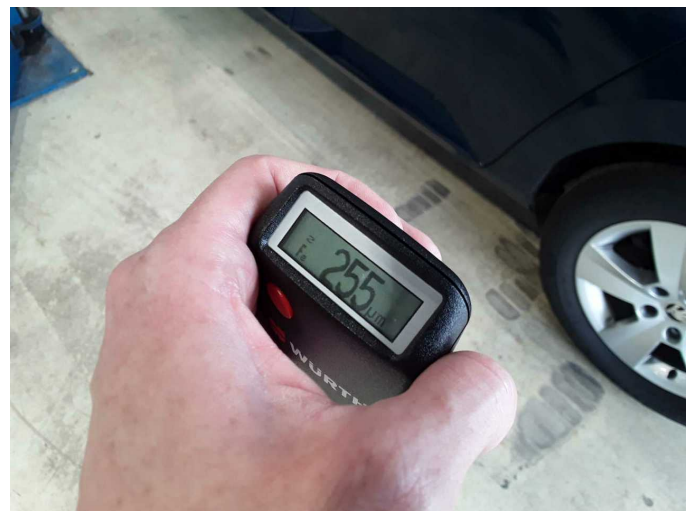
| No. | Repainting |
|---|---|
| 1 | Door - rear left side, Professionally carried out, Invoice of repair done Non-existent |

**Repainting 1: Door - rear left side**
