Expertise

Protocol number: 46901169  
Order No. / Reference: 26758217  
Inspection date: 5 Aug 2026

Manufacturer: Opel

Model: Astra 1.5 D Start/Stop Sports Tourer Automatik Edition

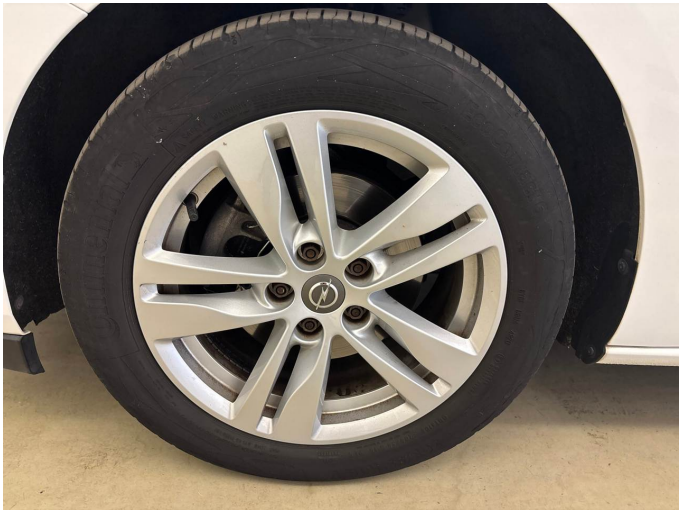
Figure 12: Mounted tyres

| # | Tyre size | Type of tyre | Manufacturer | Tread depth |
|---|---|---|---|---|
| 1) | 205/55 R16 91V | Summer tyres on Light alloy | Continental | 4mm / 4mm |
| 2) | 205/55 R16 91V | Summer tyres on Light alloy | Continental | 4mm / 4mm |

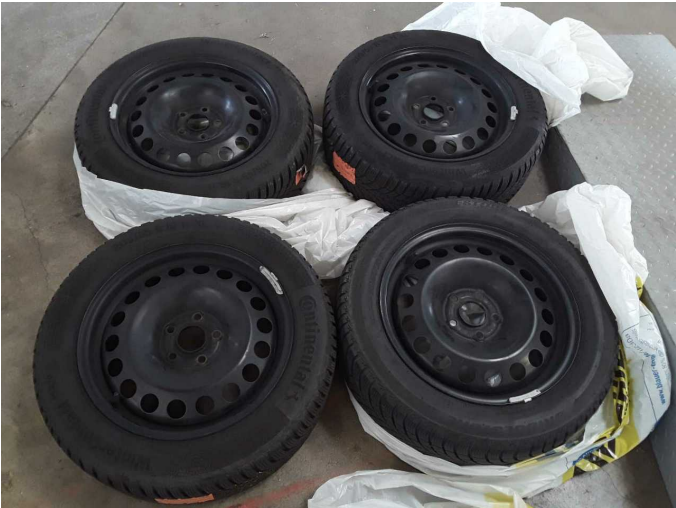
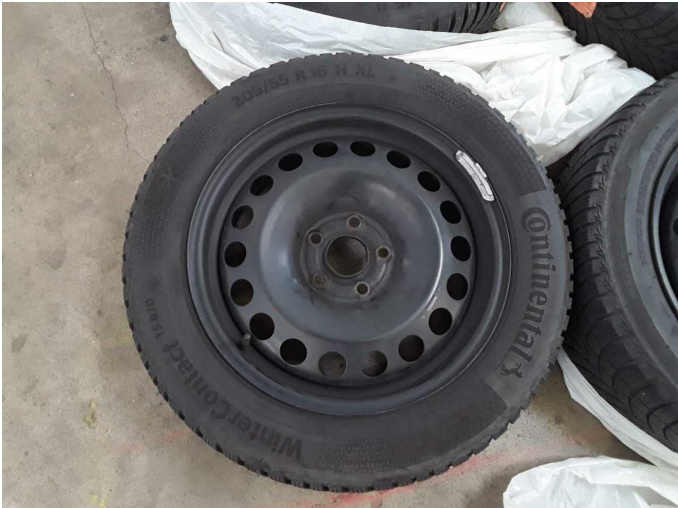
Figure 15: Additional tyres

| # | Tyre size | Type of tyre | Manufacturer | Tread depth |
|---|---|---|---|---|
| 1) | 205/55 R16 91H | Winter tyres on Steel | unterschiedliche Hersteller | 4mm / 7mm |
| 2) | 205/55 R16 91H | Winter tyres on Steel | Continental | 6mm / 6mm |

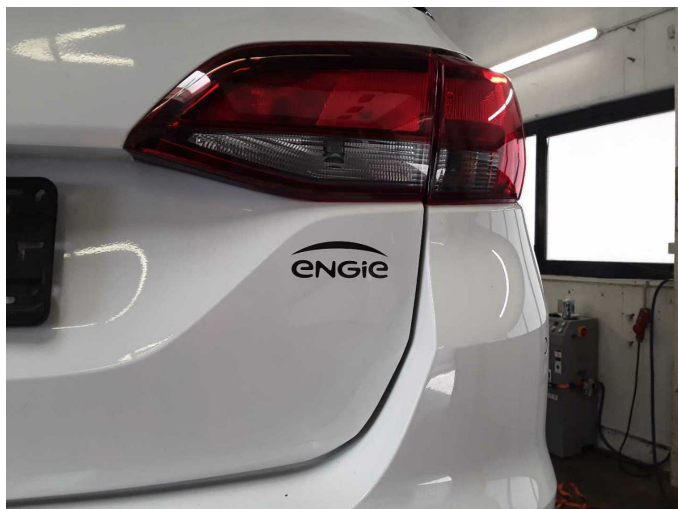
| No. | Component group | Description |
|---|---|---|
| 1 | Body | Body - Glued / labelled - De-glue / neutralise |

**Damage 1:** Body: Body - Glued / labelled - De-glue / neutralise

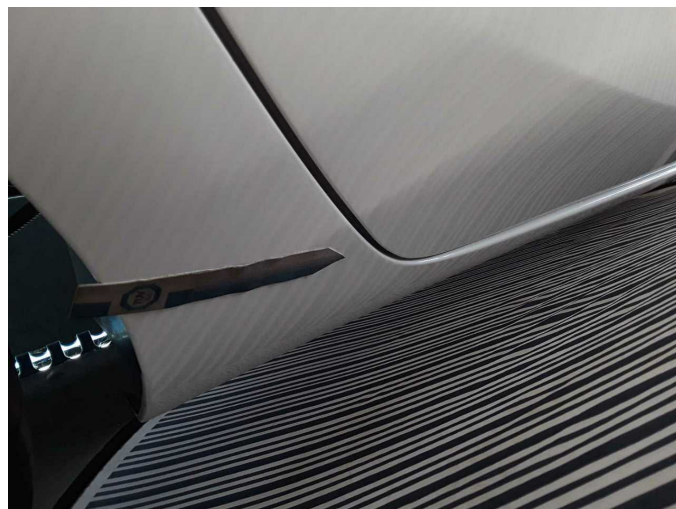
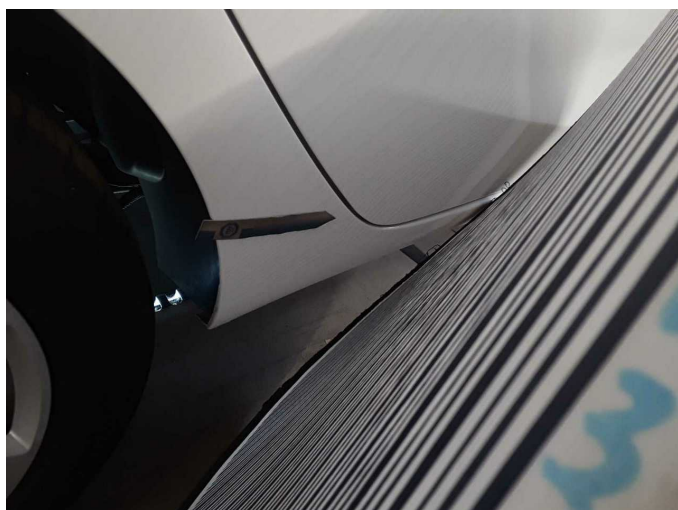
| No. | Component group | Description |
|---|---|---|
| 2 | Side panel - rear right side | Side panel - dent(s) - Smooth repair work |

**Damage 2:** Side panel - rear right side: Side panel - dent(s) - Smooth repair work

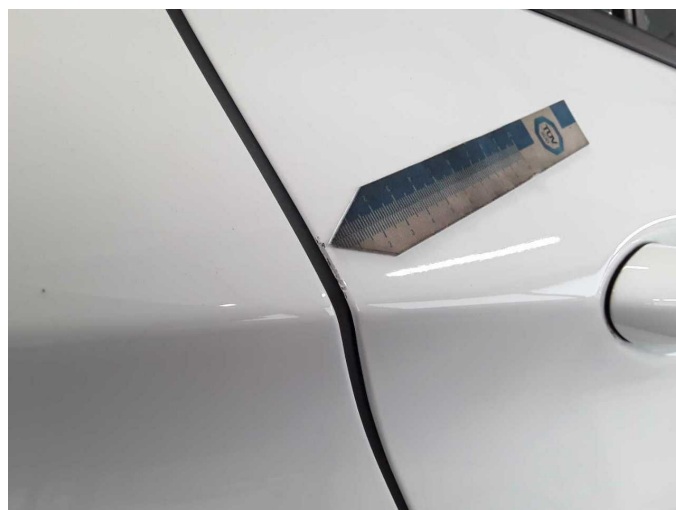
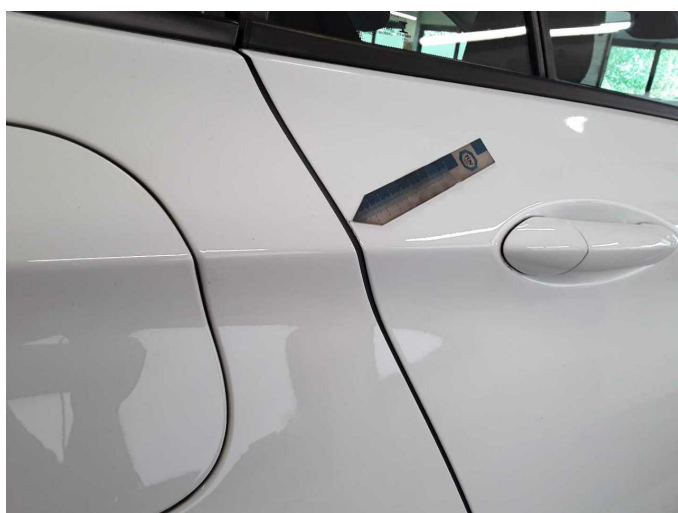
| No. | Component group | Description |
|---|---|---|
| 3 | Door - rear right side | Door edge - Scratch(es) - Smart repair |

**Damage 3:** Door - rear right side: Door edge - Scratch(es) - Smart repair

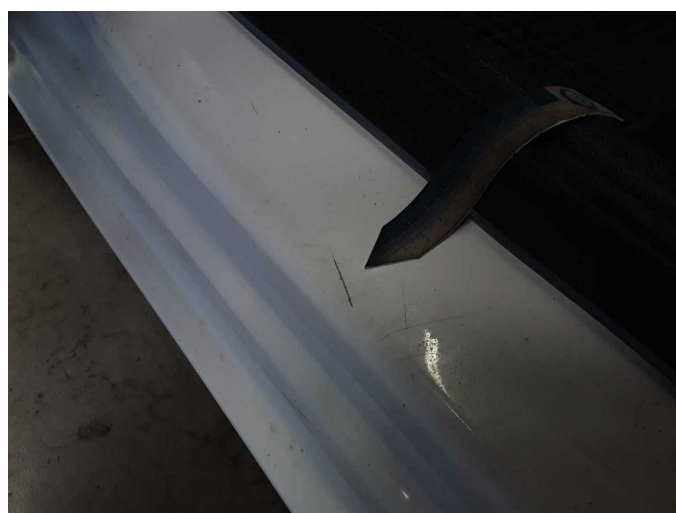
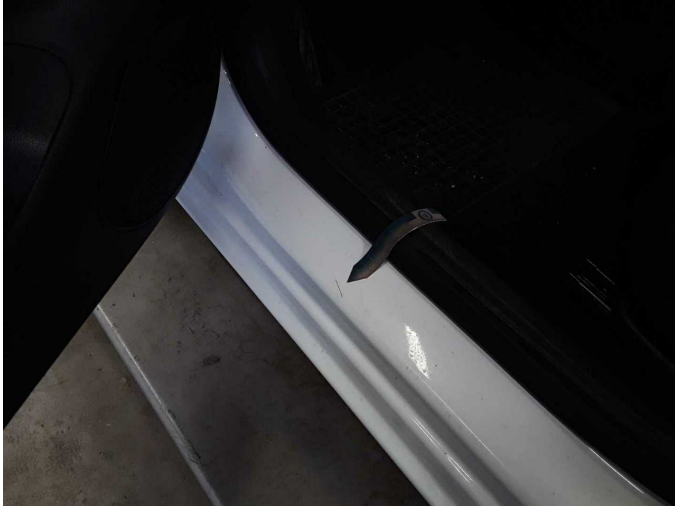
| No. | Component group | Description |
|---|---|---|
| 4 | Sill - left side | Sill - Scratch(es) - Smart repair |

**Damage 4:** Sill - left side: Sill - Scratch(es) - Smart repair

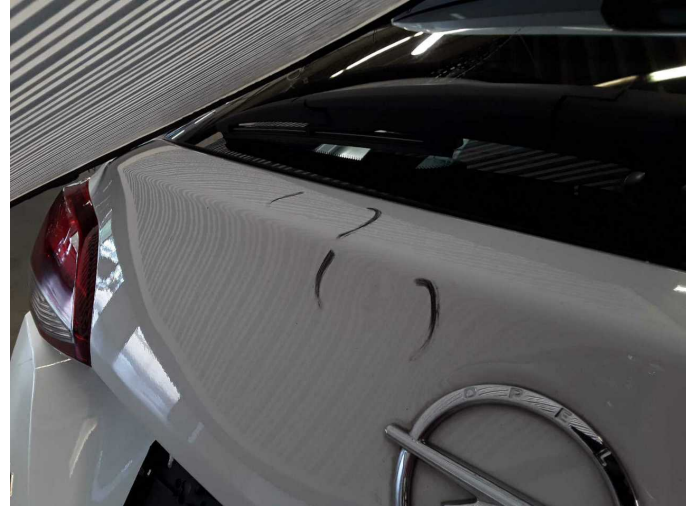
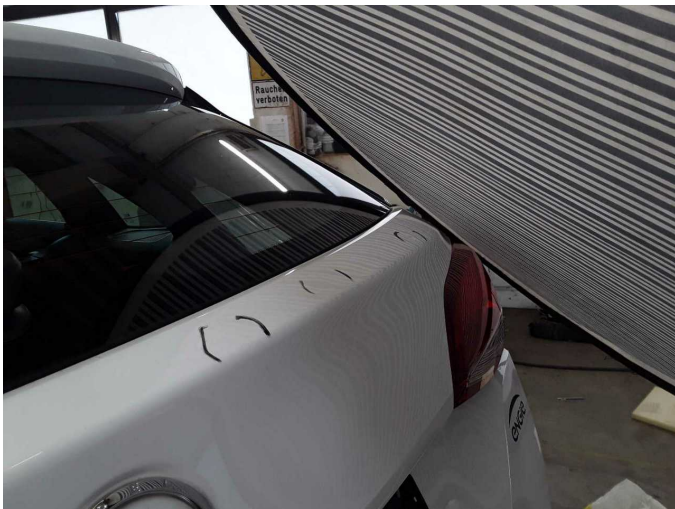
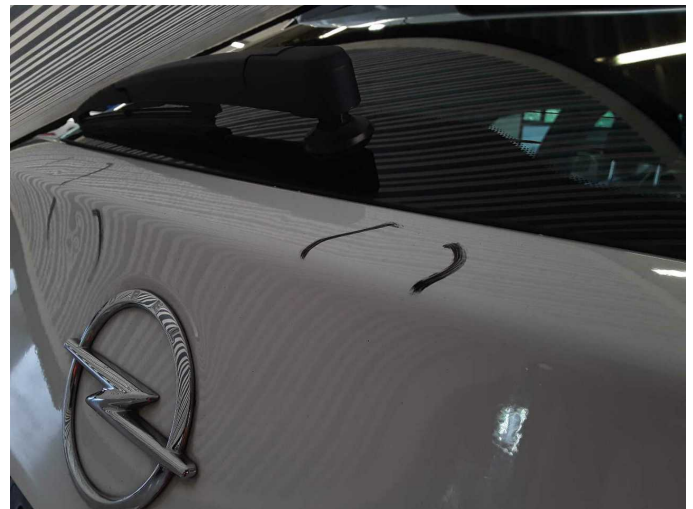
| No. | Component group | Description |
|---|---|---|
| 5 | Boot lid / rear door | Boot lid - dent(s) - Smooth repair work |

**Damage 5:** Boot lid / rear door: Boot lid - dent(s) - Smooth repair work

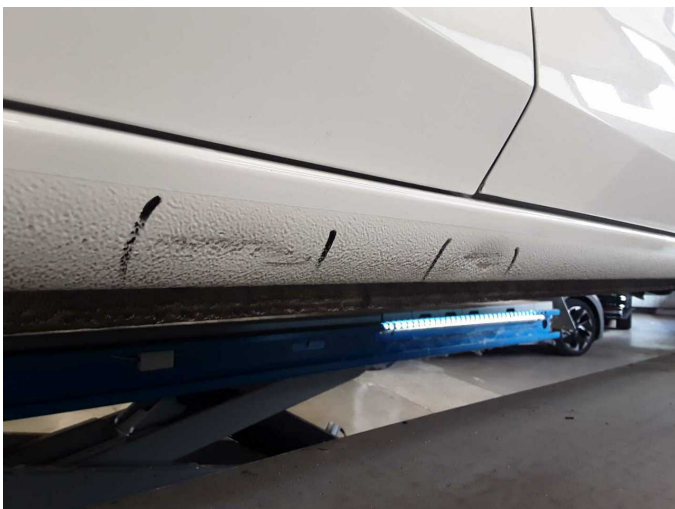
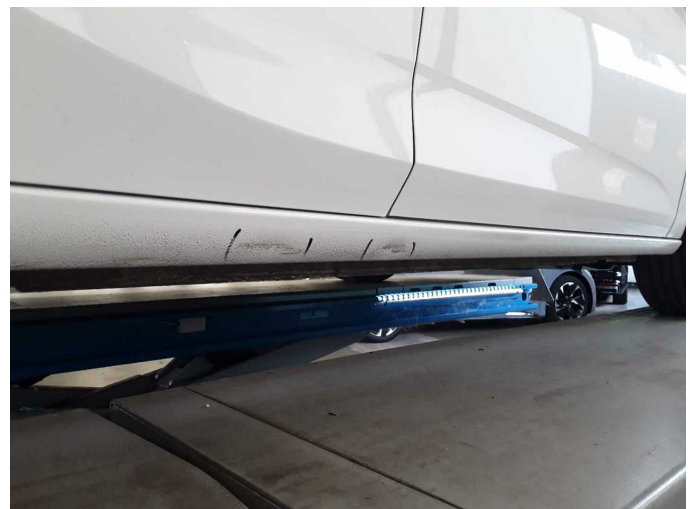
| No. | Component group | Description |
|---|---|---|
| 6 | Sill - right side | Sill - dent(s) - Repair and paint |

**Damage 6:** Sill - right side: Sill - dent(s) - Repair and paint

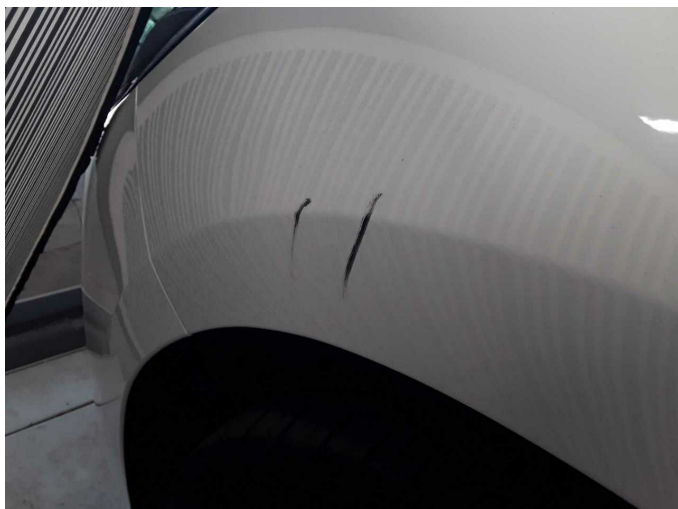
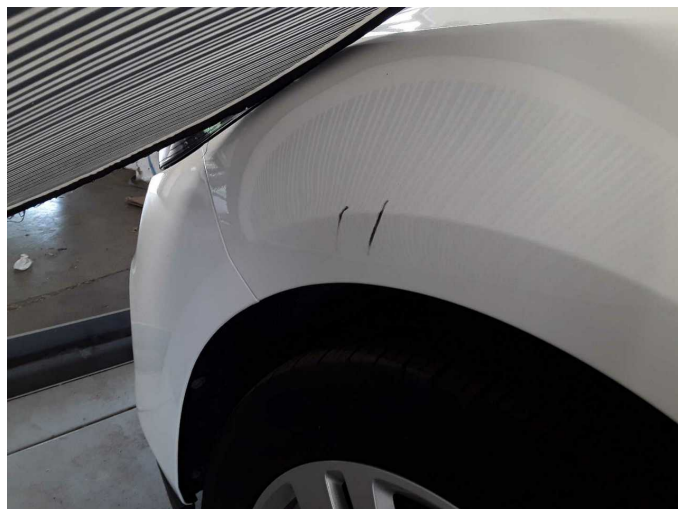
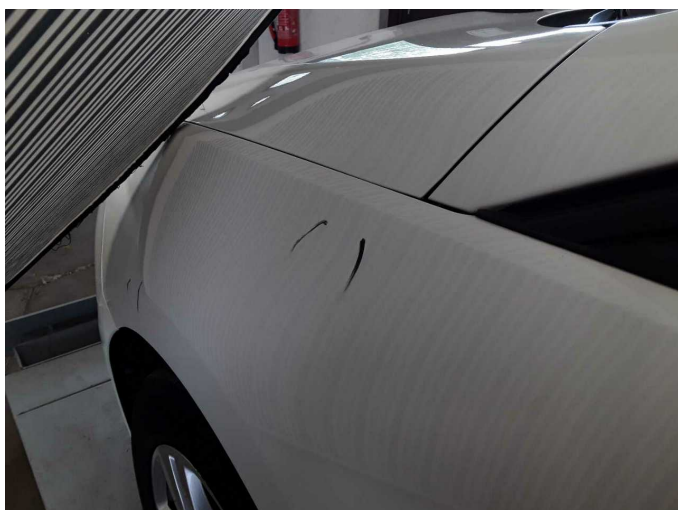
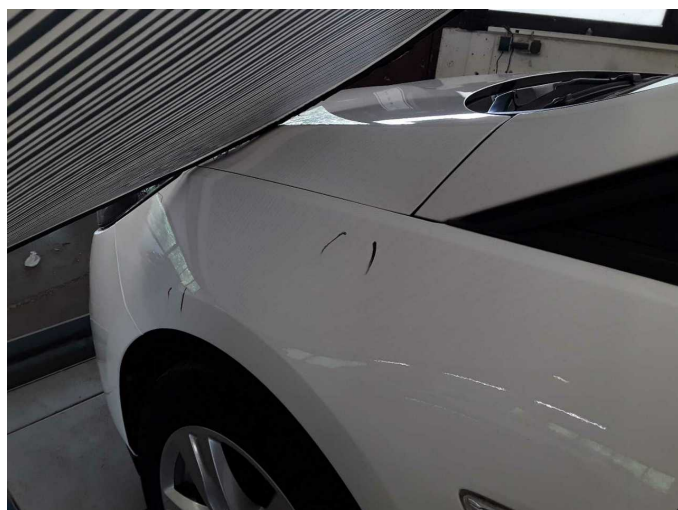
| No. | Component group | Description |
|---|---|---|
| 7 | Mudguard - left side | Mudguard - left side (Delle auf der Kante) - dent(s) - Repair and paint |

**Damage 7:** Mudguard - left side: Mudguard - left side (Delle auf der Kante) - dent(s) - Repair and paint

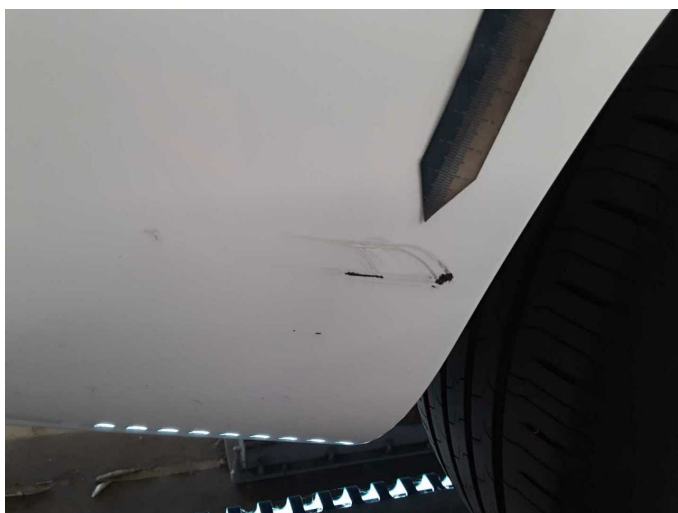
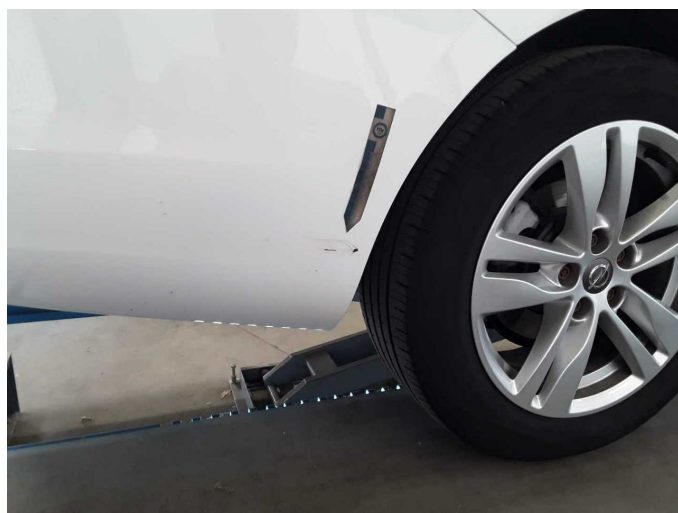
| No. | Component group | Description |
|---|---|---|
| 8 | Rear bumper | Rear bumper - Scratched - Paint |

**Damage 8:** Rear bumper: Rear bumper - Scratched - Paint

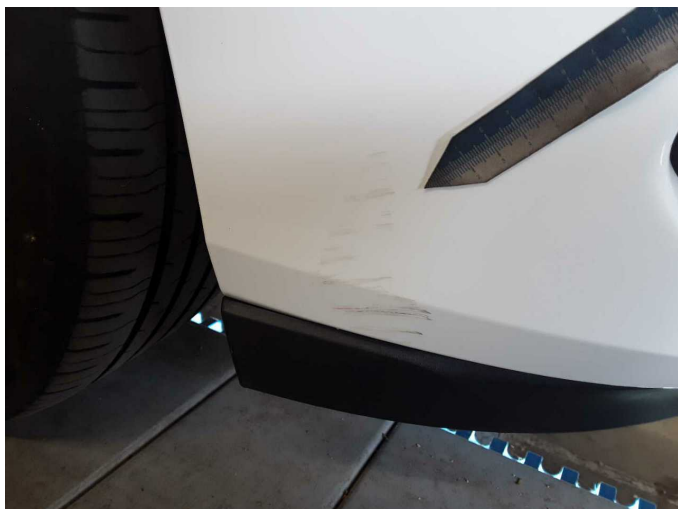
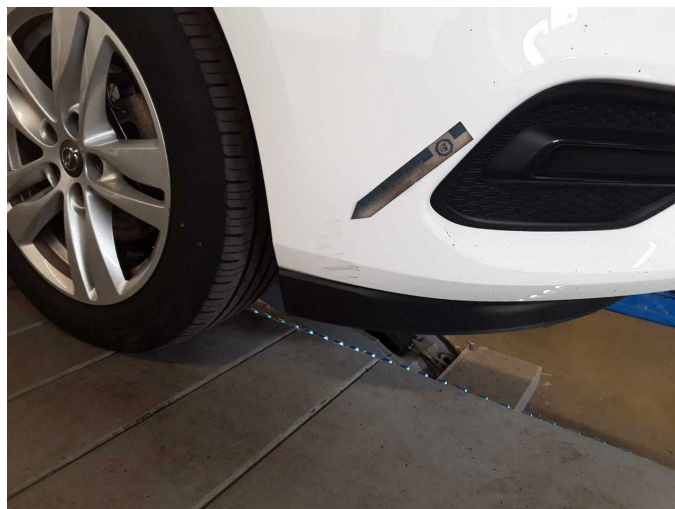
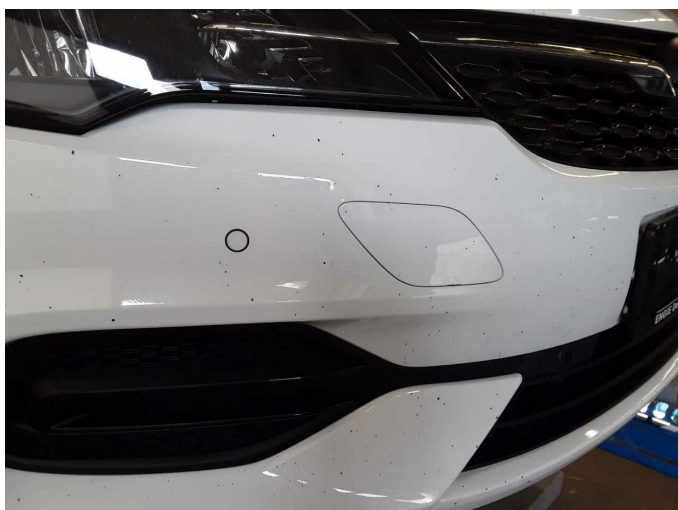
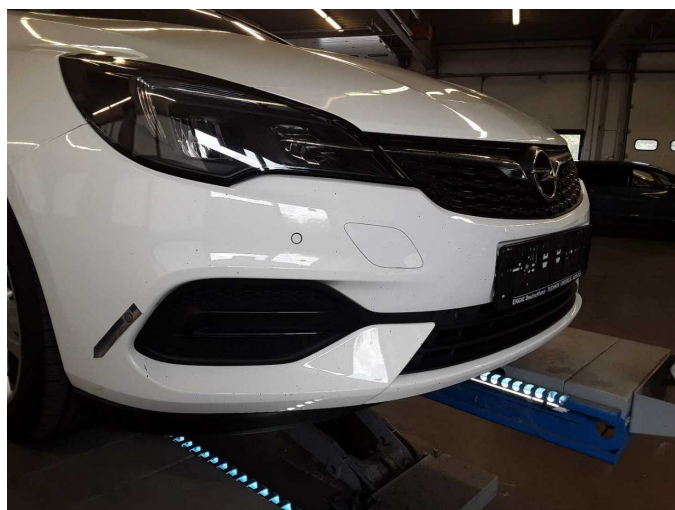
| No. | Component group | Description |
|---|---|---|
| 9 | Front bumper | Front bumper (Inklusive Steinschläge) - Scratched - Paint |

**Damage 9:** Front bumper: Front bumper (Inklusive Steinschläge) - Scratched - Paint

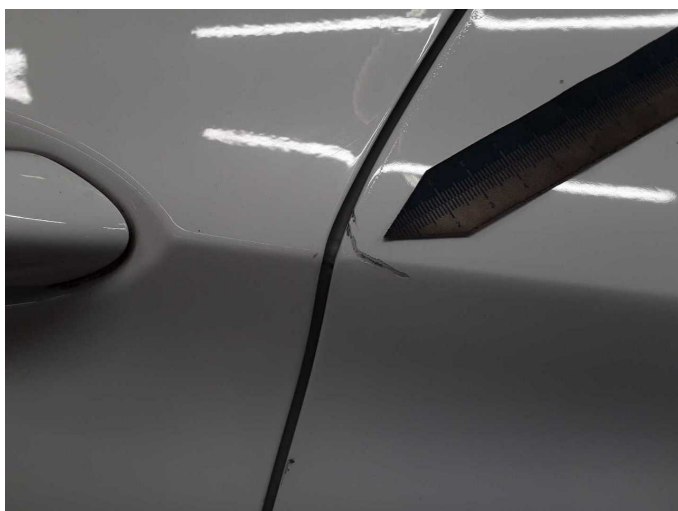
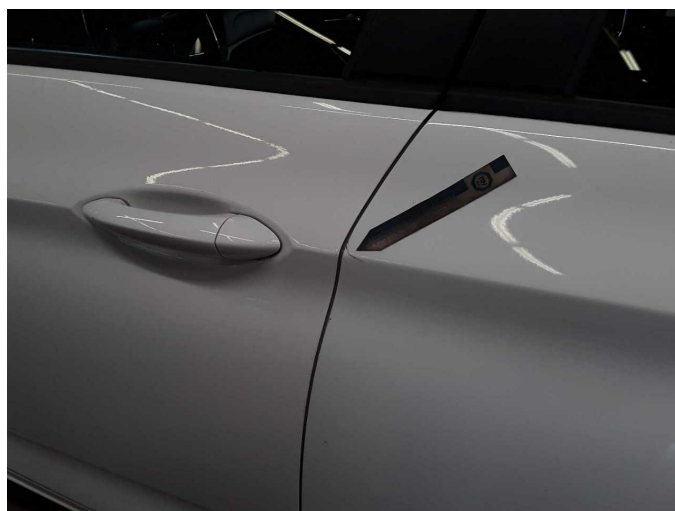
| No. | Component group | Description |
|---|---|---|
| 10 | Door - rear left side | Door - Scratched - Paint |

**Damage 10:** Door - rear left side: Door - Scratched - Paint

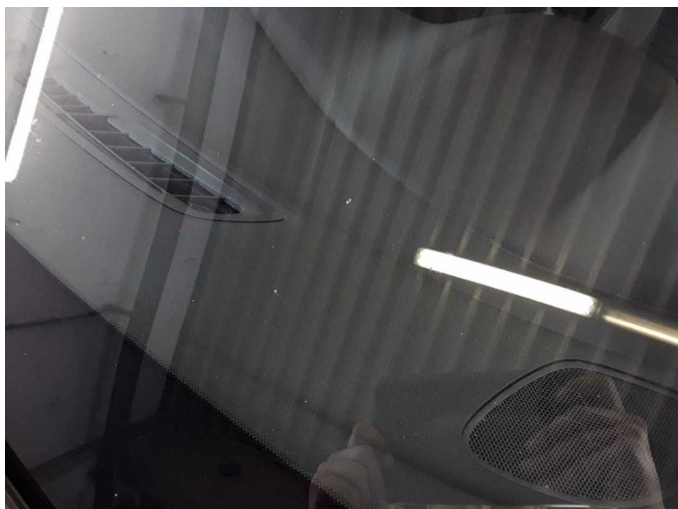
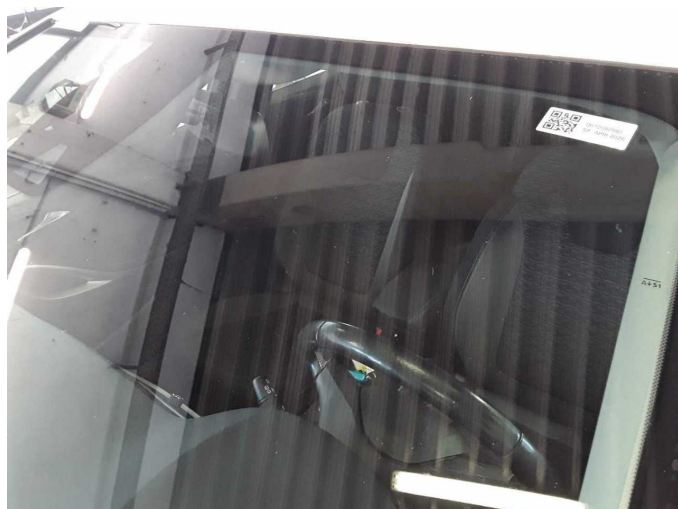
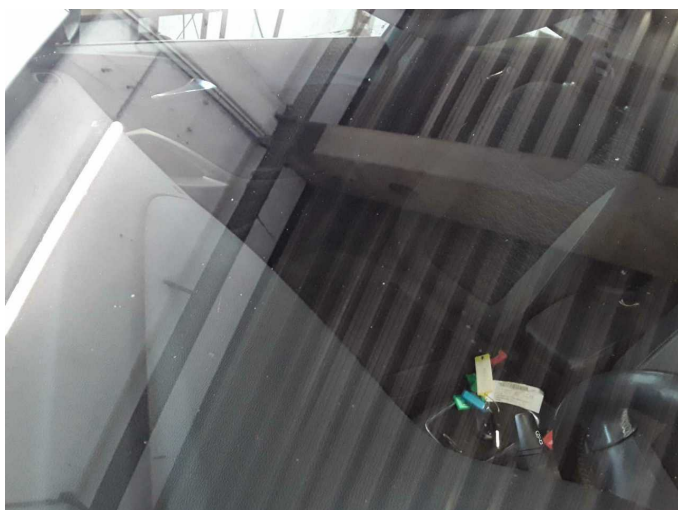
| No. | Component group | Description |
|---|---|---|
| 11 | Vehicle glazing | Windscreen (viele kleine Steinschläge im Sichtbereich) - Stone chips - Replace |

**Damage 11:** Vehicle glazing: Windscreen (viele kleine Steinschläge im Sichtbereich) - Stone chips - Replace

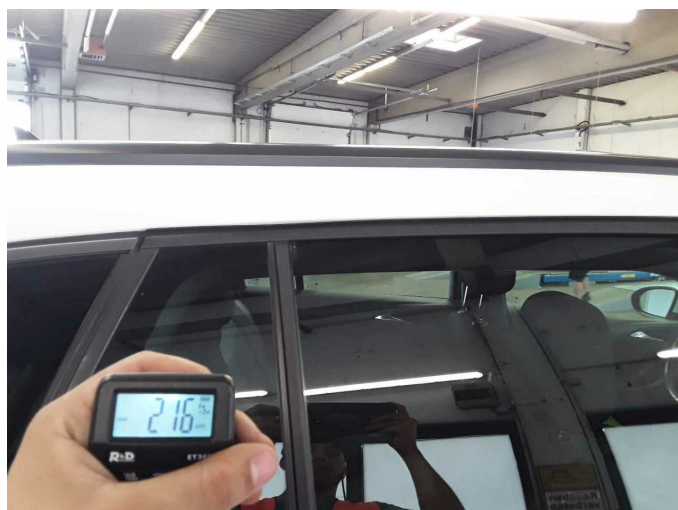
| Roof rail - right side | 216 µm | Bonnet | 202 µm |

**Roof rail - right side:** 216 µm

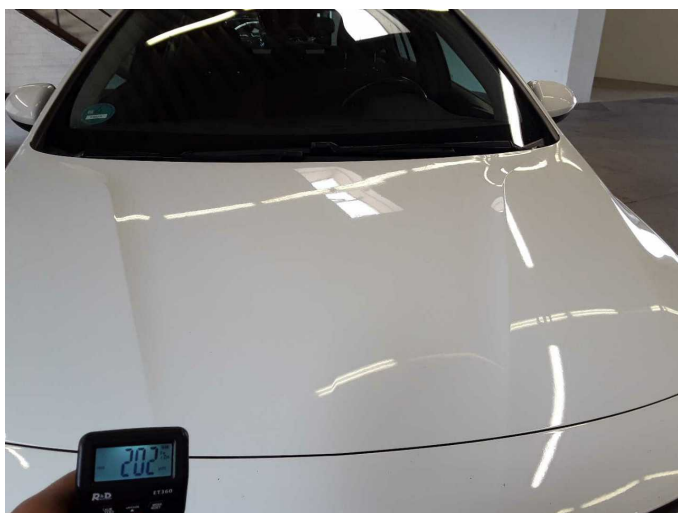
**Bonnet:** 202 µm

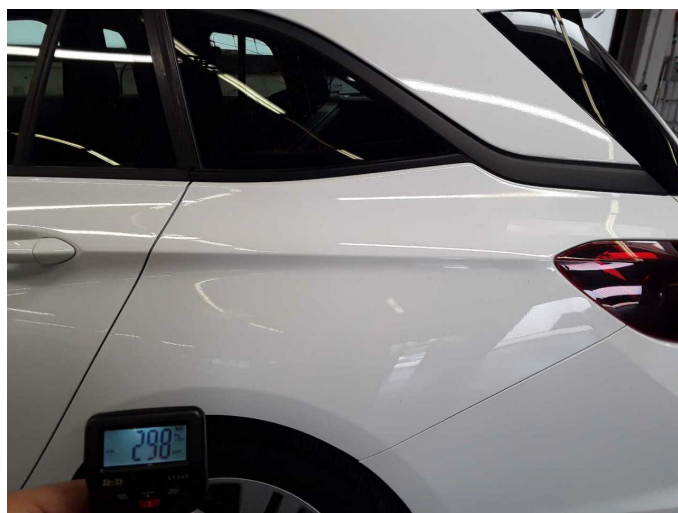
| Side panel - rear left side | 298 µm | Side panel - rear right side | 298 µm |

**Side panel - rear left side:** 298 µm

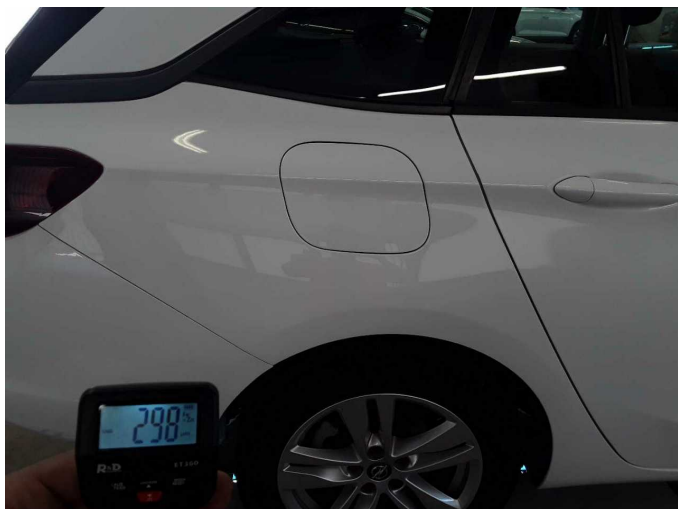
**Side panel - rear right side: 298 µm**

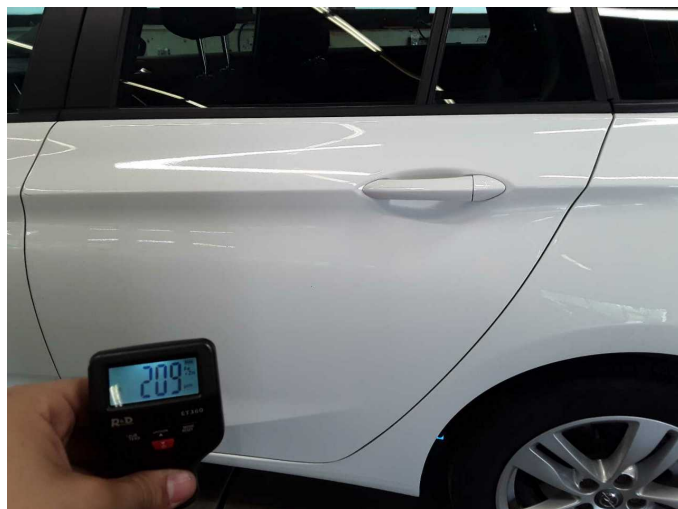
| Door - rear left side | 209 µm | Door - rear right side | 201 µm |

**Door - rear left side: 209 µm**

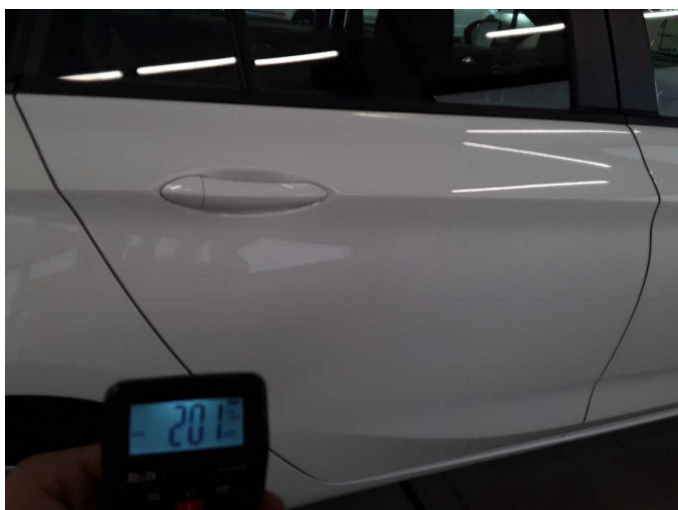
**Door - rear right side: 201 µm**
