Expertise

Protocol number: 45560105
Order No. / Reference: 26419856
Inspection date: 21 May 2026

Model: Octavia Combi 2.0 TDI DSG Ambition

VIN: TMBJJ8NXXPY077475

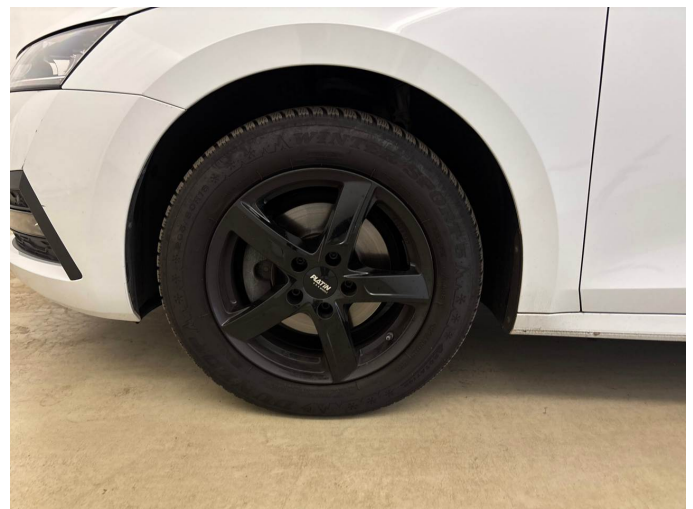
Figure 12: Mounted tyres

#	Tyre size	Type of tyre	Manufacturer	Tread depth
1)	205/60 R16 96H	Winter tyres on Light alloy	Dunlop	5mm / 5mm
2)	205/60 R16 96H	Winter tyres on Light alloy	Dunlop	5mm / 5mm

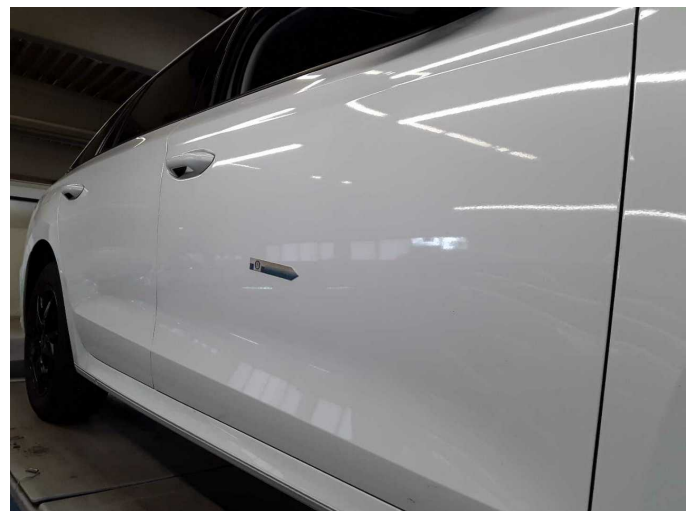
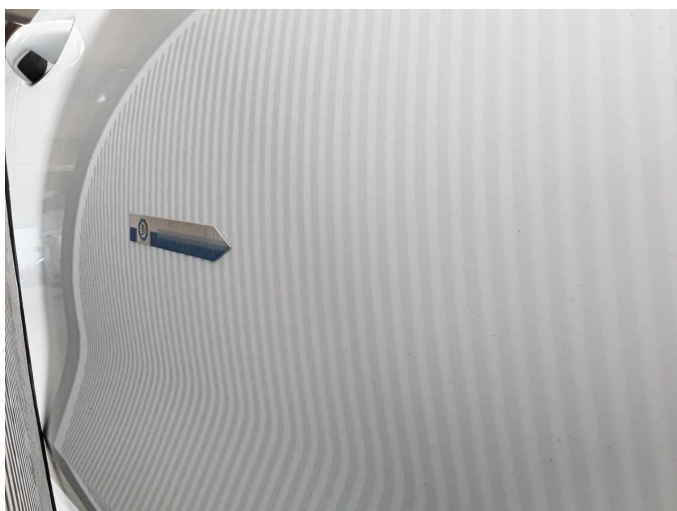
Damage 1: Door - front right side: Door - dent(s) - Smooth repair work

No.	Component group	Description
1	Door - front right side	Door - dent(s) - Smooth repair work
2	Front bumper	Front bumper - Scratch(es) - Paint
3	Bonnet	Bonnet - Dent / paintcoat damage - Repair and paint

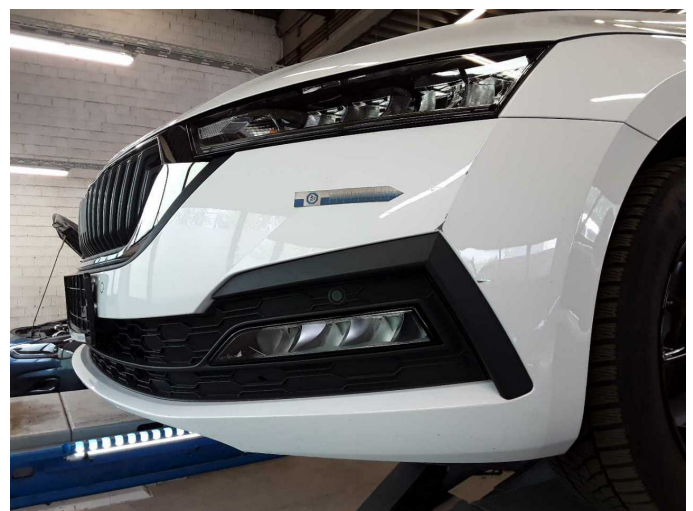
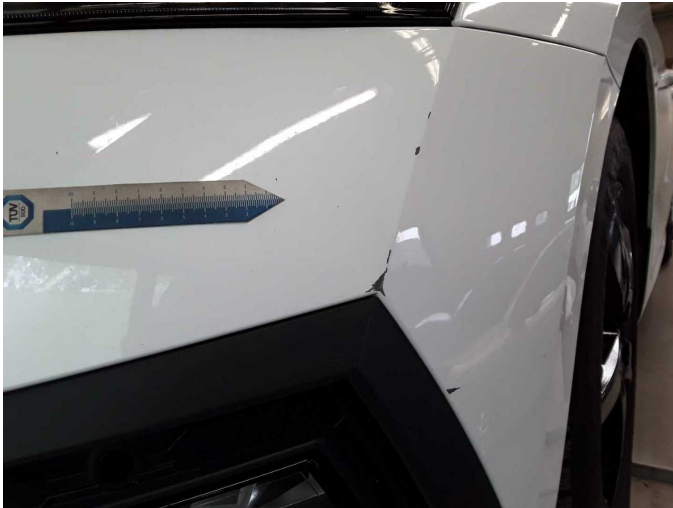
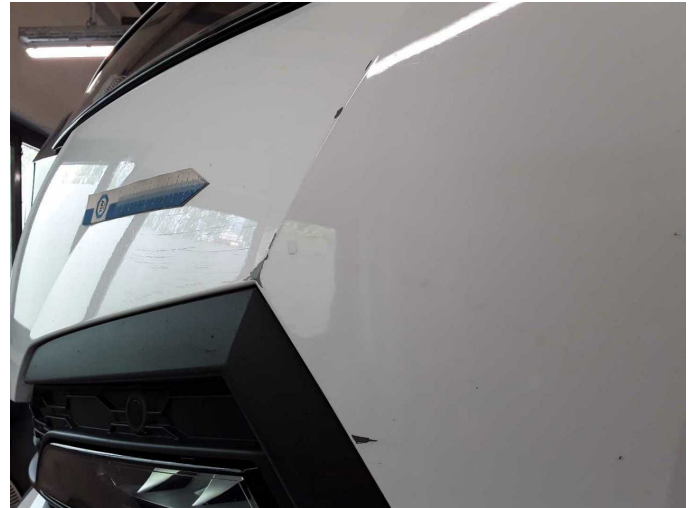
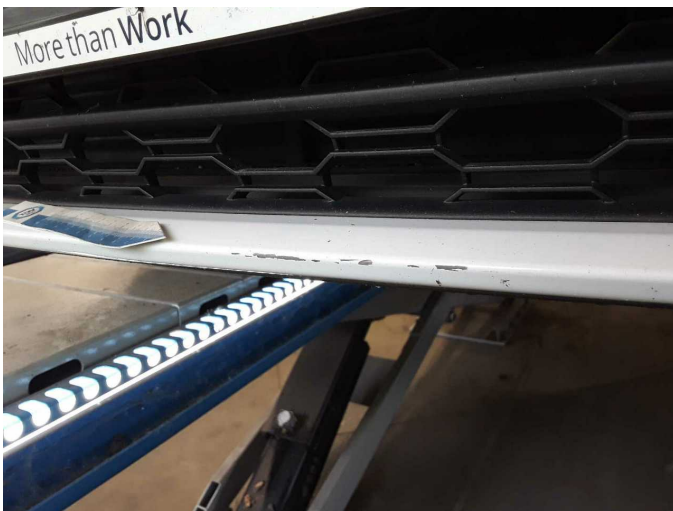
Damage 2: Front bumper: Front bumper - Scratch(es) - Paint

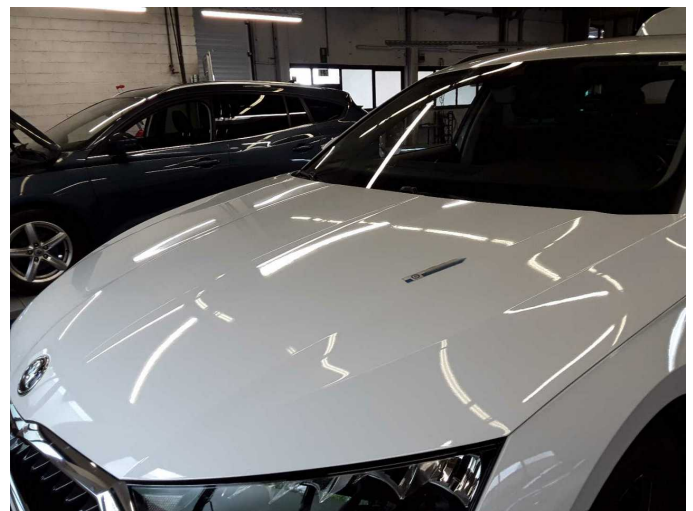
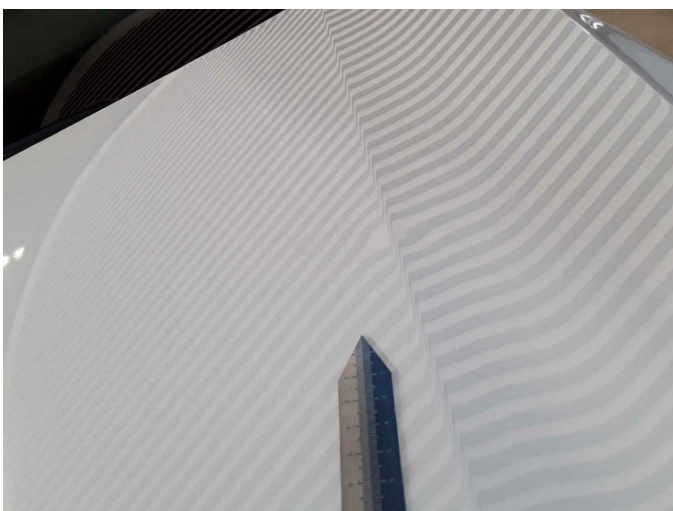
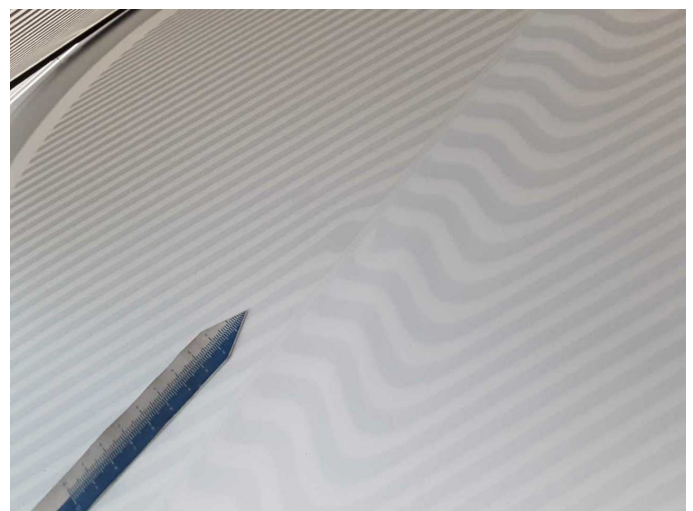
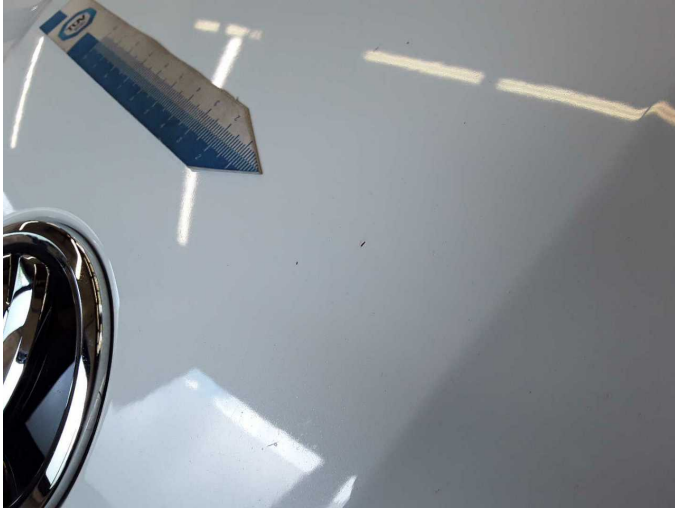
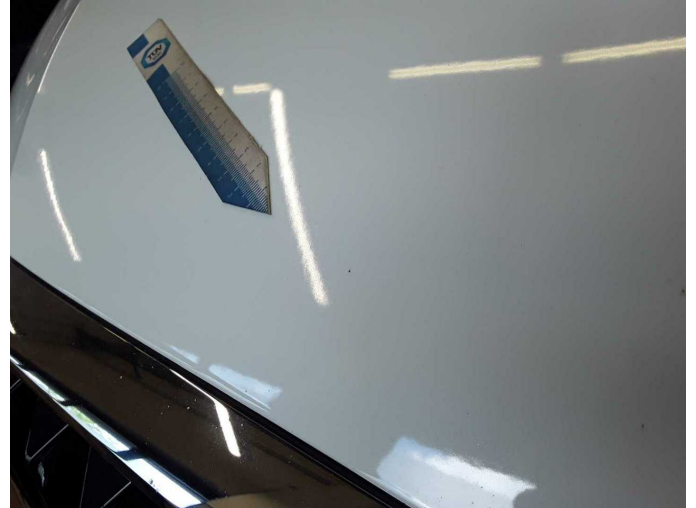
Damage 3: Bonnet: Bonnet - Dent / paintcoat damage - Repair and paint

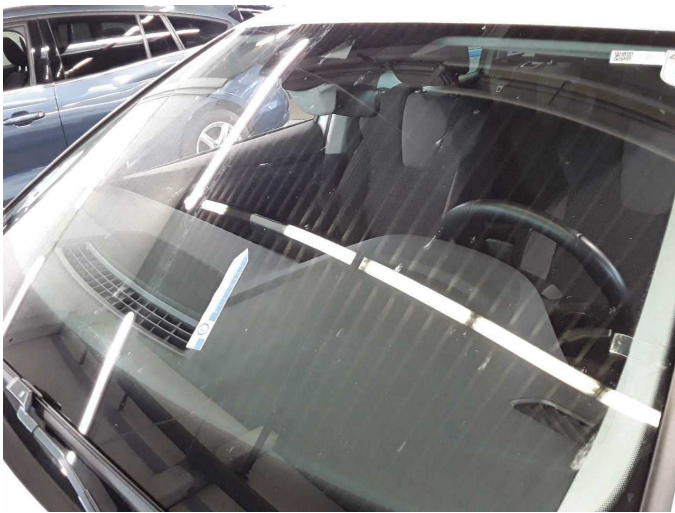
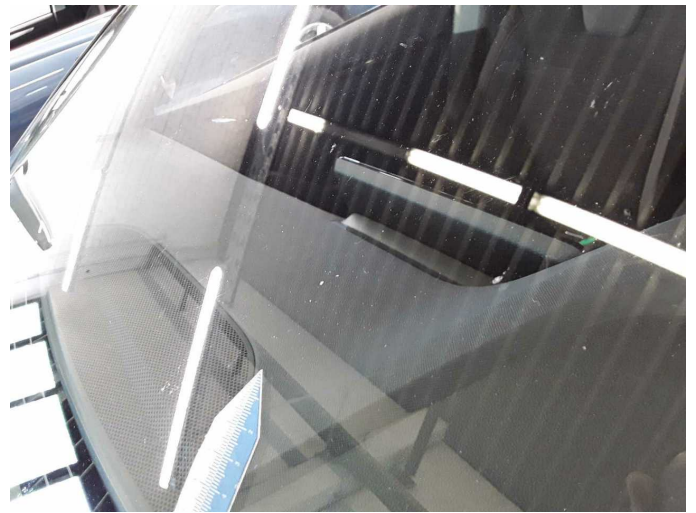
Wear and tear 1: Vehicle glazing: Windscreen - Stone chips - No deduction

No.	Component group	Description
1	Vehicle glazing	Windscreen - Stone chips - No deduction

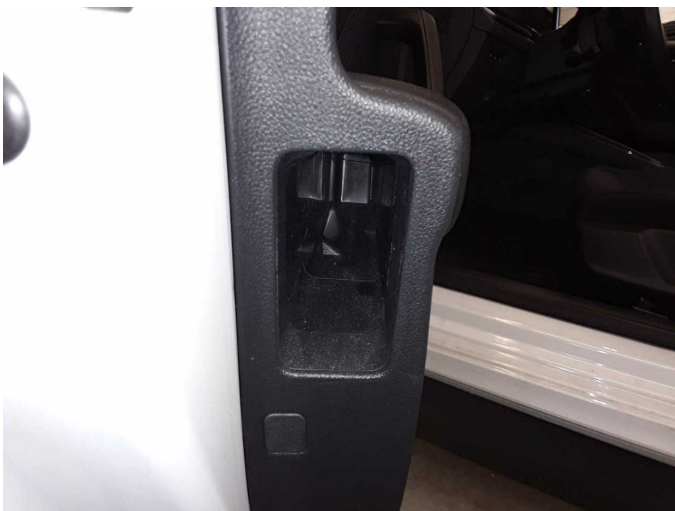
Missing part 1: Equipment: Umbrella - Missing - No deduction
