Expertise

Protocol number: 46601238  
Order No. / Reference: 26549192  
Inspection date: 20 Jul 2026

Manufacturer: Mercedes-Benz  
VIN: W1NKM0FBXPF033836

Model: GLC 220 d 4Matic 9G-TRONIC AMG Line Advanced

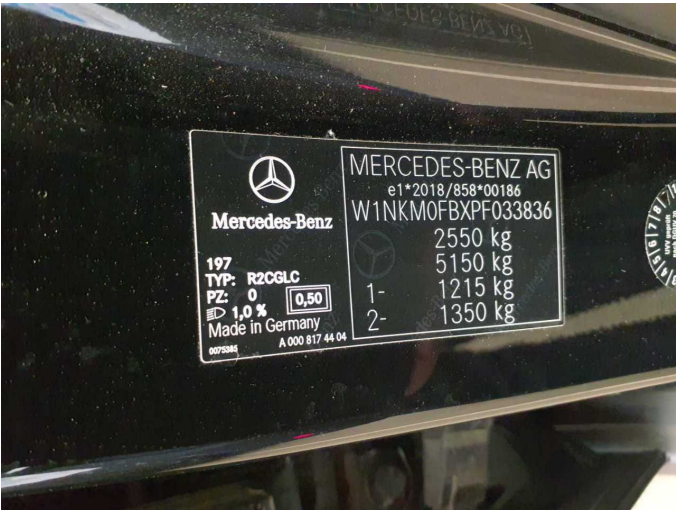
Figure 11: VIN

| VIN comparison | The vehicle identification number (VIN) was read from the vehicle and its conformity with the submitted documents was confirmed by the undersigned during the inspection. |

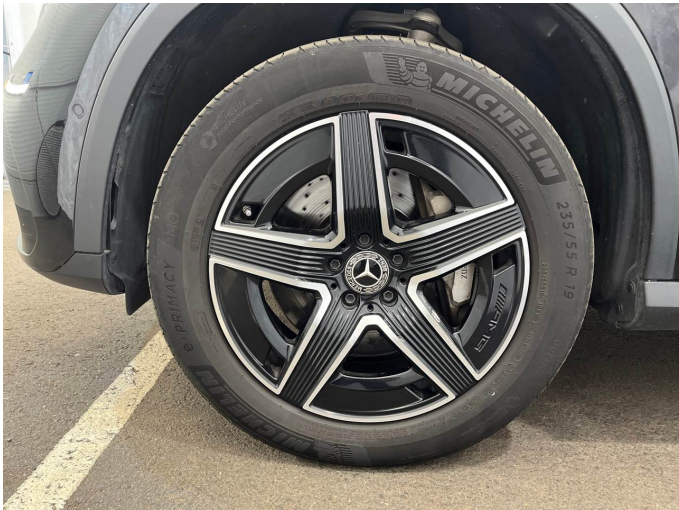
Figure 12: Mounted tyres

| # | Tyre size | Type of tyre | Manufacturer | Tread depth |
|---|---|---|---|---|
| 1) | 235/55 R19 105W | Summer tyres on Light alloy | Michelin | 4mm / 4mm |
| 2) | 235/55 R19 105W | Summer tyres on Light alloy | Michelin | 4mm / 4mm |

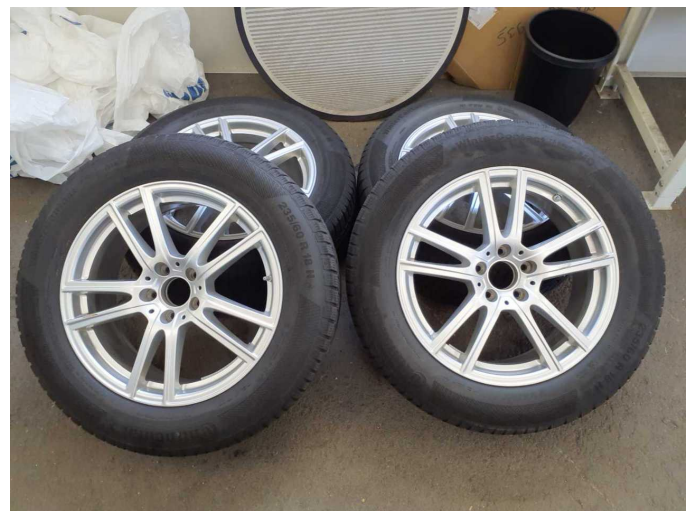
Figure 16: Additional tyres

| # | Tyre size | Type of tyre | Manufacturer | Tread depth |
|---|---|---|---|---|
| 1) | 235/60 R18 103H | Winter tyres on Light alloy | Continental | 6mm / 6mm |
| 2) | 235/60 R18 103H | Winter tyres on Light alloy | Continental | 6mm / 6mm |

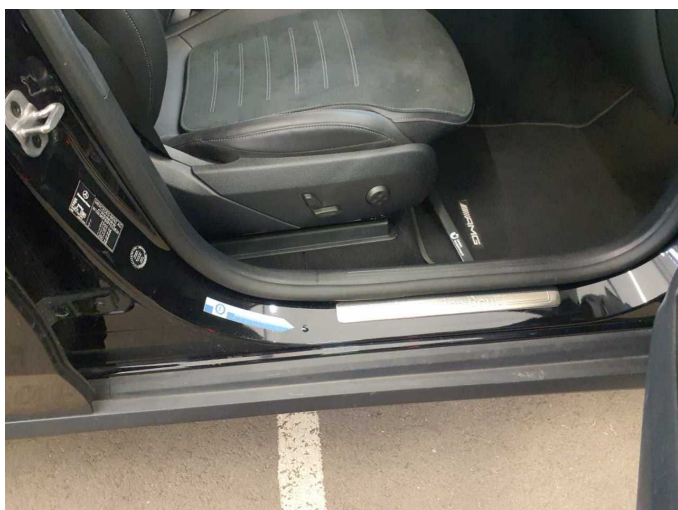
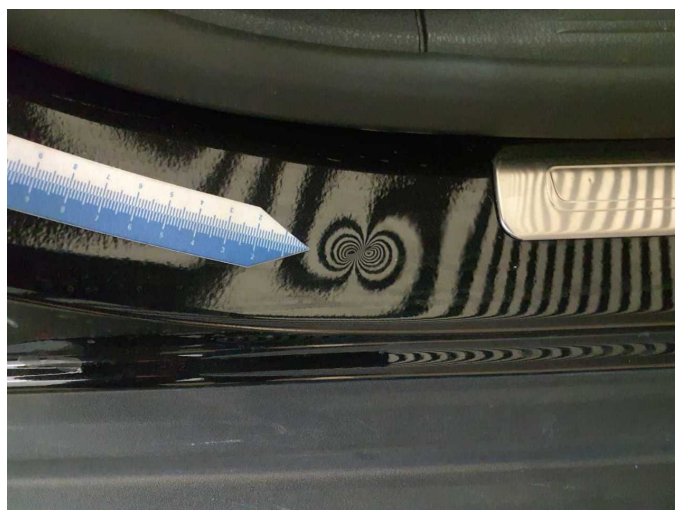
| No. | Component group | Description |
|---|---|---|
| 1 | Sill - right side | Sill - dent(s) - Smart repair |

**Damage 1:** Sill - right side: Sill - dent(s) - Smart repair

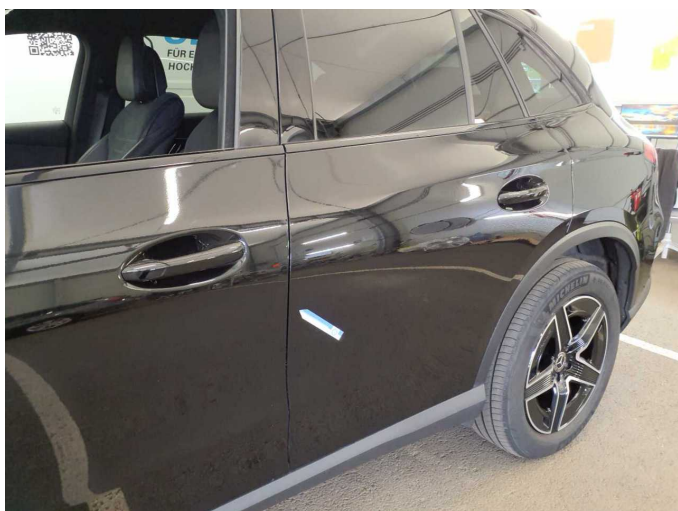
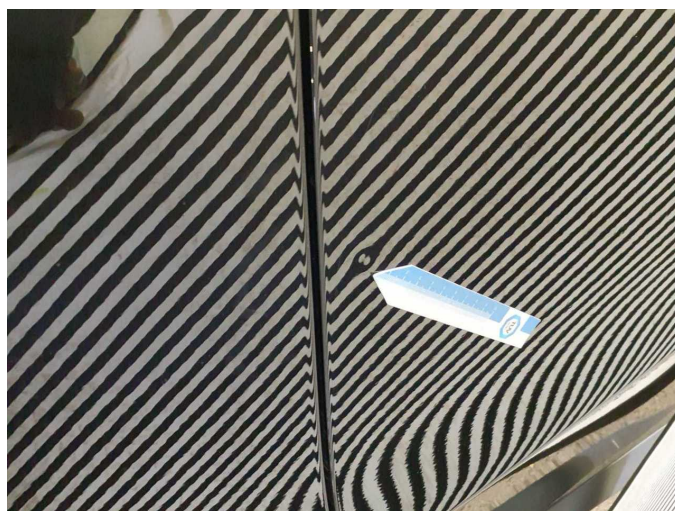
| No. | Component group | Description |
|---|---|---|
| 2 | Door - rear left side | Door - dent(s) - Smart repair |

**Damage 2:** Door - rear left side: Door - dent(s) - Smart repair
