Expertise

Protocol number: 46227492  
Order No. / Reference: 26521521  
Inspection date: 29 Jun 2026

Manufacturer: Volkswagen

Model: Transporter T6.1 DSG Kurz

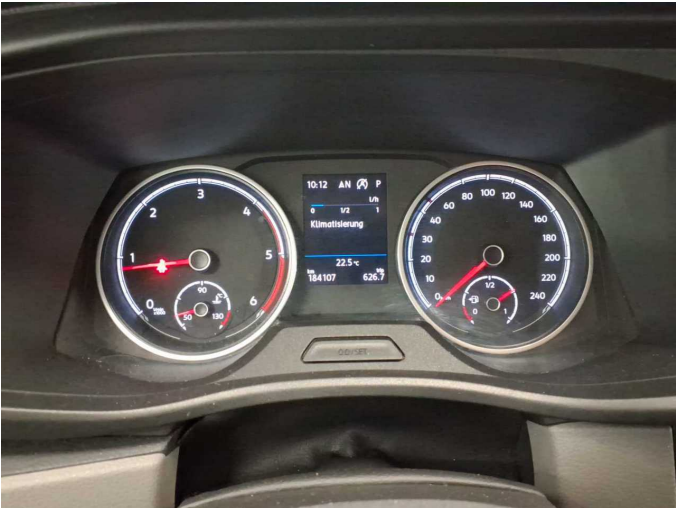
Figure 7: Instrument cluster

| Vehicle details | |
|---|---|
| Mileage (Read) | 184,107 km |

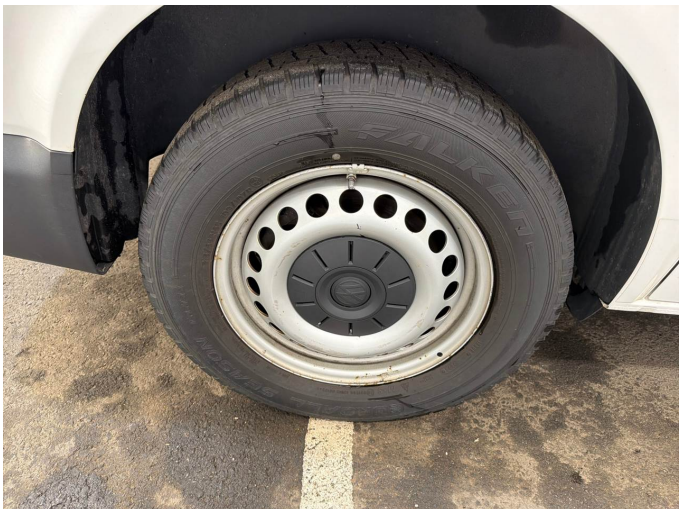
Figure 12: Mounted tyres

| # | Tyre size | Type of tyre | Manufacturer | Tread depth |
|---|---|---|---|---|
| 1) | 215/65 R16 109T | Winter tyres on Steel rim with wheel cover | Falken | 5mm / 5mm |
| 2) | 215/65 R16 109T | Winter tyres on Steel rim with wheel cover | Falken | 5mm / 5mm |

Der montierte Winterradsatz ist nicht Bestandteil der Ausstattung.

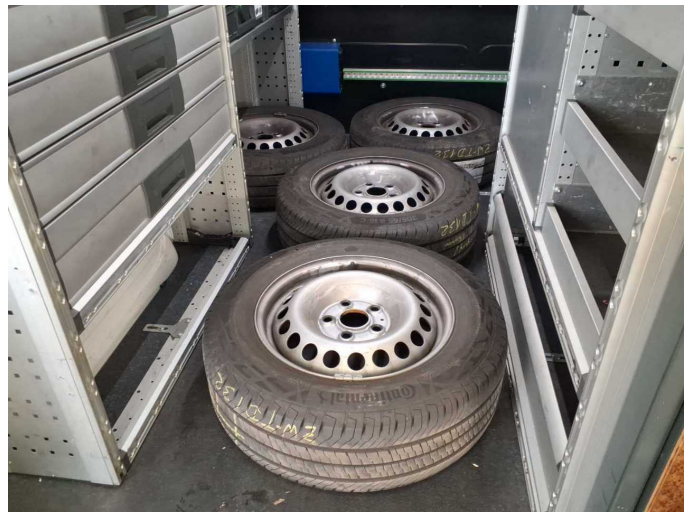
Figure 16: Additional tyres

| # | Tyre size | Type of tyre | Manufacturer | Tread depth |
|---|---|---|---|---|
| 1) | 215/65 R16 109T | Summer tyres on Steel | Continental | 5mm / 5mm |
| 2) | 215/65 R16 109T | Summer tyres on Steel | Continental | 5mm / 5mm |

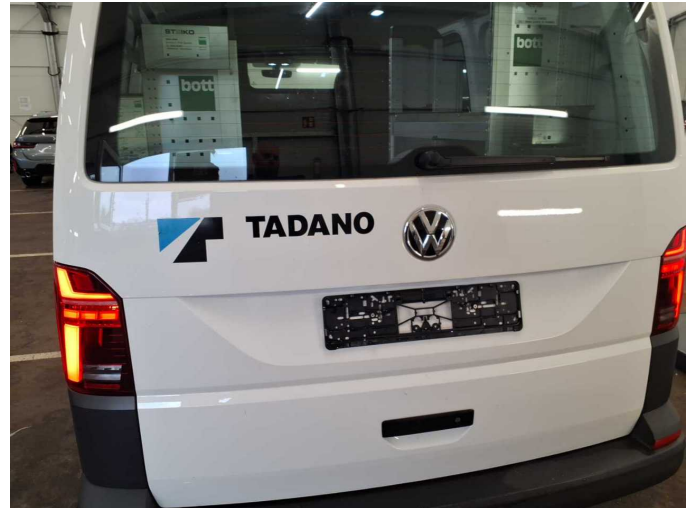
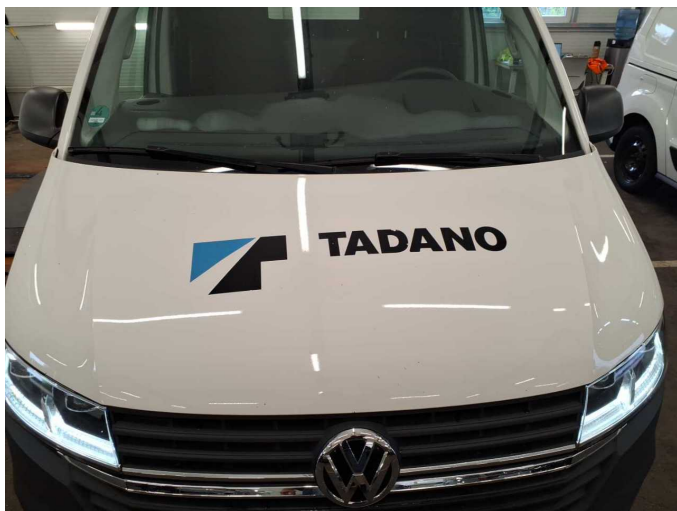
| No. | Component group | Description |
|---|---|---|
| 2 | Body | Body - Glued / labelled - De-glue / neutralise |

**Damage 2:** Body: Body - Glued / labelled - De-glue / neutralise

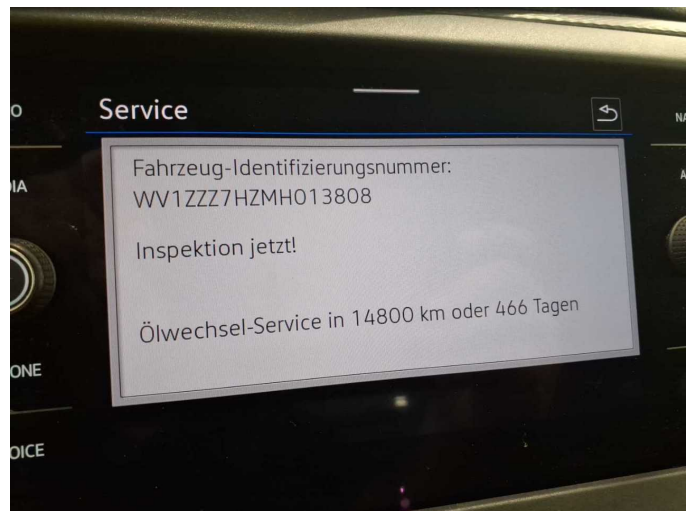
| No. | Component group | Description |
|---|---|---|
| 1 | Misc. | Inspection / maintenance (Nachweis unvollständig, Inspektion fällig) - No evidence - No deduction |
| 3 | Misc. | Inspection / maintenance - Due - Perform |

**Damage 3:** Misc.: Inspection / maintenance - Due - Perform

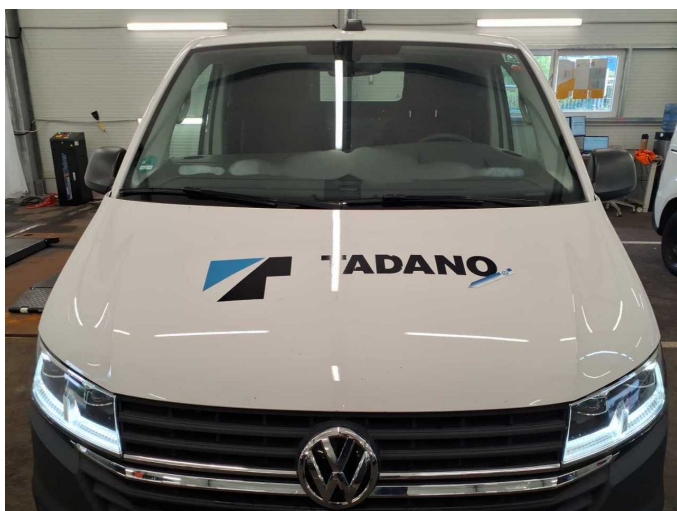
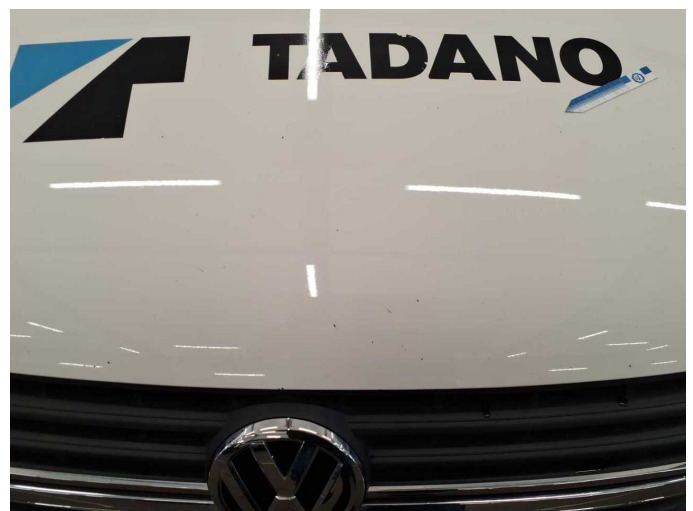
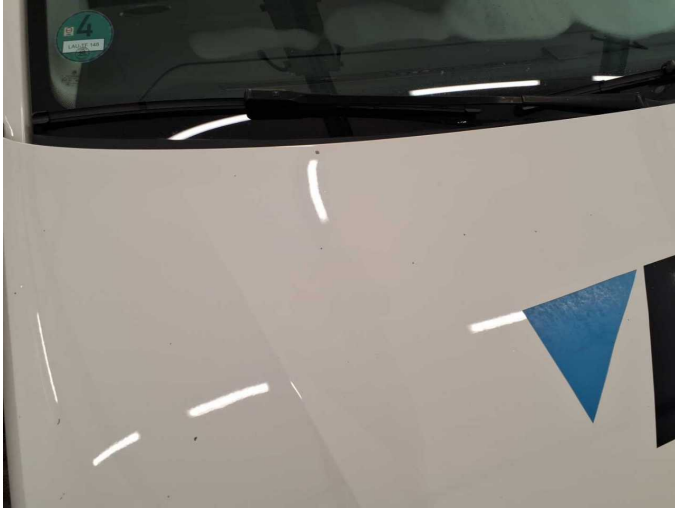
| No. | Component group | Description |
|---|---|---|
| 4 | Bonnet | Bonnet (Übermäßige Steinschläge) - Stone chips - Paint |

**Damage 4:** Bonnet: Bonnet (Übermäßige Steinschläge) - Stone chips - Paint
