Expertise

Protocol number: 46745681  
Order No. / Reference: 26768076  
Inspection date: 27 Jul 2026

Manufacturer: Volkswagen

Model: Passat Variant 2.0 TDI SCR DSG Business

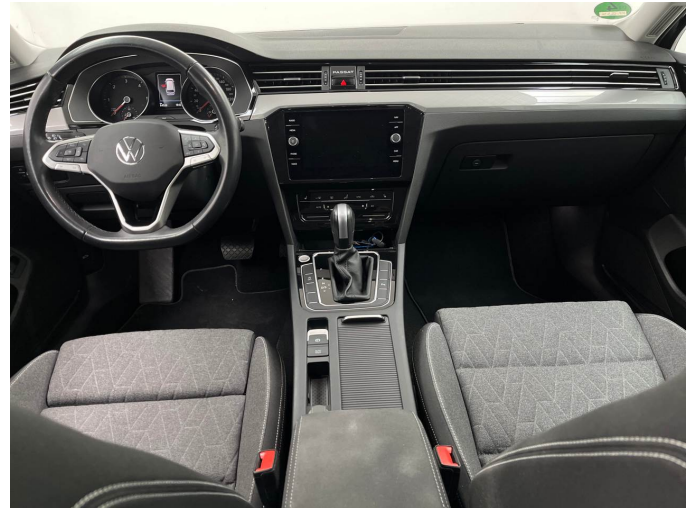
Figure 8: Instrument panel

| No. | Component group | Description |
|---|---|---|
| 1 | Instrument panel | Indicator light - on - Diagnosed and repair if necessary |

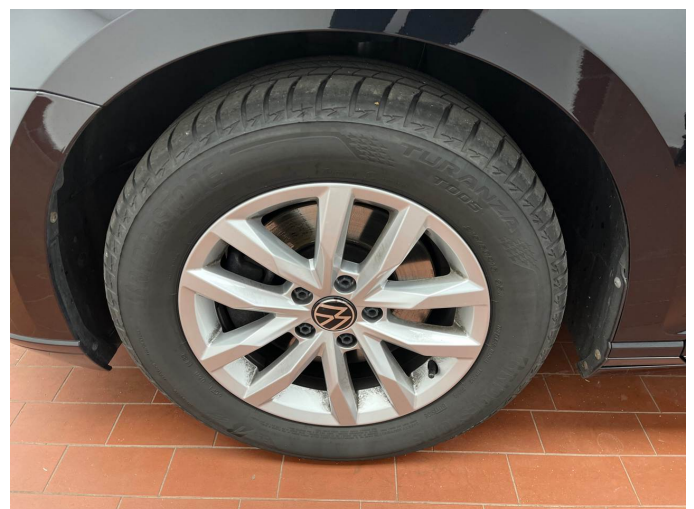
Figure 12: Mounted tyres

| # | Tyre size | Type of tyre | Manufacturer | Tread depth |
|---|---|---|---|---|
| 1) | 215/60 R16 95V | Summer tyres on Light alloy | Bridgestone | 5mm / 5mm |
| 2) | 215/60 R16 95V | Summer tyres on Light alloy | Bridgestone | 4mm / 4mm |

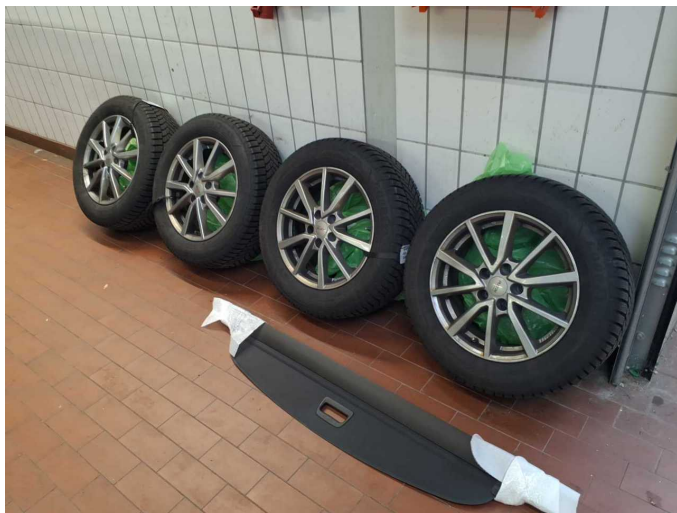
Figure 15: Additional tyres

| # | Tyre size | Type of tyre | Manufacturer | Tread depth |
|---|---|---|---|---|
| 1) | 215/60 R16 99H | Winter tyres on Light alloy | Goodyear | 6mm / 6mm |
| 2) | 215/60 R16 99H | Winter tyres on Light alloy | Goodyear | 7mm / 7mm |

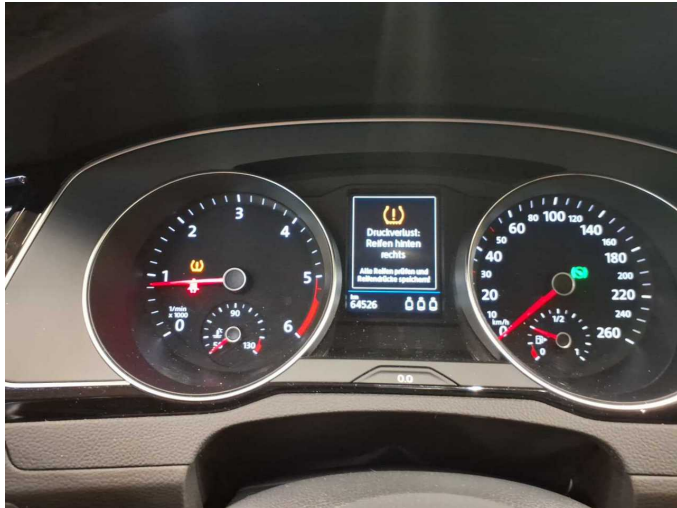
**Damage 1:** Instrument panel: Indicator light - on - Diagnosed and repair if necessary

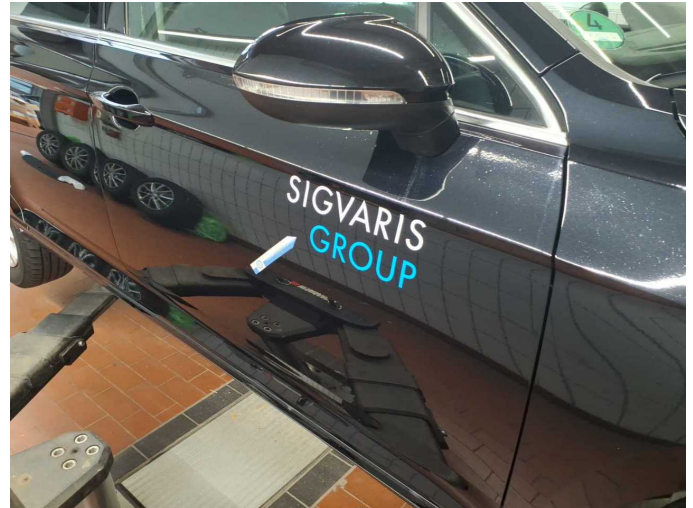
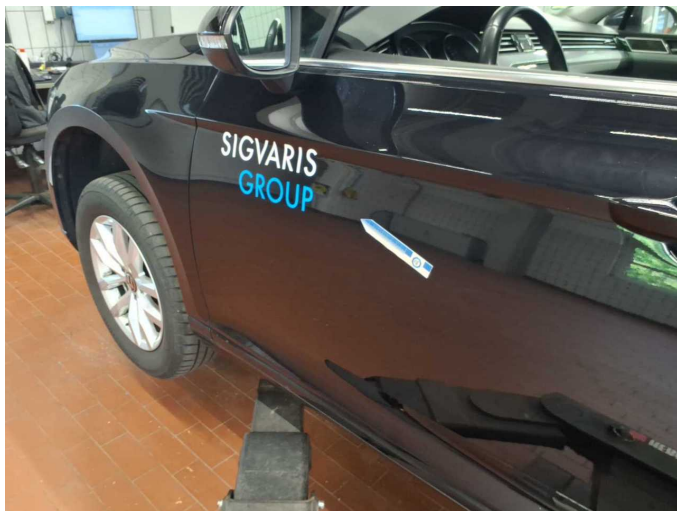
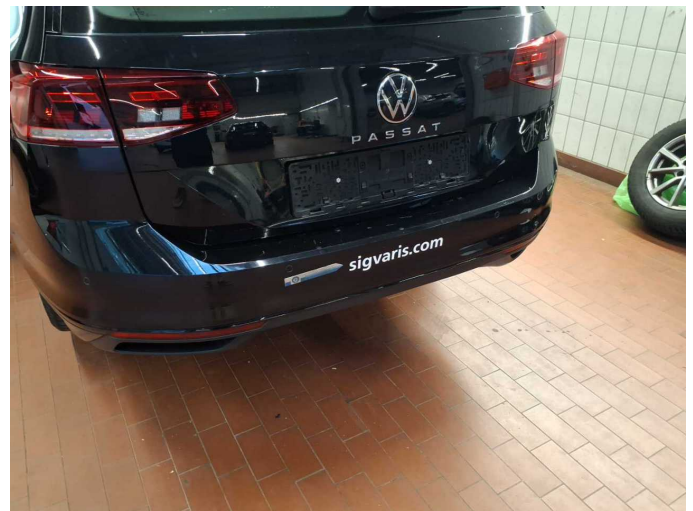
| No. | Component group | Description |
|---|---|---|
| 2 | Body | Body - Glued / labelled - De-glue / neutralise |

**Damage 2:** Body: Body - Glued / labelled - De-glue / neutralise

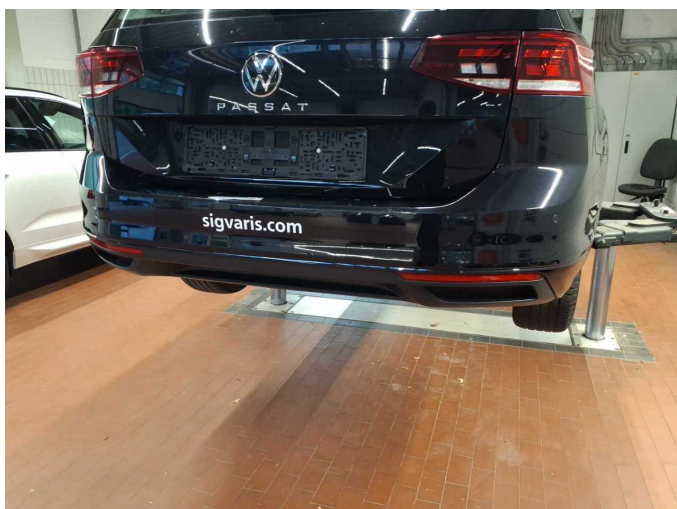
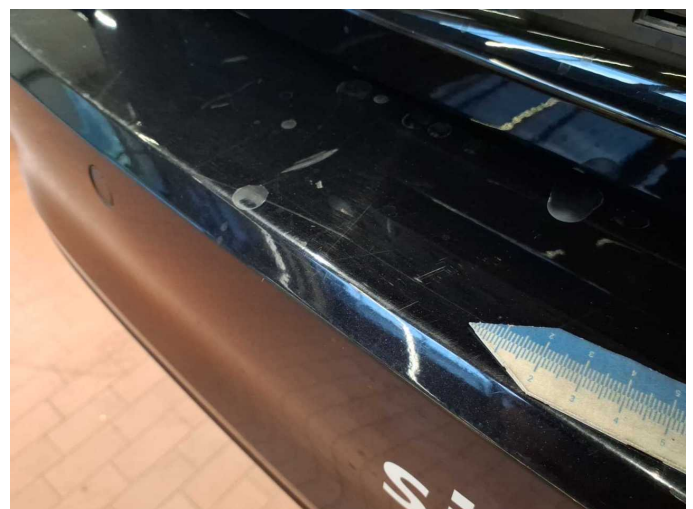
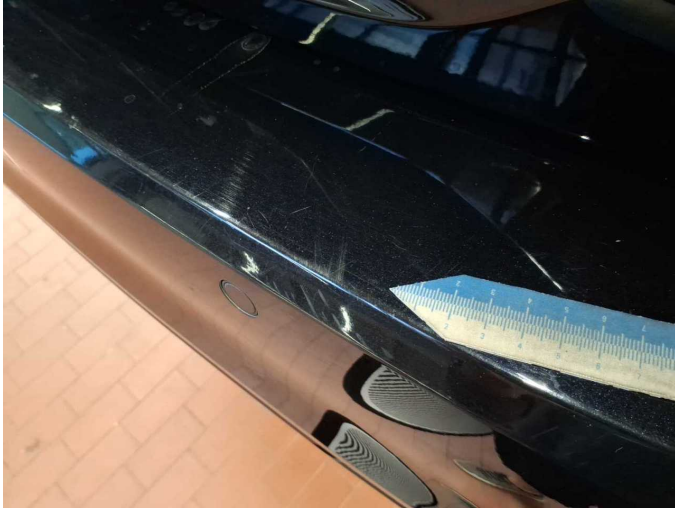
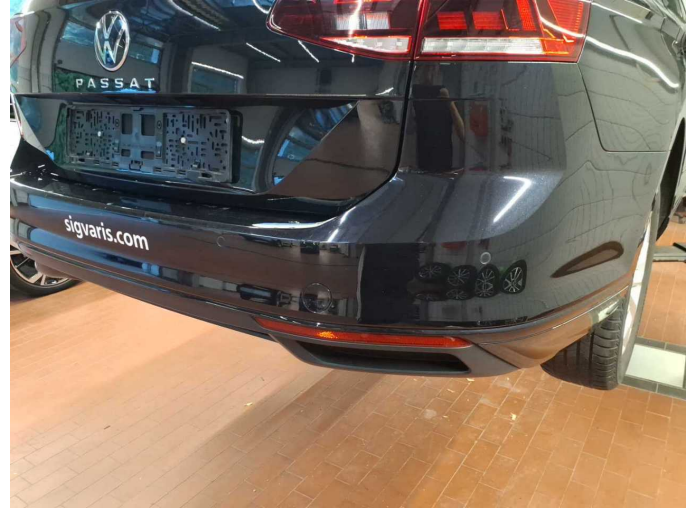
| No. | Component group | Description |
|---|---|---|
| 3 | Rear bumper | Rear bumper - Scratch(es) - Paint |

**Damage 3:** Rear bumper: Rear bumper - Scratch(es) - Paint

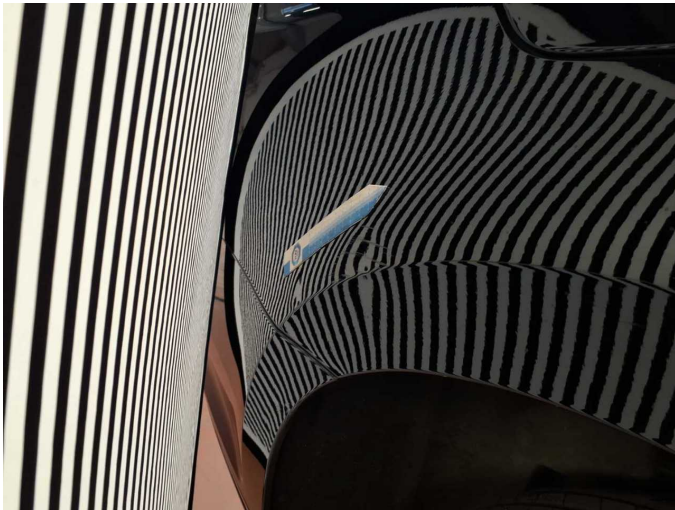
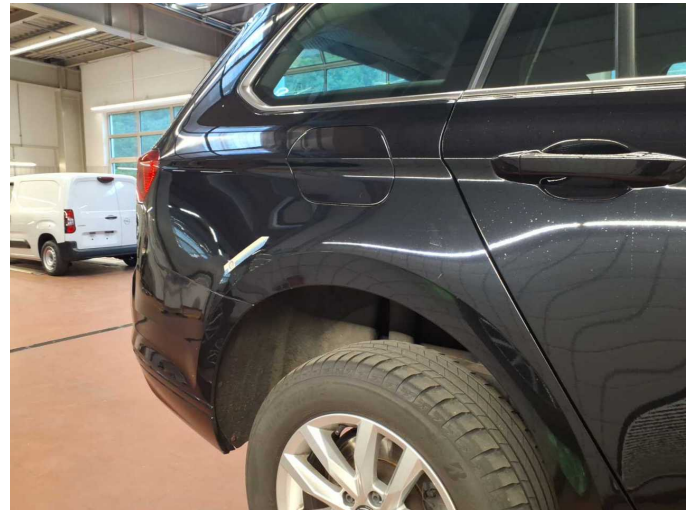
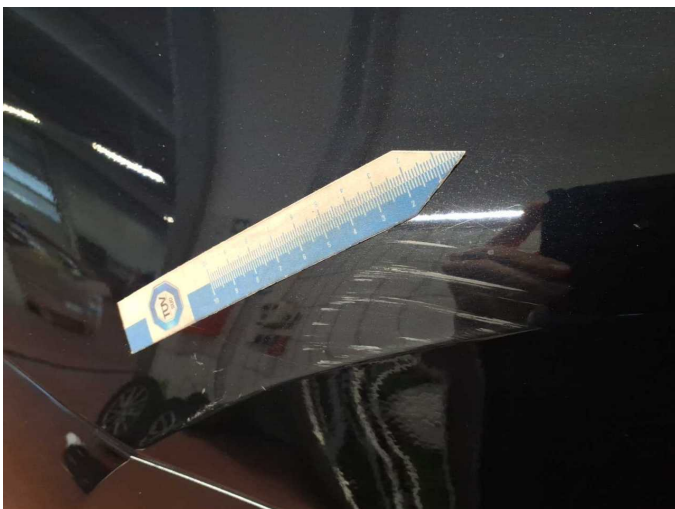
| No. | Component group | Description |
|---|---|---|
| 4 | Side panel - rear right side | Side panel - Dent / paintcoat damage - Repair and paint |

**Damage 4:** Side panel - rear right side: Side panel - Dent / paintcoat damage - Repair and paint

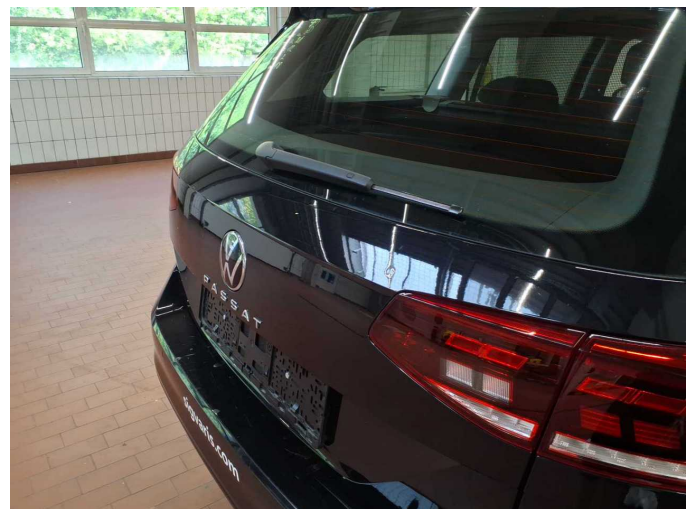
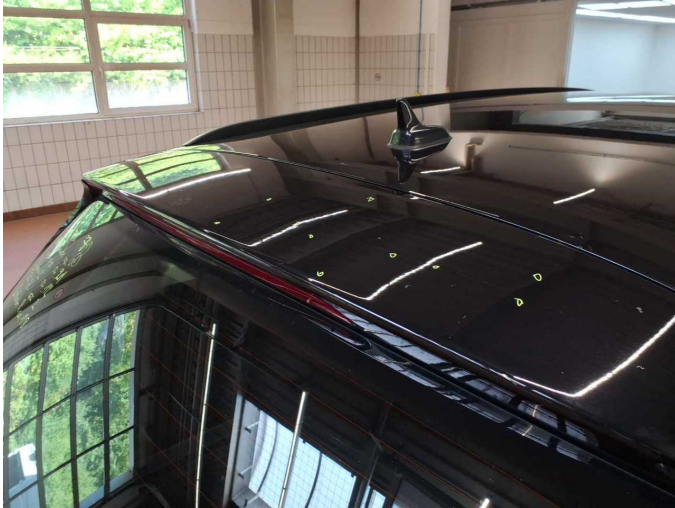
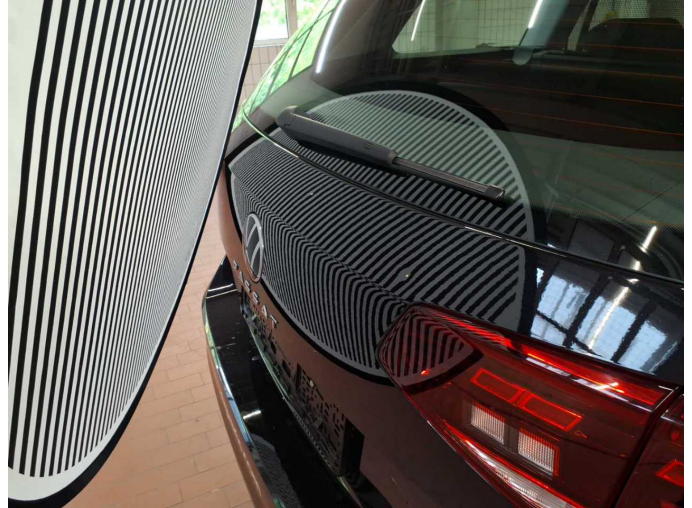
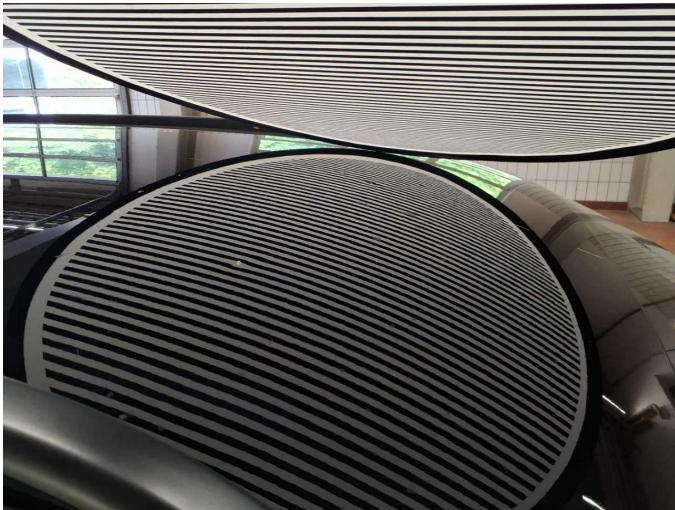
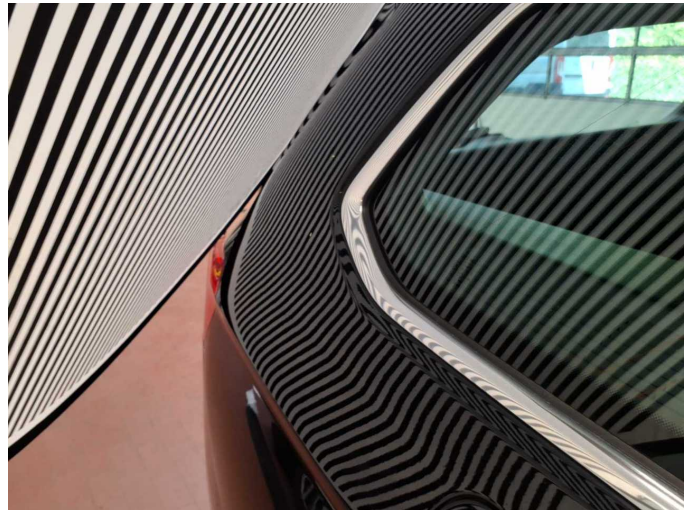
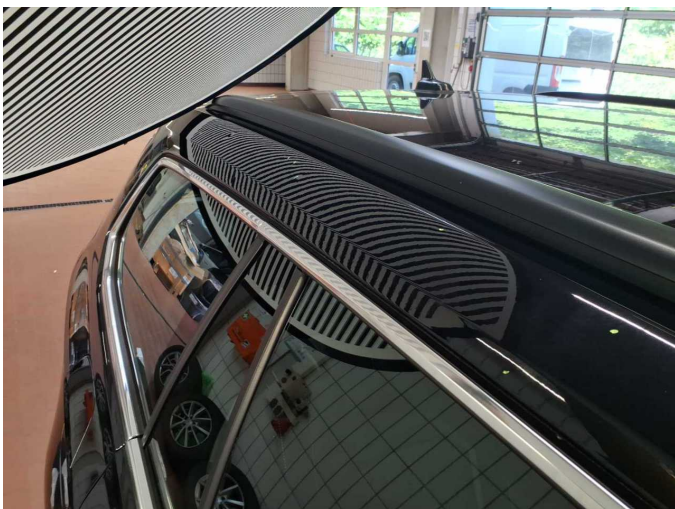
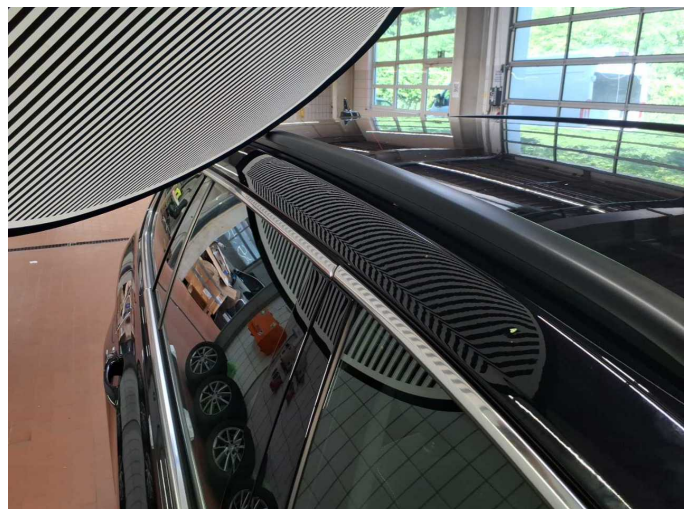
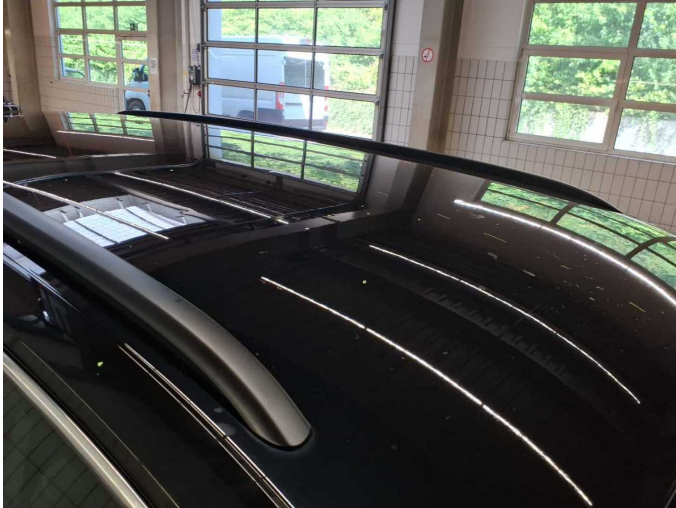
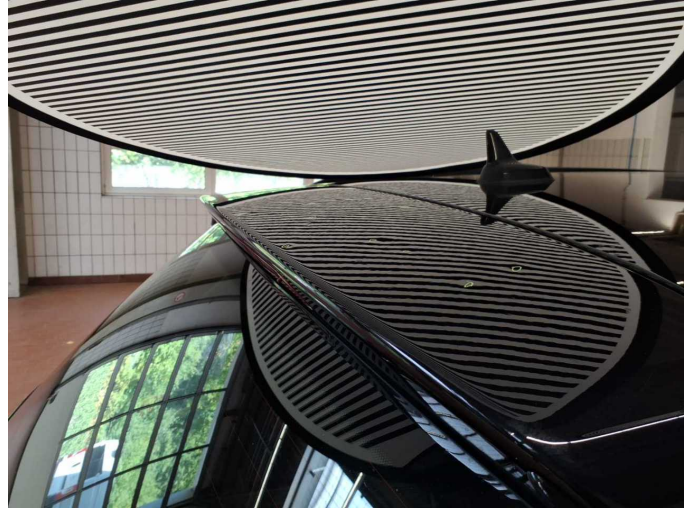
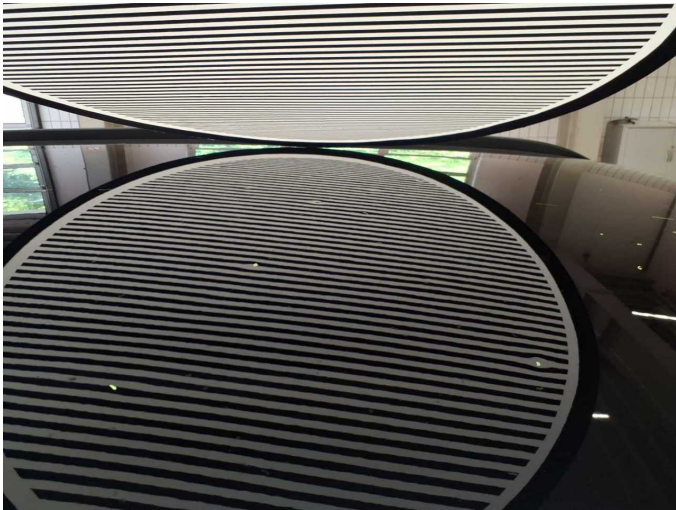
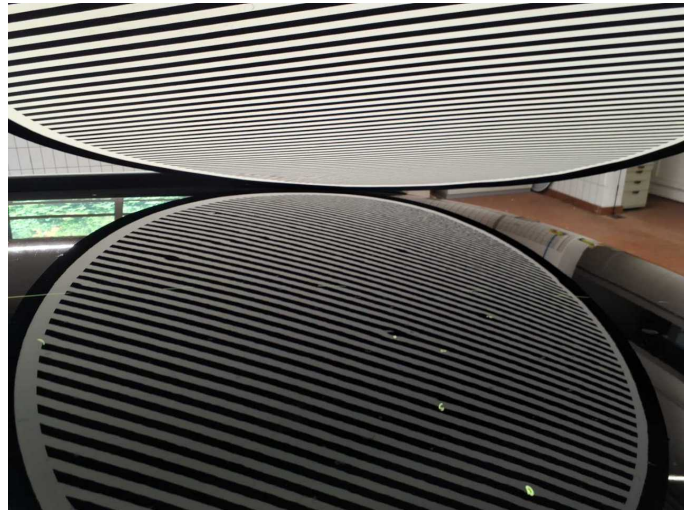
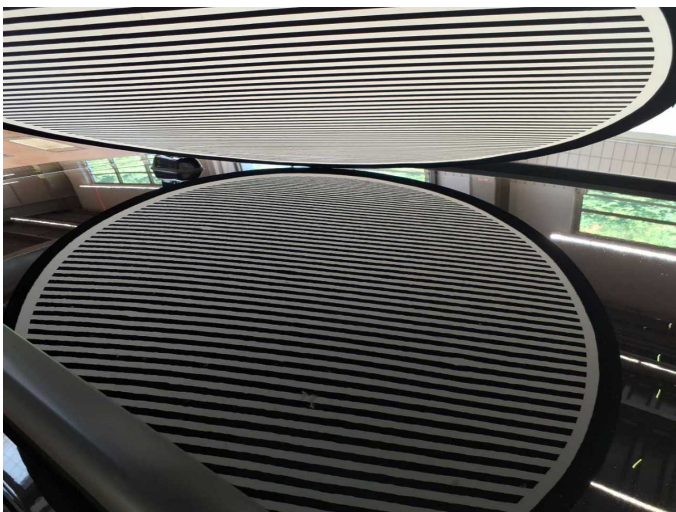
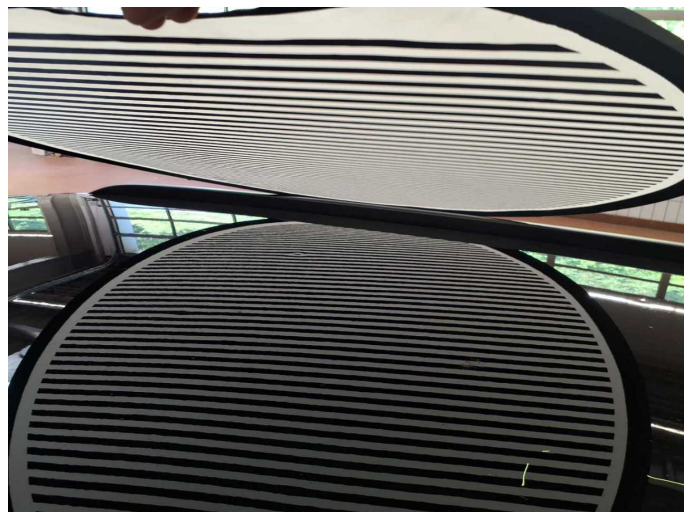
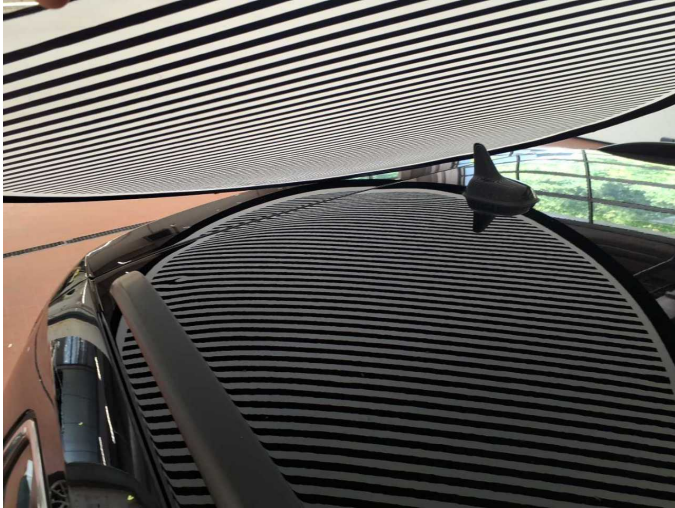
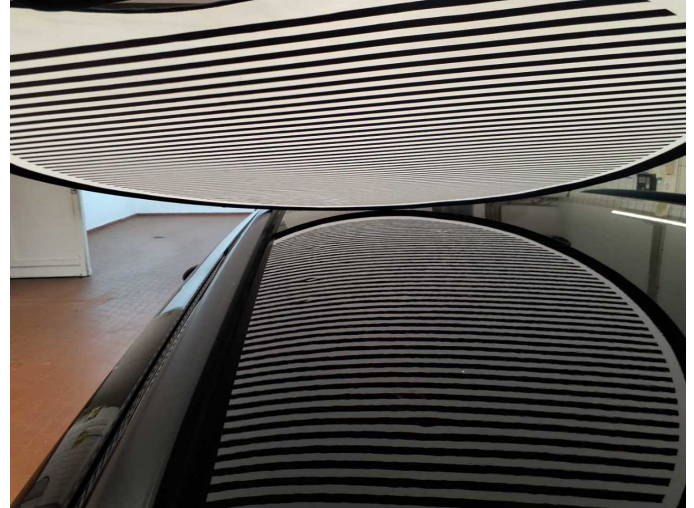
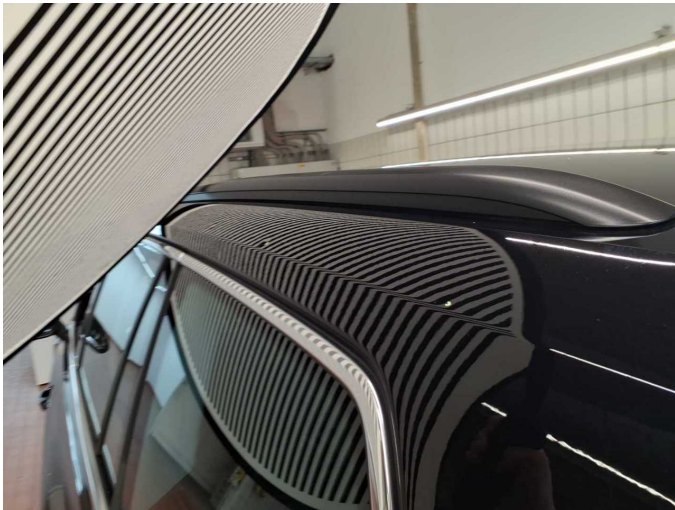
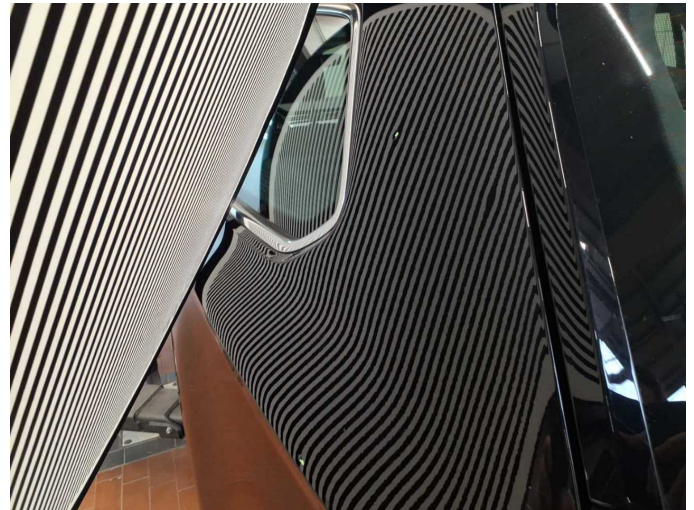
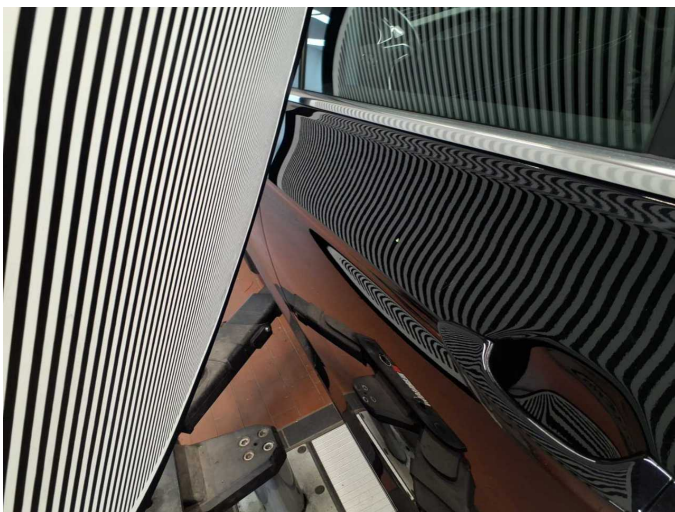
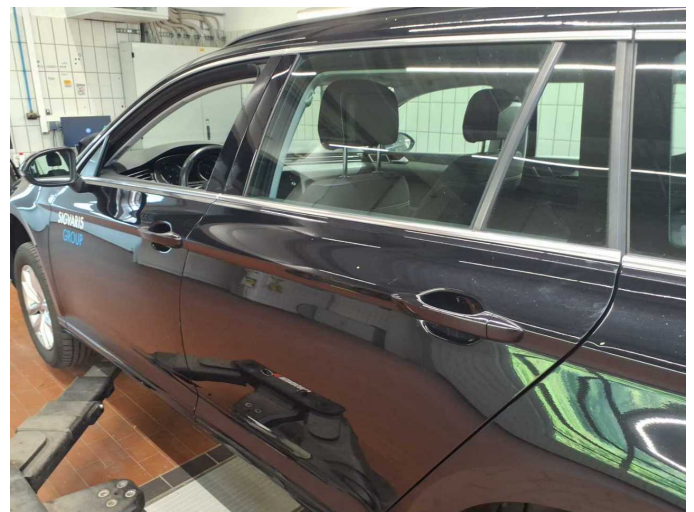
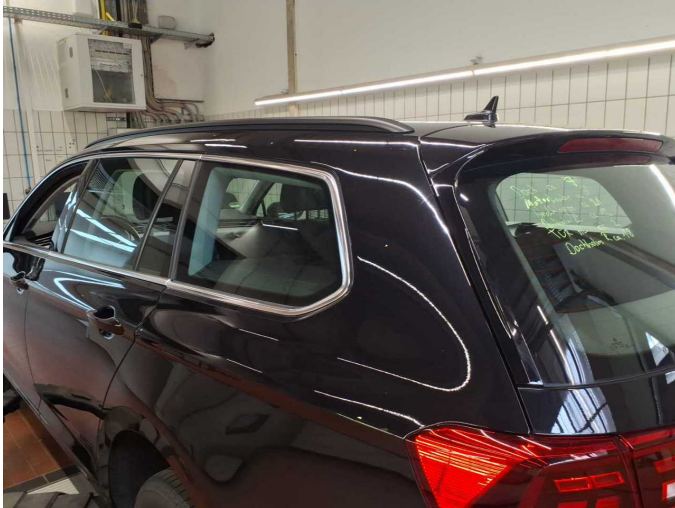
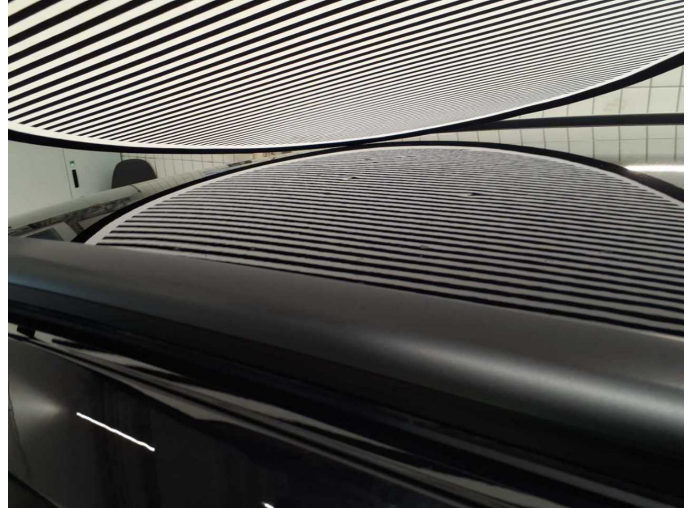
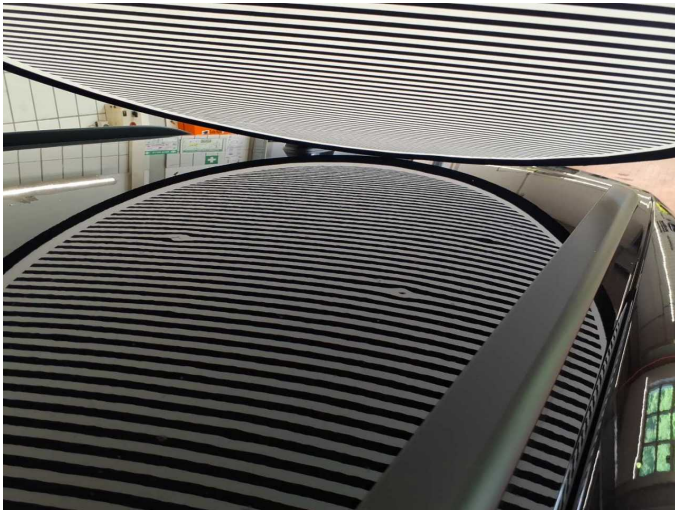
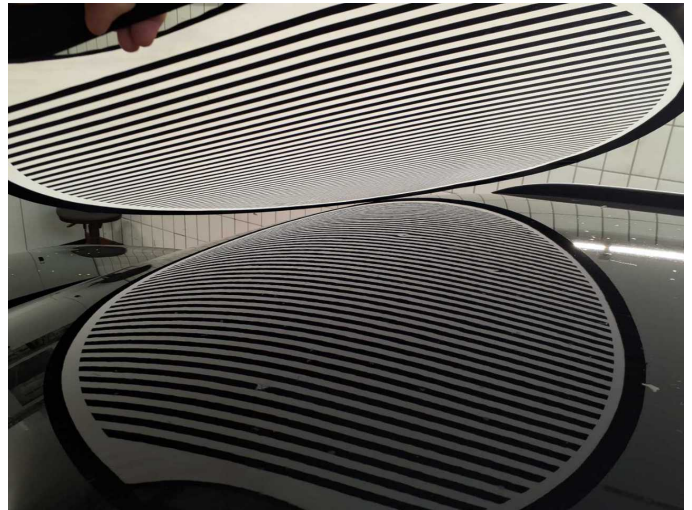
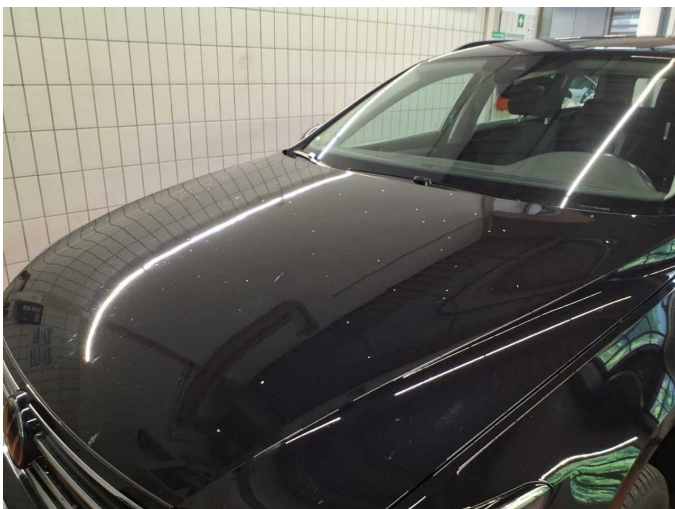
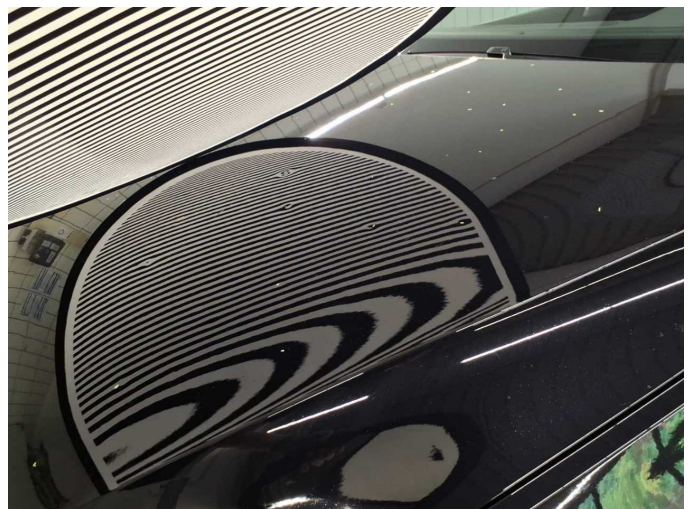
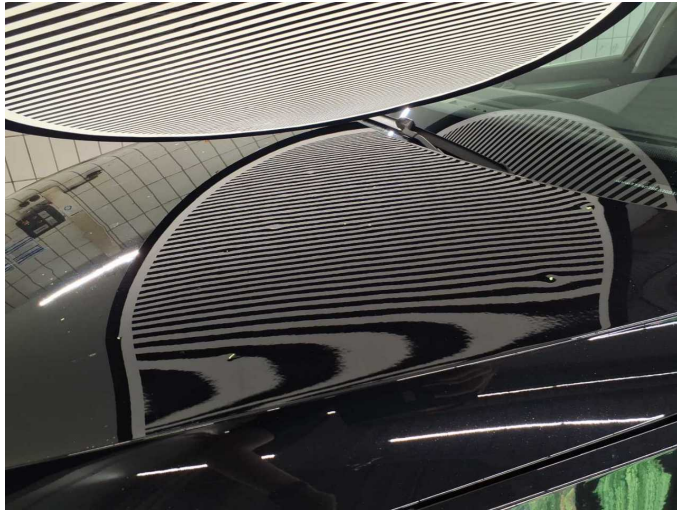
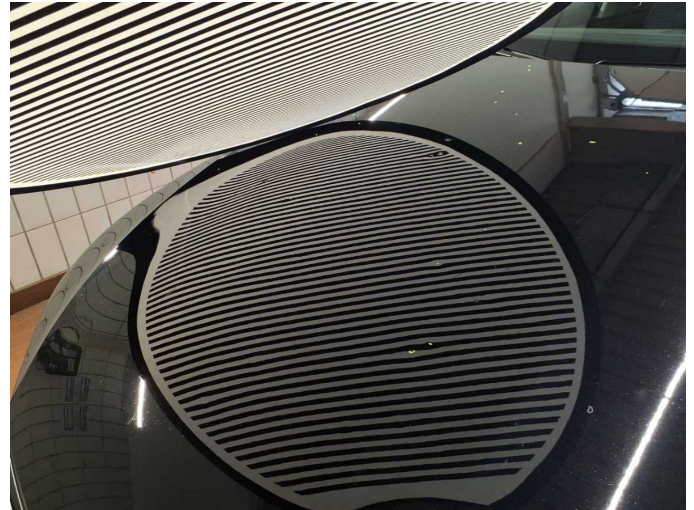
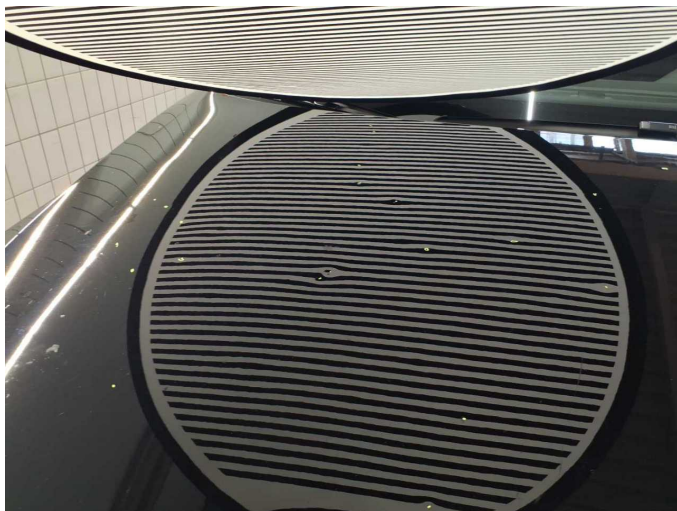
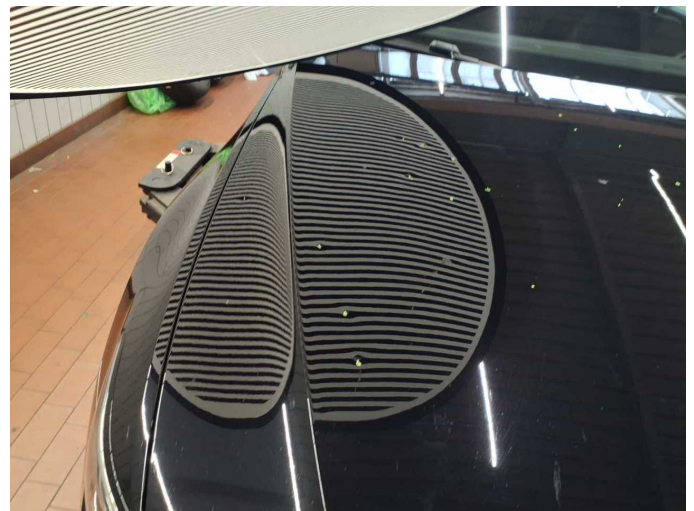
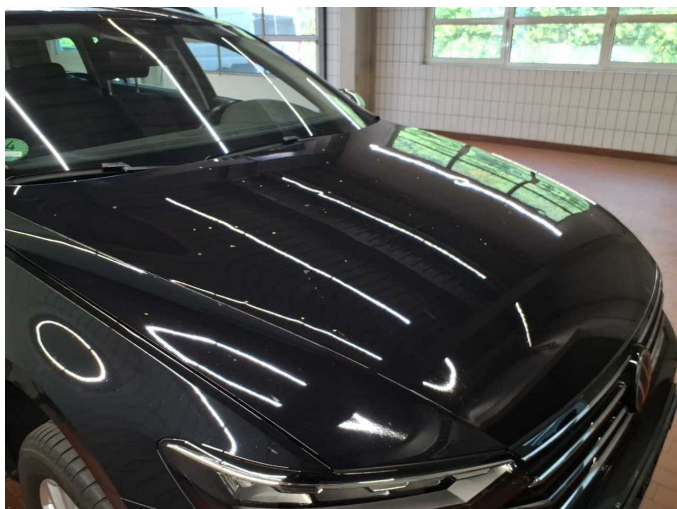
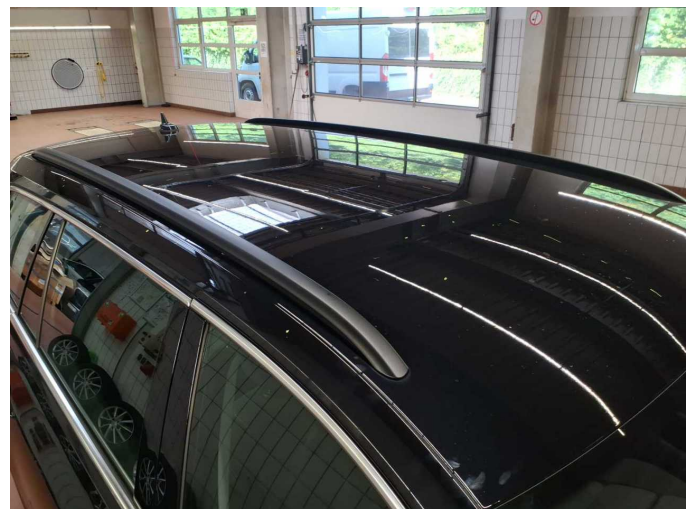
| No. | Component group | Description |
|---|---|---|
| 5 | Body | Body - Damage by hail - repair according to calculation |

**Damage 5:** Body: Body - Damage by hail - repair according to calculation
