Expertise

Protocol number: 46382511  
Order No. / Reference: 26553685  
Inspection date: 7 Jul 2026

Manufacturer: Volkswagen

Model: Tiguan 2.0 TDI SCR 4MOTION DSG Life

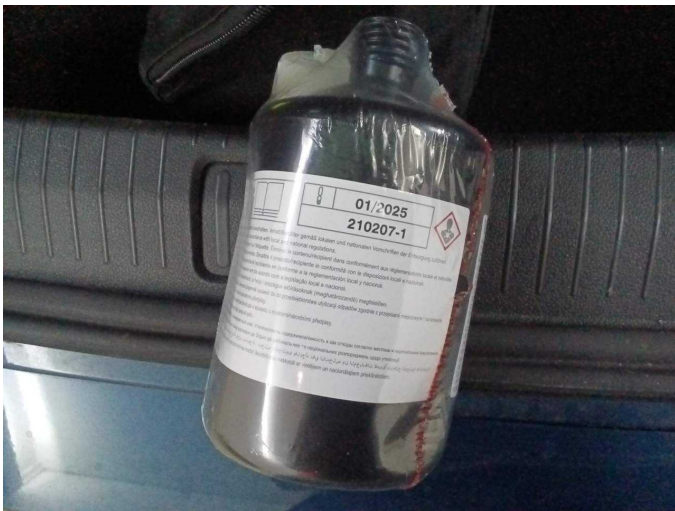
**Damage 1:** Equipment: Tirefit filler - Expired - Replace

| No. | Component group | Description |
|---|---|---|
| 1 | Equipment | Tirefit filler - Expired - Replace |

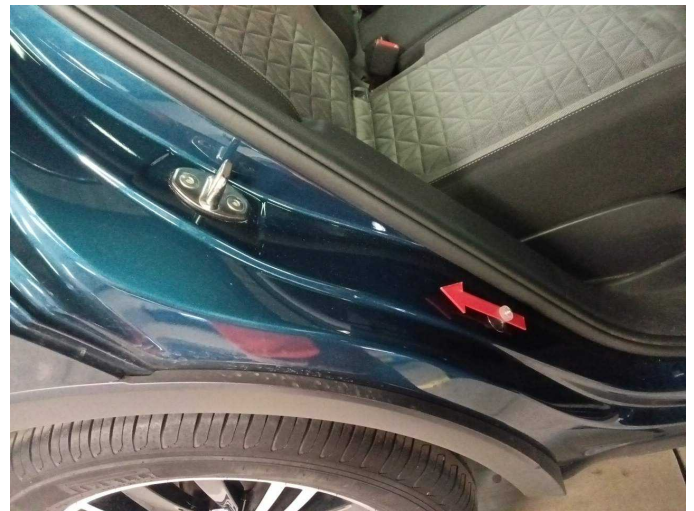
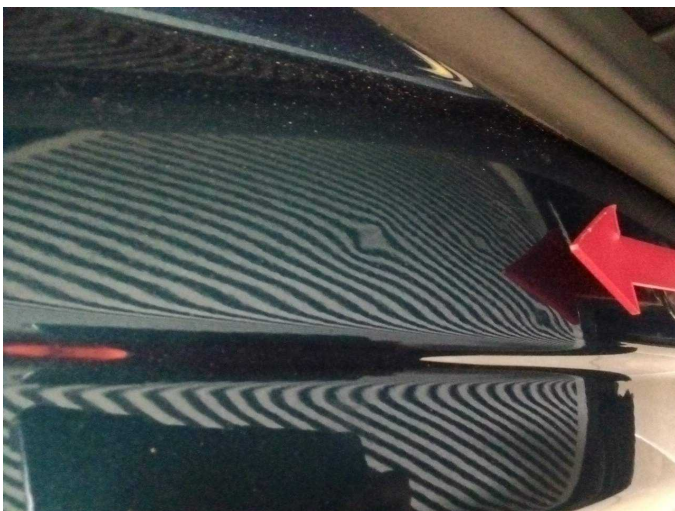
**Damage 2:** Side panel - rear right side: Sill - dent(s) - Smooth repair work

| No. | Component group | Description |
|---|---|---|
| 2 | Side panel - rear right side | Sill - dent(s) - Smooth repair work |

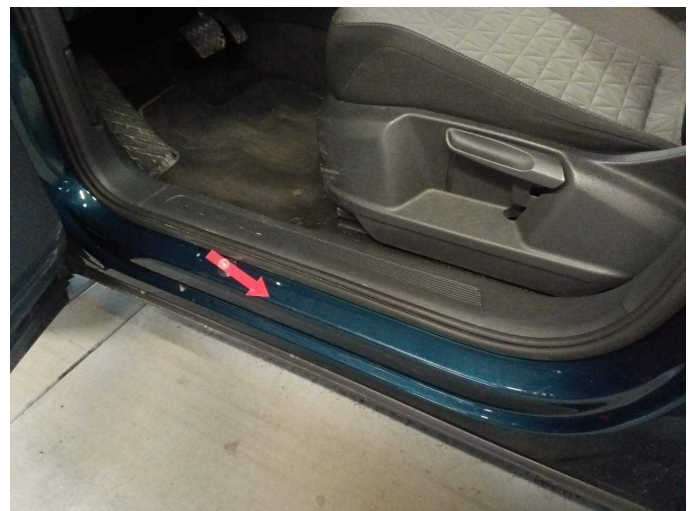
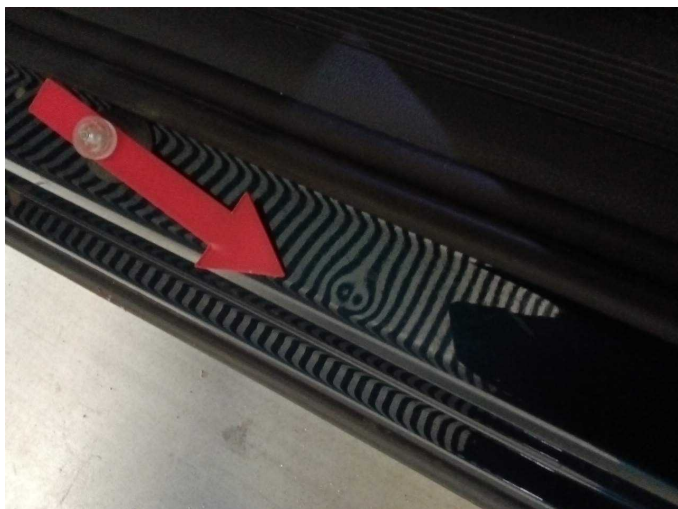
**Damage 3:** Sill - left side: Sill - dent(s) - Smooth repair work

| No. | Component group | Description |
|---|---|---|
| 3 | Sill - left side | Sill - dent(s) - Smooth repair work |

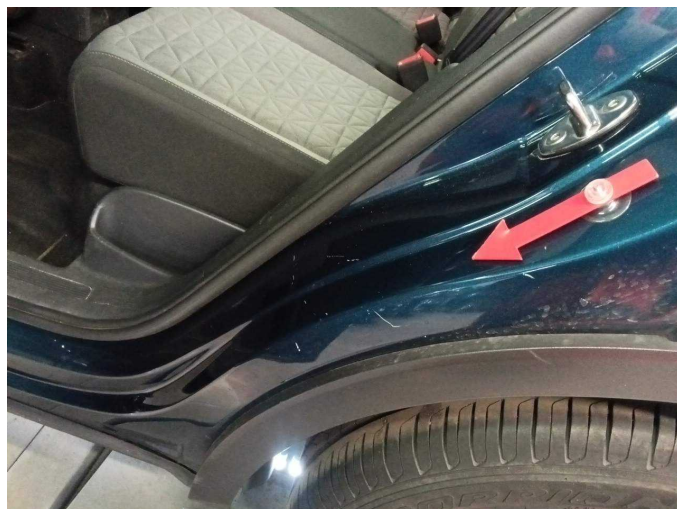
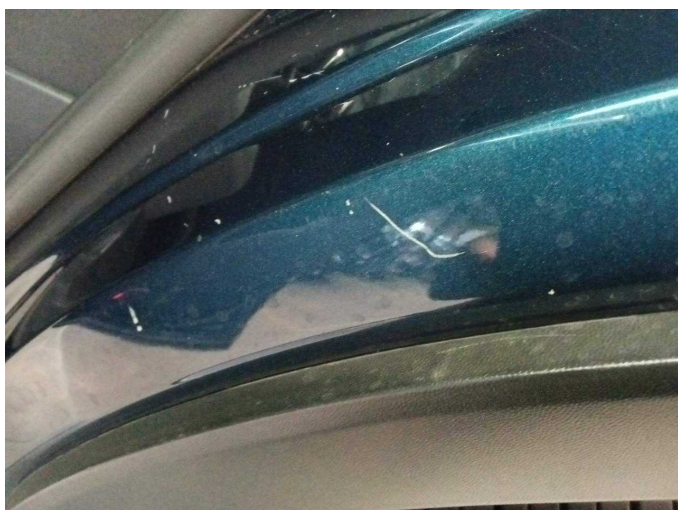
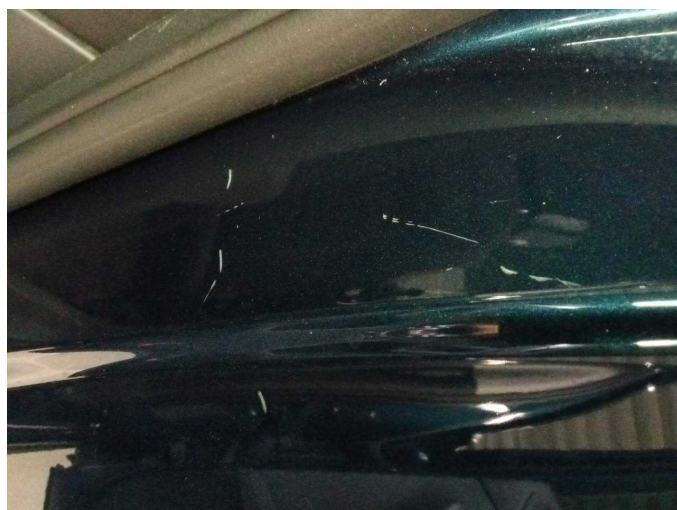
**Damage 4:** Side panel - rear left side: Sill - Scratch(es) - Smart repair

| No. | Component group | Description |
|---|---|---|
| 4 | Side panel - rear left side | Sill - Scratch(es) - Smart repair |

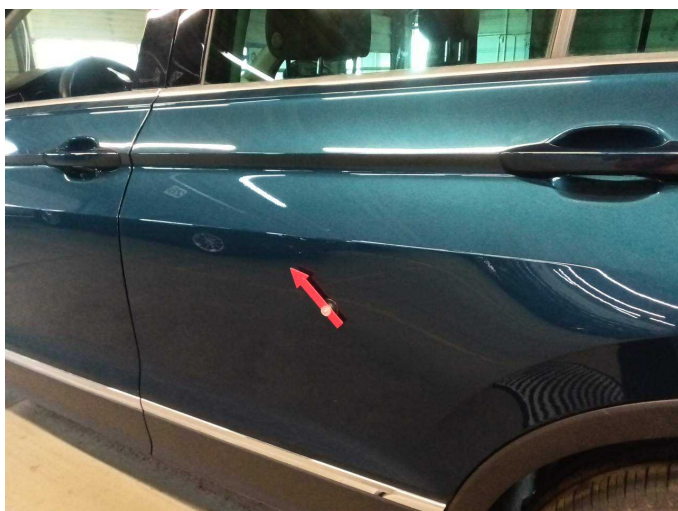
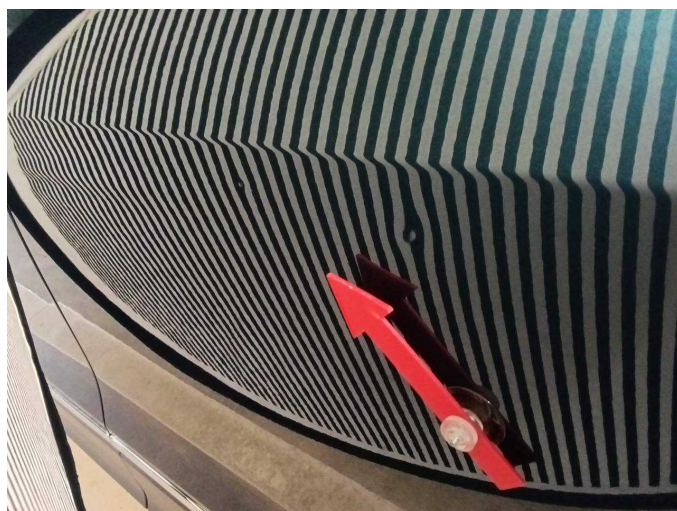
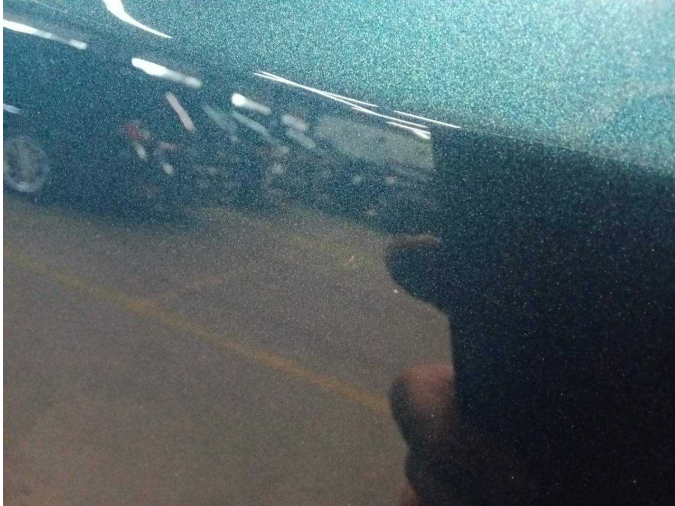
**Damage 5:** Door - rear left side: Door - Dent / paintcoat damage - Smart repair

| No. | Component group | Description |
|---|---|---|
| 5 | Door - rear left side | Door - Dent / paintcoat damage - Smart repair |

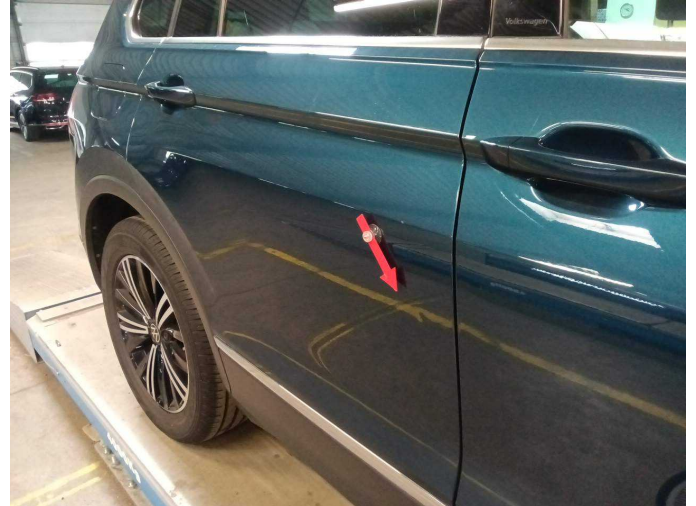
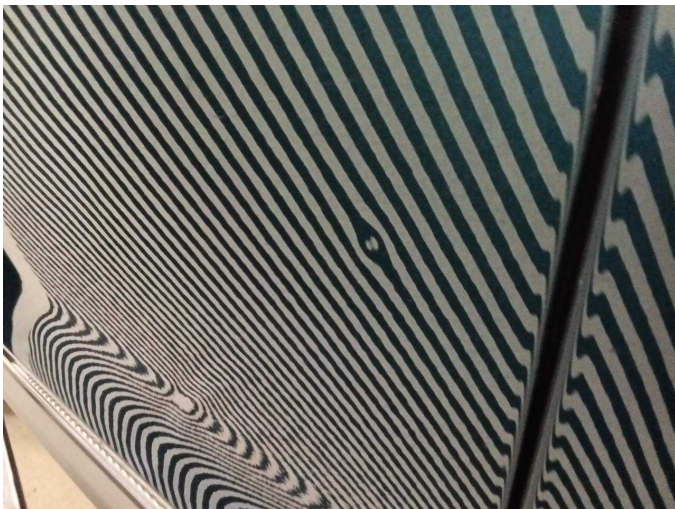
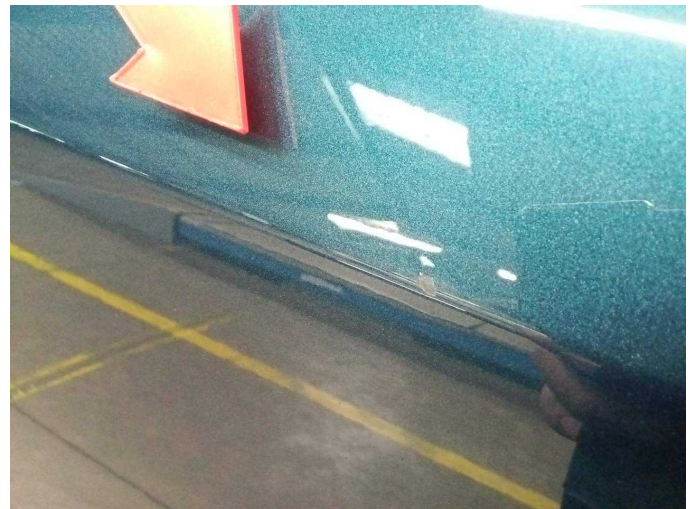
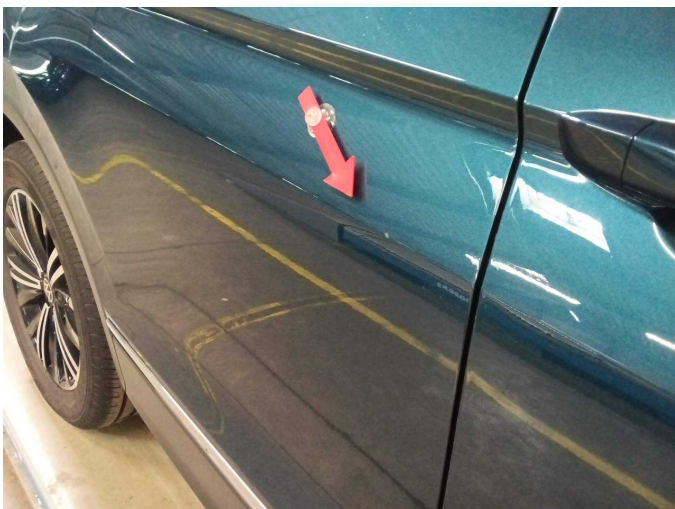
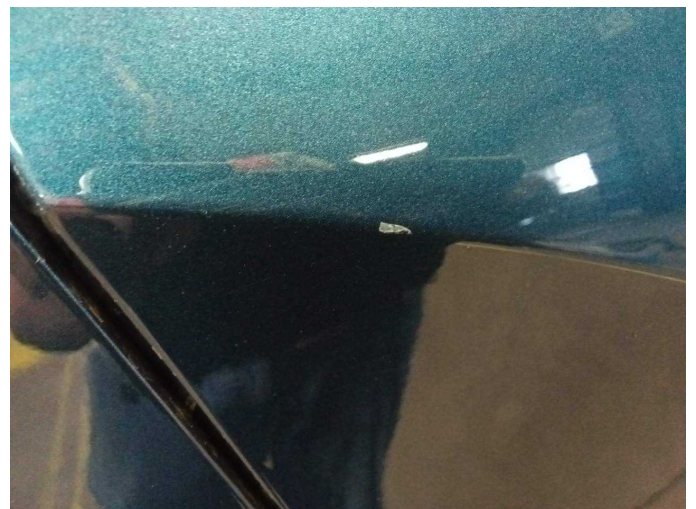
**Damage 6:** Door - rear right side: Door - Dent / paintcoat damage - Smart repair

| No. | Component group | Description |
|---|---|---|
| 6 | Door - rear right side | Door - Dent / paintcoat damage - Smart repair |

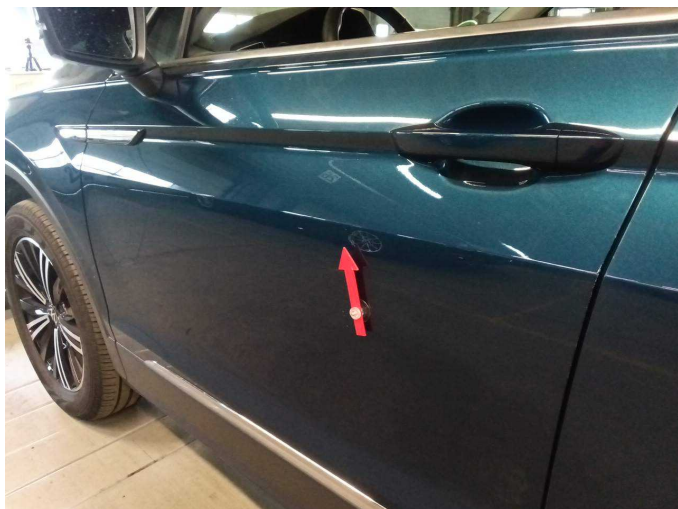
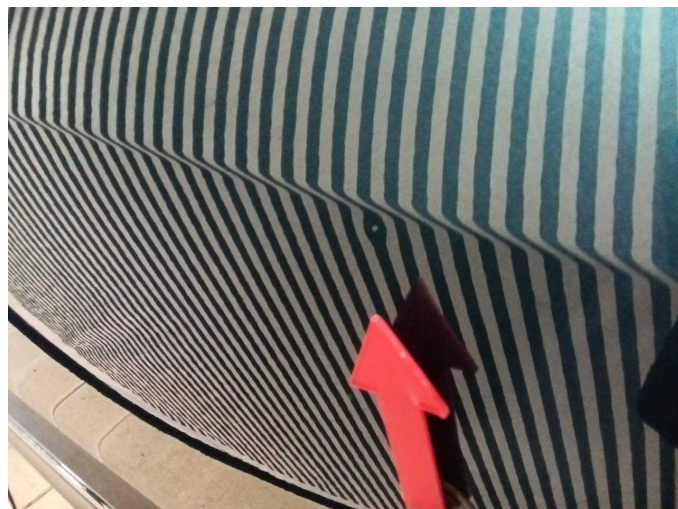
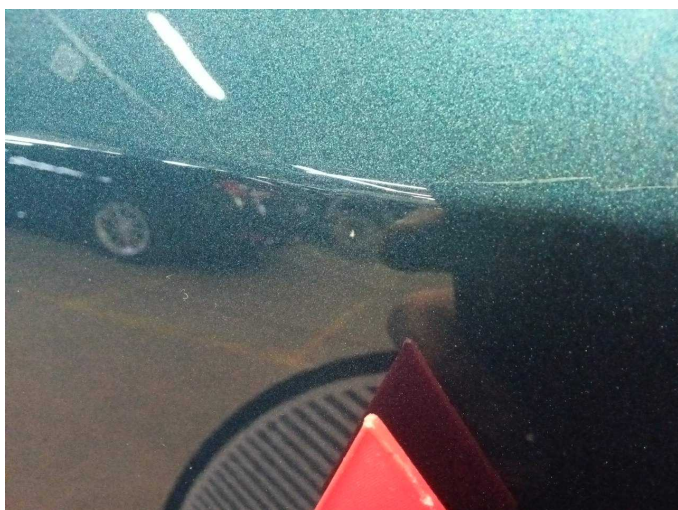
**Damage 7:** Door - front left side: Door - Dent / paintcoat damage - Smart repair

| No. | Component group | Description |
|---|---|---|
| 7 | Door - front left side | Door - Dent / paintcoat damage - Smart repair |

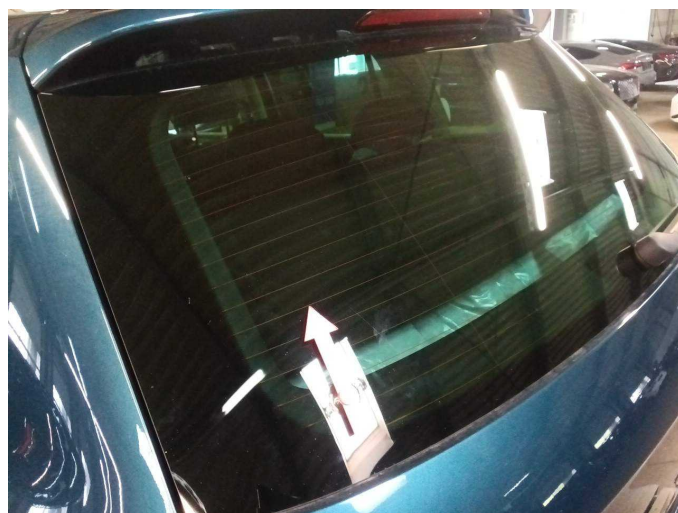
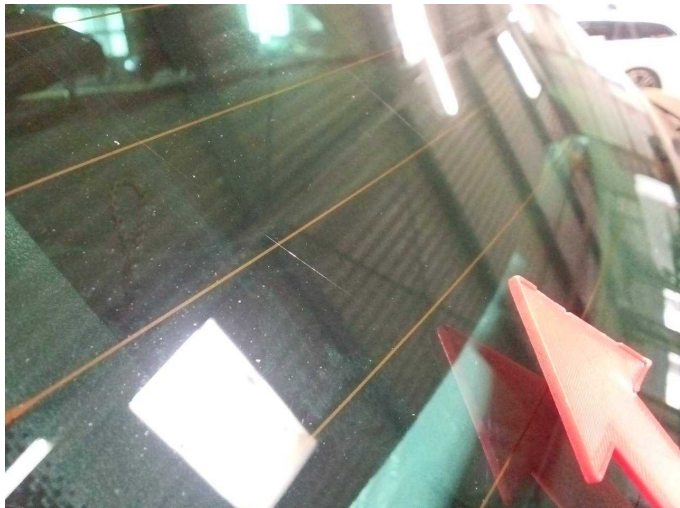
**Damage 9:** Vehicle glazing: Rear window - Scratch(es) - Replace

| No. | Component group | Description |
|---|---|---|
| 9 | Vehicle glazing | Rear window - Scratch(es) - Replace |

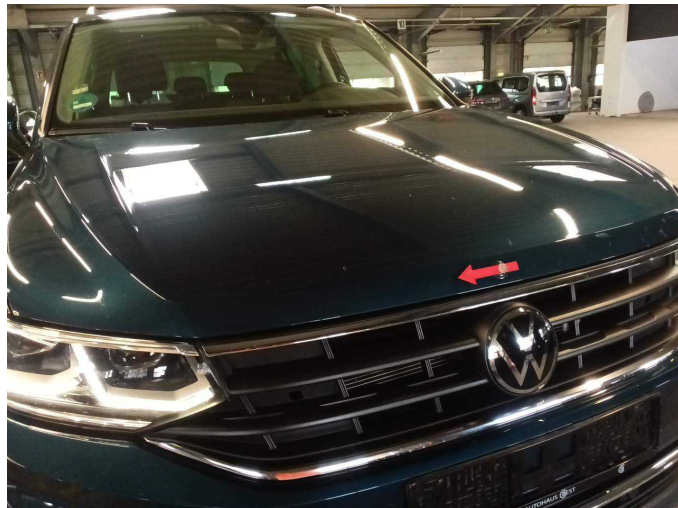
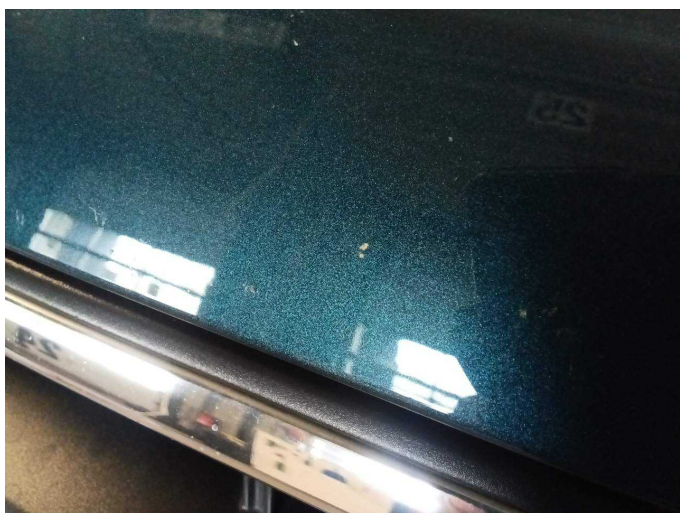
**Wear and tear 1:** Bonnet: Bonnet - Stone chips - No deduction

| No. | Component group | Description |
|---|---|---|
| 1 | Bonnet | Bonnet - Stone chips - No deduction |

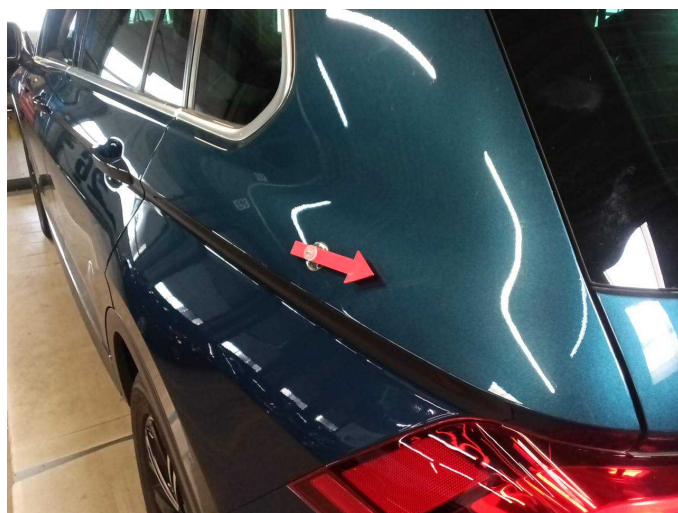
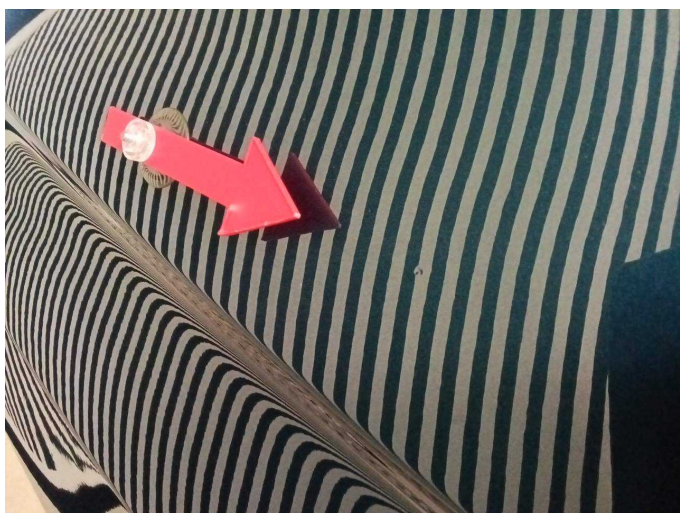
**Wear and tear 2:** Side panel - rear left side: Side panel - dent(s) - Smooth repair work

| No. | Component group | Description |
|---|---|---|
| 2 | Side panel - rear left side | Side panel - dent(s) - Smooth repair work |
