Expertise

Protocol number: 46080752  
Order No. / Reference: 26328462  
Inspection date: 22 Jun 2026

Manufacturer: Opel

Model: Corsa-e Elegance

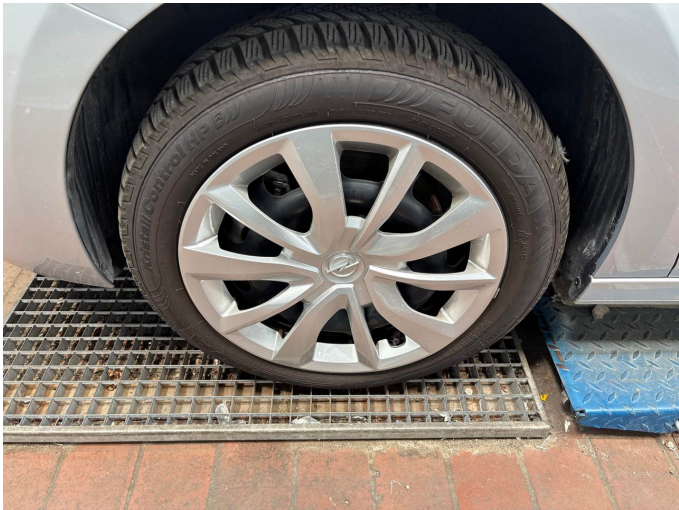
| # | Tyre size | Type of tyre | Manufacturer | Tread depth |
|---|---|---|---|---|
| 1) | 195/55 R16 87H | Winter tyres on Steel rim with wheel cover | Fulda | 6mm / 6mm |
| 2) | 195/55 R16 87H | Winter tyres on Steel rim with wheel cover | Fulda | 6mm / 6mm |

Figure 12: Mounted tyres

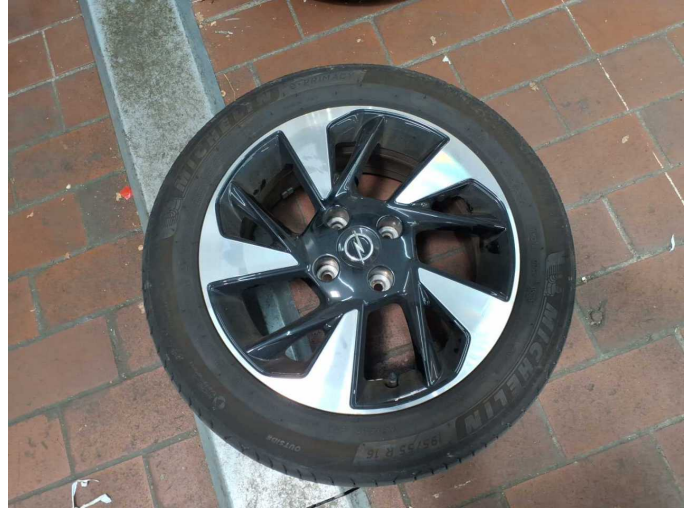
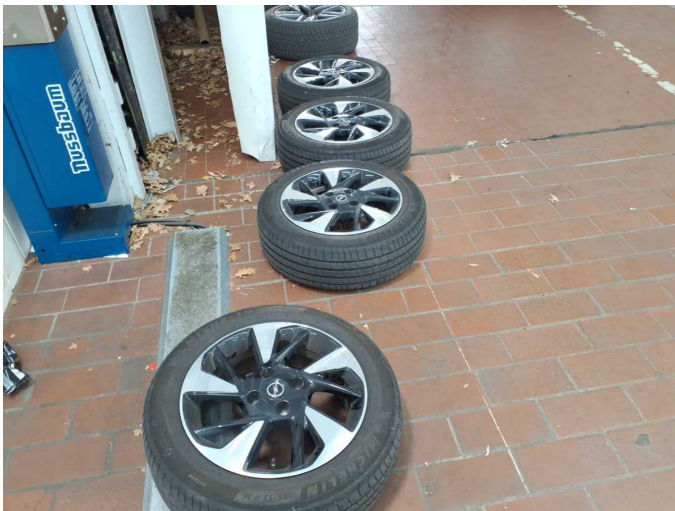
| # | Tyre size | Type of tyre | Manufacturer | Tread depth |
|---|---|---|---|---|
| 1) | 195/55 R16 91H | Summer tyres on Light alloy | Michelin | 4mm / 4mm |
| 2) | 195/55 R16 91H | Summer tyres on Light alloy | Michelin | 4mm / 4mm |

Figure 14: Additional tyres

Figure 15: Additional tyres

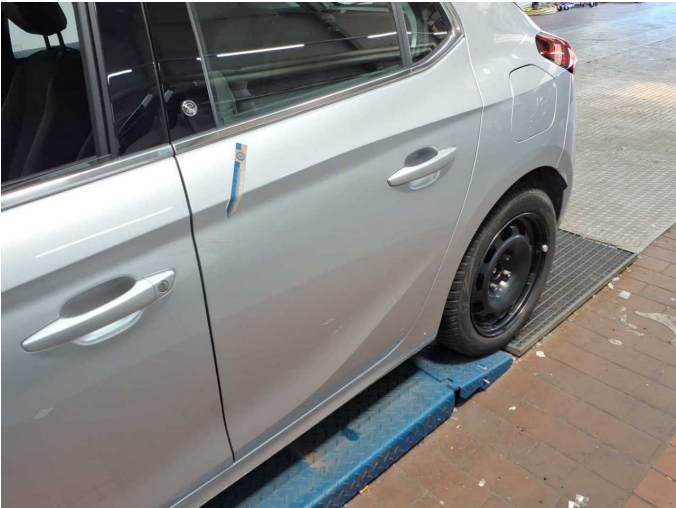
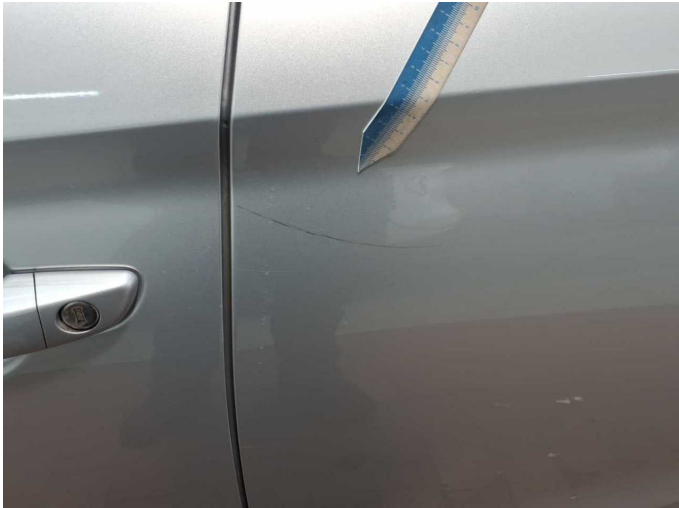
| No. | Component group | Description |
|---|---|---|
| 1 | Door - rear left side | Door - Scratch(es) - Smart repair |

Damage 1: Door - rear left side: Door - Scratch(es) - Smart repair

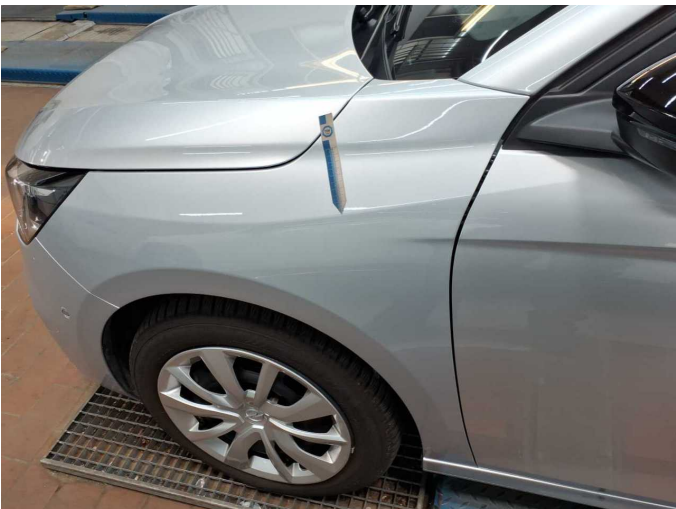
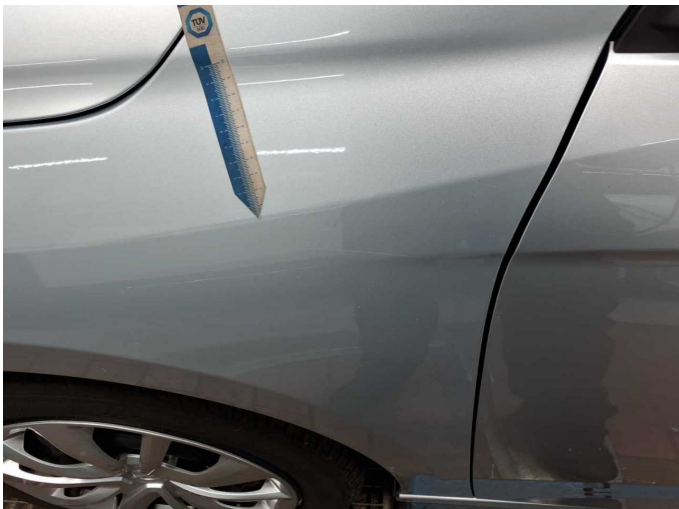
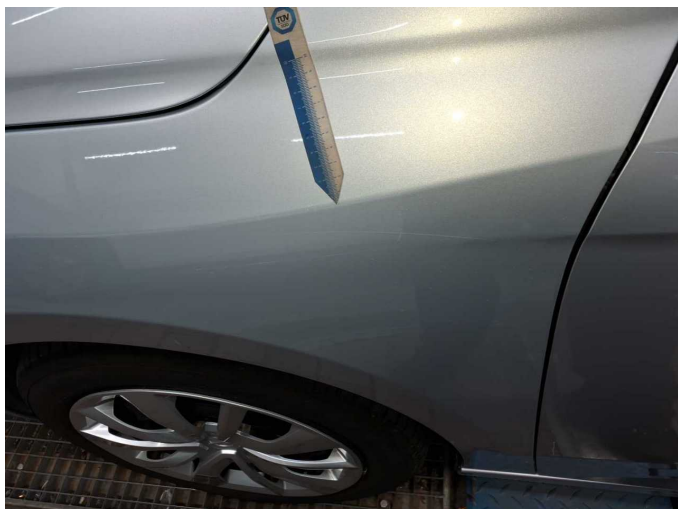
| No. | Component group | Description |
|---|---|---|
| 2 | Mudguard - right side | Mudguard - right side - Scratch(es) - Paint |

Damage 2: Mudguard - right side: Mudguard - right side - Scratch(es) - Paint

**Damage 2:** Mudguard - right side: Mudguard - right side - Scratch(es) - Paint

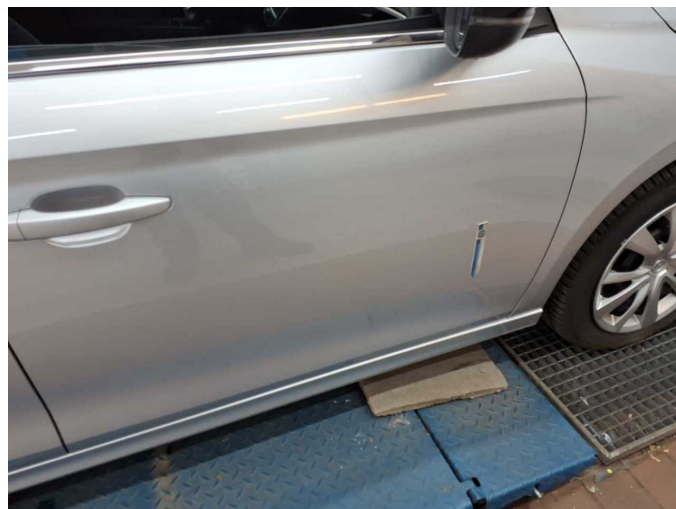
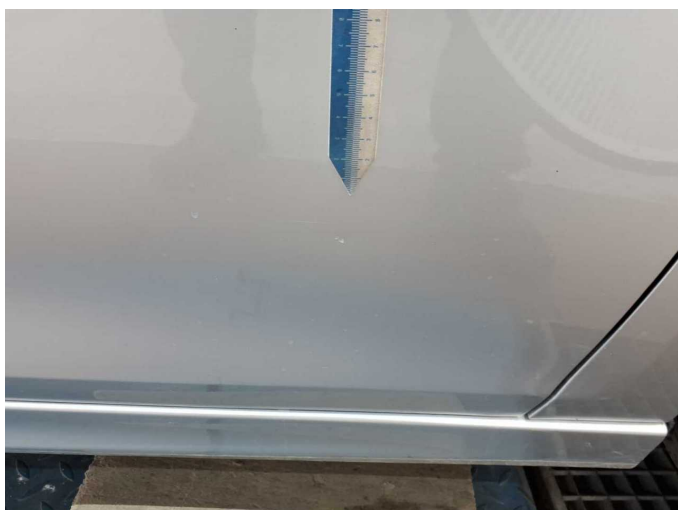
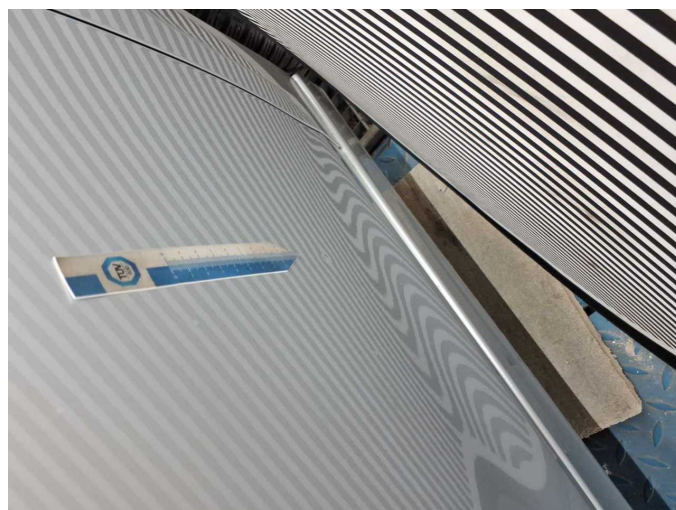
| No. | Component group | Description |
|---|---|---|
| 3 | Door - front right side | Door - Dent / paintcoat damage - Repair and paint |

**Damage 3:** Door - front right side: Door - Dent / paintcoat damage - Repair and paint

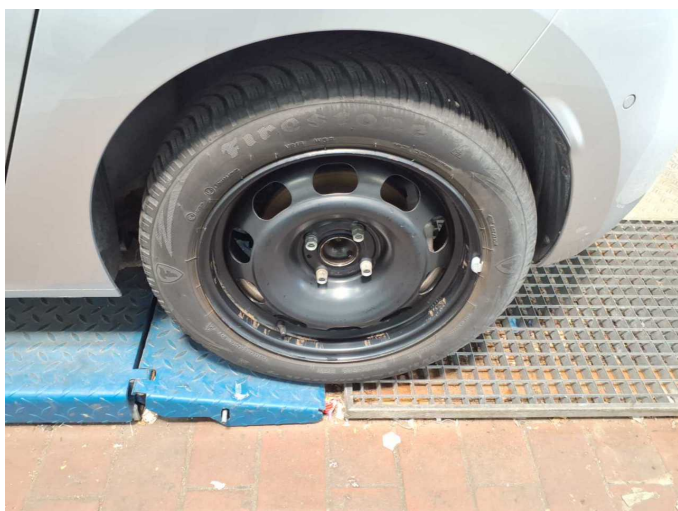
Wheel / tyres - Wheel rim - rear left side (Radkappe fehlt)

**Missing part 1:** Wheel / tyres: Wheel rim - rear left side (Radkappe fehlt)  
- Missing - Replace
