Expertise

Protocol number: 46046863  
Order No. / Reference: 26307744  
Inspection date: 19 Jun 2026

Manufacturer: Opel

Model: Astra Sports Tourer 1.2 Turbo Automatik GS

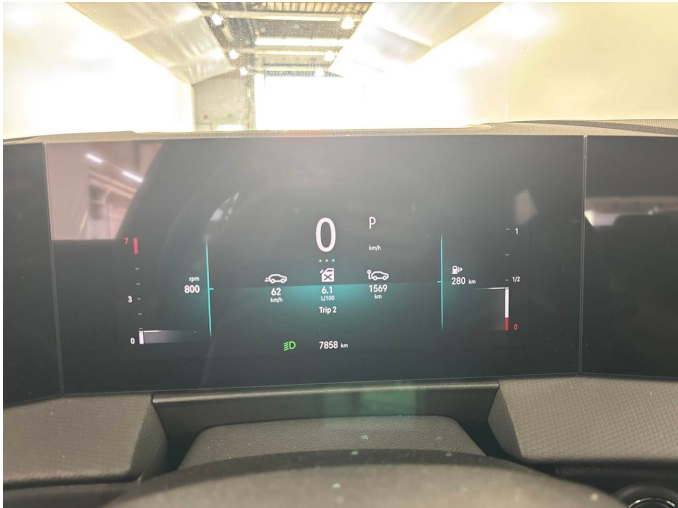
Figure 7: Instrument cluster

| Vehicle details | |
|---|---|
| Mileage (Read) | 7,858 km |

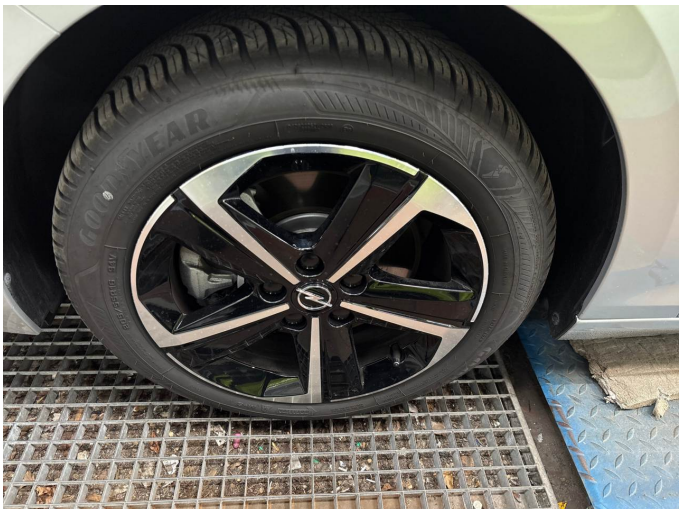
Figure 12: Mounted tyres

| Tyres | | | |
|---|---|---|---|
| 1) | 205/55 R16 94V | All-season tyres on Light alloy | 5mm / 5mm |
| 2) | 205/55 R16 94V | All-season tyres on Light alloy | 5mm / 5mm |

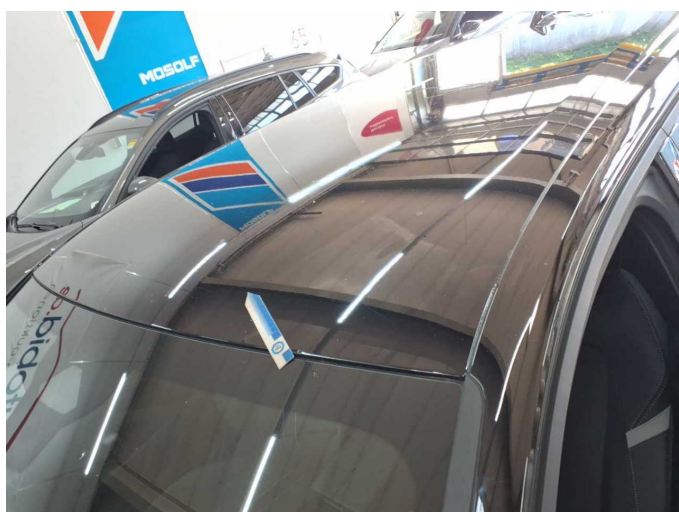
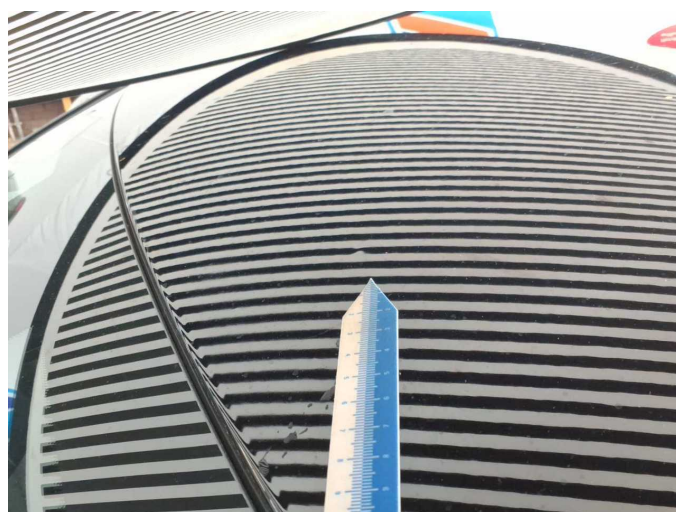
| No. | Component group | Description |
|---|---|---|
| 1 | Roof | Roof - dent(s) - Smooth repair work |

Damage 1: Roof: Roof - dent(s) - Smooth repair work

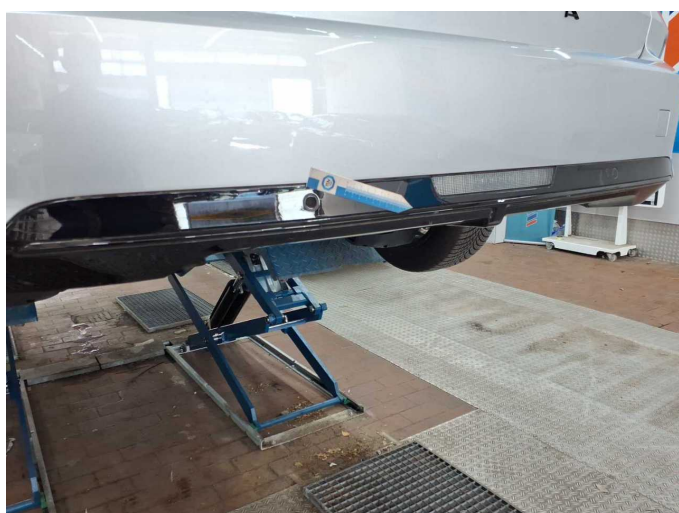
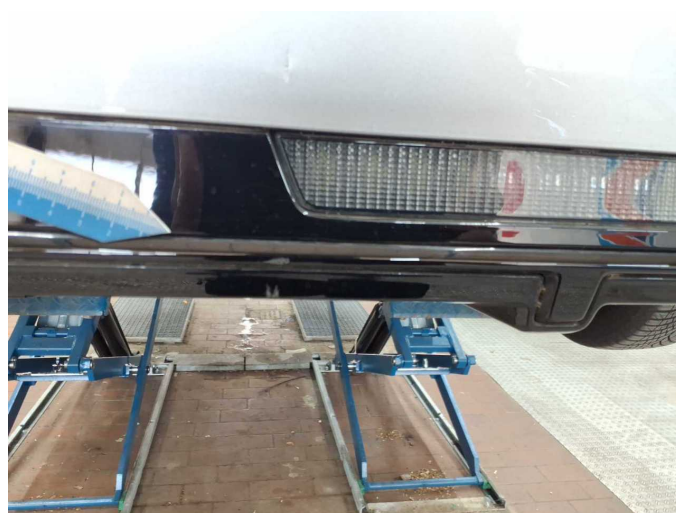
| No. | Component group | Description |
|---|---|---|
| 2 | Rear bumper | Spoiler - Scratch(es) - Smart repair |

Damage 2: Rear bumper: Spoiler - Scratch(es) - Smart repair

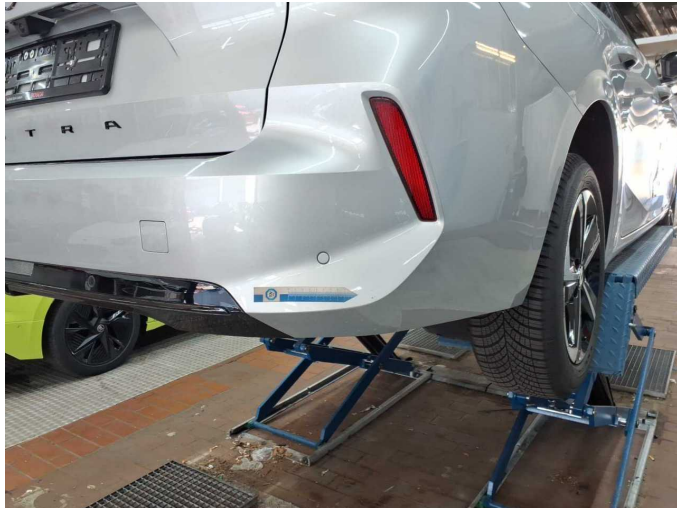
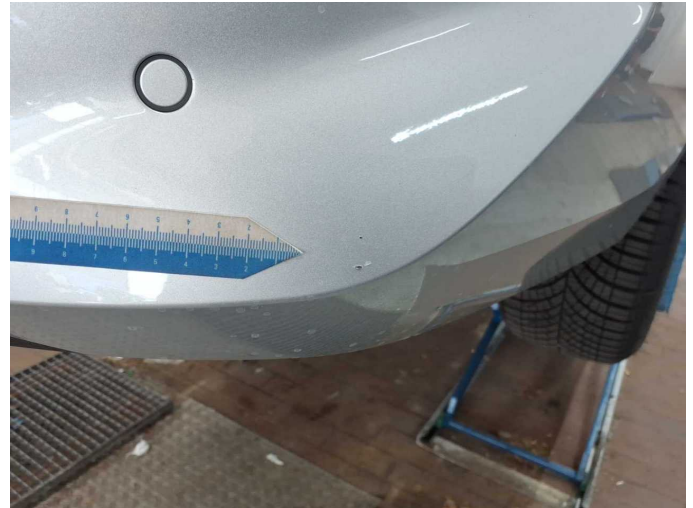
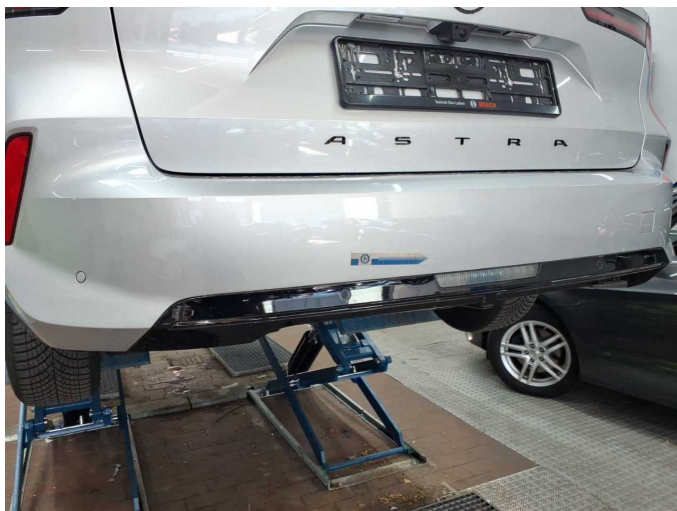
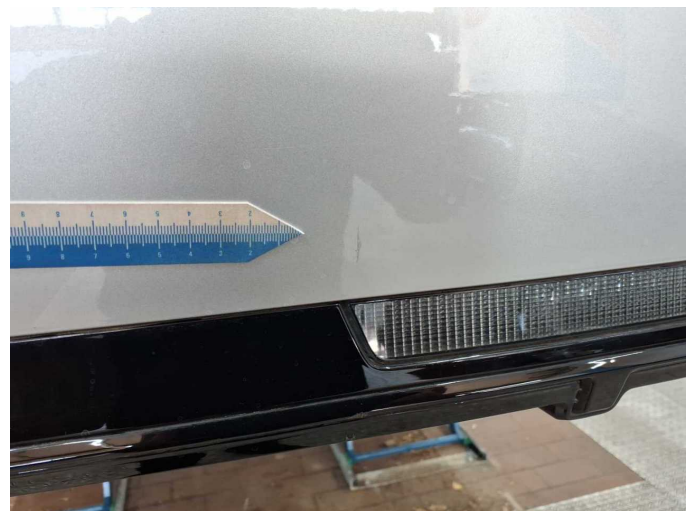
| No. | Component group | Description |
|---|---|---|
| 3 | Rear bumper | Rear bumper - Scratch(es) - Paint |

**Damage 3:** Rear bumper: Rear bumper - Scratch(es) - Paint
